Transportation
Safety Board
of Canada

AIR TRANSPORTATION SAFETY INVESTIGATION REPORT A21C0038

COLLISION WITH TERRAIN

Great Slave Helicopters 2018 Ltd.
Airbus Helicopters AS350 B2 (helicopter), C-FYDA
Griffith Island, Nunavut
25 April 2021

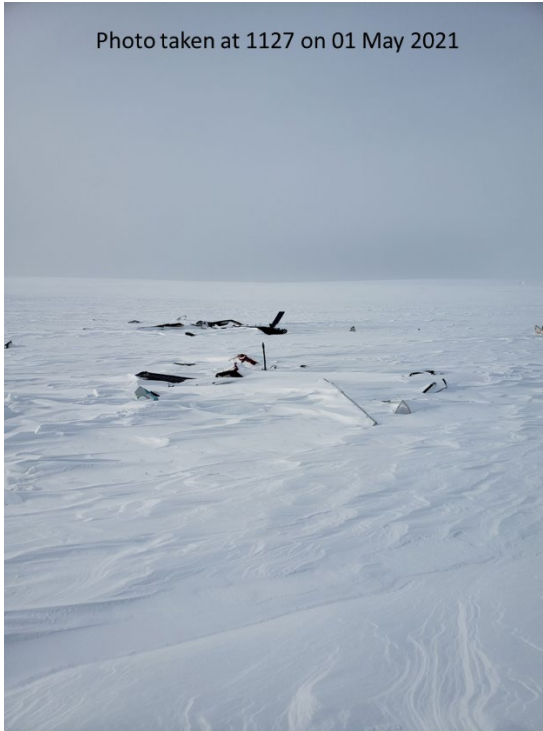
Figure 4. Photo of the crash site taken the day the TSB investigators reached the site (Source: TSB)

At the time of the occurrence, the ground was covered in more than 2 feet of snow. When ground SAR personnel reached the accident site, there was a coating of snow on most of the debris, from snow that had fallen since the accident. The fan-shaped crash site measured approximately 175 feet in length, and consisted of 4 main sections. The debris field was oriented on a track almost 180° to the occurrence flight's track towards CYRB. All debris was found beyond the initial impact crater in the snow.

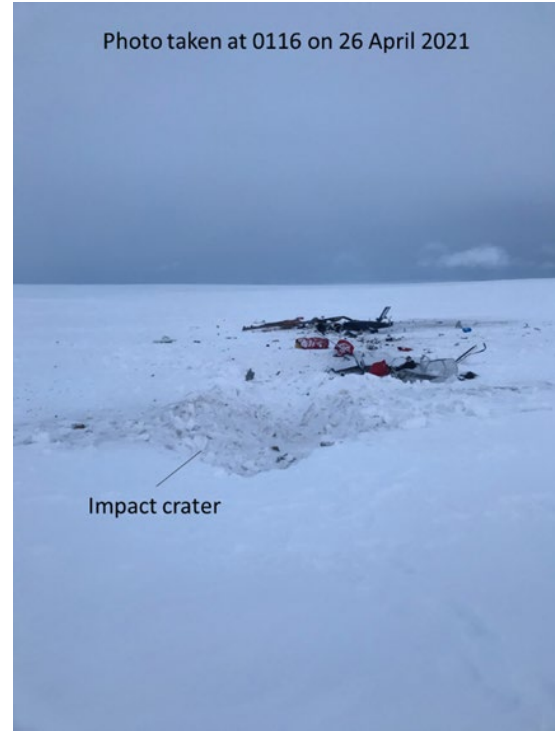
Figure 5. Photo of the crash site taken the day of the occurrence (Source: RCMP)

Ground SAR personnel who responded observed undisturbed snow to the sides of, and leading up to, the initial impact mark. The TSB laboratory used the available data and determined that the helicopter's pitch attitude and bank angle would have had to have been less than 35° and 22° respectively not to have left blade marks in the snow, assuming that the main-rotor blades were straight and not coning²⁰ (Figure 6). The extent of the damage and the length of the debris field were consistent with the helicopter impacting terrain with a relatively high horizontal and vertical speed. These impact characteristics are most commonly associated with a controlled-flight-into-terrain (CFIT) accident rather than a
