# AIR TRANSPORTATION SAFETY INVESTIGATION REPORT A21Q0131

## **LATERAL RUNWAY EXCURSION**

Keewatin Air LP  
Beechcraft King Air B200, C-FSKO  
Sanikiluaq Airport, Nunavut  
17 December 2021

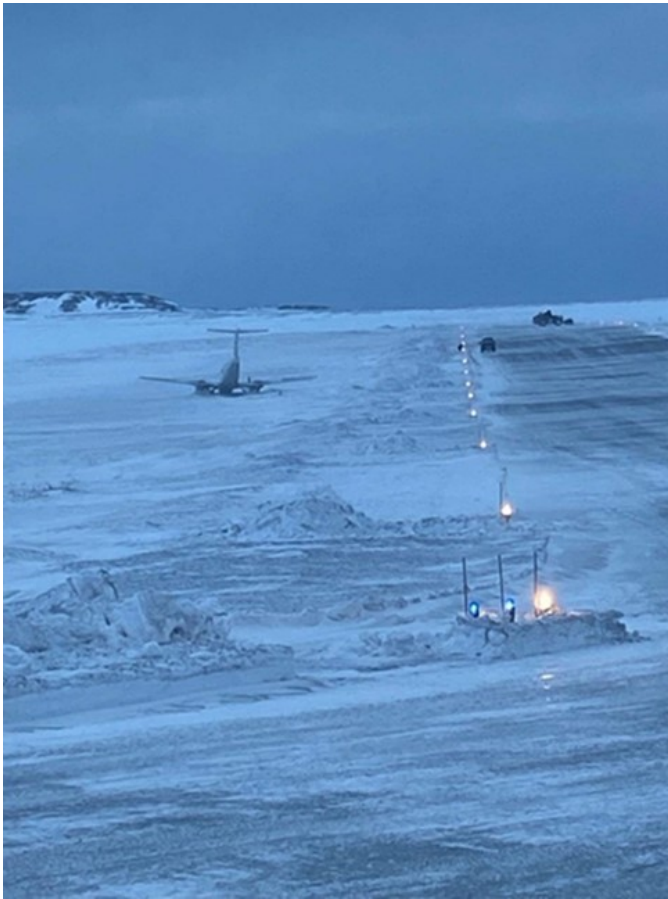
The occupants were able to egress the aircraft safely. One medical staff member received minor injuries. The aircraft was substantially damaged.

Figure 1. Occurrence aircraft where it came to rest in the snow following the runway excursion at the Sanikiluaq Airport, a few hours after the occurrence (Source: Sanikiluaq Airport universal communications facility)

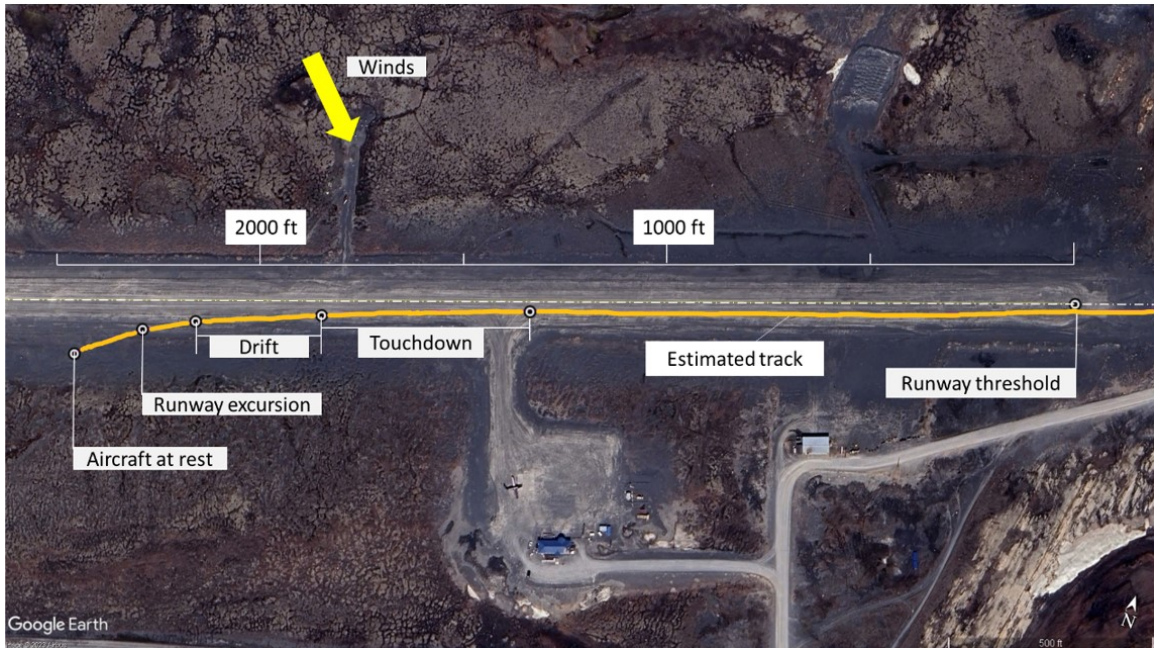
Figure 2. Estimated track of the occurrence aircraft over Runway 27 at Sanikiluaq Airport, along with points where the aircraft touched down, drifted to the left, exited the runway, and came to rest (Source: Google Earth, with TSB annotations)

The combination of the strength of the crosswind and the degree of tire traction on the runway surface caused the aircraft to drift to the left. When the PIC realized that he was unable to control the drift after about 3 seconds, he conducted a go-around as planned, but the aircraft exited the runway surface immediately thereafter.

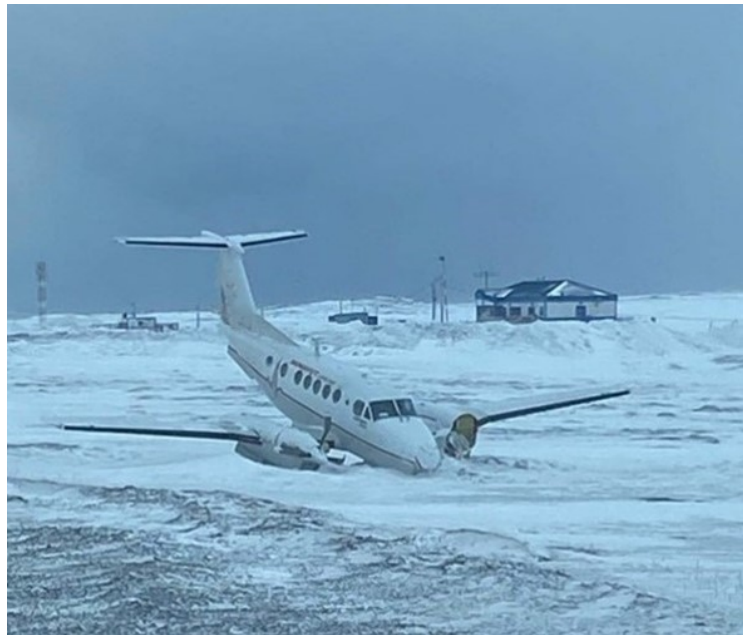
The aircraft came to rest, nose down (Figure 3). The left engine was torn from the firewall and folded completely under the wing between the nacelle and the fuselage. The propeller blades on the right engine were damaged and the nose landing gear strut failed. The nose of the aircraft sustained significant structural damage.

Figure 3. The occurrence aircraft after the runway excursion, stopped with the nose down (Source: Keewatin)
