AIR TRANSPORTATION SAFETY INVESTIGATION REPORT A22P0023

ENGINE FAILURE AND COLLISION WITH TERRAIN

Kestrel Helicopters Ltd.
Hughes Helicopters, Inc. 369D (helicopter), C-GJLC
Port McNeill Aerodrome, British Columbia, 25 NM ESE
06 April 2022

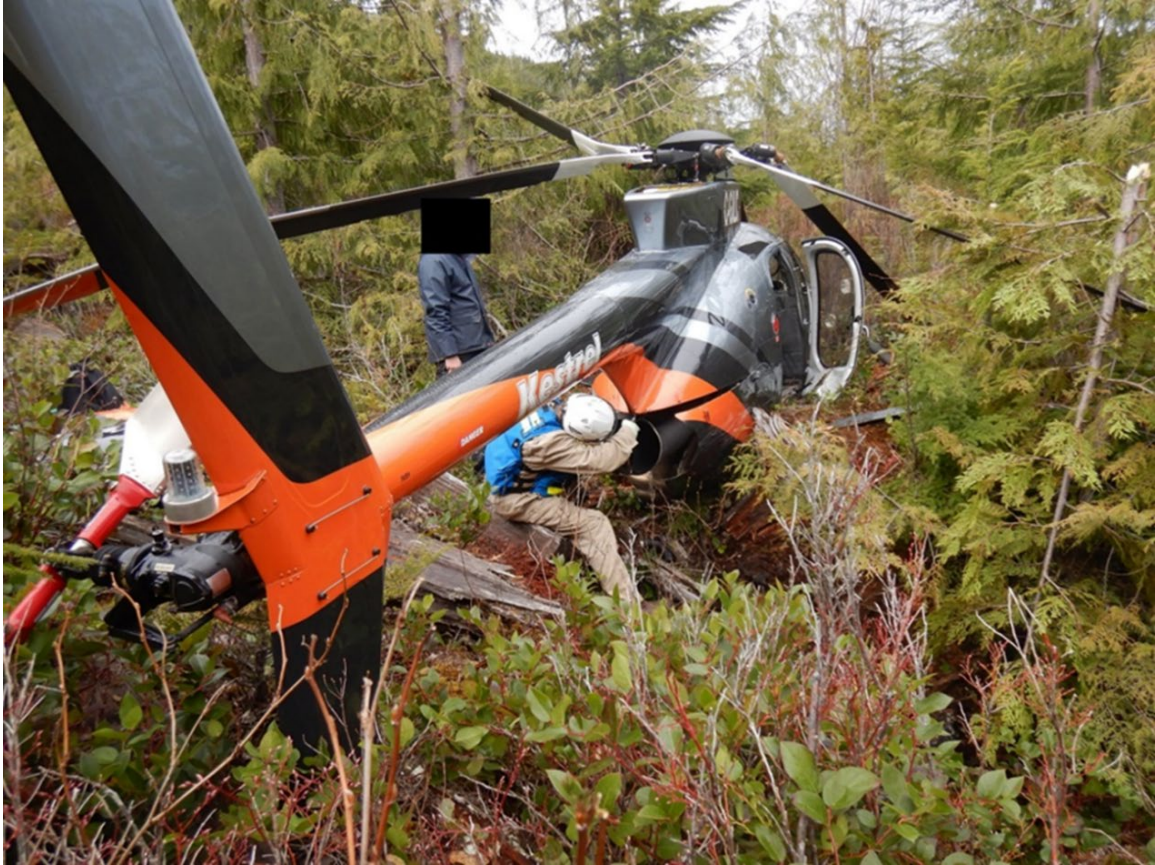
During the occurrence, the helicopter crashed into a wooded area (Figure 4), in an upright attitude and with no horizontal speed.

Figure 4. Occurrence helicopter at accident site (Source: TSB)

Following the impact, the tail boom remained straight; there was no sign of it having been struck by a main rotor blade. Both forward and aft struts of the landing gear were spread. A detailed examination of the aircraft showed that while both forward struts of the landing gear remained straight and intact, their connections with the dampers had broken. The rear left strut had fractured in its middle, and the rear right strut had separated from its connection with the fuselage.

The damage to the belly of the fuselage appeared to be uneven, likely due to impact with uneven terrain. The section aft of the passenger cabin showed minimal crushing damage. However, the section between the forward and aft landing gear struts had been bent by the impact, and the section underneath the cockpit was severely crushed.

Both the markings on the trees surrounding the helicopter and the main rotor blade damage were consistent with low rotational energy at impact.

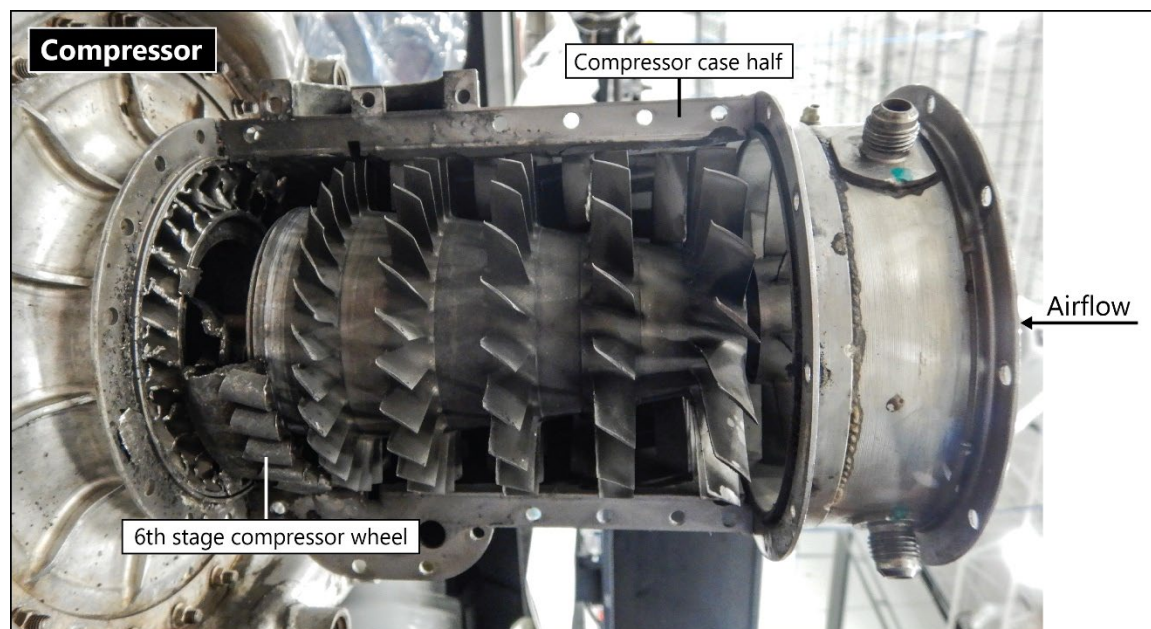
The compressor assembly of the engine (Figure 5) was disassembled and examined at the TSB Engineering Laboratory in Ottawa, Ontario.

Figure 5. Compressor assembly (Source: TSB)

During this examination, it was determined that the compressor blades and guide vanes of the compressor assembly were damaged. In particular the compressor blades on the first through fifth stage compressor wheels were damaged but still in place. On the sixth stage compressor wheel, all of the blades were fractured or curled over. The guide vanes on the first through fourth stages were bent and damaged but still in place, whereas all of the guide vanes on the fifth and sixth stages were either liberated or bent over completely in the direction of engine rotation. There was no obvious damage noted on the outside of the case

halves. The sixth stage compressor wheel was broken and wedged within the assembly. Gross plastic deformation of the wheel was also noted.

The tie bolt, which holds the compressor assembly together, had failed at the aft end. Visual examinations of the bearings were completed as the compressor was disassembled, and all bearings rotated freely with no obvious damage observed.

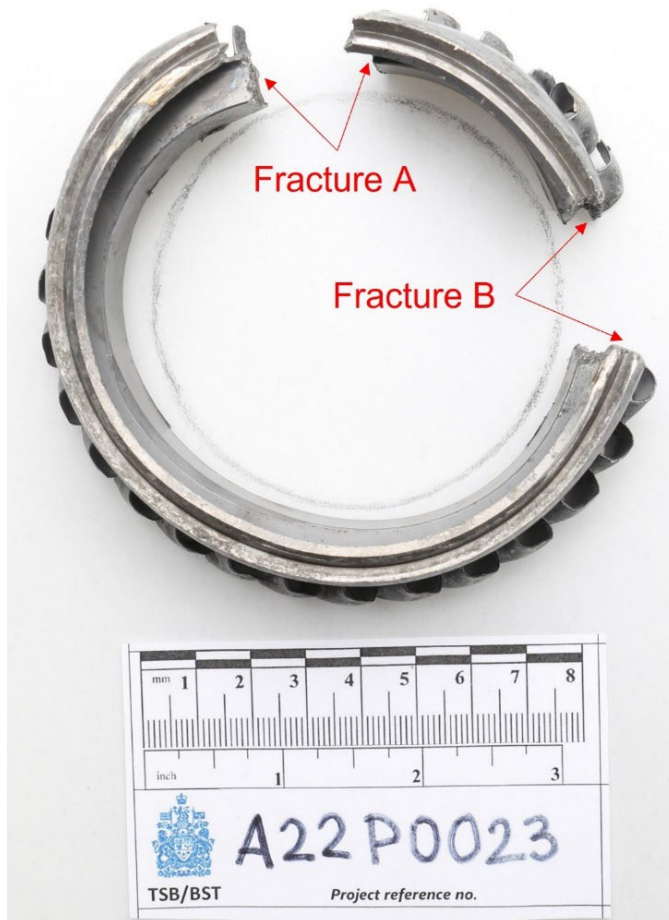
The sixth stage compressor wheel (part number 23057116, serial number KR59007) was extracted from the compressor assembly and found to have fractured into 2 pieces, with no pieces missing (Figure 6).

Figure 6. Fractured sixth stage compressor wheel. The drawn circle indicates the circumference of the wheel before it was fractured (Source: TSB)

One of these fractures (fracture A) was caused by multiple fatigue cracks that had propagated inward from the forward face of the wheel. This cracking appears to have developed at shrinkage voids,⁷ some of which appeared to be partially open to the surface, located on the forward face, closer to the inner circumference of the wheel (Figure 7). The

final separation at this fracture was due to overstress. The 2nd fracture (fracture B) was caused entirely by overstress.

The sixth stage compressor wheel eventually failed when 2 separate fractures, one due to fatigue caused by shrinkage voids and the other due to overstress, occurred. The failure of the sixth stage compressor wheel resulted in a catastrophic engine failure.

On 18 May 2023, the engine manufacturer re-issued Commercial Service Letter 1255, which includes a recommendation that its customers convert the compressor to the new wheel design during the next overhaul.

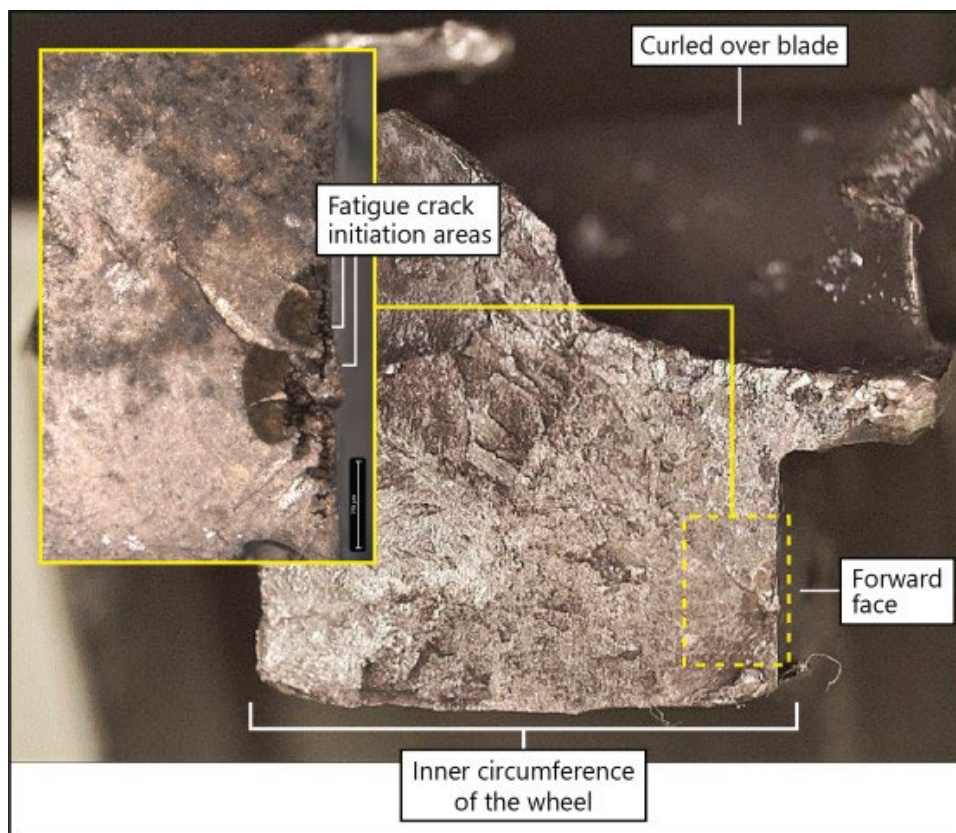
Figure 7. Occurrence sixth stage wheel cross-section showing estimated location of fatigue crack initiation areas (fracture A) and orientation to the inner circumference of the wheel (Source: TSB)

The sixth stage compressor wheel separated into 2 pieces, resulting from 2 fractures. One of these fractures was caused by multiple fatigue cracks that had propagated inward from the forward face of the wheel. This cracking appears to have developed at shrinkage voids,

some of which appeared to be partially open to the surface, located on the forward face, closer to the inner circumference of the wheel. The final separation at this fracture was due to overstress. The other fracture was entirely due to overstress.

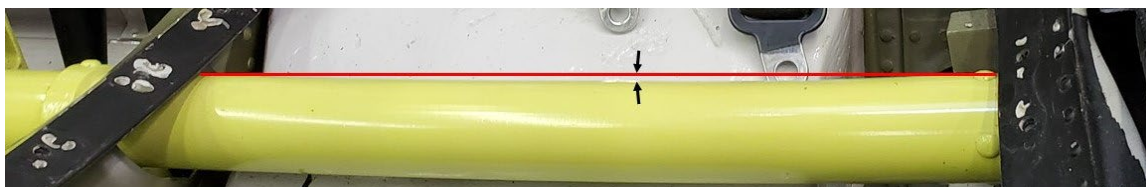
The 3rd protective structure, the seat, was partially and unevenly crushed as a result of the occurrence. Per crashworthiness design principles, the seat is typically designed to assume the inertial load during the whole process of its yielding or collapse in order to absorb the impact energy. Because of the relatively small clearance between the seat panel and collective control torque tube, the yielding of the seat structure results in contact between them. As a result, part of the inertial load from the occupant is transferred to the collective control torque tube, as was the case in this occurrence (Figure 8).

Figure 8. Collective control torque tube deformation (Source: TSB)

A calculation based on the structural damage to the seat and collective control torque tube of the occurrence helicopter indicates that the occupant experienced an estimated vertical acceleration force greater than 53 g .¹¹

Based on an examination of the structural damage to the helicopter's seat and collective control torque tube, investigators estimated that the vertical acceleration force experienced by the occurrence pilot was greater than 53 *g*. Studies conducted by the Federal Aviation Administration of the United States and the National Aeronautics and Space Administration concluded that *g* force levels beyond 27 will result in serious injury and could potentially be fatal.
