AIR TRANSPORTATION SAFETY INVESTIGATION REPORT A22P0111

COLLISION WITH TERRAIN

Geotech Aviation Ltd.
Airbus Helicopters AS350 B3, C-FVCR
Kitsault, British Columbia, 2 NM SSW
09 November 2022

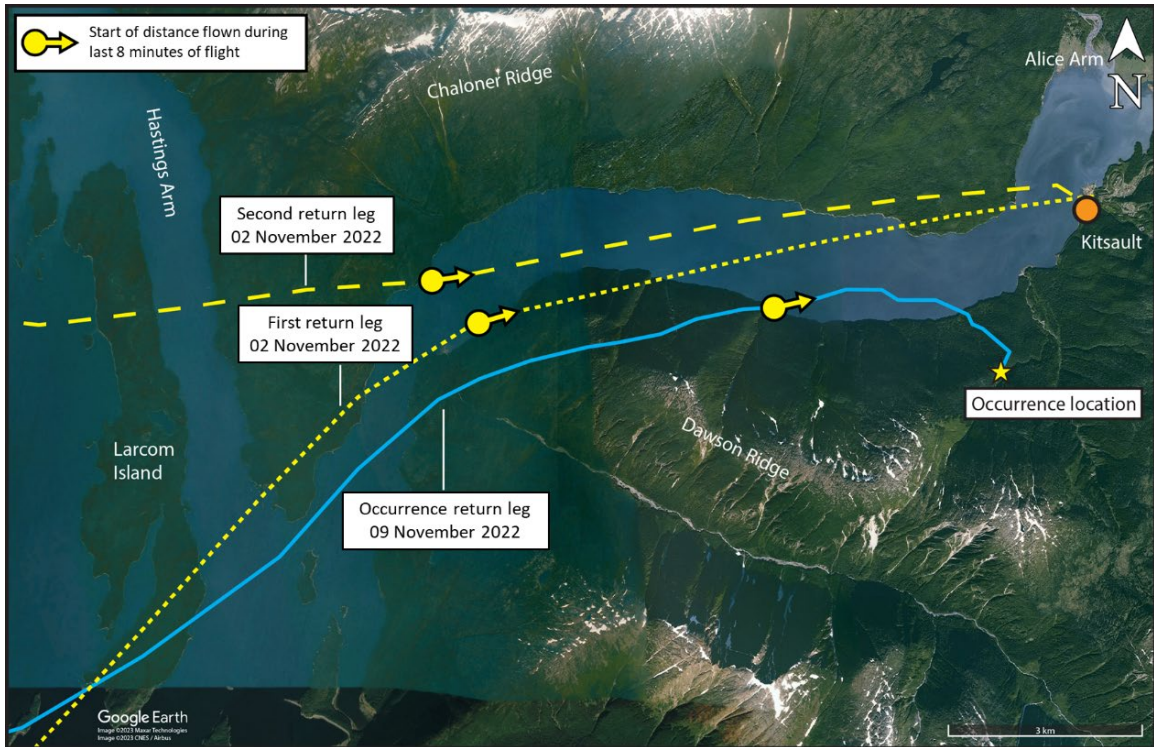
The investigation compared the inbound leg on the occurrence flight to the last 2 inbound legs flown by the occurrence pilot 7 days beforehand (Figure 4) and found the following differences on the occurrence inbound leg:

Figure 4. Flight tracks for the last 3 inbound legs to Kitsault flown by the occurrence pilot, with the segments flown during last 8 minutes of flight indicated (Source: Google Earth, with TSB annotations)

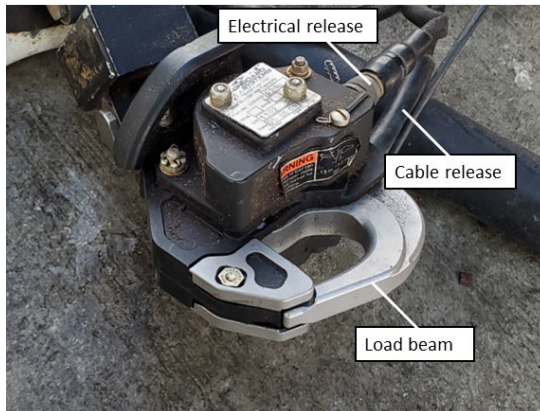
Figure 5. Cargo hook from the occurrence helicopter in the closed position (Source: TSB)

The cargo hook was removed from the helicopter and additional testing was conducted on the release system in accordance with the Acceptance Test Procedure⁹ outlined in the component maintenance manual. The cargo hook release system operated normally and was not a factor in this occurrence.

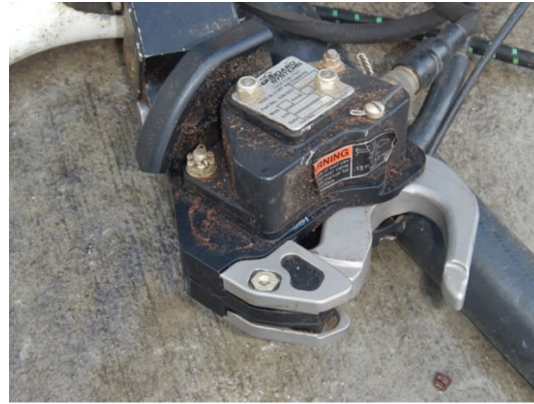
Figure 6. Cargo hook from the occurrence helicopter in the open position, after the mechanical (cable) release lever had been actuated (Source: McLarens Aviation)

Investigators conducted multiple tests on the cargo hook release system both while it was attached to the wreckage and after it had been removed. Although the tests indicated that the release system at the hook was operating normally, the broken weak link cable at the occurrence site indicated that the Versatile Time Domain Electromagnetic external loops were likely attached to the cargo hook at the time of the occurrence. The pilot had not activated the hook's mechanical or electrical release system.

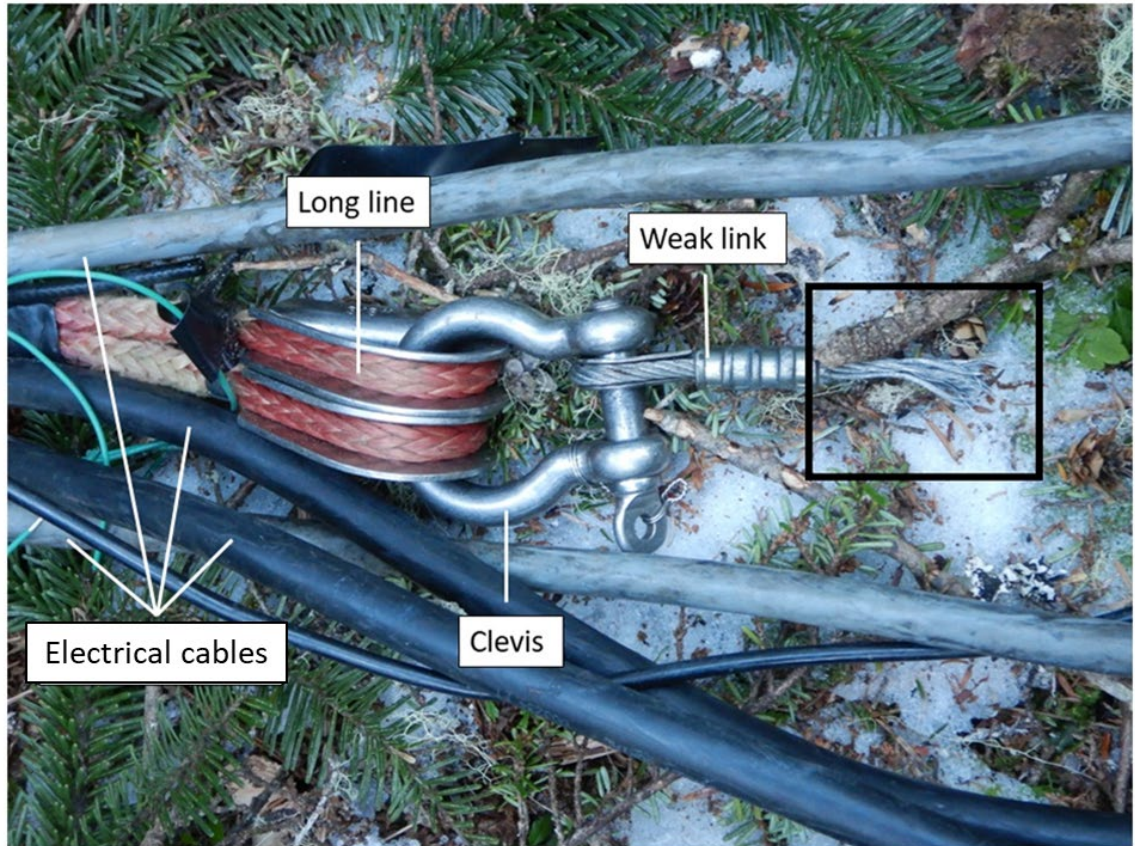
Investigators examined the survey loops, magnetometer, and associated rigging and found that the weak link remained attached to the long line with the lower clevis and that the cable was broken on the other side of the cable crimp (Figure 7). The other part of the cable and the other clevis were not recovered.

Figure 7. Long line, electrical cables, and weak link found at the occurrence site, with the broken steel cable of the weak link highlighted in black square (Source: TSB)

The long line assembly was intact from the broken steel cable to the small-diameter ropes. However, the ropes and electrical cables that were connected to the 2 survey loops had failed, and investigators were unable to determine whether they had failed during the occurrence or the recovery.
