AIR TRANSPORTATION SAFETY INVESTIGATION REPORT A22O0146

RUNWAY INCURSION

Greater Toronto Airports Authority
Maintenance Vehicle 31
Toronto/Lester B. Pearson International Airport, Ontario
15 October 2022

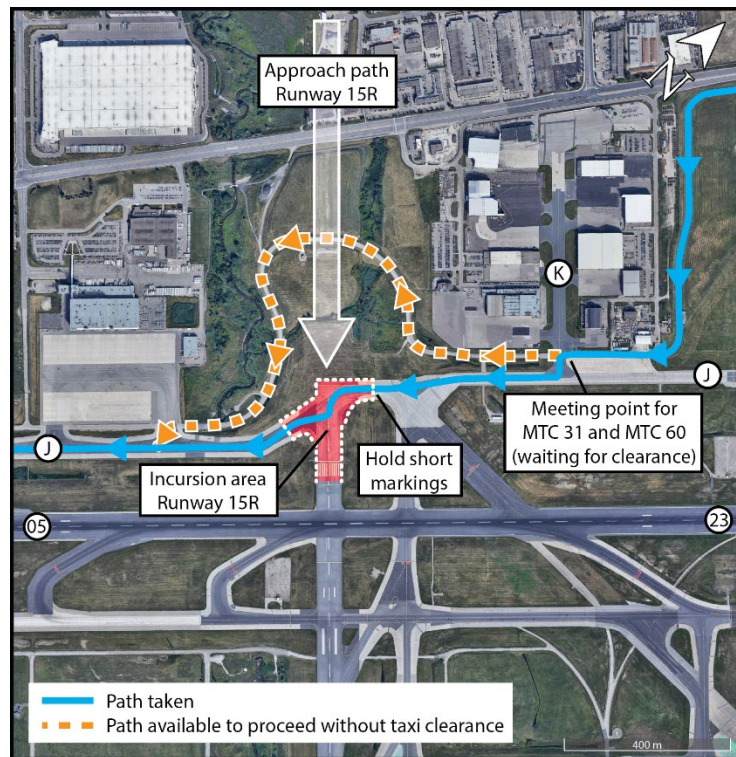
Figure 1. Maintenance 31's path (solid line) and the alternate route (dashed line) (Source: Google Earth, with TSB annotations)

Although the North Service Road would have allowed them to drive to a position west of Runway 15R without requiring a taxi clearance or crossing the runway, they instead planned a more direct route via Taxiway J (Figure 1). This

route would require a taxi clearance and clearance to cross the runway; however, it was frequently used by the drivers of MTC 31 and MTC 60, as well as other GTAA drivers.

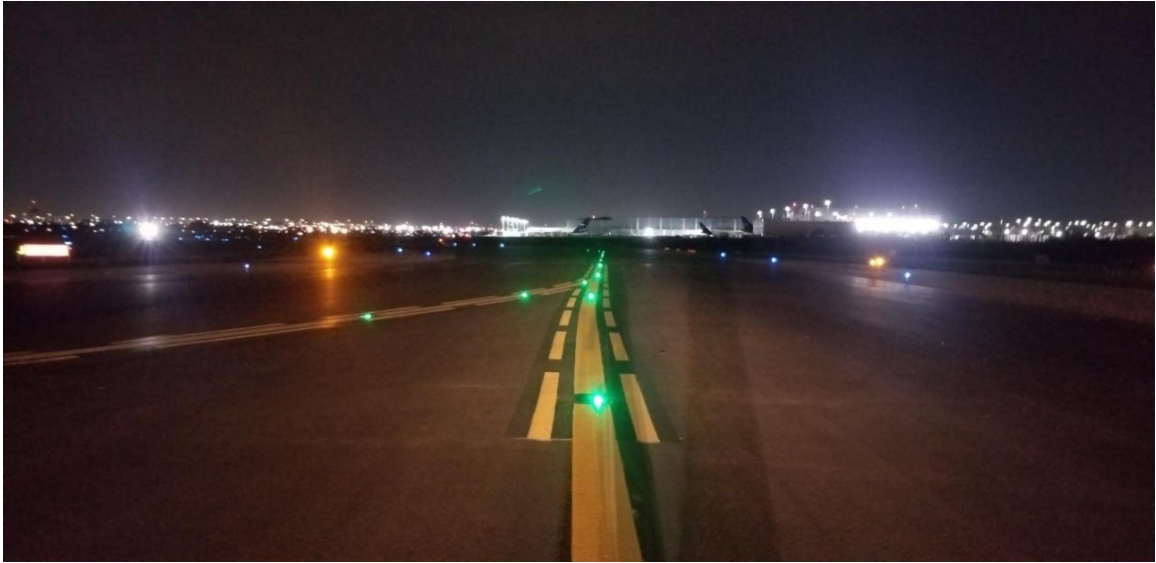
Figure 3. Taxiway J in the hours of darkness, approaching the hold-short line for Runway 15R, facing southwest (Source: Greater Toronto Airports Authority)

The runway holding position markings on Taxiway J are painted markings that span the width of the taxiway, extending beyond the solid yellow taxiway boundary line. They are accompanied by a set of 2 flashing amber guard lights adjacent to the taxiway (Figure 3). There is also an illuminated sign on each side of the taxiway indicating the taxiway and runway identifiers (Figure 4). This configuration is less conspicuous than some of the other runway crossings at CYYZ that also incorporate stop-bar lighting.
