AIR TRANSPORTATION SAFETY INVESTIGATION REPORT A23O0008

LOSS OF CONTROL IN FLIGHT

Chartright Air Inc. (dba Chartright Air Group)
Cessna 560 Encore, C-FYMM
Vicinity of Cayuga, Ontario
27 January 2023

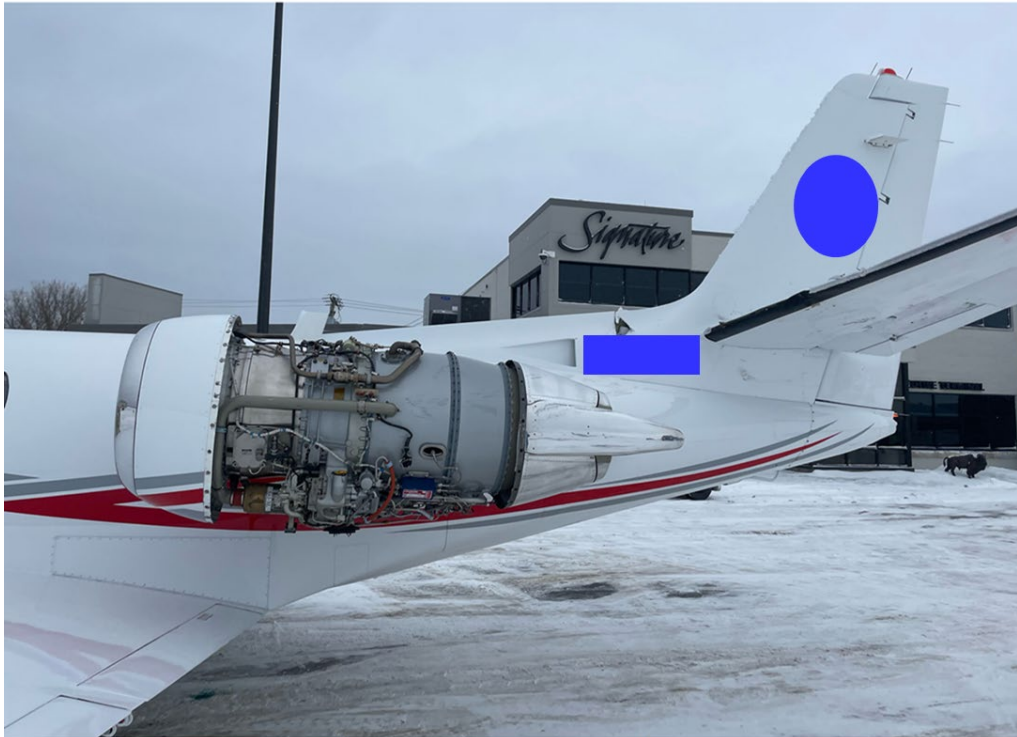
The aircraft sustained substantial damage caused by the detachment of the upper and lower left-engine cowl doors while the aircraft was in flight (Figure 2).

Figure 2. The occurrence aircraft after landing without the upper and lower cowl doors (Source: Chartright Air Inc., with TSB annotations)

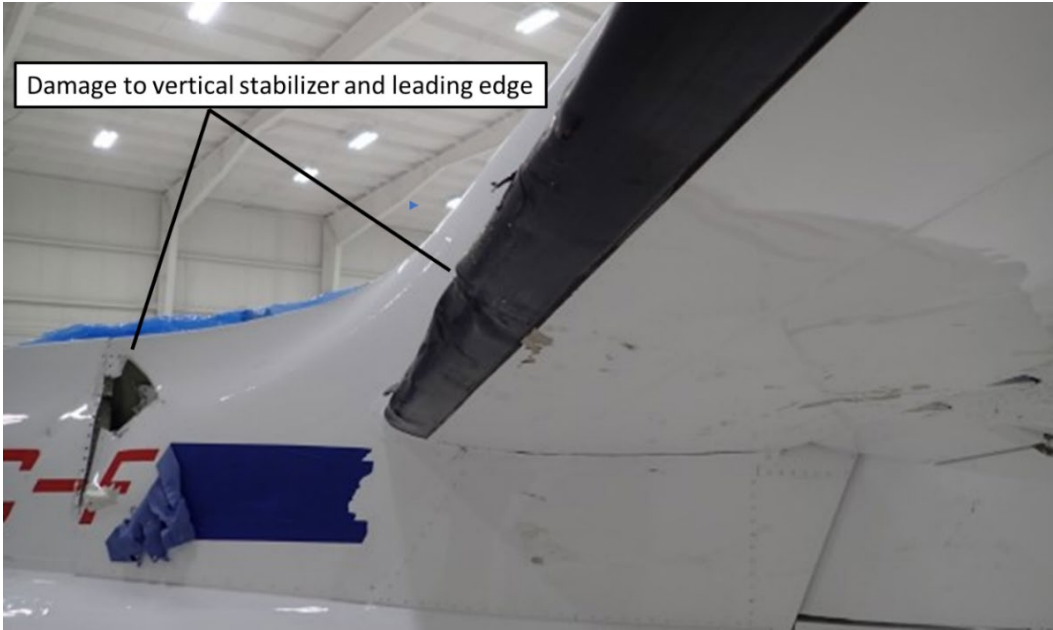
The left side of the fuselage, near the engine, and the left side of the vertical stabilizer were dented in several locations (Figure 3). A section of aluminum skin on the vertical stabilizer, covering approximately 150 square inches near the base, was punctured and torn.

Figure 3. Photo showing the damage to the vertical stabilizer and leading edge of the left horizontal stabilizer (Source: TSB)

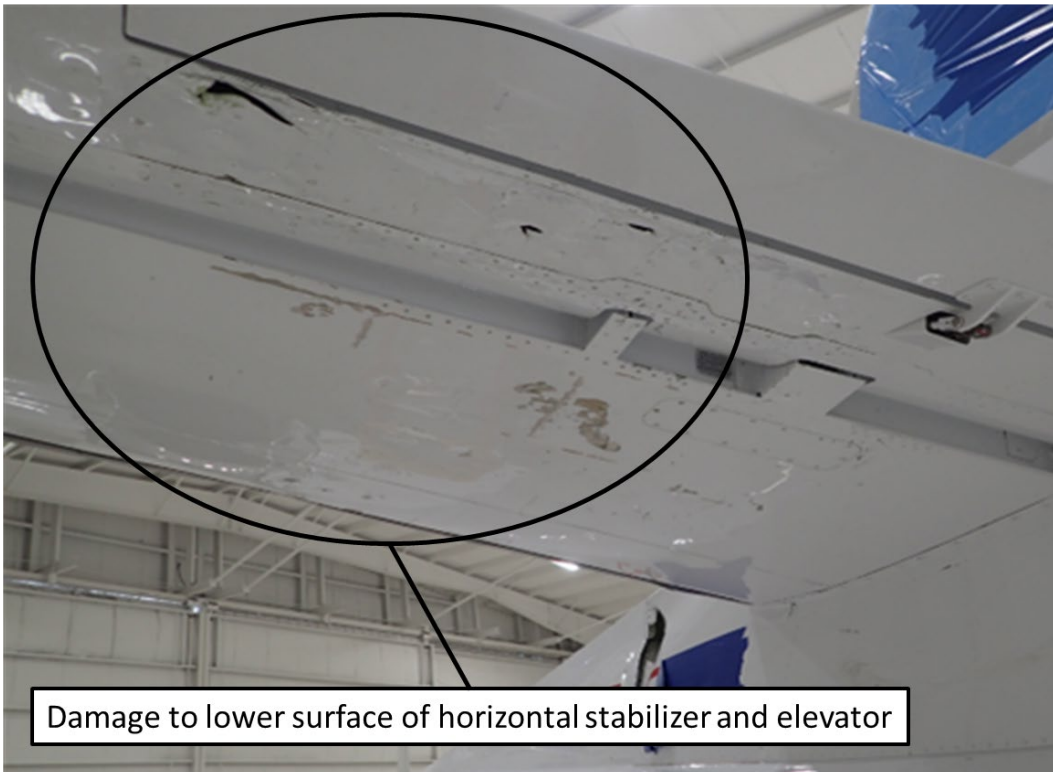
On the left horizontal stabilizer, the leading edge was dented, and the de-icing boot had been cut in multiple locations. Its upper and lower surfaces, as well as those of the elevator, were also dented and punctured in different locations (Figure 4).

Figure 4. Photo showing damage to the lower surface of the left horizontal stabilizer and elevator (Source: TSB)

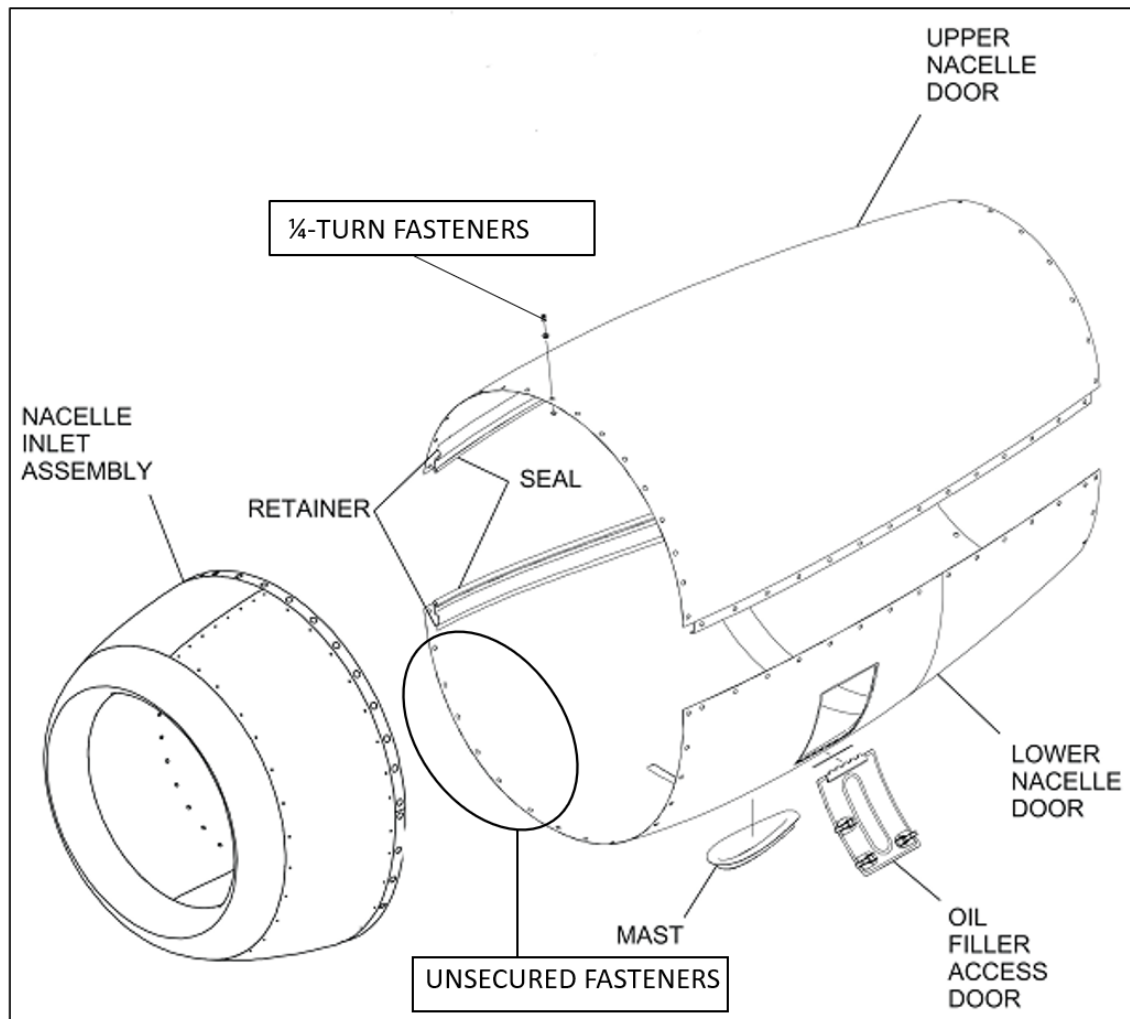
The Cessna 560 maintenance manual provides instruction for the installation and removal of the engine cowl doors. It specifies that the upper and lower cowl doors have quick-release fasteners (Figure 5) that can be unlocked when turned counterclockwise approximately $\frac{1}{4}$ of a turn.¹⁵ The manual also explains that these fasteners have recessed heads to prevent tool slippage that could potentially lead to scratches and damage to the cowl door's surface. A note at the beginning of the task warns technicians to “[u]se care when installing engine cowling. If the engine nacelle contacts an engine component other than at the attaching points, an audible rumble may be generated.”¹⁶

Figure 5. Left-engine nacelle (Source: Textron Aviation Inc., *Maintenance Manual—Model 560-001 And On*, Revision 36 [01 December 2019], Section 71-11-01, Figure 401, Sheet 1: Engine Cowling Installation, p. 3 of 5, with TSB annotations)
