# AIR TRANSPORTATION SAFETY INVESTIGATION REPORT A23P0063

## COLLISION WITH WATER

Privately registered  
Savannah (advanced ultralight), C-ISVG  
Simpson Lake, British Columbia  
25 June 2023

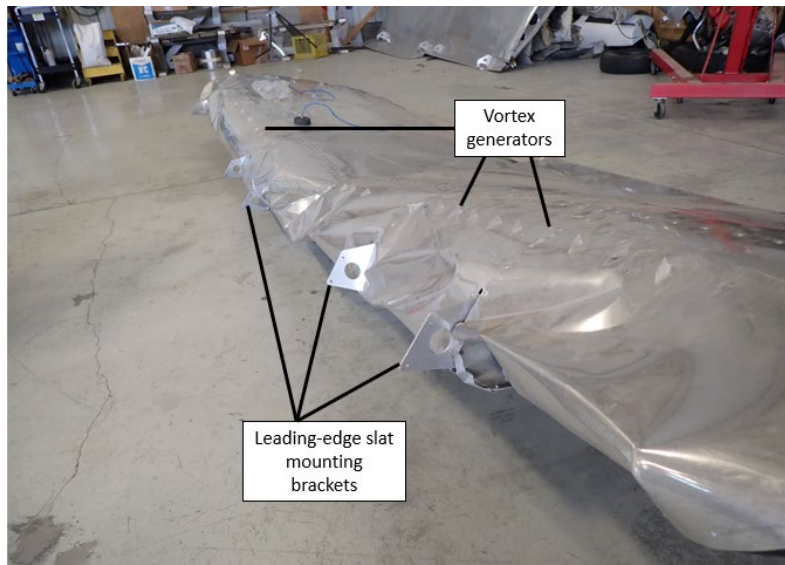
The occurrence aircraft's wings were found with VGs installed on the upper curve of the wings' leading edges. The wings were also found with the slat mounting brackets attached to the wings' leading edges, but without their leading-edge slats installed (Figure 2). The investigation determined that these modifications were completed by the person who owned the

**Figure 2. Occurrence aircraft's left wing showing vortex generators and leading-edge slat mounting brackets (Source: TSB)**

aircraft before the owner at the time of the occurrence. The occurrence pilot had flown the aircraft with and without the leading-edge slats installed.

The aircraft manufacturer approved neither the engine upgrade kit nor the VG wing modification on the occurrence aircraft. Additionally, the VG wing modification did not follow the manufacturer’s approved kit.

Advanced ultralight aircraft owners are reminded that approval must be received from the manufacturer before any modifications are made to their aircraft.

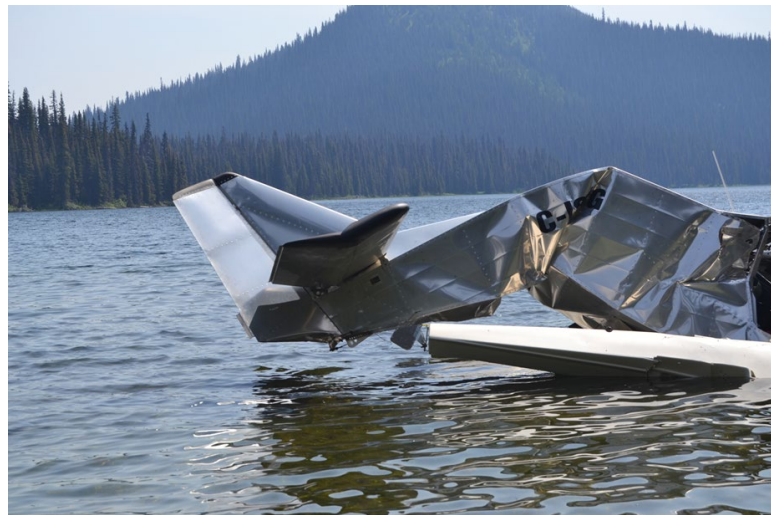
The aircraft was found in an upright position with the floats’ wheels retracted. The forward section of the floats and the lower portion of the engine were damaged. The aft section of the fuselage was pushed downward, and the bottom of that section was found crushed (Figure 3). A 10-pound bag of gravel was found in the aft section of the fuselage.

**Figure 3. Aft section of the occurrence aircraft (Source: Chetwynd Royal Canadian Mounted Police, with permission)**

The damage to the aircraft indicates that it impacted the water in a nose-low attitude, slightly left wing low, and in an upright position. The pilot's seat pan collapsed under the significant downward inertia forces. The upper rivets that attach the right wing to the fuselage were ripped out of the wing, causing the right wing to hang downward.

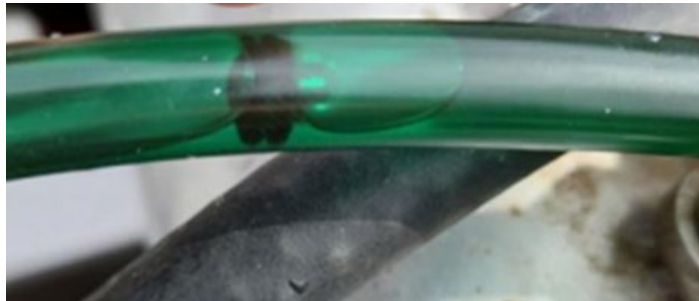
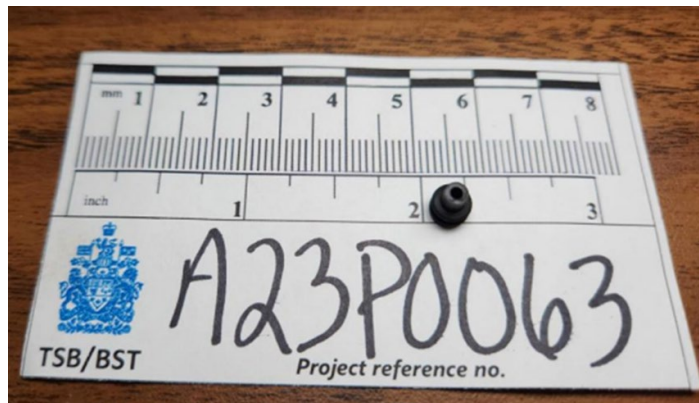
During the initial engine trial runs, fuel overflow issues were observed, resulting in rough engine operation. Further examinations revealed a small electrical grommet blocking the fuel return flow (figures 4 and 5). After its removal, subsequent test runs showed normal engine operation without anomalies.

The engine may have experienced a fuel system blockage due to the electrical grommet in the fuel return line. This would have resulted in flooding of the carburetor and subsequent fuel overflow to the catch can installed on the firewall.

Figure 4. Electrical grommet observed in fuel return line (Source: TSB)

Figure 5. Electrical grommet found in fuel return line (Source: TSB)
