AIR TRANSPORTATION SAFETY INVESTIGATION REPORT A23P0123

COLLISION WITH TERRAIN

Privately registered
De Havilland DHC-2 (Beaver), C-GSBA
Campbell River Airport, British Columbia, 10 NM SSE
20 September 2023

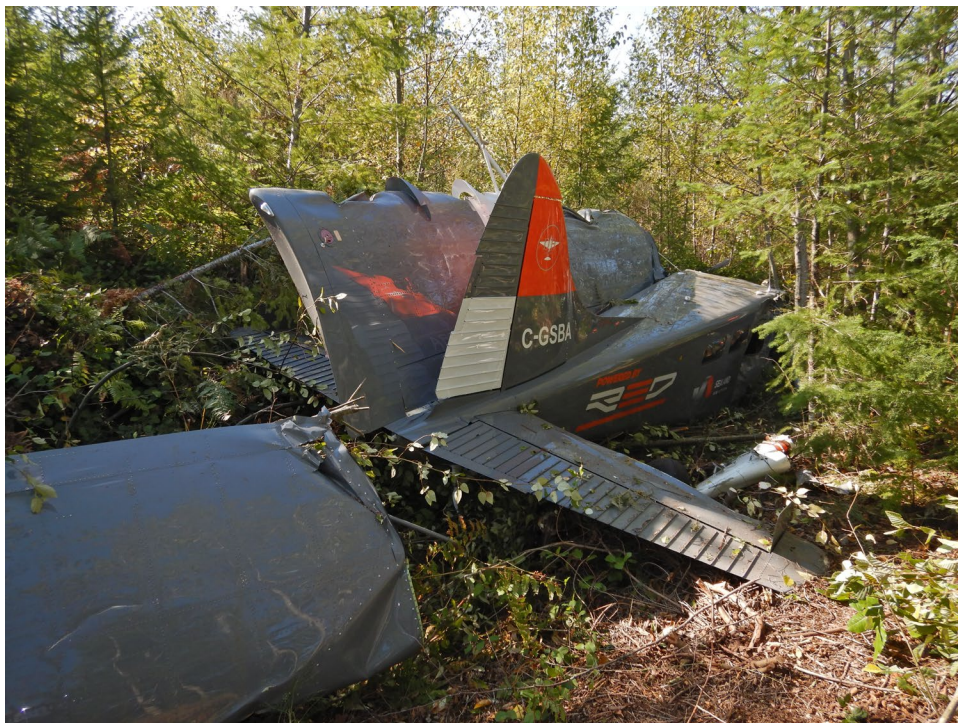
The aircraft struck the ground in a heavily wooded area with uneven terrain (Figure 4). The wreckage showed signs of a low-energy, low-angle impact, consistent with a forced landing. The wings and landing gear were separated from the aircraft, with damage along the leading edges of the wings. All propeller blades received damage consistent with propeller rotation on impact. The fuel tanks in the aircraft's belly were damaged, releasing an unknown quantity of fuel. The occupiable space within the fuselage was not compromised. There was no post-impact fire.

Figure 4. Occurrence site from rear right side of aircraft (Source: TSB)

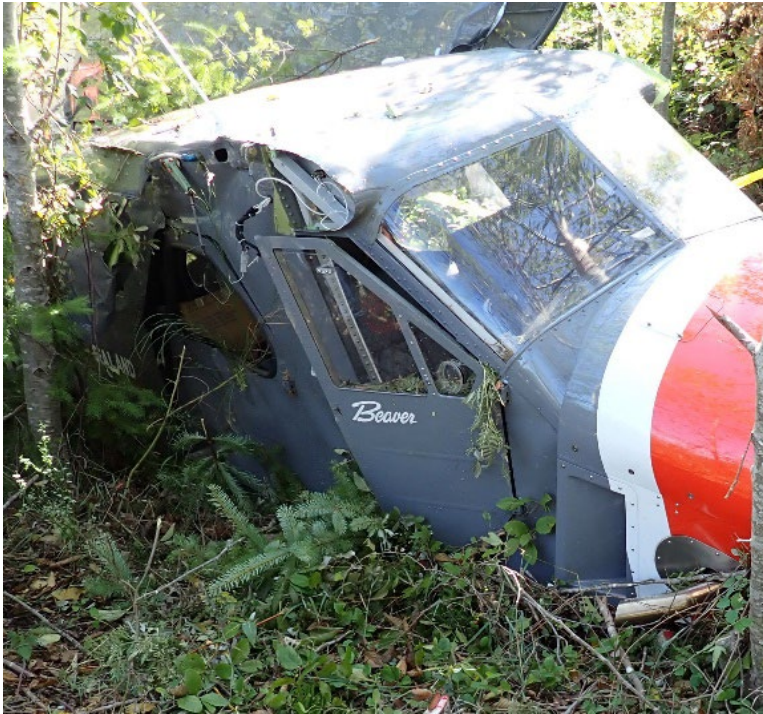
Several aircraft exits were unusable due to fuselage compression or obstruction by aircraft debris and terrain features (Figure 5); however, the pilots were able to egress the aircraft unassisted via the left cockpit door.

Figure 5. Accident site, showing right cockpit door obstructed by terrain (Source: TSB)
