AIR TRANSPORTATION SAFETY INVESTIGATION REPORT A23P0143

COLLISION WITH TERRAIN

Privately registered
Piper PA-28-180 (Cherokee), C-GGOR
Brisco, British Columbia
24 November 2023

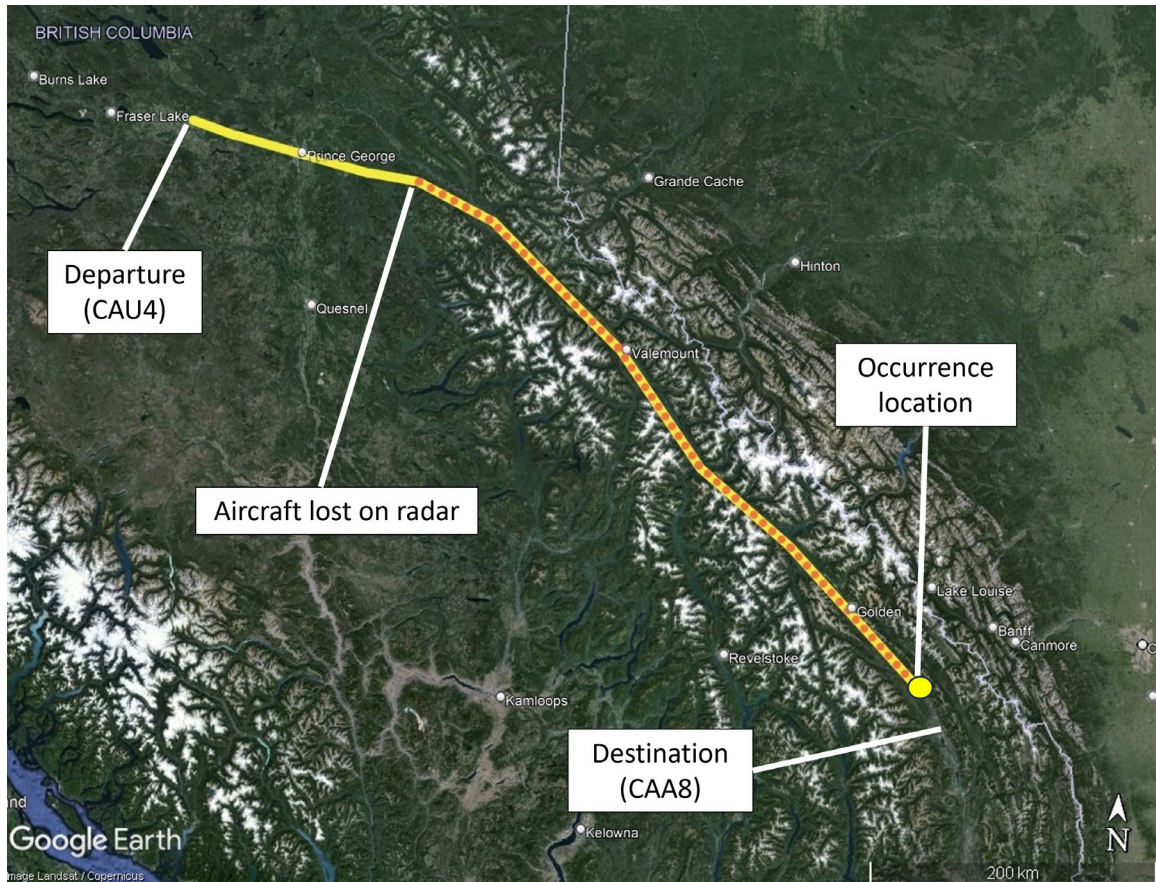
aircraft was observed in a vertical dive, approaching the ground at high speed approximately 2 nautical miles west of the community of Brisco, BC. The aircraft was reported to have executed an abrupt pull-up from the dive to a level attitude at an altitude of approximately 300 to 500 feet above ground level. The aircraft then reportedly had a wing and nose drop before impacting the ground in an inverted attitude (Figure 1).

Figure 1. Known and presumed portions of the occurrence flight (known track [solid line] based on radar information; presumed track [dotted line] based on the pilot's flight itinerary) (Source: Google Earth, with TSB annotations)

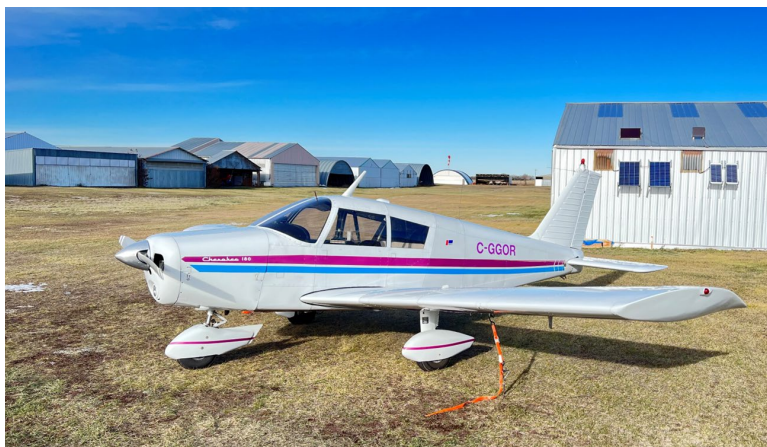
The occurrence Piper PA-28-180 aircraft (Figure 2) was manufactured by the Piper Aircraft Corporation in 1963. It was equipped with a 180 hp Lycoming Engines O-360-A3A engine and a fixed-pitch propeller. It was not equipped with a flight data recorder or a cockpit voice recorder, nor was it required to be by regulation.

Figure 2. Occurrence aircraft (Source: Third party, with permission)

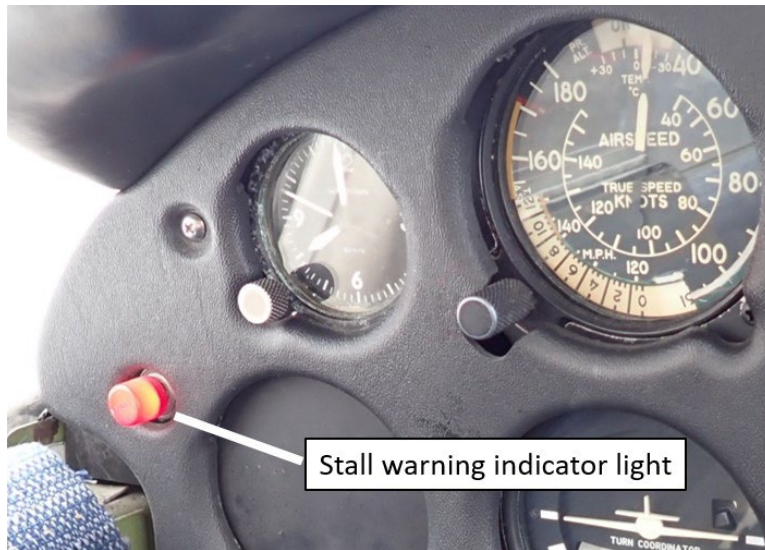
The aircraft was equipped with a stall warning system, which consisted of a red-filtered, incandescent lightbulb that illuminated when the system detected the aircraft was at, or near, a stalled condition (Figure 3).

Figure 3. Illuminated stall warning light in an aircraft similar to the occurrence aircraft type (Source: TSB)

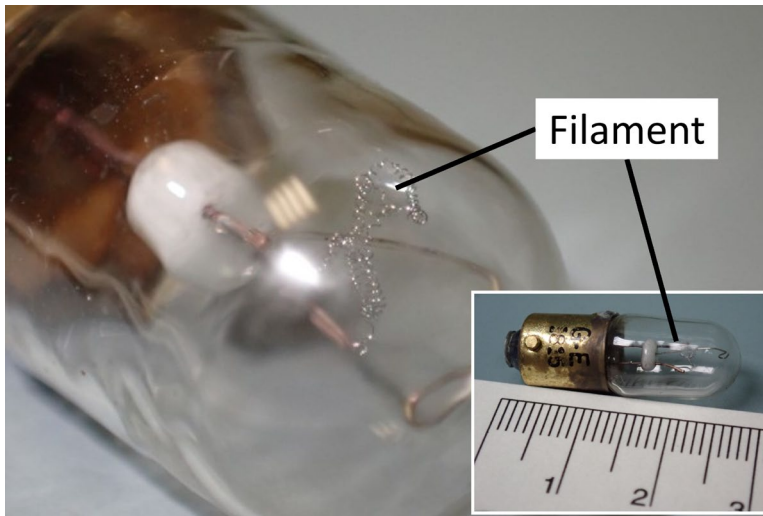
A lightbulb filament analysis showed that the typically tightly wound coils of the filament were severely stretched (Figure 4). This occurs when an illuminated light filament becomes more ductile as a result of the high temperature from its illumination and is then exposed to sufficient shock; like that of an aircraft impacting terrain. This filament stretching indicates the stall warning light was illuminated at the time the aircraft struck the ground.

Figure 4. Enlarged view of the filament from the lightbulb removed from the occurrence aircraft's stall warning system, with full view of the lightbulb in inset (scale reference in cm) (Source of images: TSB)

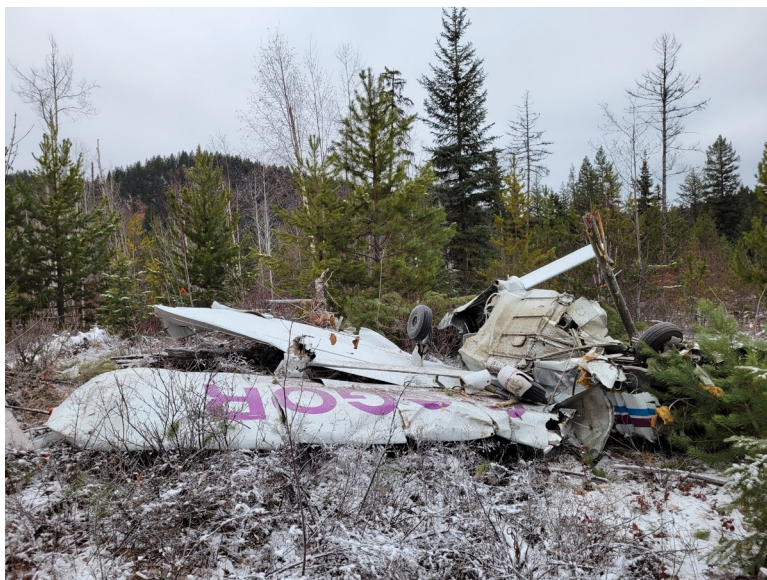
The aircraft came to rest in a wooded area in an inverted attitude. The wreckage indicated a high-angle impact with little forward velocity. One propeller blade exhibited rearward bending whereas the other blade had a slight forward bend, which is consistent with low or no propeller rpm at the time of impact. The aft section of the fuselage and tail were bent to the right, and both wings were found on the left side of the fuselage, indicating rotational forces existed when the aircraft

struck the ground. The occupiable space inside the aircraft was significantly compromised (Figure 5).

Figure 5. Occurrence aircraft wreckage (Source: RCMP, with permission)

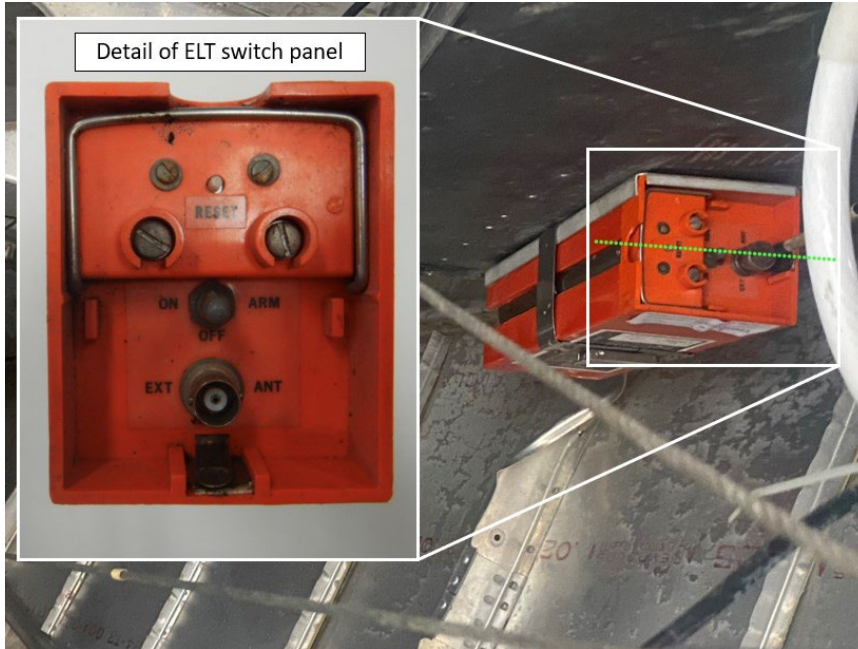
The occurrence aircraft was equipped with an automatic fixed ELT capable of transmitting on 121.5 MHz and 243 MHz. The ELT did not activate.

The ELT switch was in the OFF position when the aircraft was found by SAR personnel (Figure 6). The investigation was unable to confirm what position the switch was in before the occurrence.

Figure 6. Occurrence aircraft's emergency locator transmitter as found by search and rescue personnel, with dotted line showing the switch aligned with the antenna attachment and reset button, and with detail of the transmitter switch in inset (Source of main image: Third party, with permission. Source of the inset image: TSB)

Laboratory analysis of the power supply to the ELT indicated that no significant draw on the battery had occurred. SAR logs indicate no signal was received from the ELT on the frequencies over which it was capable of transmitting. As of 01 February 2009, only 406 MHz ELT signals are monitored by the Cospas-Sarsat satellite system.⁶ In 2020, Transport Canada amended the CARs to require that aircraft be equipped with ELTs capable of transmitting simultaneously on 121.5 and 406 MHz;⁷ however, compliance for recreationally operated aircraft is not required until 25 November 2025.

The Cospas-Sarsat satellite system only detects ELT signals transmitted on 406 MHz. As a result, occupants in aircraft equipped with ELTs not transmitting on that frequency may be exposed to life-threatening delays in SAR service following an occurrence. Pilots should make sure that automatic fixed ELTs are properly installed, serviced, and armed in order for them to perform their intended function.
