RAIL TRANSPORTATION SAFETY INVESTIGATION REPORT R19T0147

EMPLOYEE FATALITY

Canadian National Railway Company
Remote control locomotive system
Dual hump yard assignment YDHF60
Mile 0.0, Halton Subdivision
MacMillan Yard
Vaughan, Ontario
15 August 2019

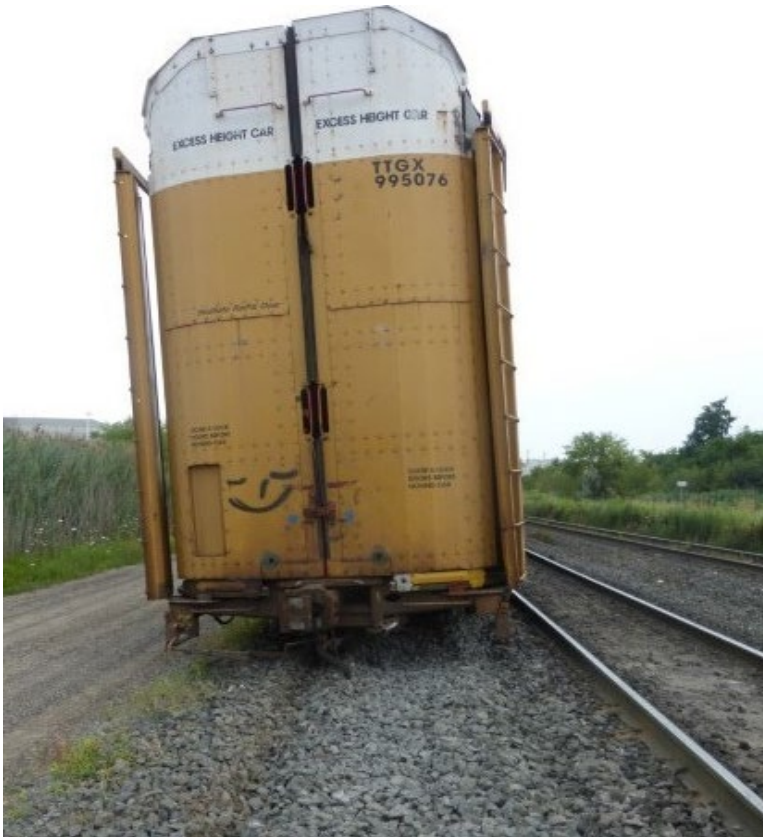
The 26th car, empty autorack car TTGX 995076, had derailed but came to rest upright. The leading A-end truck did not derail but all 4 wheels of the trailing B-end truck were derailed in the ballast on the west side of the track, just north of the W100 switch (Figure 5). As the car came to rest, it struck and damaged the W100 switch. The remainder of the head-end cars were inspected with no defects noted.

Figure 5. Trailing B-end truck of 26th car TTGX 995076 derailed; A-end truck remained on the rails (Source: TSB)

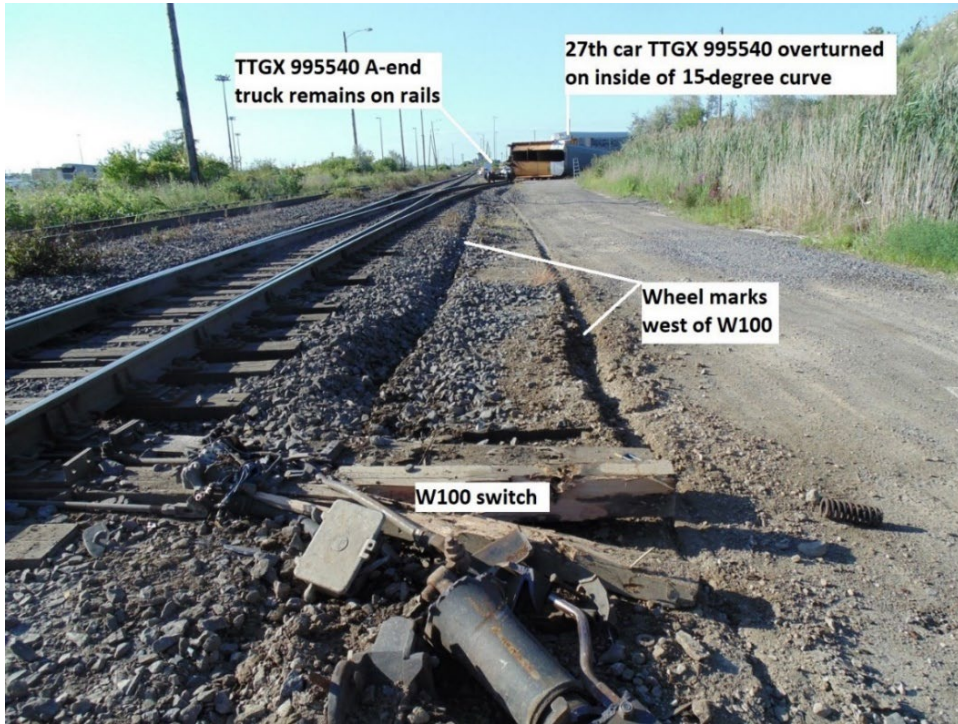
From the W100 switch, wheel marks were observed in the ballast extending southward for about 400 feet. The marks in the ballast stopped near the leading end of the 27th car, TTGX 995540. The leading A-end truck of TTGX 995540 remained intact, did not derail and rolled along the track clear of the car. It came to a stop on the rails about 40 feet north of the car (Figure 6).

Figure 6. View southward from the W100 switch (Source: TSB)

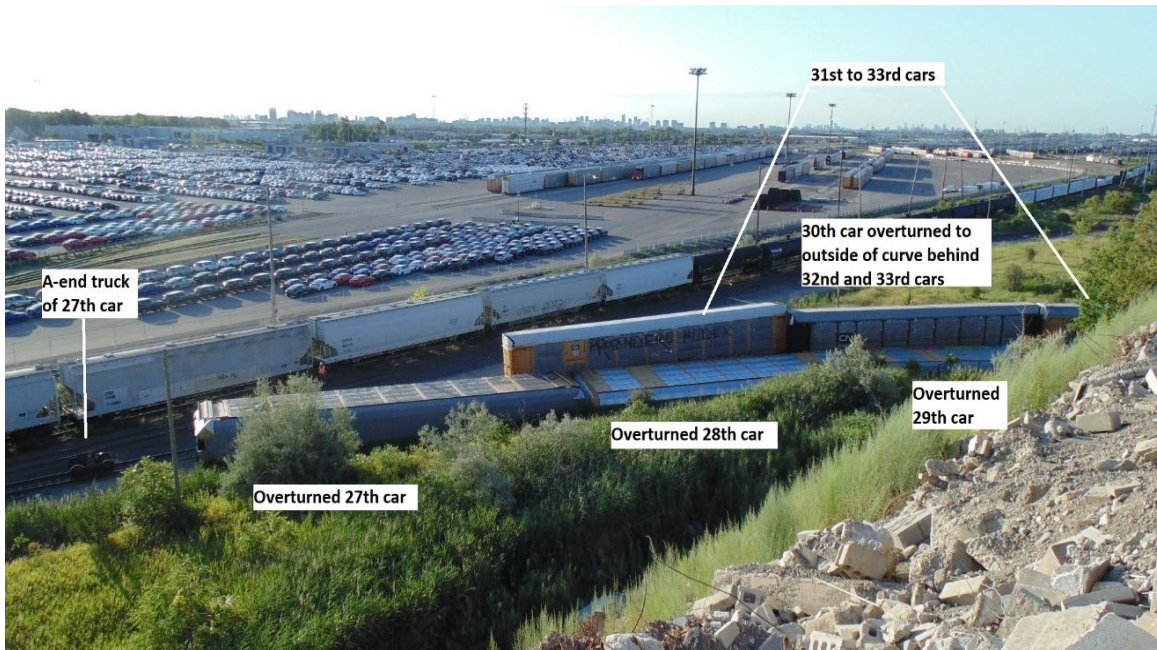
The 27th, 28th, and the 29th cars were coupled together, had all rolled off their trucks and overturned on their sides on the inside of the 15-degree curve (Figure 7).

Figure 7. Occurrence site (Source: TSB)

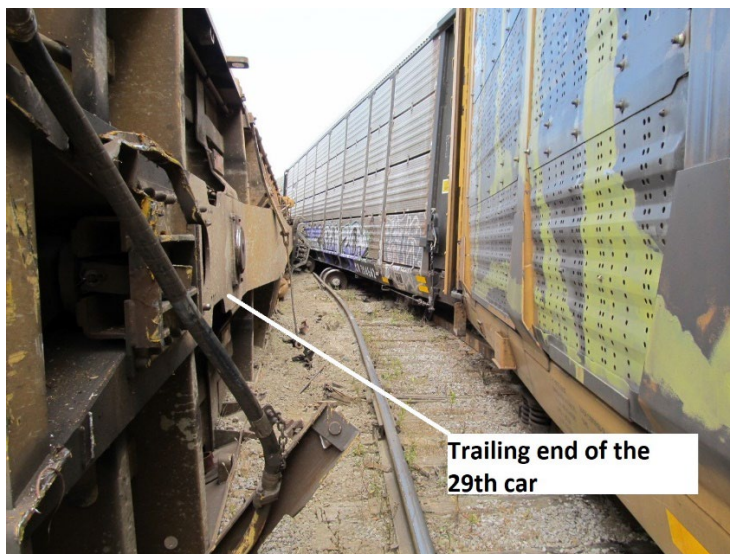
Each of the 3 cars came to rest about 2 feet from the inside rail of the curve (Figure 8).

Figure 8. Looking from the trailing end of the 29th car as it came to rest about 2 feet from the inside rail of the curve. Note missing trucks (Source: Canadian National Railway Company)

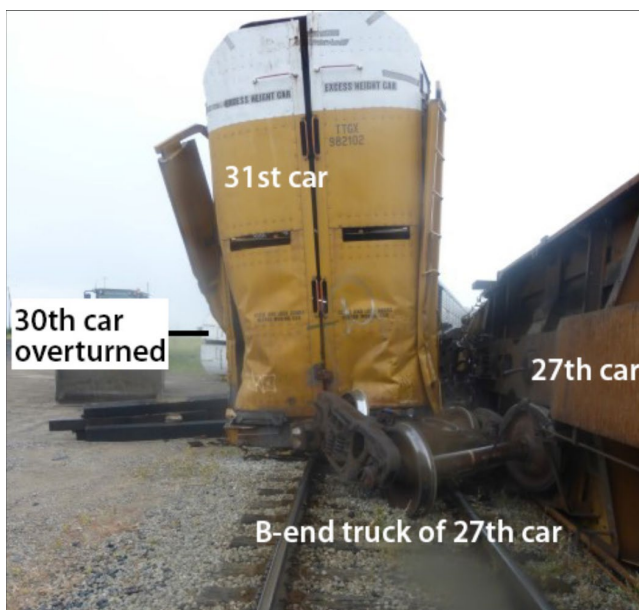
The 31st to the 34th cars remained upright and coupled together. The outer rail of the curve had rolled to the outside (eastward) beneath these cars. The 31st to 33rd cars derailed all wheels along the track, while only the wheels on the leading end of the 34th car had derailed (Figure 10).

Figure 9. Leading end of 31st car TTX 982102 and the trailing truck of 27th car (Source: TSB)

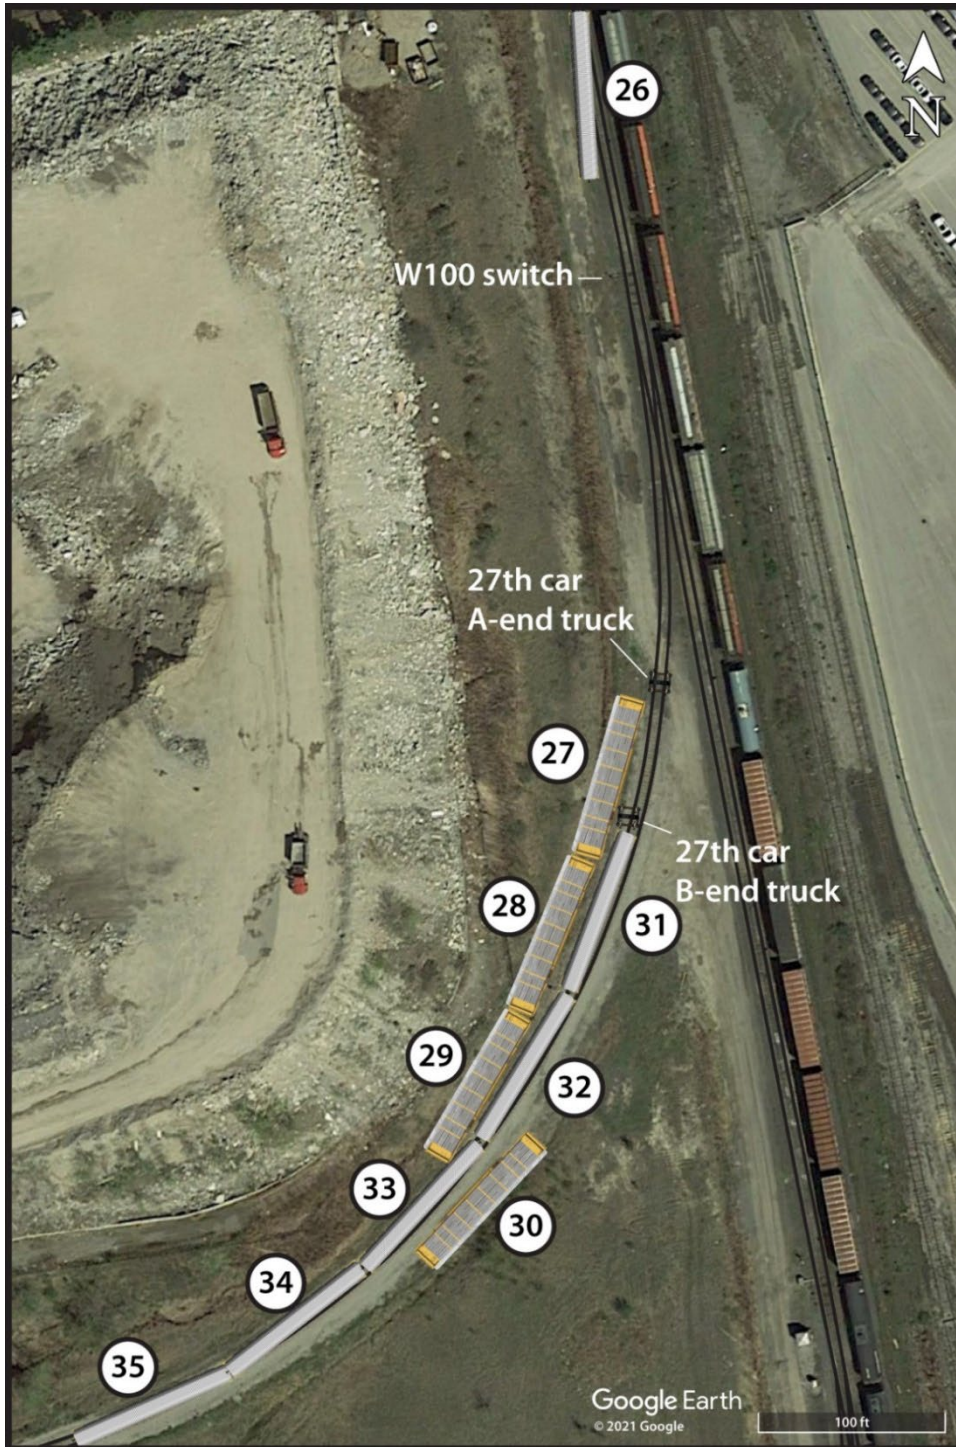
Figure 10. Location of derailed cars (Source: Google Earth, with TSB annotations)

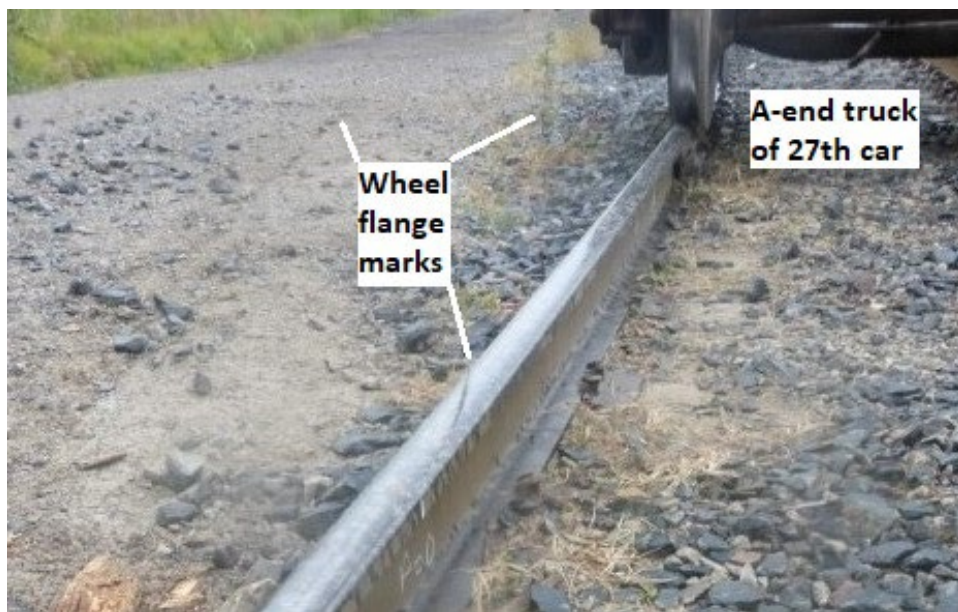
Short wheel flange marks were observed on the running surface of the west rail in the exit spiral of the 15-degree curve that transitioned to a tangent section of W100. The marks were located about 5 feet north of the overturned 27th car. The marks extended from the gauge side to the field side of the rail at which point they dropped off to the west into the adjacent ballast on the inside of the curve, and continued northward to the W100 switch (Figure 11).

Figure 11. Wheel flange marks on rail head and ballast (Source: TSB)

From the W100 switch, wheel marks were observed in the ballast extending southward for about 400 feet. These wheel marks ended near the leading end of the 27th car, where short wheel flange marks were also found on the running surface of the west rail in the exit spiral of the 15-degree curve. These flange marks were indicative of the left-side wheels of the trailing truck of the 26th car climbing the rail.

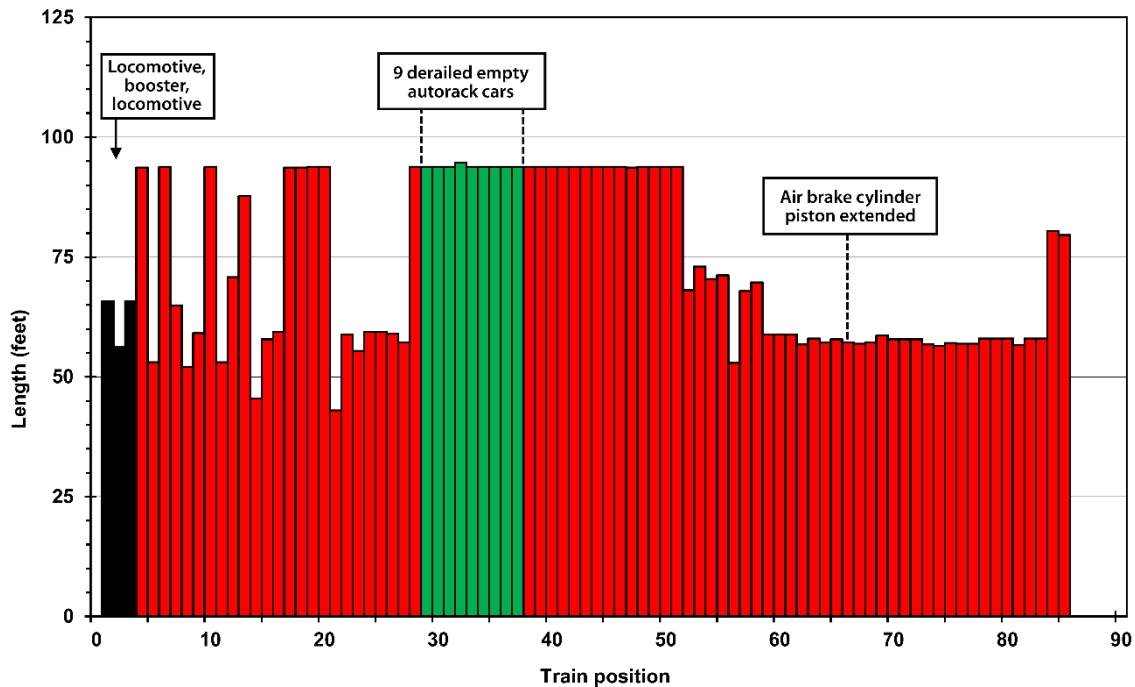
The assignment length profile (Figure 14) displays the positions of the locomotive hump set, the 9 long empty autorack cars that derailed and the car in the 63rd position that was observed to have its air brake cylinder piston extended.

Figure 14. Assignment length profile (Source: TSB)

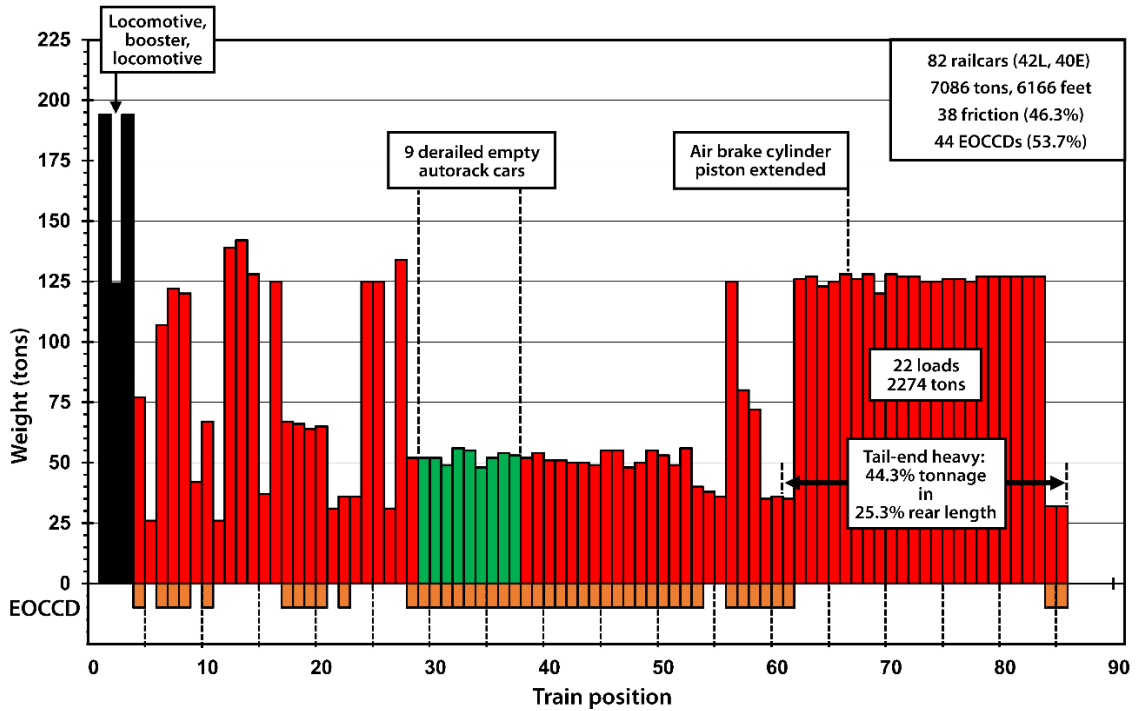
Figure 15 also illustrates how each of the 3 cuts of cars were positioned and identifies the cars equipped with EOCCDs and standard friction draft gears. In particular, the cut of heavy cars added to the rear of the assignment also contained the car in the 63rd position that was observed to have its air brake cylinder piston extended.

Figure 15. Assignment tonnage profile (Source: TSB)
