RAIL TRANSPORTATION SAFETY INVESTIGATION REPORT R20W0025

MAIN-TRACK TRAIN DERAILMENT

Canadian Pacific Railway Company
Freight train 516-380
Mile 43.66, Sutherland Subdivision
Guernsey, Saskatchewan
06 February 2020

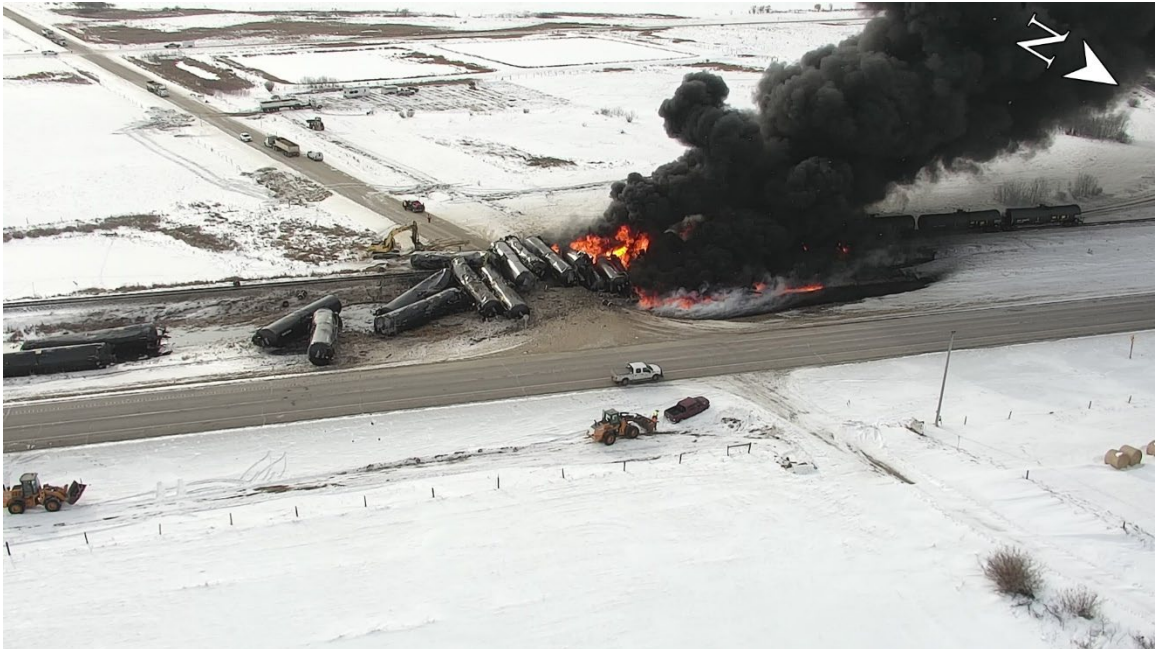
An inspection of the train determined that 32 tank cars (the 31st to the 62nd car behind the head-end locomotives) had derailed, 30 of which were breached. Approximately 1.75 million L of crude oil were released. The product ignited and resulted in a large fire (Figure 2). There were no injuries reported.

Figure 2. Aerial view of the derailment site, taken at 1300 on 06 February 2020, showing derailed tank cars, several of which are engulfed in a large fire (Source: Humboldt fire department)

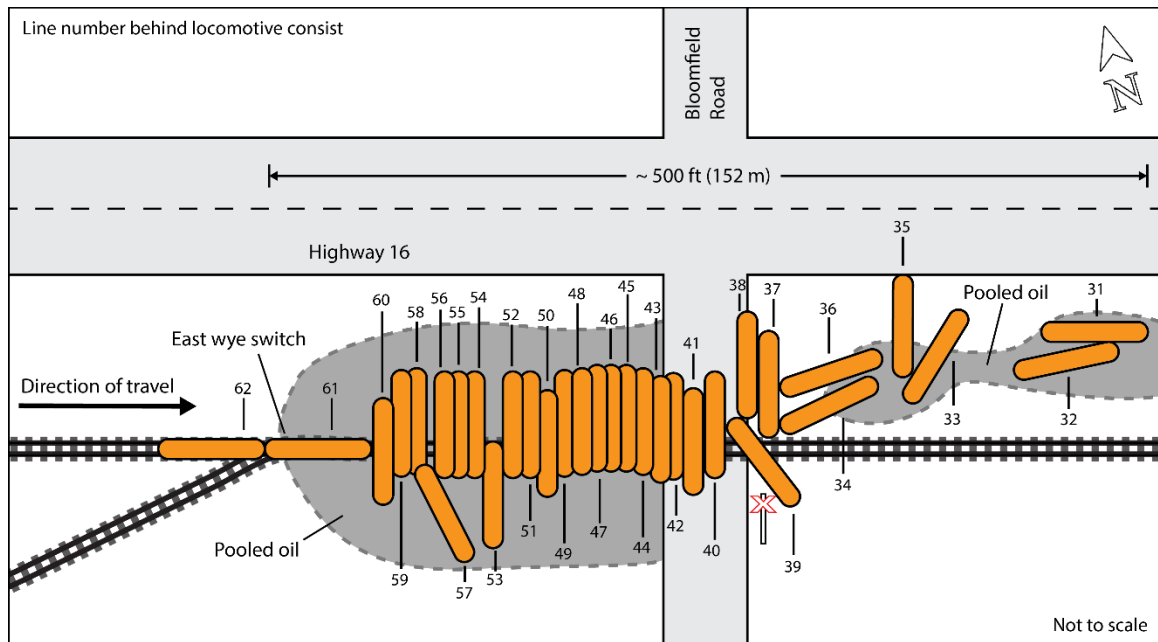
Figure 3. Site diagram (Source: TSB)

The derailment site (where the cars came to rest and the track was damaged) began at the east wye switch of the spur that leads southward to a nearby potash mine and continued eastward for about 500 feet over the Bloomfield Road public crossing at Mile 43.63.

Because of the topography of the site, crude oil pooled on both sides of the crossing. The oil on the west side was first to ignite. The crossing acted temporarily as a berm but the fire propagated to the east side.

About 300 feet of track extending eastward from the east wye switch was destroyed. The track leading up to the derailment site was inspected and no impact marks were observed on the track structure.

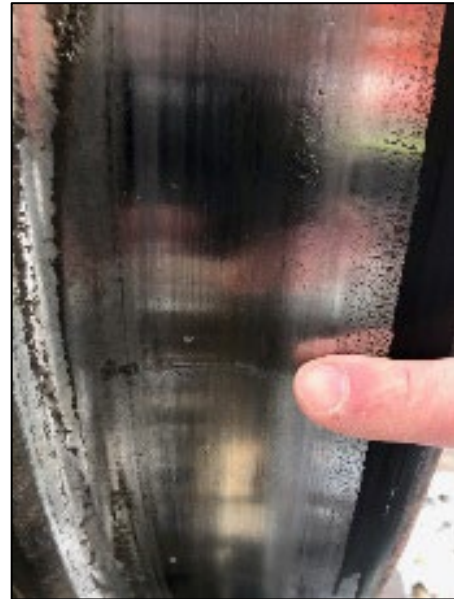
Impact marks were observed on the north-side wheel treads of tank cars located in lines 28, 29, and 30 (Figure 4). The impact mark on the tread of a wheel from the north side of the 28th car began at the flange and extended perpendicular across the wheel tread for about 2¼ inches.

Figure 4. Impact mark on the tread of a wheel from the north side of car CBTX 721371 (line 28) (Source: Canadian Pacific)

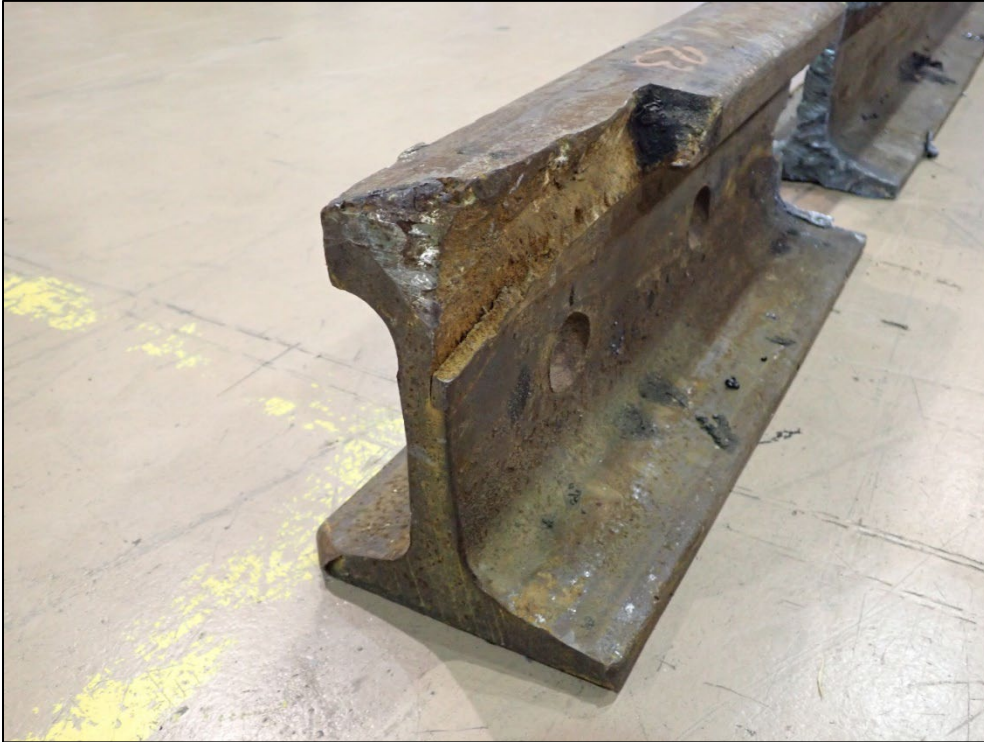
At the west end of the plug rail, the rail exhibited a vertical head crack and a 6.3-inch missing portion of rail head on the gauge side (Figure 5). The overall appearance and

orientation of the fracture surface is consistent with either a vertical split head³¹ or a shear break failure. When a vertical split head occurs at a joint, it is categorized as a VSJ (vertical split head joint area).³²

Figure 5. West end of the recovered plug rail, showing impact mark and missing rail head (Source: TSB)

Examinations of the fracture surfaces of the VSJ/shear break and the bolt hole crack found that extensive rubbing and corrosion damage obliterated most of the fracture surface features. It was concluded that the remaining scattered pockets of cleavage facets indicated that both cracks probably led to failure due to brittle overload. The inspection of the fracture surfaces did not reveal signs of fatigue.

It was not possible to determine with certainty if the fractures occurred before the derailment or as result of it.

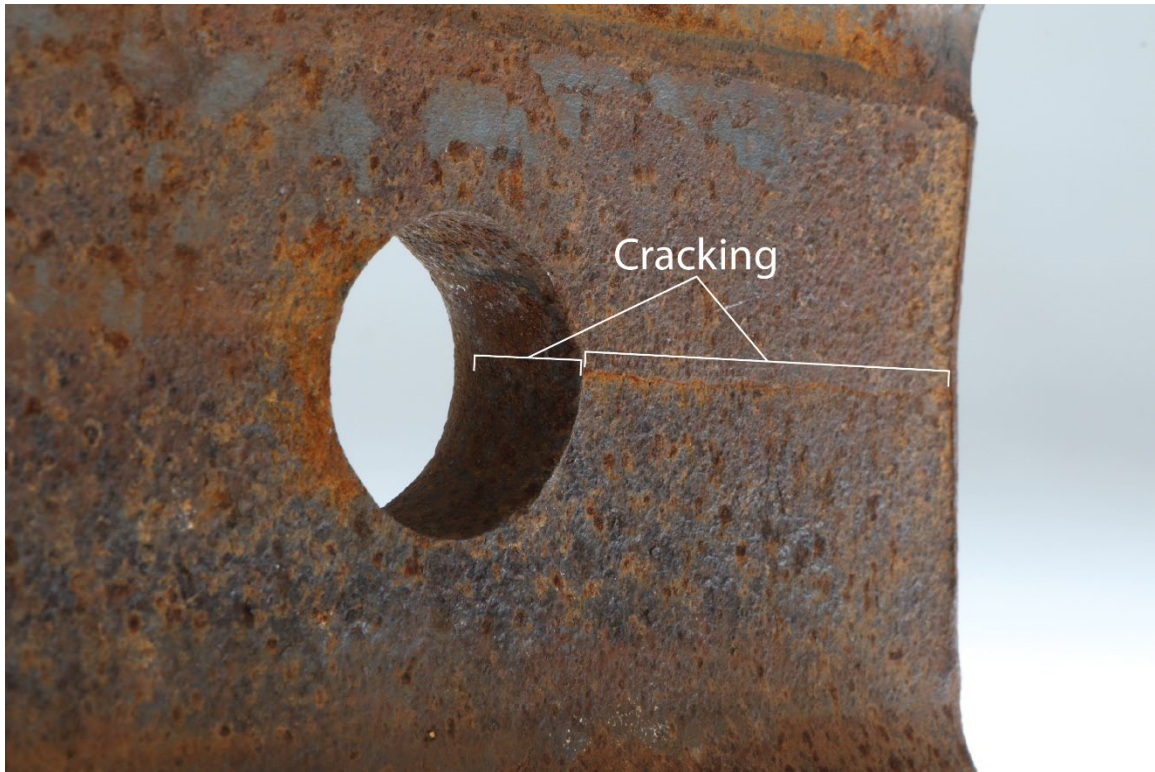
At the same rail end, the remaining head of the rail on the field side had been battered by wheel impacts. On the gauge side, no impact or rubbing marks were visible on the transverse fracture of the rail head. There was also a horizontal crack extending from the rail end to the first bolt hole (Figure 6).

Figure 6. West end of the recovered plug rail showing a bolt hole crack (Source: TSB)

Bolt hole cracks are usually the result of “unusual stresses along the edge of the hole from the bolt itself. These stresses may be caused by pumping or swinging joints, improper drilling, excessively worn joint bars or abnormal rail end impacts from rolling stock.”³³
