RAIL TRANSPORTATION SAFETY INVESTIGATION REPORT R22V0238

COLLISION BETWEEN A TRAIN AND A TRACK UNIT

Canadian Pacific Railway Company
Freight train 302-25 and hi-rail vehicle L15034
Mile 116.7, Shuswap Subdivision
Near Campbell Creek, British Columbia
29 December 2022

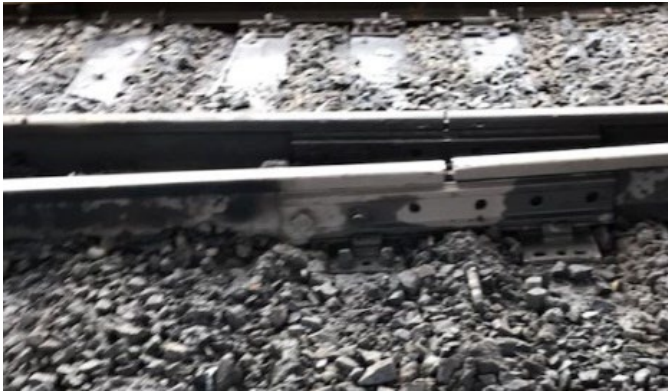
The Lafarge Spur switch at Mile 116.7 consisted of a No. 11 lift frog switch installed in 2016. At Mile 116.67, there was a 2-inch pull-apart at the first joint, east of the switch (Figure 4). The rail and joint bars had contracted eastward. The bolts fastening the other end of the joint bar to the rail on the west side of the joint had sheared off as the rails pulled apart. There was some minor rail end batter, indicating that there may have been train traffic through the area before the pull-apart was identified.

Figure 4. Pull-apart at Mile 116.67 (Source: Canadian Pacific)

The joint that had pulled apart had been secured with 6-hole joint bars for 136-pound rail, fastened with elastic clips and supported on rolled plates with lag bolts; the rolled plates were fastened with Pandrol clips and anchored every tie. The joint had been secured with 4 bolts, 2 on each side.¹⁷ The joint rails were drilled to accommodate the 4 outer holes in each joint bar; i.e., the rails had not been drilled to accommodate the 2 holes in each joint bar closest to the rail ends.

At the time that the pull-apart was discovered, the 2 bolts on the west side of the joint had broken and fallen out, and the 2 bolts on the east side of the joint were still in place. At the time of the collision, 1 of the remaining bolts on the east side (for 115-pound rail)¹⁸ had
