MARINE TRANSPORTATION SAFETY INVESTIGATION REPORT M22C0231

STRIKING OF BERTH

Passenger ferry *Sam McBride*
Toronto, Ontario
20 August 2022

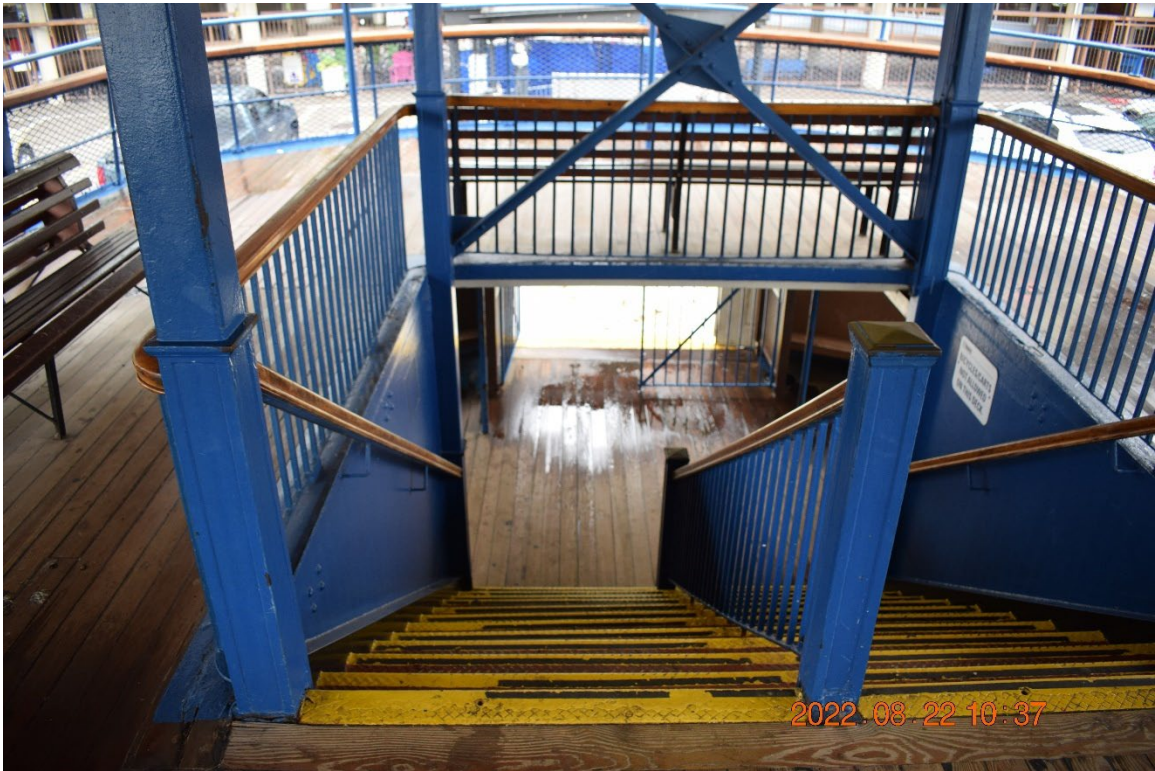
Figure 3. Stairs descending from the promenade deck to the main deck (Source: TSB)

Without effective measures to prevent passengers from standing in these high-risk areas, many passengers were at risk of falling when the vessel struck the dock. As the vessel came to a sudden stop, its momentum carried people forward and caused many to lose their balance. Those standing on one of the decks were at less risk because they could recover their balance by stepping forward, and, if they fell, it was only onto the deck or the person in front of them. Only a few passengers standing on the decks were injured. However, those standing on or at the top of the stairs did not have level ground in front of them to allow them to catch themselves. This resulted in people falling down the stairs and onto others standing in front of them, leading to multiple injuries.

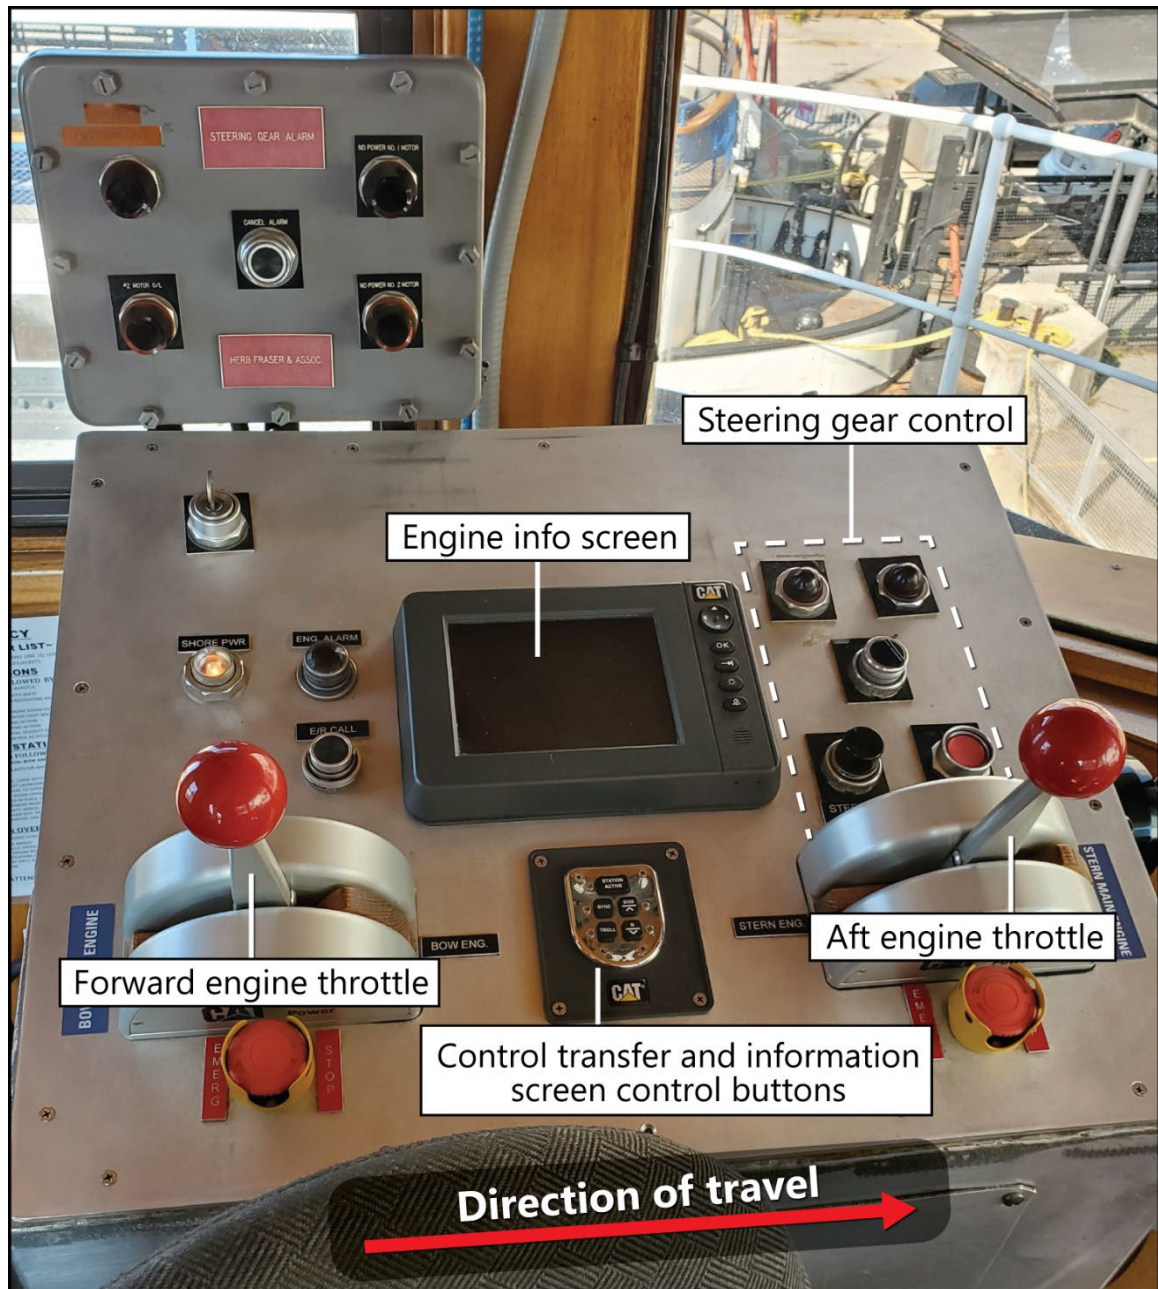
Figure 4. Engine control console in the forward wheelhouse, on the port side of the steering position (Source: TSB)

At 1702, the master reduced the throttle to begin approaching the dock. Over the next 2 minutes, the master reduced the throttle to neutral, reversed the throttle, and moved the throttle back to neutral. The crew noted that the forward engine was not responding normally. At this time, the vessel reached the first mooring dolphin, approximately 40 m from the dock, at a speed of approximately 5 knots. As the vessel approached the dock, passengers had begun moving toward the exit; some passengers were standing on or at the top of the forward stairs to the main deck.

TSB investigators observed sea trials of the vessel after the occurrence; both engines and their control systems were found to be in good working order. As well, the engine control modules for the bow and stern engines did not show any fault codes or events for the day of the occurrence. The investigation was unable to determine why the forward engine and propeller did not engage to slow the vessel on the occurrence voyage.

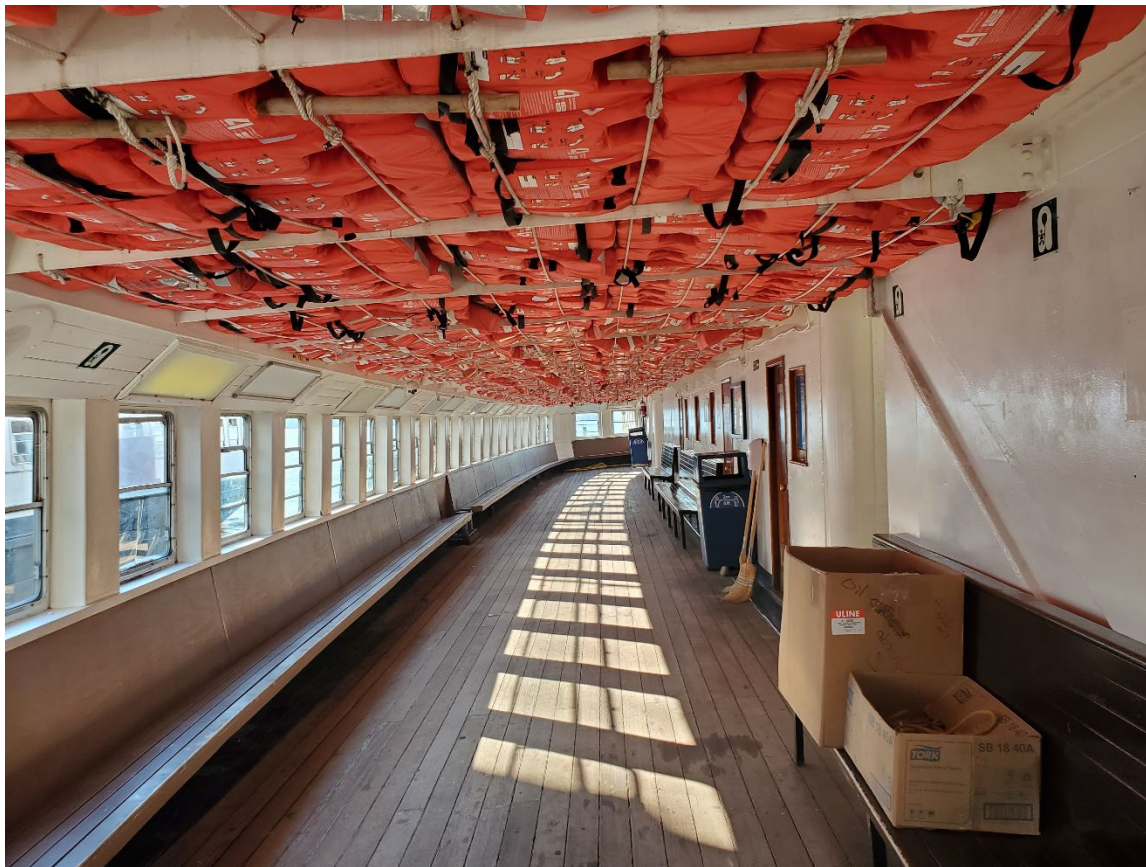
Figure 8. Lifejacket stowage above the main deck (Source: TSB)

Some of the lifejackets were stored in a way that obscured the information about sizing, which could impede the ability of passengers to select an appropriate lifejacket. Although there was 1 sign posted per deck (Figure 9), containing information in English and French on how to don adult lifejackets, the information was not specific to either of the 2 types on board.
