HYDRAULICS DIVISION

Technical Note

DATE: April 2, 1980 REPORT NO. 80-18

TITLE: Erosion at the tip of Long Point near the Long Point Lighthouse, Lake Erie

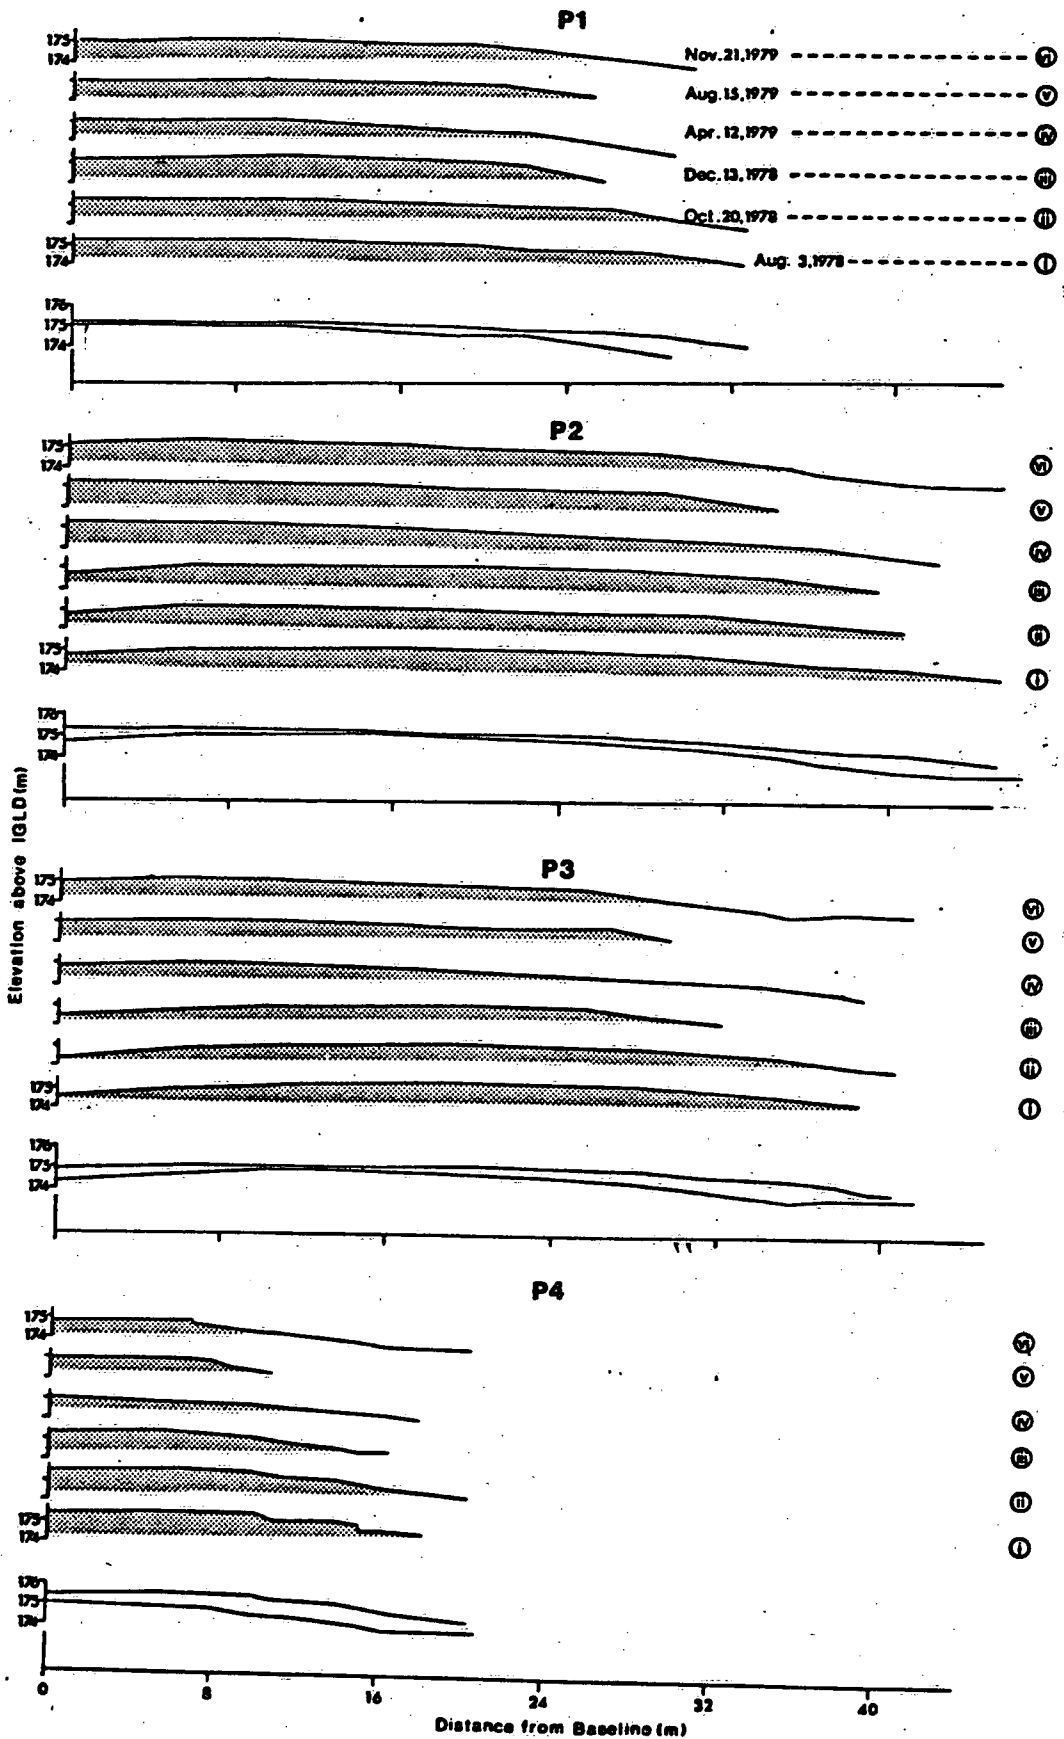
Cross sections show a continuous recession of the beach at all four sites. This averaged 7.3 m for the survey period referenced to elevation 174.25. In addition, the attached plan of the groyne system shows water's edge positions as recorded on the first and last surveys. It indicates general recession in spite of a drop in lake level of 22 cm. Furthermore, the pattern of deposition indicates a reversal in littoral current. During the surveys, no predominant direction has been evidenced. This reversal in drift direction may be the cause for the lack of any overall infilling.

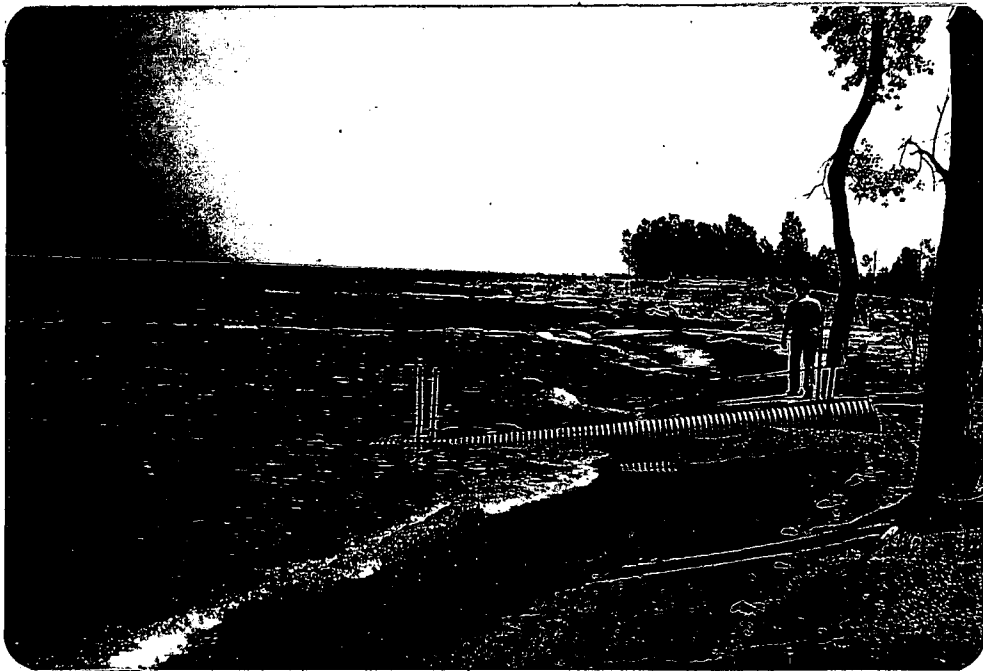
Picture #4 is a general view looking towards the end of the Point. The tree to the immediate right has obviously been free from erosion for some time as it has quite a large diameter of trunk. Note also that the groyne are awash so that their ability to trap and build up sand is limited. The groyne seem to be quite stable but are of insufficient height to trap large volumes of sand. The lighthouse-keeper added the culvert pipe in the foreground.
