A BRIEF SURVEY OF ICEFALL IN  
SOUTHERN ONTARIO

Project report (Canadian Meteorological  
Service, Climatology Division)

Andrew Gilbert and Douglas Pitcher

*PROJECT REPORT NO. 5*

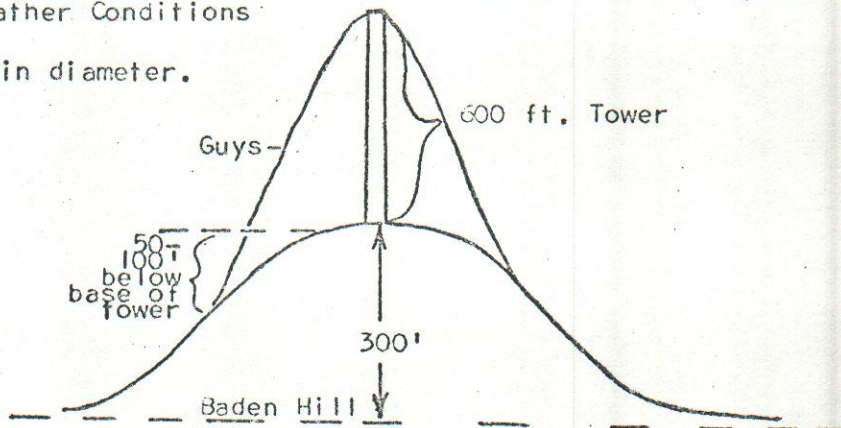
Freezing rain, most severe when wind is from east. Ice falls usually with  
S.W. wind. Drifts slightly with wind. Ice found 500 ft. from tower base,  
attributed to guys though 3 to 4 ft. sections from tower proper frequent.

Much ice falls from guys, ice 6" + in diameter.

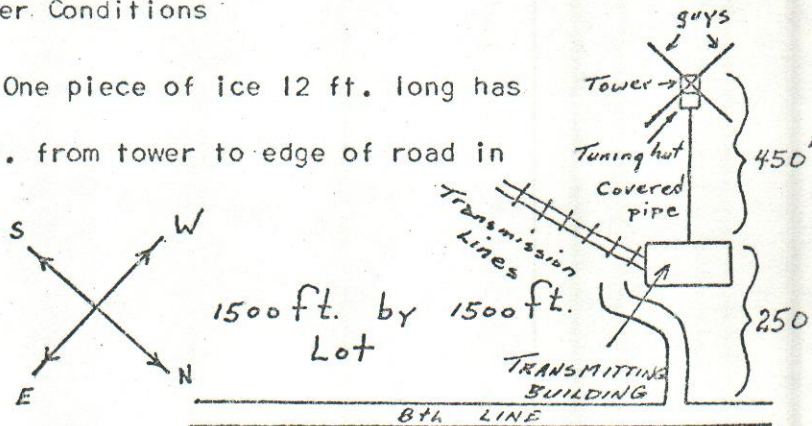
Ice falls east of tower within 200 ft. of base. Some fall to other sides, but much of this goes unnoticed. Most falls closer than 200 ft. as there is a tar-paper-covered copper pipe with more holes in it due to ice fall near the tower than 200+ ft. from it.

Ice can fall 200-700 ft. from tower. One piece of ice 12 ft. long has hit transmission lines marking them. One piece of ice 6" x 6" glided 700 ft. from tower to edge of road in one case.

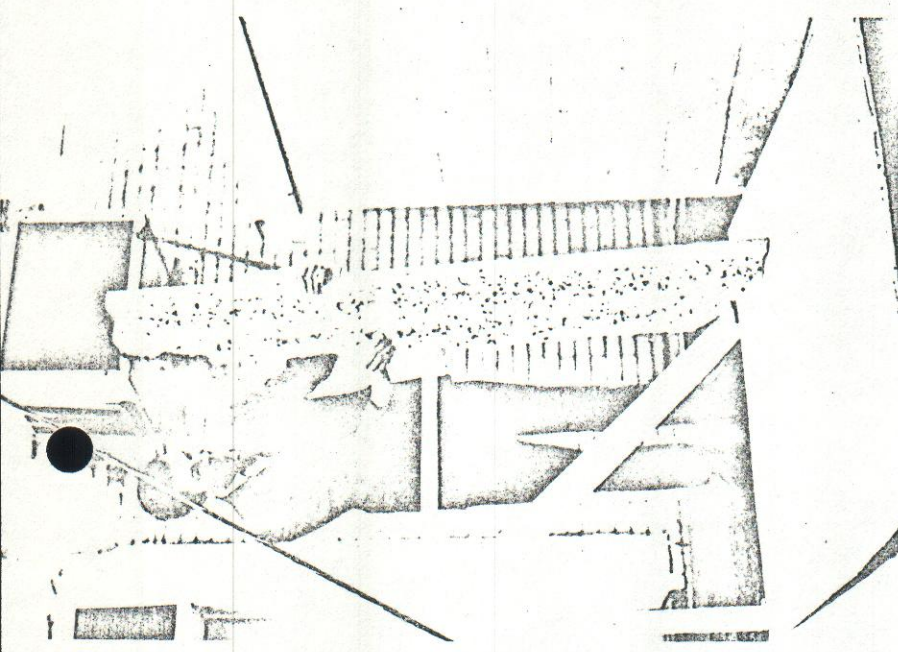
Damaged roof pieces, C.H.I.C.  
A.M., Brampton.

This one-hundred-and-fifty-foot tower has a small tuning hut beneath it, the eaves of which have been broken off by icefalls. Six-foot-by-six-inch pieces of the quarter inch corrugated asbestos on wood roof have been broken off.

Some falls smashed corrugated asbestos roofing at eaves of small shack. Roofing was 5 ft. x 1/2 ft. x 1/4 inch, unflexible corrugated asbestos.

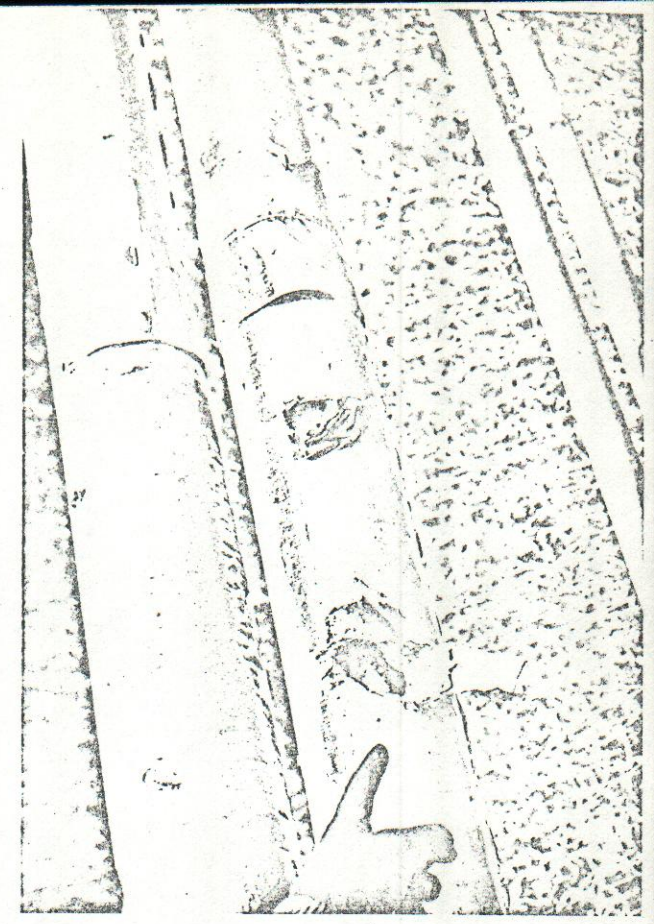
Holes in tar-paper cover  
of pipe - C.B.C., Hornby.

lines, marking them; while another piece six inches square was found seven hundred feet from the tower. Damage to ventilators and to the tar paper covering of a copper pipe are indicative of large amounts of icefall. Little buildup takes place on the guys because ice is shaken off by their continuous motion. (see photos)

Aluminum ventilators on tuning hut below tower bent and dented by falling ice. Falling ice makes holes in tar-paper-covered pipe. (Note: Only holes in tar paper, not in copper pipe) This pipe was recovered with tar paper in 1948. Guy wires are trembling almost continually due to wind and this enables ice to fall off almost as soon as it freezes, i.e. no accumulations of ice have been observed on the guy wires. Ice has never been known to hit building and do any damage.

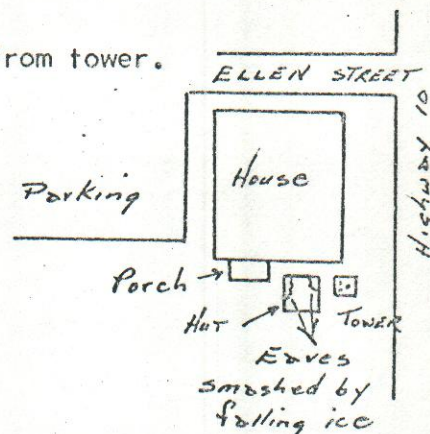
2 ft. long slabs to east and north of tower, up to 30 ft. from tower.
