## Feedback

### Canadian Aviation Service Difficulty Reports

The following content was published between 1 August 2023 and 31 December 2023. The full accessible version of each article is available on the Feedback [website](#).

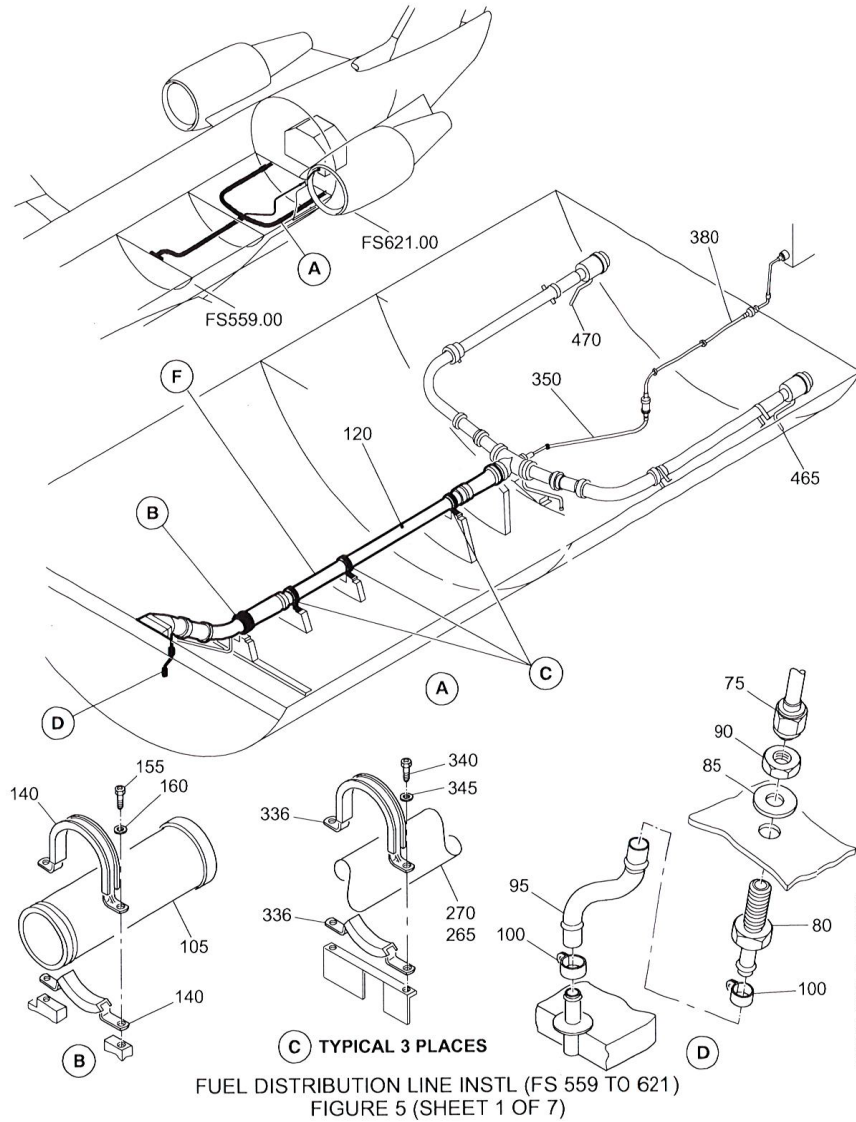
Figure 1 – IPC reference showing affected area

However, the area is still known to be susceptible to significant corrosion defects. The Illustrated Parts Manual, Section 28-20-00, Figure 5, shows the area where defects have been found, and the lines, shrouds and fittings in this area that can be affected by corrosion and develop leaks. Removal of the shroud is required to inspect and find the corrosion defects because they originate inside the shroud and on the lines.

Operators should be aware of this issue and the potential defects in this area and consider whether more frequent inspections are indicated for their operation in order to detect excessive corrosion and ensure the integrity of the lines and shrouds.

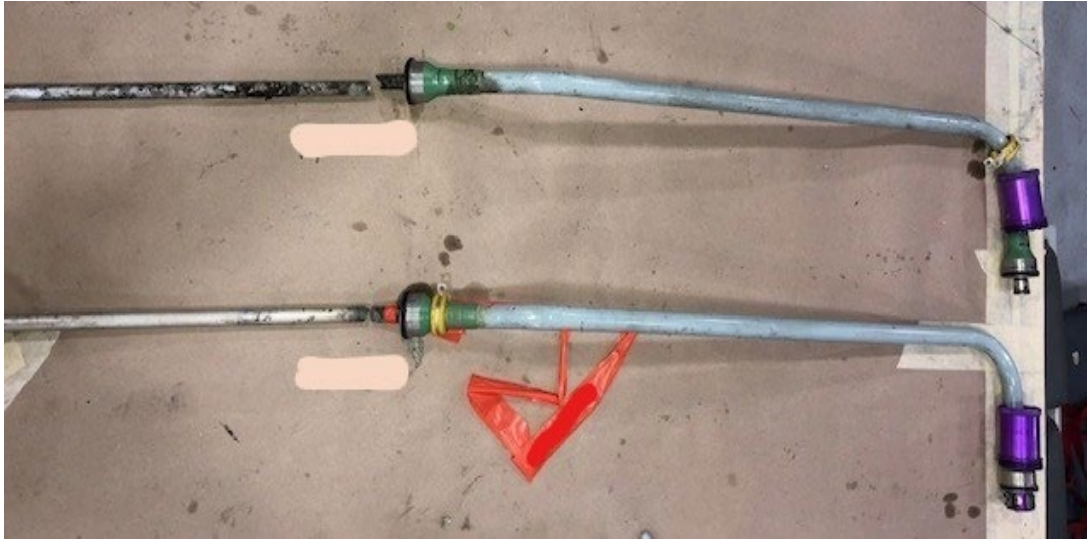
While running the auxiliary power unit (APU), maintenance discovered a fuel leak. The investigation determined that the fuel leak was caused by severe corrosion of the APU fuel feed line. Maintenance attempted to rob a replacement fuel line from another aircraft but found that the line was also corroded at the same location. The fuel lines are to be replaced with serviceable parts.

Figure 2 – Lines showing corrosion

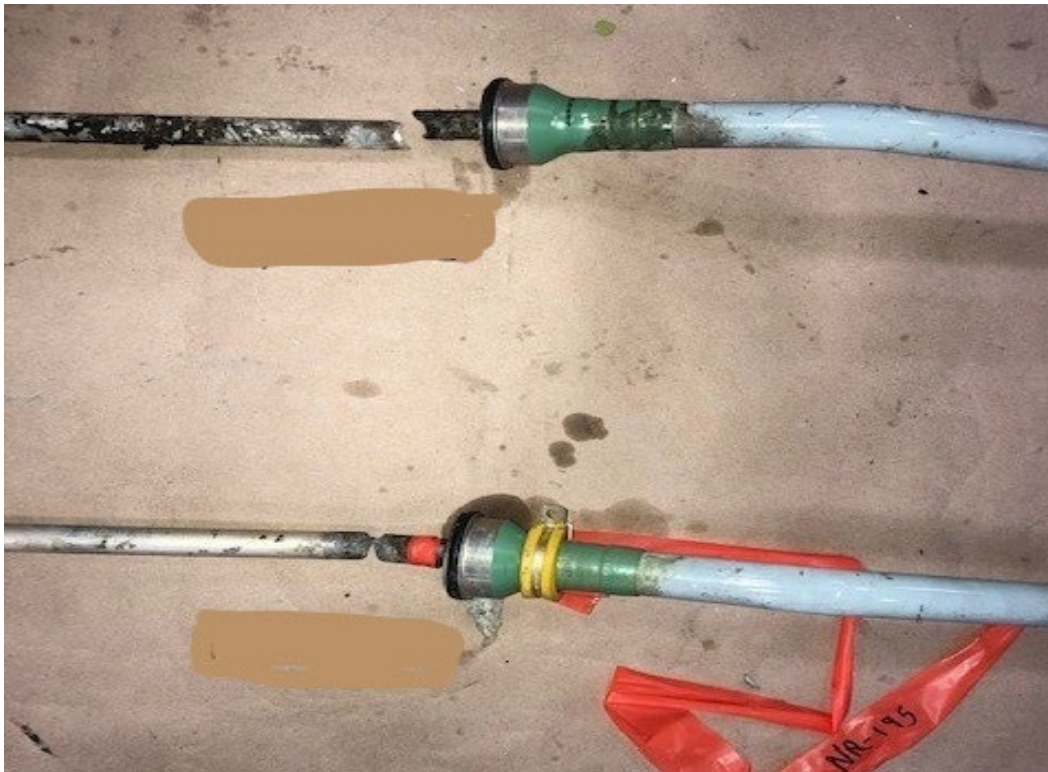
Figure 3 – Broken lines close-up

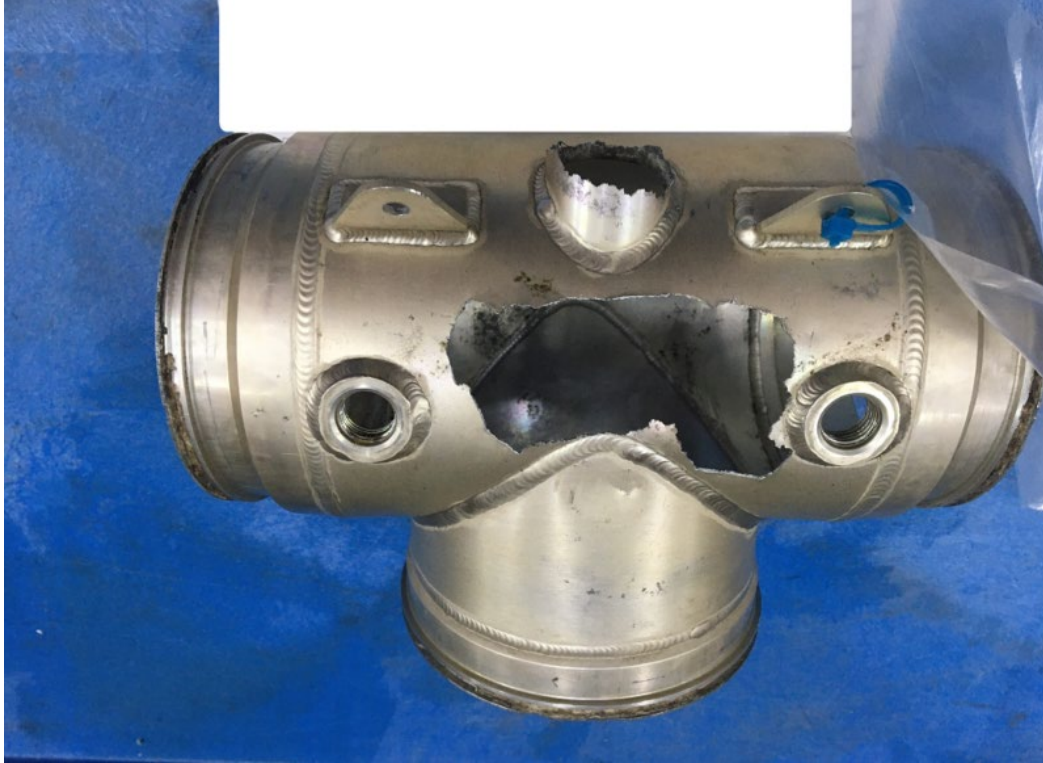
Figure 4 – Corroded Tee fitting outside view

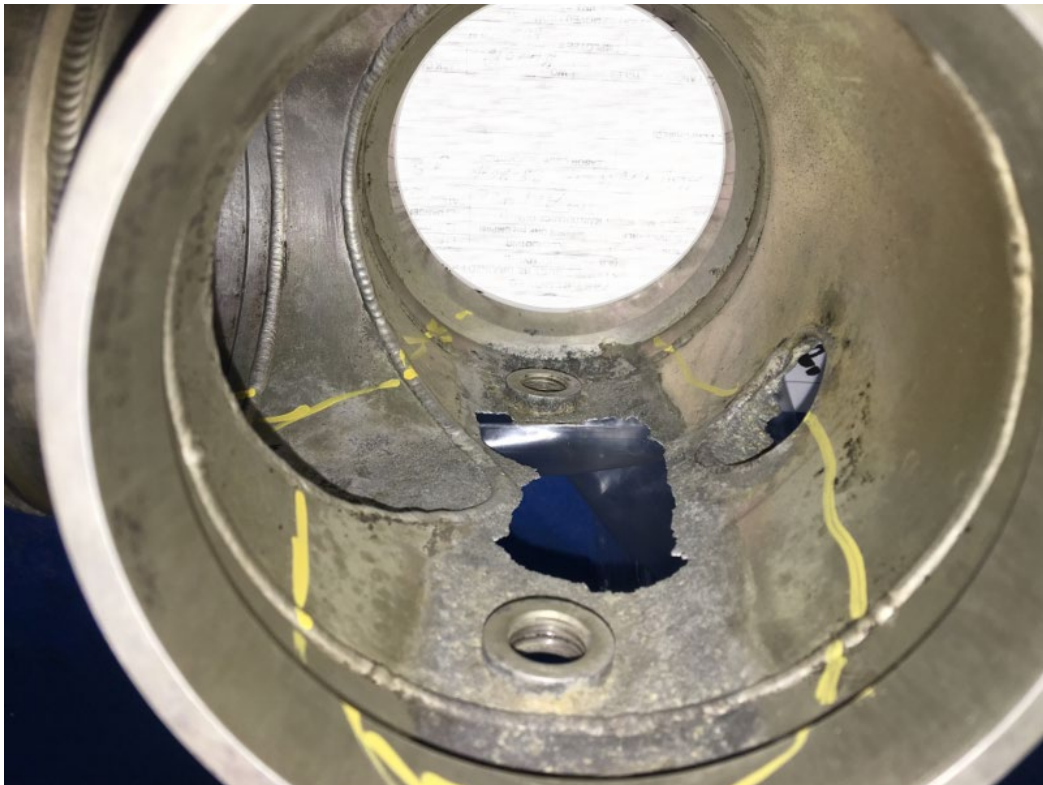
Figure 5 – Corroded Tee fitting inside showing corrosion

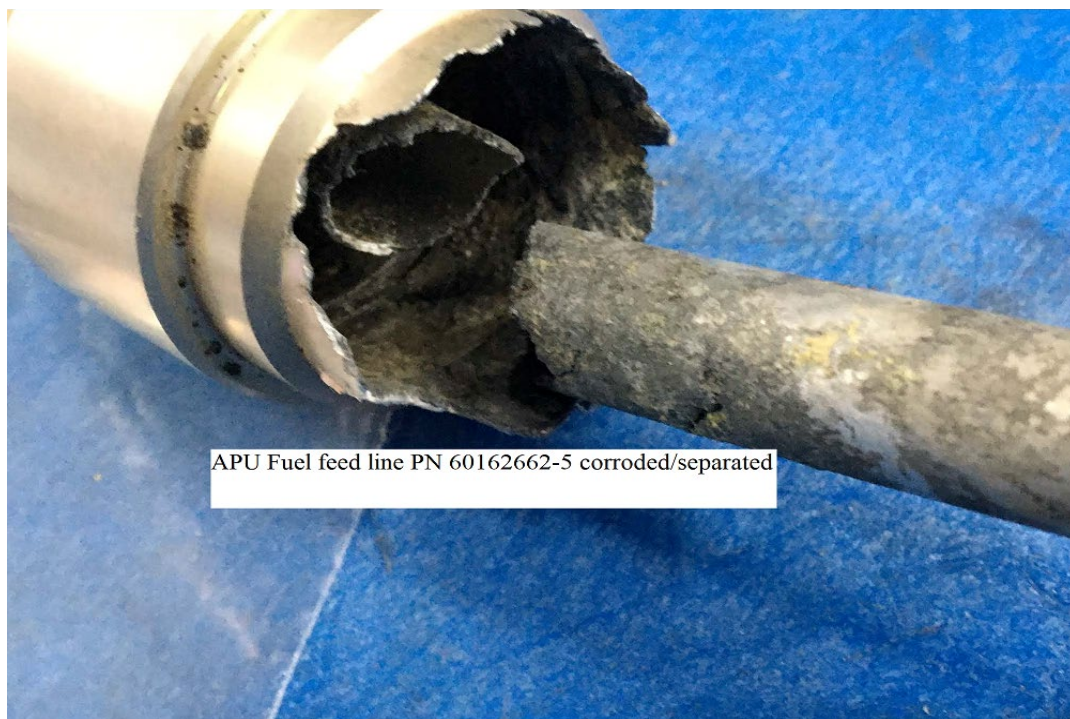
Figure 6 – Close-up of corroded line break showing extent of corrosion

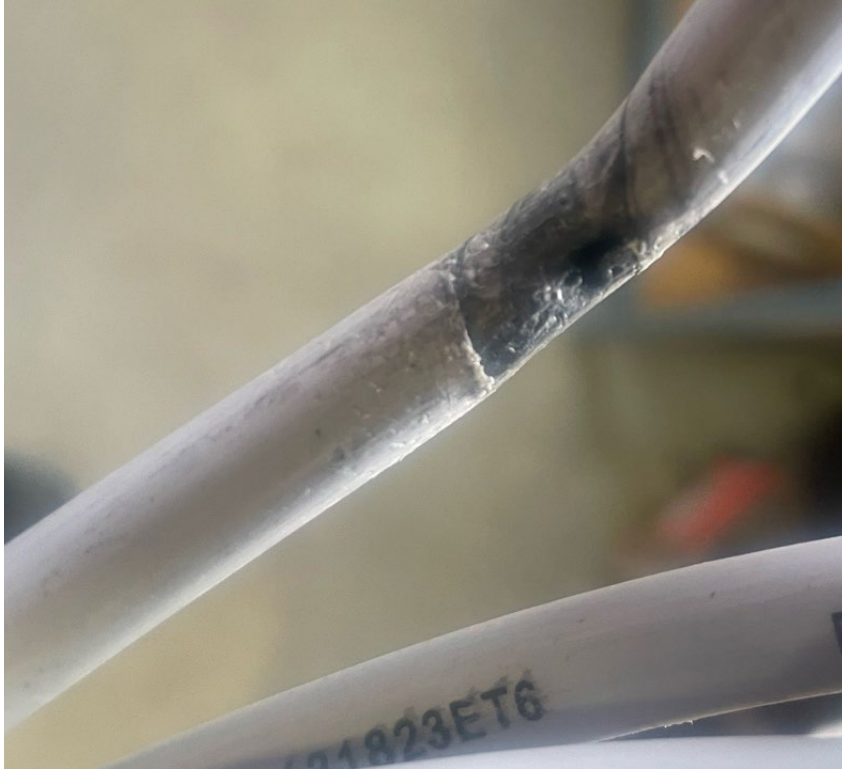
During routine maintenance of the horizontal stabilizer internal inspections, we have found the deice line that runs over top of the logo lights melted and distorted – in one case was melted right through and sealed itself shut not displaying any faults in the cockpit and no inflation of deice boots on tail-let. We have replaced line with superseded Part Number 131823PT6.

Picture 1 – Melted deice line

According to the submitter, the flight crew did not receive any fault indications. However, it is important to note that in SINGLE or MANUAL mode, the TAIL DEICE annunciator may appear to be illuminated normally, giving a false impression of a normal inflation-deflation cycle to the flight crew. Additionally, the instrument panel pneumatic pressure gauge may seem to indicate normal function even if there is a blockage or restriction in the stabilon, stabilizer, or tail-let deice boot line downstream of the tail pressure switch. Despite this, during surface deice operational checks, any insufficient boot inflation or deflation should be investigated further.

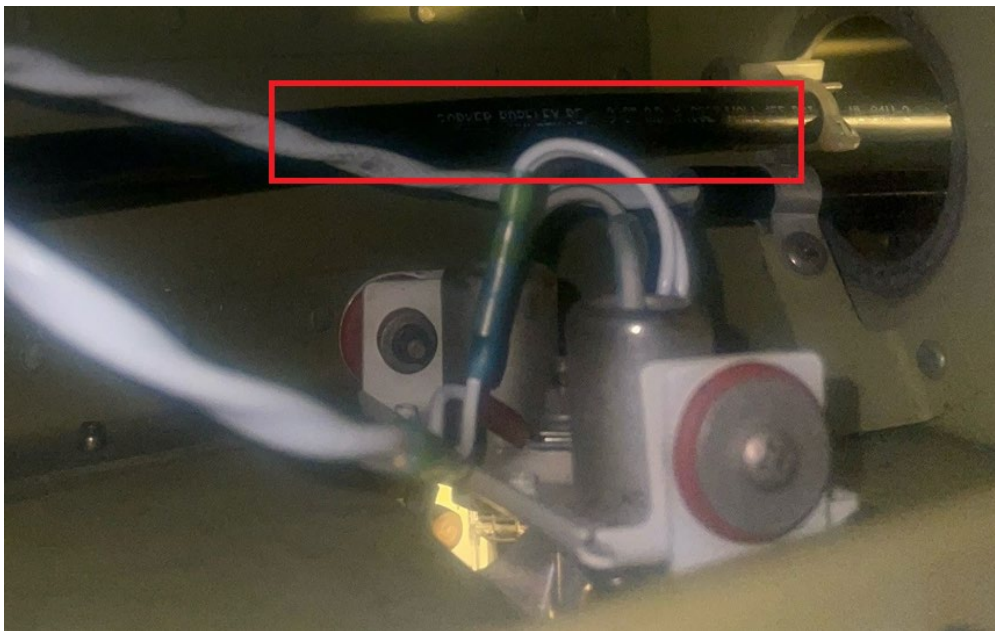
Picture 2 – Location of concern above logo light, internal of stabilizer

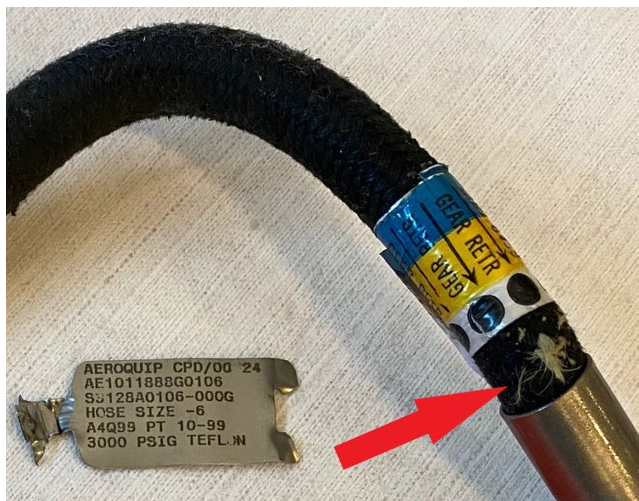
Enroute the aircraft indicated low hydraulic oil system A. As per the checklist procedures the aircraft returned to the departure airport and notified ATC (Air Traffic Control) of issues. The aircraft successfully completed landing at the airport using emergency brakes. The aircraft was towed to the maintenance hangar and discovered that the RH main landing gear retraction hose had burst. The aircraft has now been repaired and is back in service. Hose part number (P/N) S3128A0106-000G manufactured 4q99. This hose is original to this aircraft. No applicable SB (Service Bulletin) or SL (Service Letter) has been found related to this part, and there are no TLMC (Time Limit Maintenance Check) requirements for this hose.

Multiple failures of the RH main landing gear retract hose have been reported, including the alternate P/N listed in the Illustrated Parts Catalogue (IPC) P/N AS115-06K0106.

Often, failure will occur during retraction after rotation, or during extension, and accompanied by a Crew Alerting Message (CAS) such as: HYD PUMP FAIL A, or HYD VOLUME LOW A. In one reported case, HYD PTU FAIL CAS message was displayed.

In all cases reported, emergency extension of the gear using the free fall or pneumatic blow-down methods resulted in positive gear down indication and subsequent safe landing. Transport Canada suggests owners, operators, and maintainers pay attention to the age and condition of the RH main landing gear retraction hose. In particular, the section in close proximity to the swage end of the hose assembly as indicated in the picture below.

Picture 1 – Hose assembly failure location

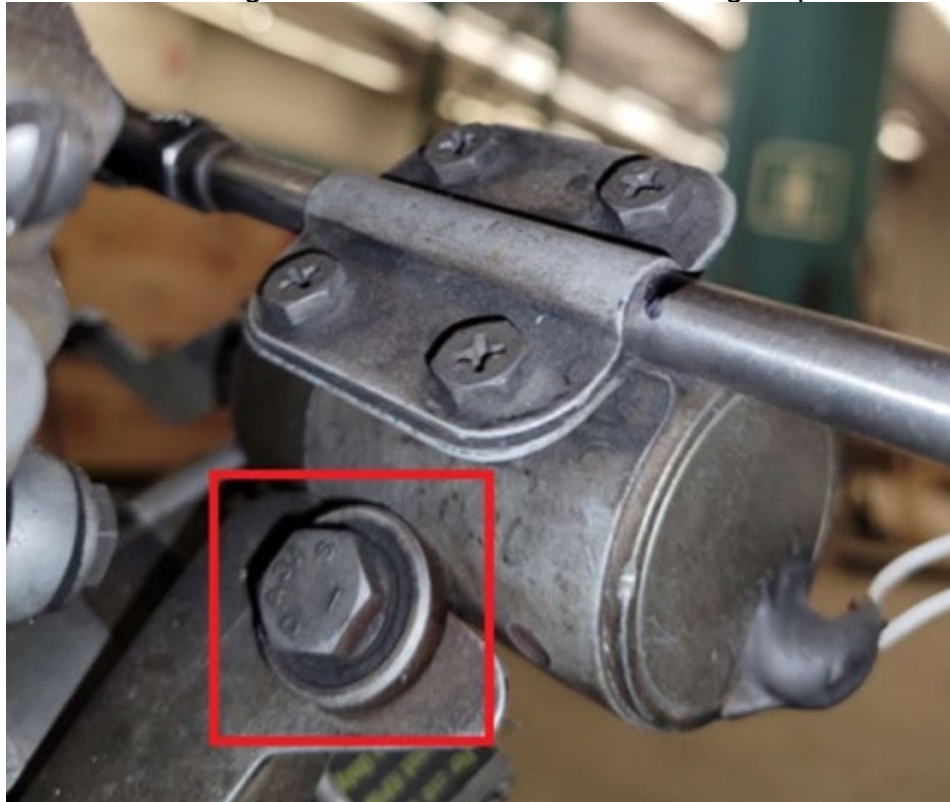
During the investigation into the incident, the left-hand (LH) and right-hand (RH) beta solenoids were disassembled, and there were signs of corrosion noted. Examination of the beta solenoid brackets found wear markings from their respective roller bearings evident along the working line of contact, from the normal in-flight position to the retracted position when the reversing cable is pulled by the pilot utilizing the power lever. The through-thickness hole on the LH bracket was observed. The location of these worn engine assemblies would make it difficult to observe the wearing marks unless disassembly during routine maintenance in the area was performed.

The beta solenoid could not be ruled out as a cause of the propeller blades progressing below the in-flight low-pitch stop setting. The beta valve could not be ruled out from having experienced a failure that prohibited it from moving freely, thereby allowing the pressure of the engine oil to drive the blades to a pitch below the normal in-flight idle low stop pitch position.

Picture 1 – Wear marks observed in the body of the solenoid bracket

Special attention should be given to the functionality of this system to avoid an inflight occurrence during a critical time such as the landing sequence.

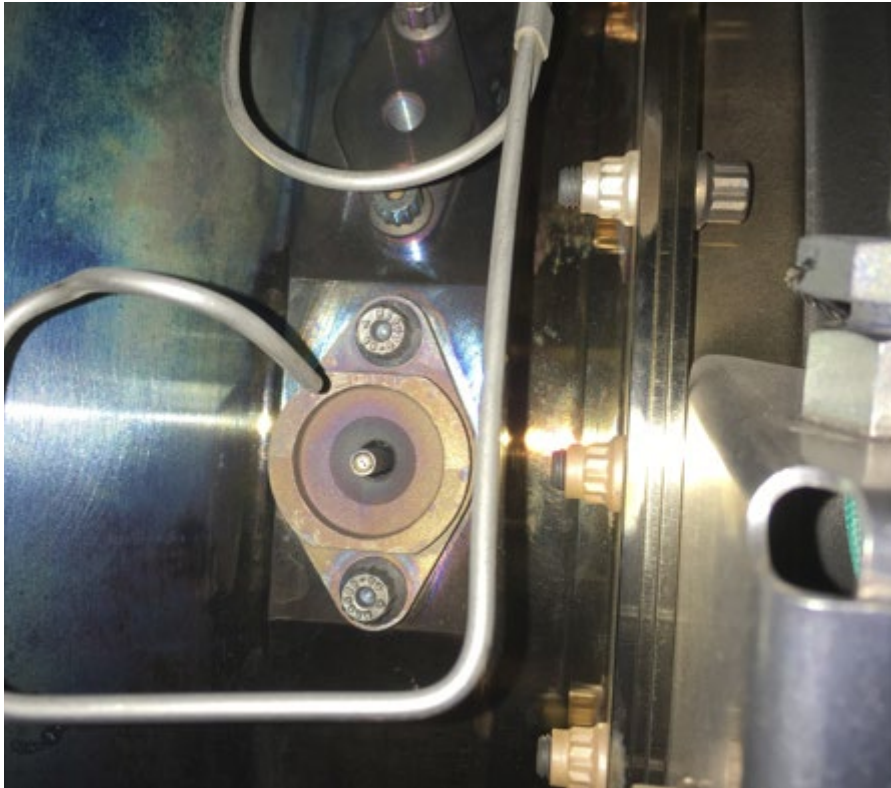
While inspecting the internal ignition lead segments to the igniter plugs, during the first 800-hour interval tasks, broken thermocouples were observed through the bypass access panel. Upon further inspection, it was discovered that there were broken probes on each wiring harness of both engines. All four thermocouple wiring harness assemblies (two per engine) required premature replacement at 818.2 hours total time since new.

From the photos provided by the service difficulty report submitter, the thermocouple leads seem to have broken close to the thermocouple probe body where the assembly is attached to the engine case. Some discoloration on the thermocouple leads may indicate corrosion and the offset alignment of the lead to the thermocouple probe after breaking suggests stress or fatigue induced during installation.

Picture 1 – Sheared Thermocouple Lead

The root cause of this event is still being investigated by the manufacturer, however, Transport Canada Civil Aviation (TCCA) would like to highlight this event for operators of PW306D engines and similar models. If performing inspections in this area or carrying out the 800-hour interval task, pay particular attention to the security and serviceability of the thermocouple harnesses and report any findings through the [Web Service Difficulty Reporting System](#).

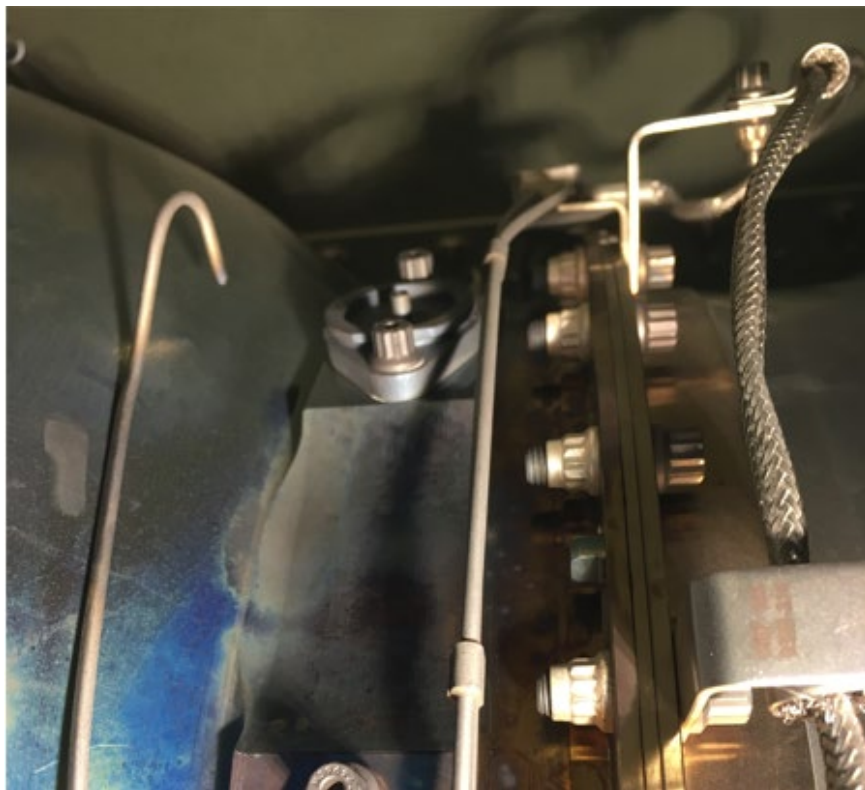
Picture 2 – Thermocouple Lead Sheared and Rubbing On Case

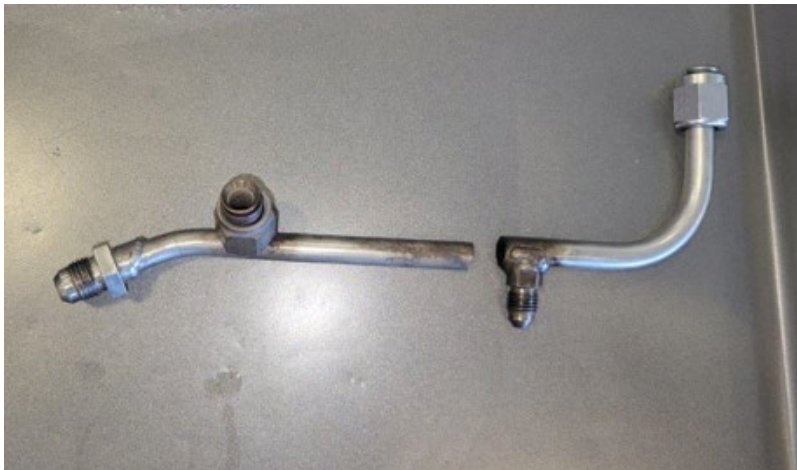
During a scheduled engine fuel nozzle replacement, the combustion chamber fuel drain line was found cracked.

The investigation into the root cause continues, however, corrosion and stress along the weld seam may have been contributing factors.

Picture 1: Broken fuel line

Please be diligent when inspecting this area and, specifically, this line. Please report any similar findings through the Transport Canada [Web Service Difficulty Reporting System](#).

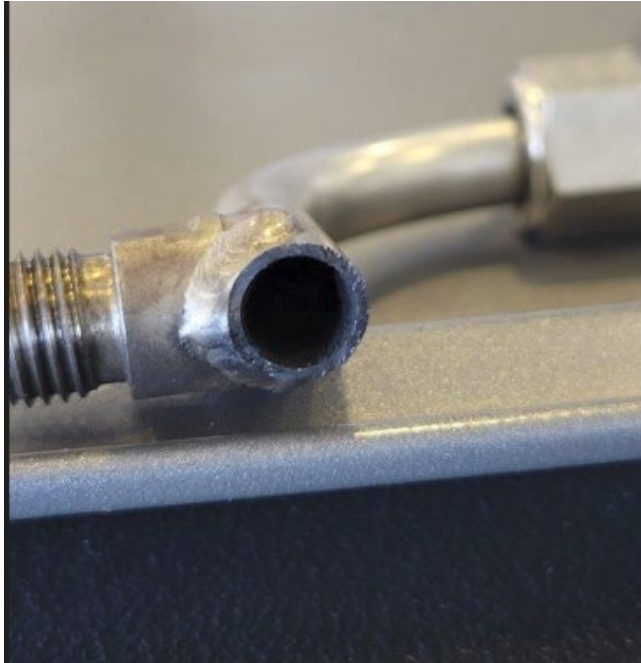
Picture 2: Broken fuel line closeup

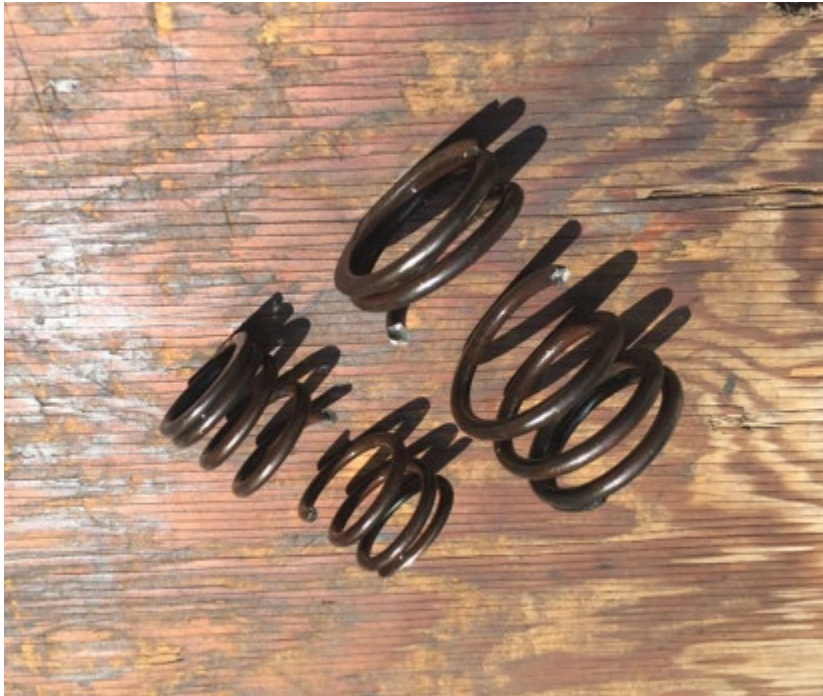
The pilot noticed the engine running rough in flight. He returned to base and landed. Upon further investigation, the Aircraft Maintenance Engineer found low compression on the #1 cylinder and both exhaust valve springs broken. He did some research and found a report of another Teledyne Continental engine O-470 with similar problems with valve springs and subsequently decided to replace all the valve springs. At that time, he found another outer spring and 4 inner springs broken and replaced them with springs from a different supplier.

Picture 1 - Broken Inner and Outer Valve Springs

Transport Canada brings this event to the attention of operators and maintainers for awareness of a potential problem with these PMA parts. If you have experienced related problems with these valve springs on this engine model or similar models, we encourage reporting events through your SDR system for trend monitoring and possible continued airworthiness safety actions.

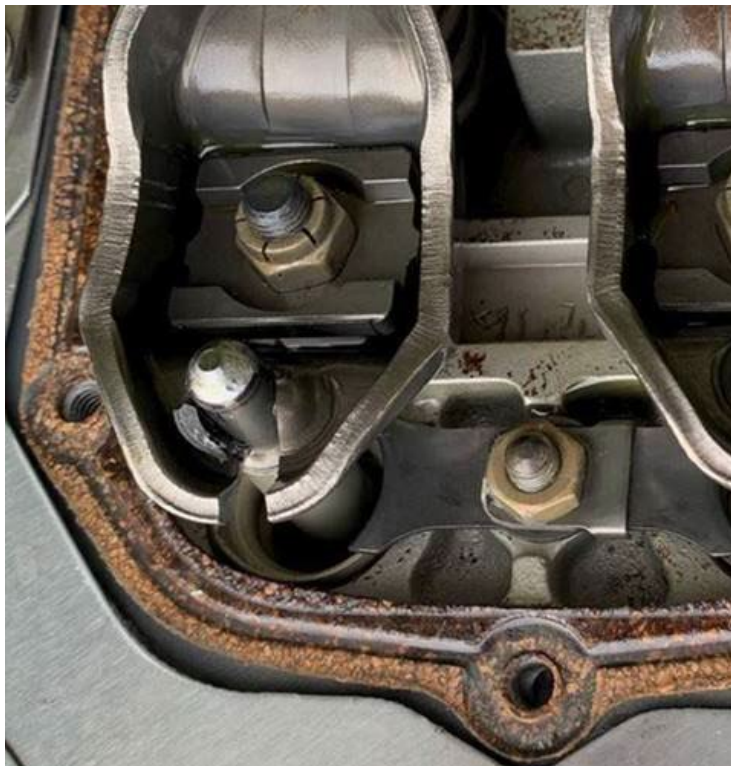
A student pilot was on a solo flight when they experienced a sudden loss of power and a rough running engine. Troubleshooting and attempting to resolve the issue was unsuccessful and the pilot was unable to maintain altitude. As such, the pilot landed the aircraft in a nearby field. They activated the ELT and completed a mayday call before touching down. Upon initial inspection there was no damage to the aircraft from the landing. The mechanical issue was quickly found to be on the cylinder #4. The intake push rod tube was bent, and the exhaust push rod broke through the rocker arm. There were approximately 240 hours on this engine since overhaul with no significant

After conducting an investigation, it was found that Lycoming Mandatory Service Bulletin (MSB) 639 had not been performed at the recommended 50-hour interval following rocker arm replacement during overhaul. To prevent further incidents, Transport Canada Civil Aviation suggests that owners, operators, and maintainers incorporate MSB 639 and continue to file Service Difficulty Reports (SDRs) in the event of rocker arm defects.

Picture 1 – Rocker Arm failure at pushrod socket

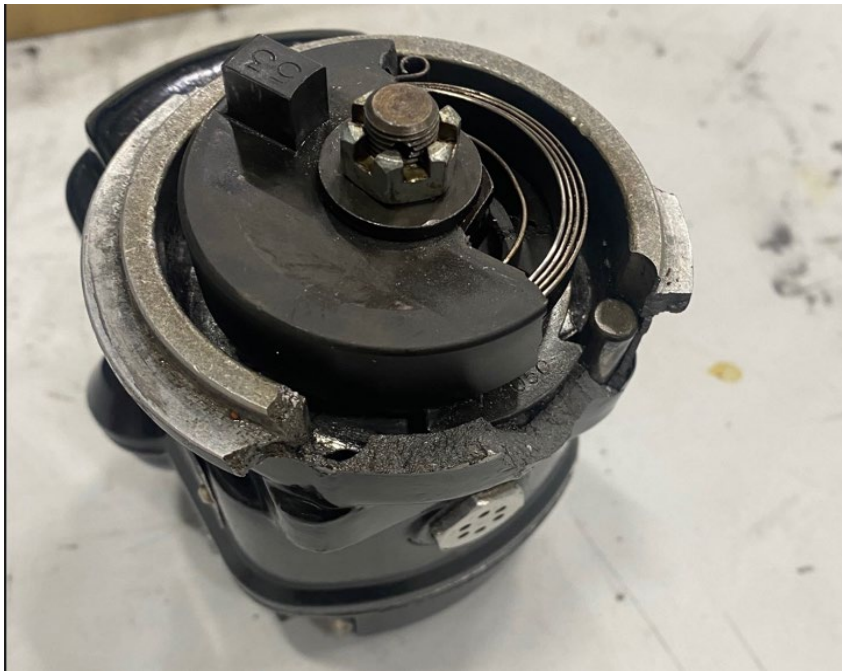
landing back on the water. A visual inspection of the aircraft on the dock revealed that the left magneto had separated from the engine. The magneto's case and the engine adapter both showed damage consistent with a sudden seizure of the magneto. No other damage to the engine/aircraft was noted. Both magnetos were replaced with overhauled units and a replacement engine adapter was installed. Aircraft was grounded and flight checked serviceable.

Picture 1 – Broken Impulse Coupling

TCCA recommends that maintainers and owners pay particular attention to the flanges and adapters while inspecting the ignition system. SLICK Service Bulletins (SB) SB1-19A and SB2-19A address reports of impulse coupling broken rivets and stop-pins liberating and potentially entering the gear train, which could contribute to seizure of a magneto. The failed magneto in this event appears to still have the pin in place but it is difficult to determine if the rivets were a factor due to the damage.

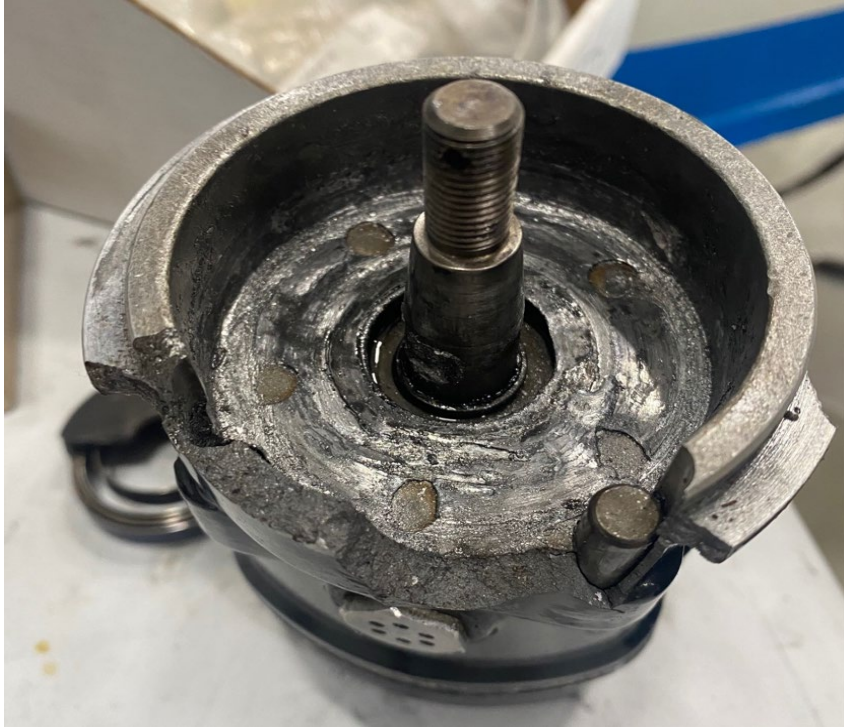
Picture 2 – Broken Magneto Case

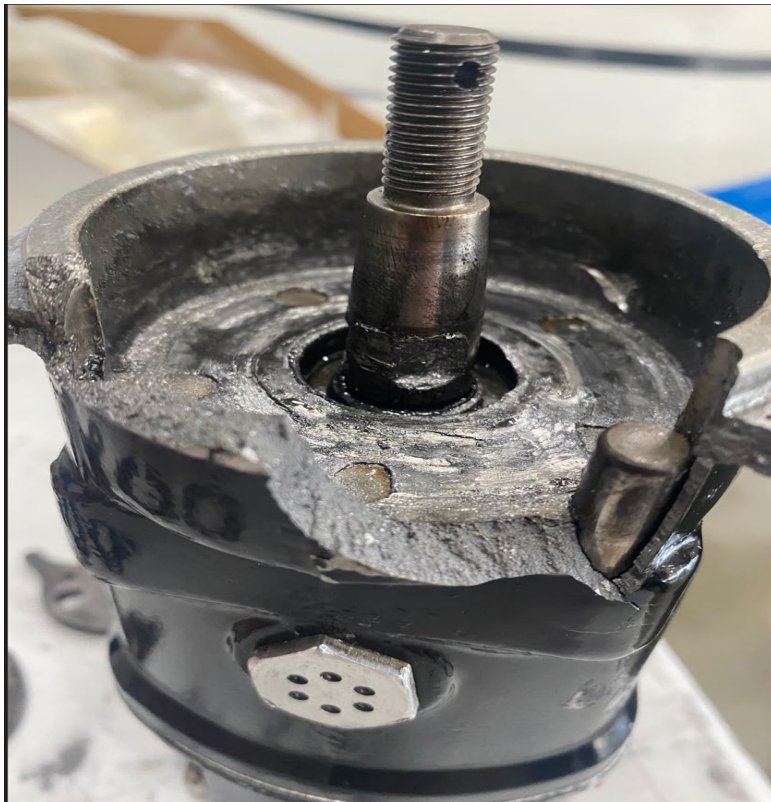
Picture 3 – Worn magneto Shaft

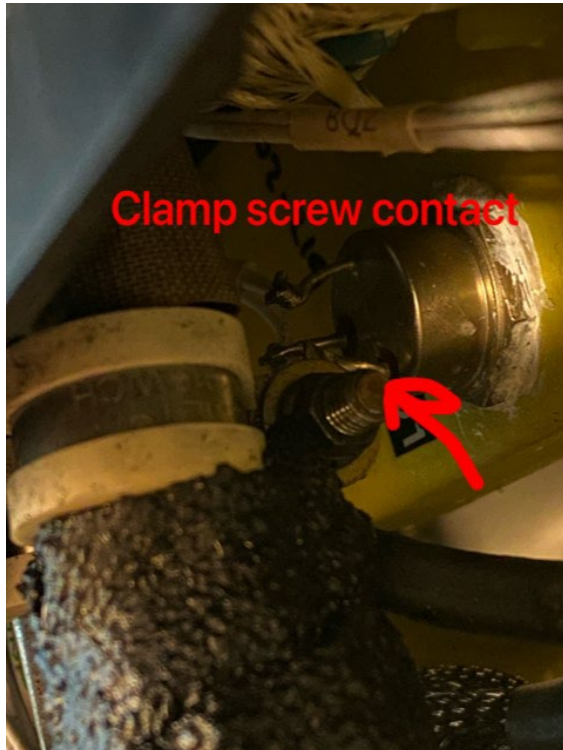
Smoke in the cockpit with ground power on was reported to Bell. A clamp was found contacting transistor.

The cause of this service difficulty was determined to be a clamp from the Air Comm Corporation air conditioner system fouling with the Bell Automatic Flight Control System (AFCS). The smoke was generated when the hardware that was used to secure the clamp contacted an electrical component of the AFCS. As a result of the Air Comm Corporation investigation, Service Bulletin (SB) 407-221012 was published. The SB provides instructions to resolve the potential fouling condition between the air conditioner system and the AFCS. Transport Canada Civil Aviation would like to raise awareness of this SB to the owners, operators and maintainers of Bell 407 helicopters with an Air Comm Corporation air conditioner system installed along with the AFCS or the provisions for the AFCS.

Picture 1 - Hardware from the air conditioning system clamp contacting the electrical component of the AFCS.

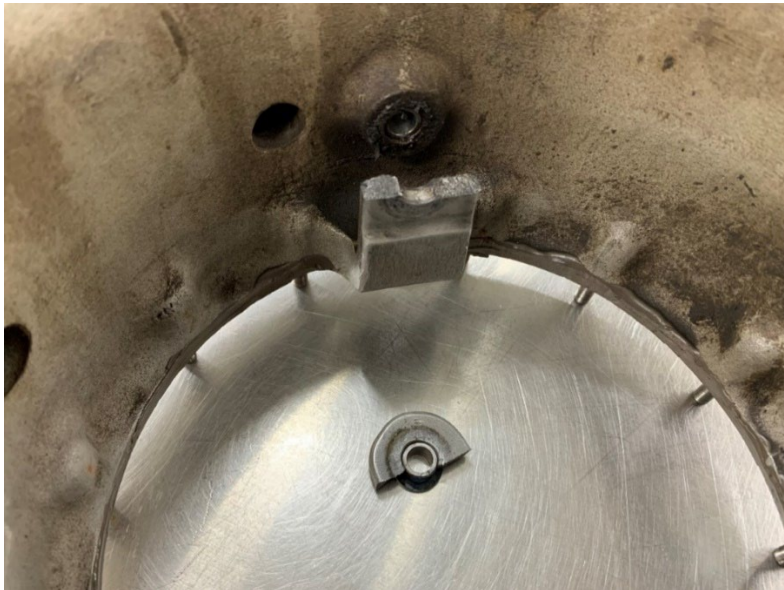
Swashplate inner ring part number 204-011-402-021 was found to have one lug broken off. It is evident that the lug was fractured for some time. Bell Helicopter has been notified of this service difficulty report. The subject parts have been placed into quarantine stores.

Picture 1 – Fractured lug on the Swashplate inner ring

Bell received reports of cracked or broken lugs on the swashplate inner ring, and to raise awareness, have subsequently published Information Letter (IL) 212-22-74. The IL is addressed to owners and operators of model 204B, 205, 205B, 212 and 412 helicopters. It emphasizes the importance of the scheduled daily and 25-hour inspections (as applicable). The IL also provides a reminder of the importance of the CAUTION notice found in the disassembly instructions of the applicable Maintenance & Overhaul (M&O) or Component Repair & Overhaul (CR&O) manual. The CAUTION is a reminder that a retaining compound was used during the installation process, and that in order to prevent damage to the lug, it must be supported when driving out the bolts. To raise awareness of this service difficulty, Transport Canada Civil Aviation (TCCA) encourages the owners and operators of the affected helicopter models to review Bell IL 212-22-74 and to remain vigilant during the inspection and disassembly of the swashplate and support assembly.

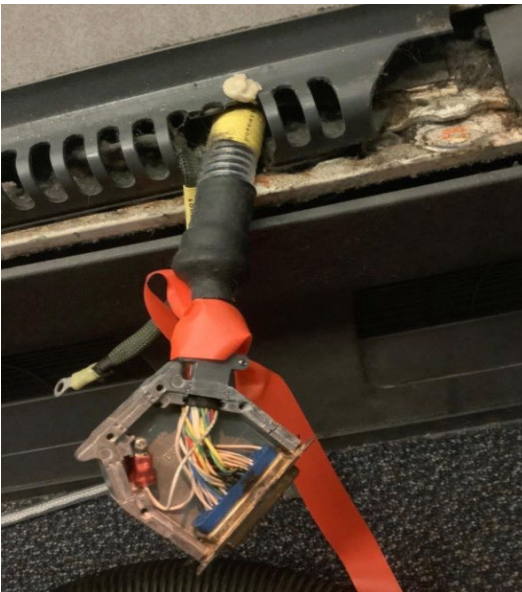
While troubleshooting the aircraft cabin entertainment system, after it was reported that all video display units from row 18AC to 27AC were inoperative, light smoke and a burning smell were noted originating from electrical plug 11P3402 at seat 24AC when the system was being powered up. The electrical plug was disconnected, and evidence of arcing was observed. Passenger seat 24AC electrical harness A127012-501 was replaced, but the electrical plug 11P3402 had to be deactivated due to a part shortage. The aircraft is currently operating under a minimum equipment list (MEL) extension. The electrical plug will be replaced when it becomes available. Aircraft time: 37100:48 flight hours and 25340 cycles.

Picture 1 – IFE wiring cannon plug with burnt connections

Operators are asked to remember the importance of the IFE system wiring even though it is not the most important system on the aircraft.

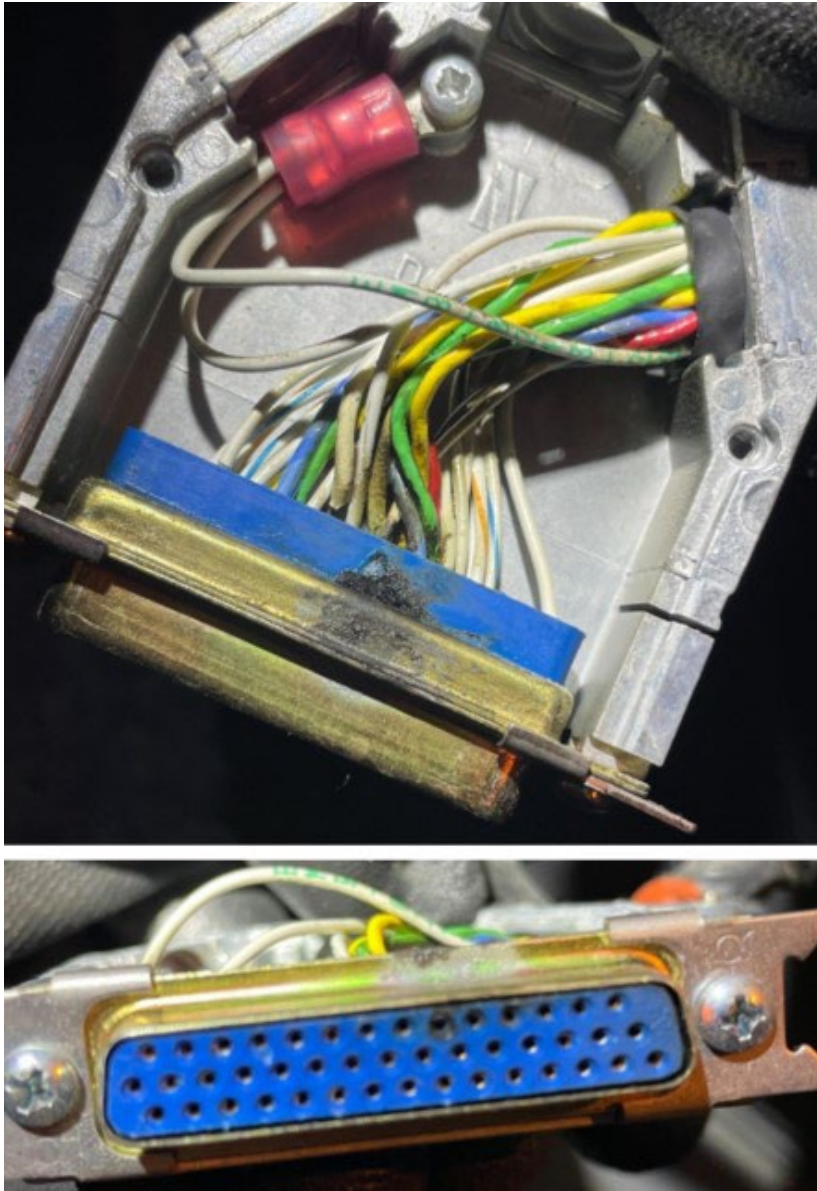
Picture 2 – Close-up of plug with burnt pins

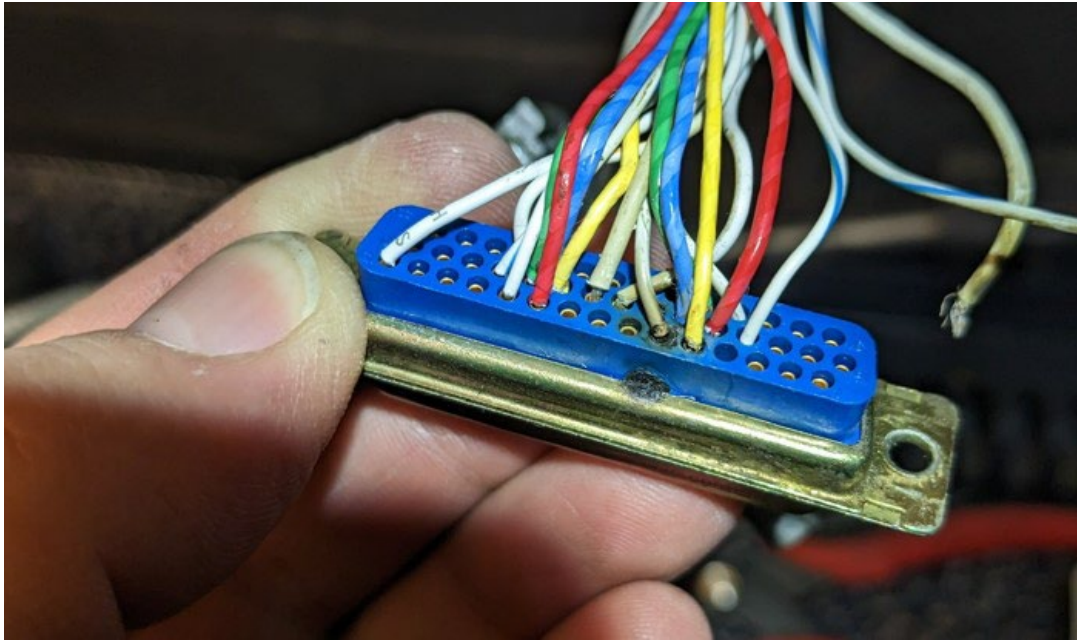
Picture 3 – Plug disassembled, and wire found severed

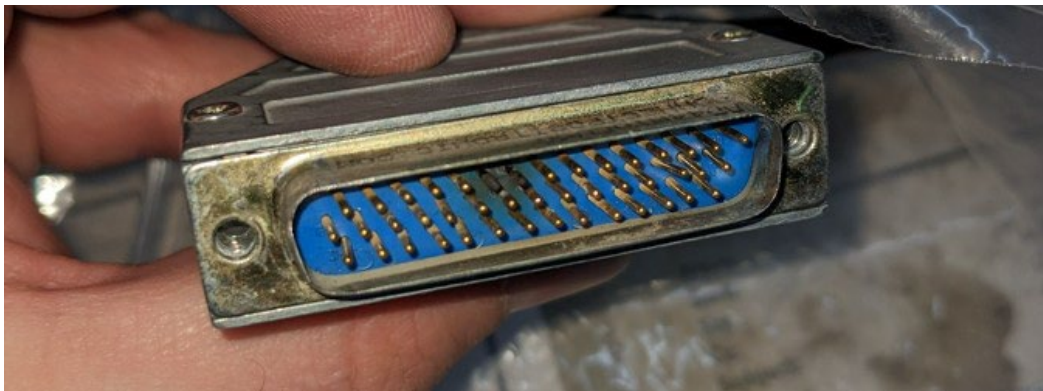
Picture 4 – Close-up of charred pins
