**GEOLOGICAL SURVEY OF CANADA
OPEN FILE 8737**

**Photographs taken in the field by E.A. Hodgson
following the 1925 magnitude 6.2 Charlevoix,
Quebec, earthquake**

M. Lamontagne

2020

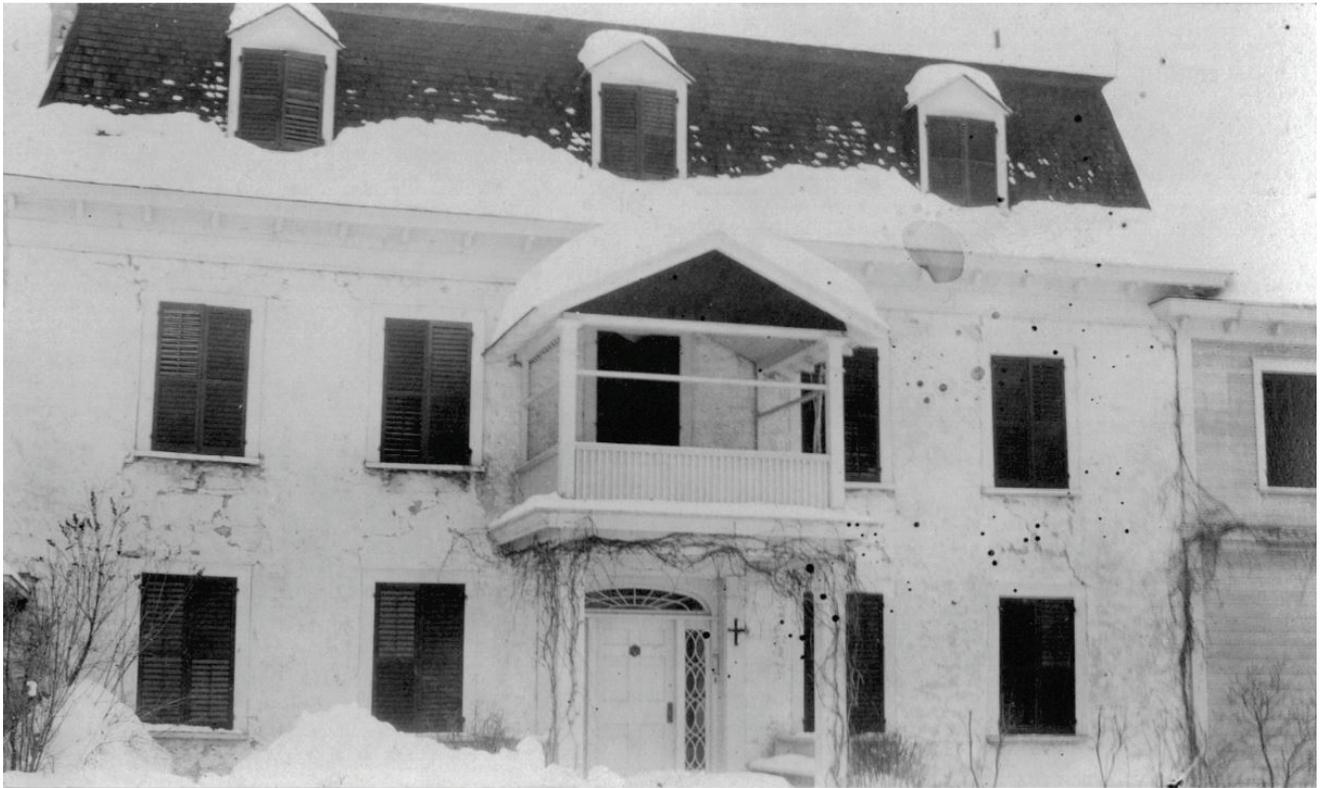
The old Cabot manor house (Figure 3), also of solid stone construction, suffered severe damage. The south wall bulged out, the great chimneys were tilted and the verandah came loose from the wall. Picture 3 shows in-plane shear failure between the two rows of windows. Hodgson (1925) states that the house was standing on a deep sand slope. Other buildings in the vicinity were not seriously damaged.

Figure 3. Manoir Cabot house near La Malbaie suffered severe interior and exterior damage. Hodgson (1950) and Bruneau and Lamontagne (1994) described the damage to this construction. Photograph by E.A. Hodgson. NRCan photo number: (NRCan photo: 2012-075).

11. Philippe Warren's Store, Pointe au Pic, Quebec.
12. Manor Cabot near Murray Bay. This is an old house but was in good repair. It has been badly cracked by the earthquake and is now being examined by experts to see if it can be saved. (NRCan photo: 2012-075)

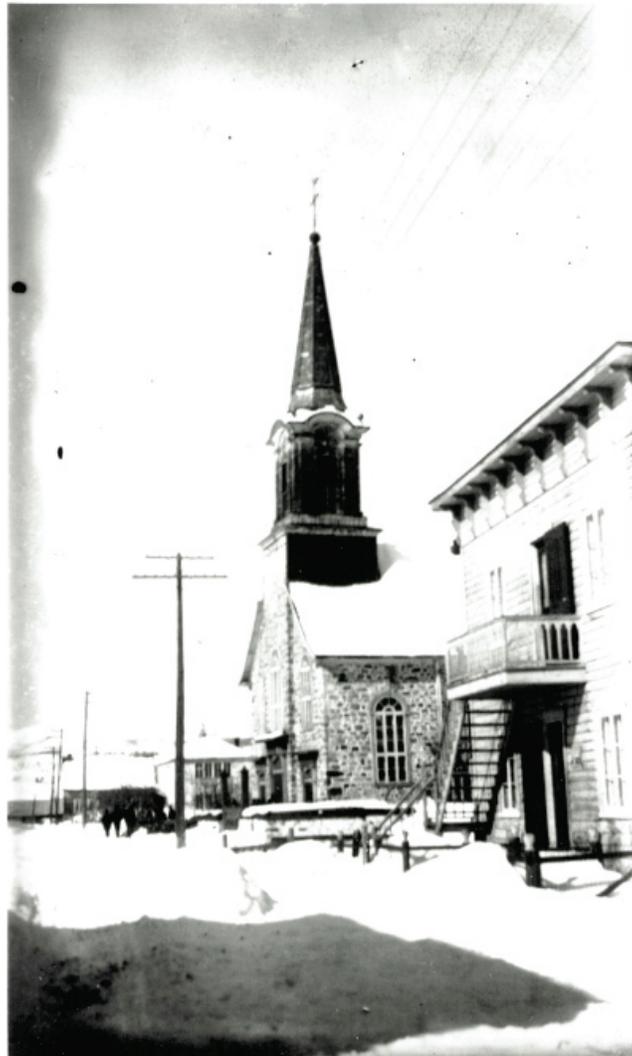
Saint-Urbain: Broken windows and fallen chimneys were common, though houses of wood-frame construction were otherwise unharmed. The stone church which had survived the earthquake of 1870

was practically destroyed (Figure 4). The spire was dangerously tilted towards the northeast and finally fell in the middle of the night, 11 days after the earthquake (March 11).

Figure 4. The Saint-Urbain church: the earthquake caused the bell tower to lean dangerously beyond repair and the church had to be demolished. *Photograph by E.A. Hodgson. (NRCan photo: 2012-084).*

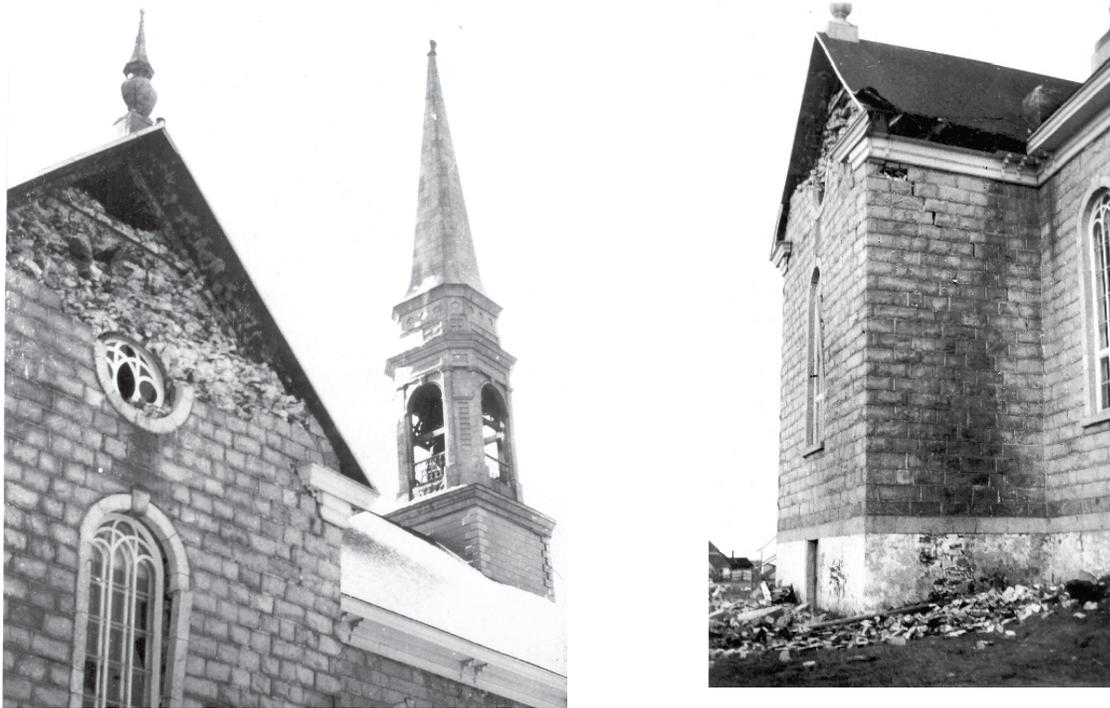
Rivière-Ouelle: This village was one of the most affected. Most chimneys fell. The church was badly damaged and the monuments in the adjacent cemetery fell or were rotated (Figures 5-9). Two stone houses had to be demolished. The train station was also damaged.

Figure 5a and b. Two views of the exterior damage to the Rivière-Ouelle church. *Photographs by E.A. Hodgson. (NRCan photo: 2012-079) (main photo)*

153. The end of the transept at the church at Rivière-Ouelle. Note too the crack parallel to the extreme right edge of the tower. The front wall of the tower is falling forward and the edge stones are out of their bedding.

154. The old (53 yrs) church at Rivière-Ouelle on the south shore. The end of the transept fell out, the bells in the tower were dislodged, the stones in the graveyard were upset and the building itself is damaged so much that it will have to be torn down. (NRCan photo: 2012-079)

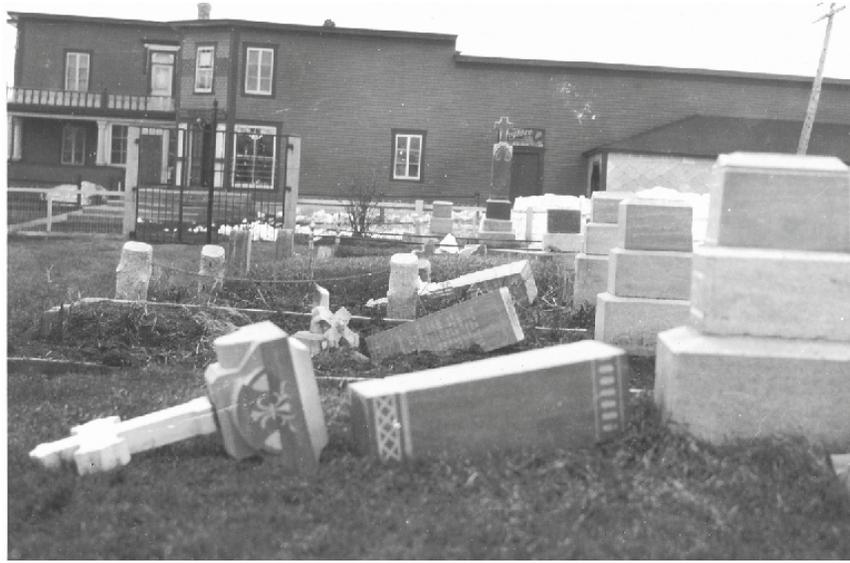
Figure 6. Overturned tombstones at Rivière-Ouelle. *Photograph by E.A. Hodgson. (NRCan photo: 2012-082).*

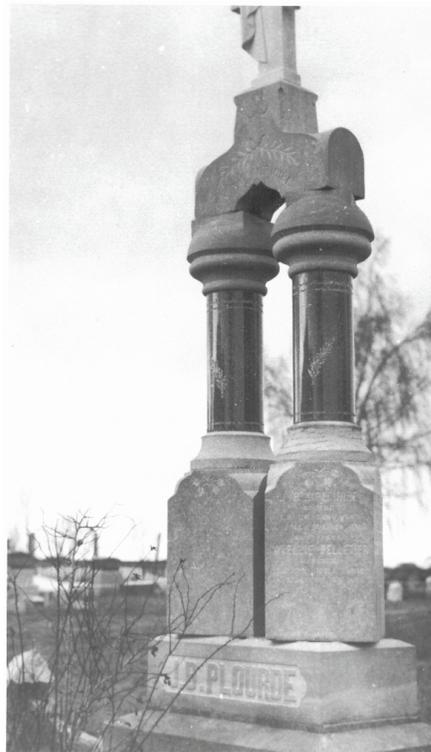
Figure 7. Rotated tombstones at Rivière-Ouelle. *Photograph by E.A. Hodgson. (NRCan photo: 1995-139D)*

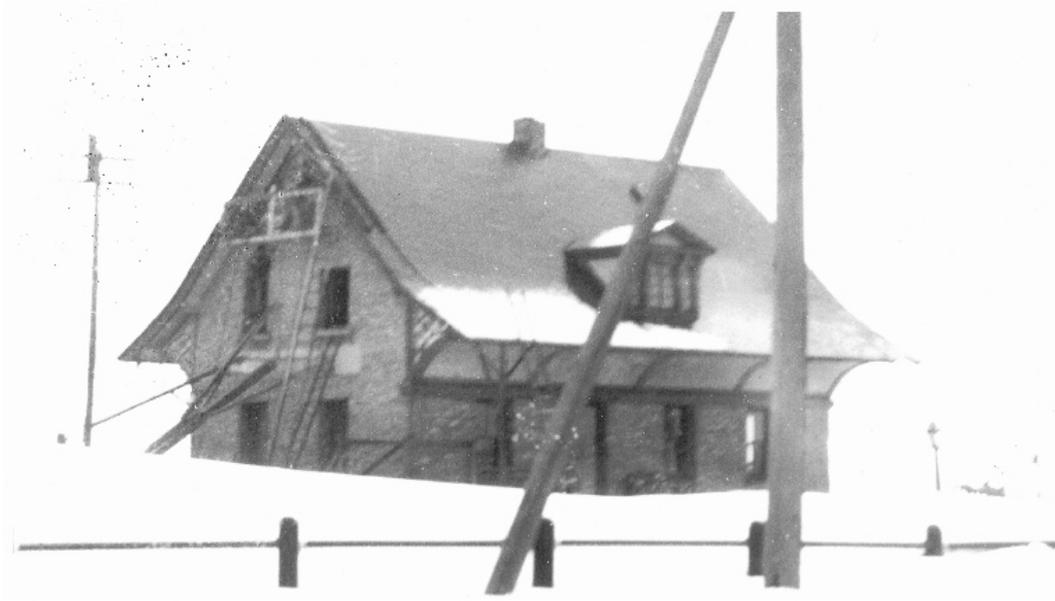
Figure 8. Rivière-Ouelle: A wall of the railroad station almost fully collapsed. *Photograph by E.A. Hodgson. (NRCan photo number: 2012-080).*

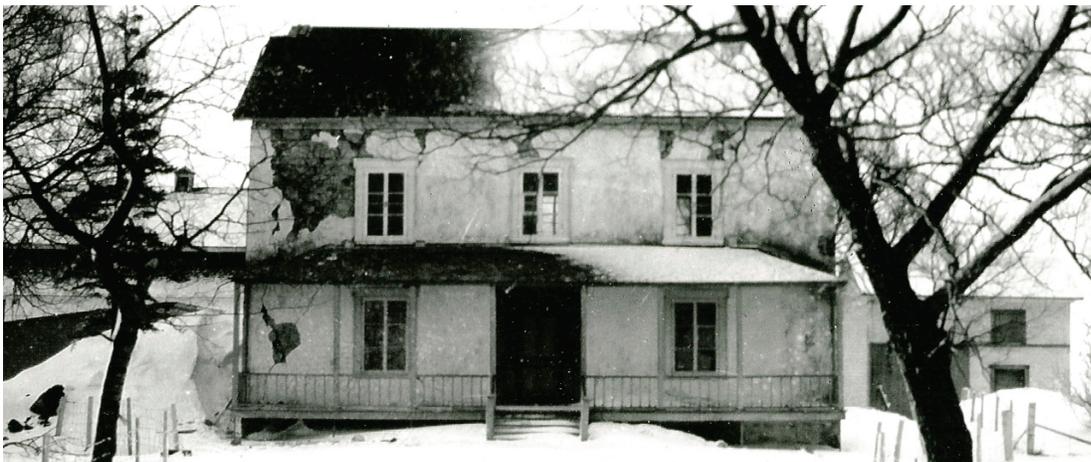
Figure 9. Rivière-Ouelle: Collapsed chimney and damaged masonry. *Photograph by E.A. Hodgson. (NRCan photo: 2012-081)*

173. Vista of monuments turned shifted SE and fallen SE Rivière-Ouelle .
174. Old stone house near Rivière-Ouelle no trees.
175. A heavy old stone house near Rivière-Ouelle, Que. It was occupied up to the time of the earthquake. The chimney has fallen off and the walls are so badly damaged that it has had to be abandoned. Visited Jul 26th. Torn down and rebuilt. (Same picture as 174) (NRCan photo: 2012-081)

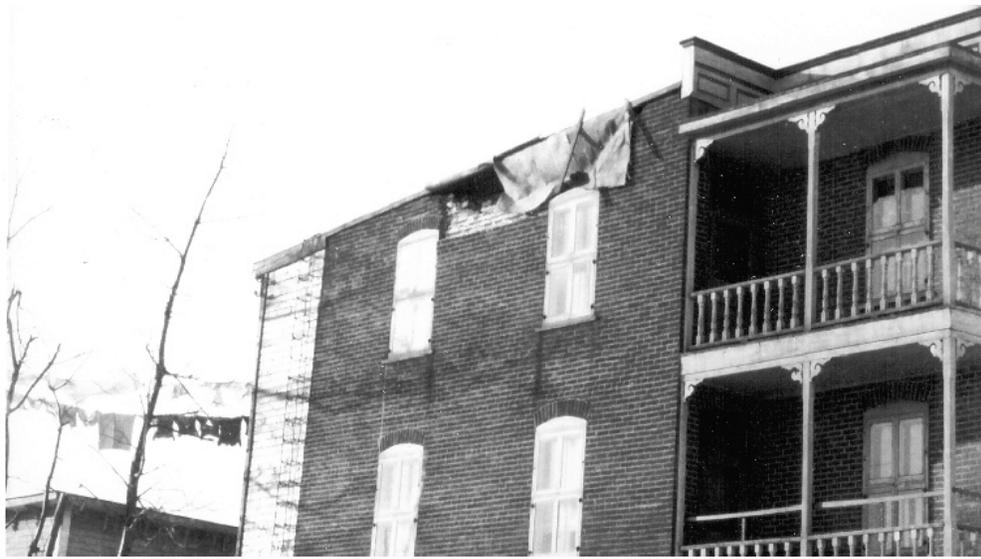
Shawinigan: Damage was reported to a series of unreinforced masonry houses and to a church built on the clay portions of the city (figures 10-12).

Figure 10. Shawinigan: damaged unreinforced masonry wall. Hodgson (1950) and Bruneau and Lamontagne (2008) described the damage sustained by this construction. Photograph by E.A. Hodgson. (NRCan photo: 2012-083; this photo was used as Figure 12 in the Hodgson (1950) report).).

66. No text (close up view of the transept of St. Marc Cathedral; (this photo was used as Figure 14 in the Hodgson (1950) report.)
67. Damage to a house of Hemlock St. St. Pierre section of Shawinigan Falls. (NRCan photo: 2012-083; this photo was used as Figure 12 in the Hodgson (1950) report.).

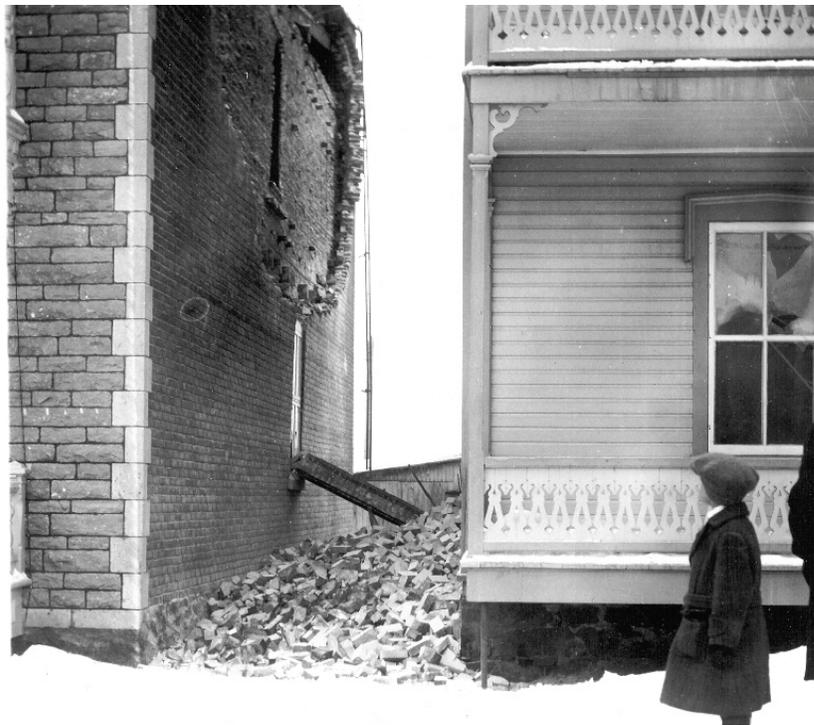
Figure 11. Shawinigan. Damaged masonry wall. Hodgson (1950) and Bruneau and Lamontagne (2008) described the damage sustained by this construction *Photograph courtesy of F. Larochelle*

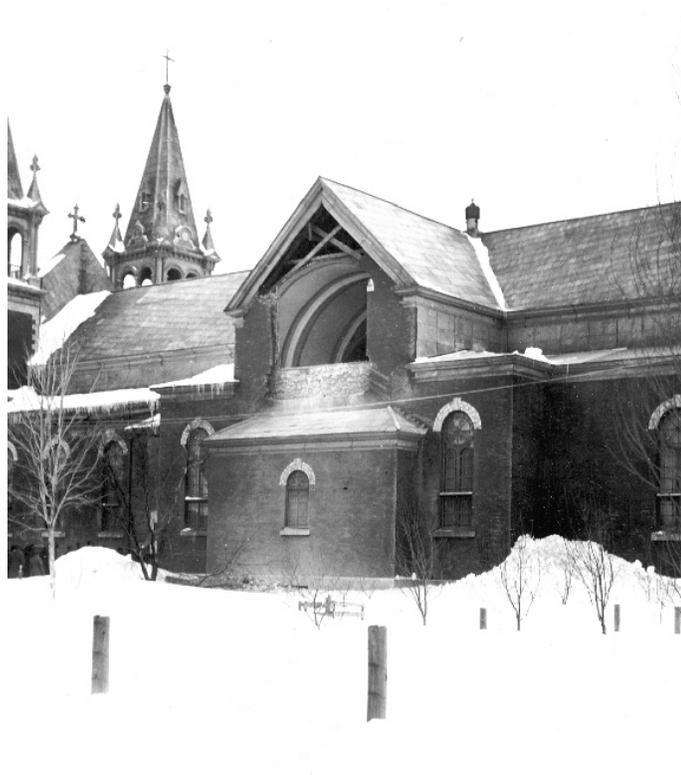
Figure 12. Shawinigan. Partial collapse of a masonry wall of St. Marc's church. *Photograph from Geological Survey of Canada Archives.*

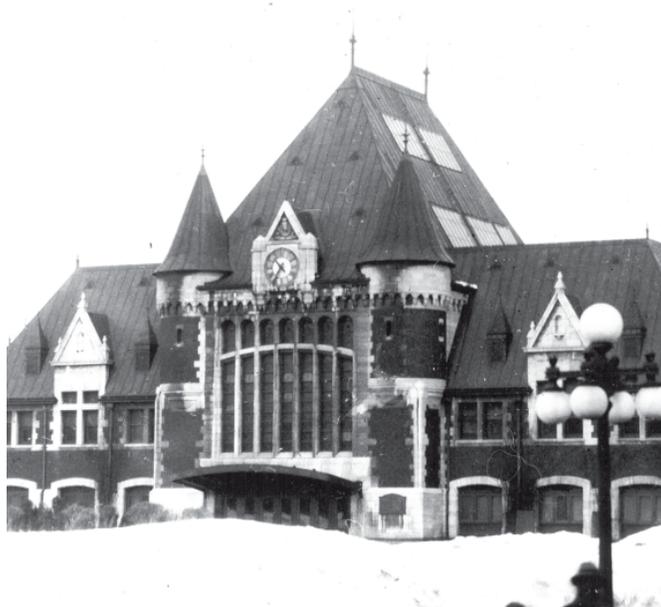
Figure 13. Quebec City : Gare du Palais train station. Hodgson (1950) and Lamontagne (2008) described the damage to this building during the Charlevoix earthquake of March 1, 1925. Photograph by E.A. Hodgson. Additional details in Lamontagne (2007). (NRCan photo: 2012-078).

1. Interior Office. Ottawa
2. The Palais station, Quebec. The inside of the north wall of this station was damaged. Several rows of bricks falling into the waiting room. (NRCan photo: 2012-078)

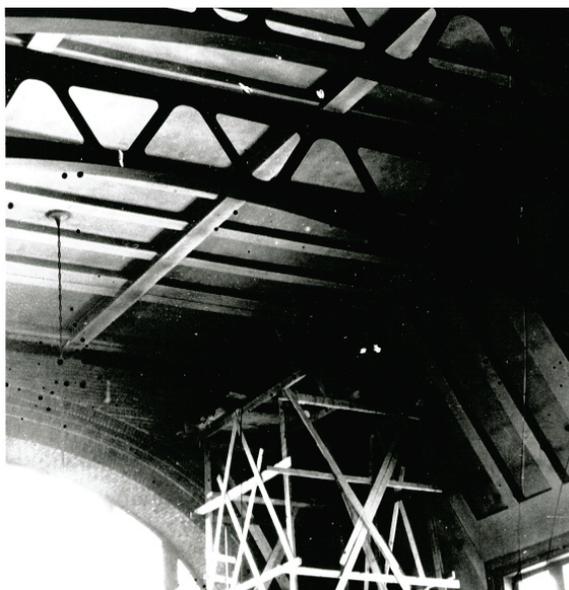
Figure 14. Quebec City : Gare du Palais train station interior: fallen row of bricks, damaged leaded windowpanes. Hodgson (1950) and Bruneau and Lamontagne (1994) described the damage to this construction. Additional details in Lamontagne (2007). *Photograph by E.A. Hodgson. (NRCan photo: 2012-077).*

3. Interior of Palais Station, Quebec. Showing scaffold in place. (NRCan photo: 2012-077)
4. The skylight of Palais Station Quebec, damaged by the earthquake. This picture was taken before the damage.
