Issue 2/2025

AVIATION SAFETY LETTER

TP 185E

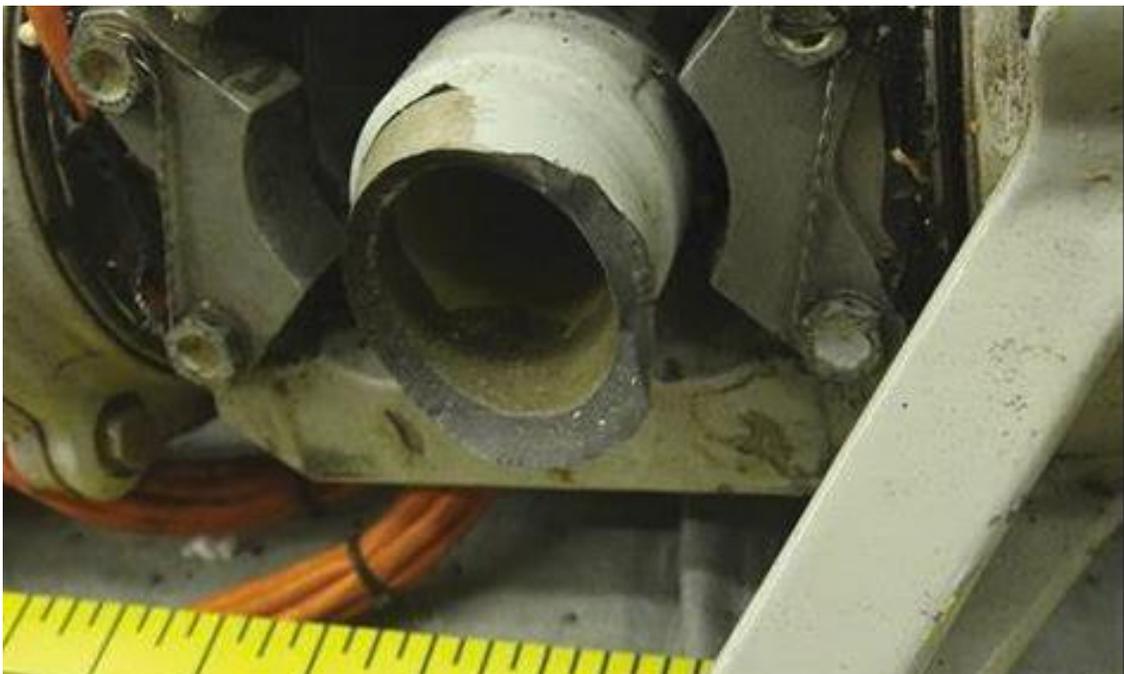
Figure 1: "NTSB" shows the failure mode of the mast just below where the static stop would be touching. The mast bumping occurred with this Bell 206 rotor from the NTSB WPR19FA109 report aircraft

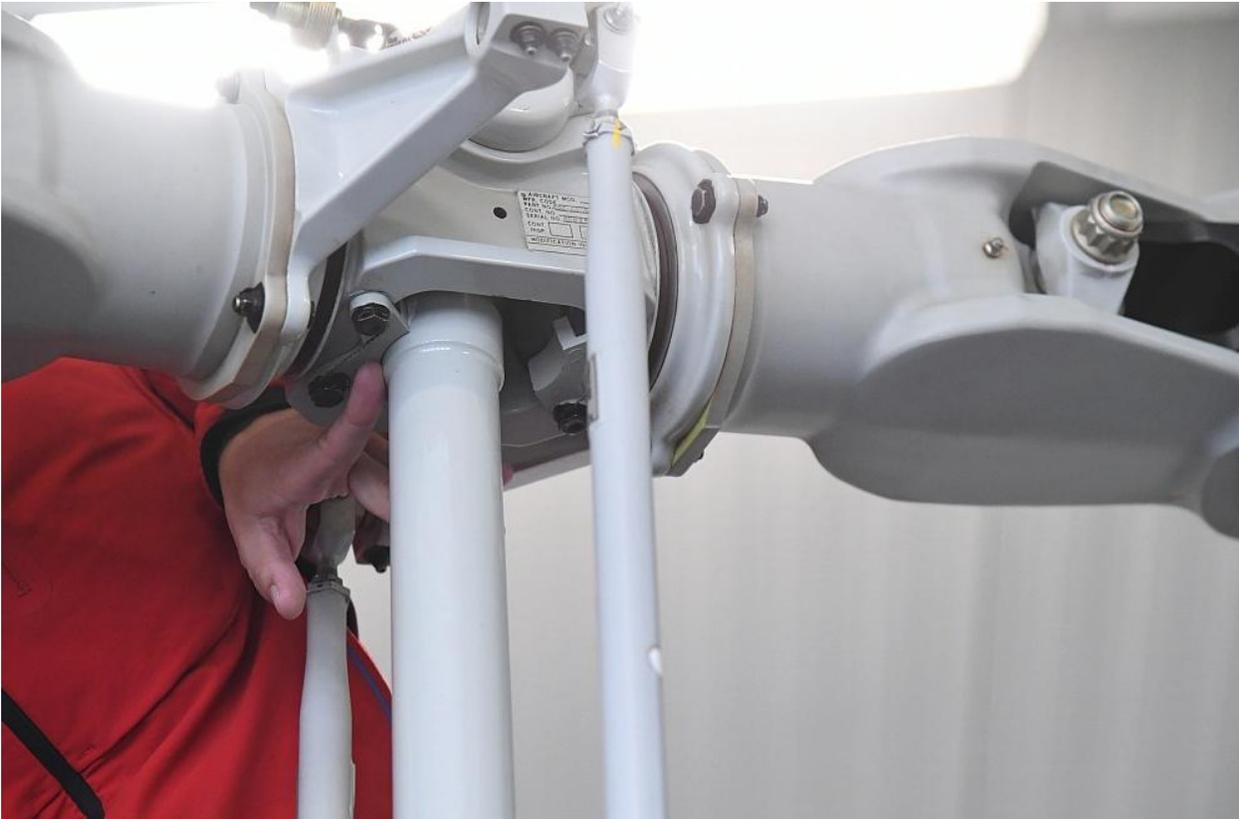
Figure 2: "B206 head" is the underside of a normal Bell 206 rotor head. Finger at the bolted static stop and next to the interference area between the stop and the mast

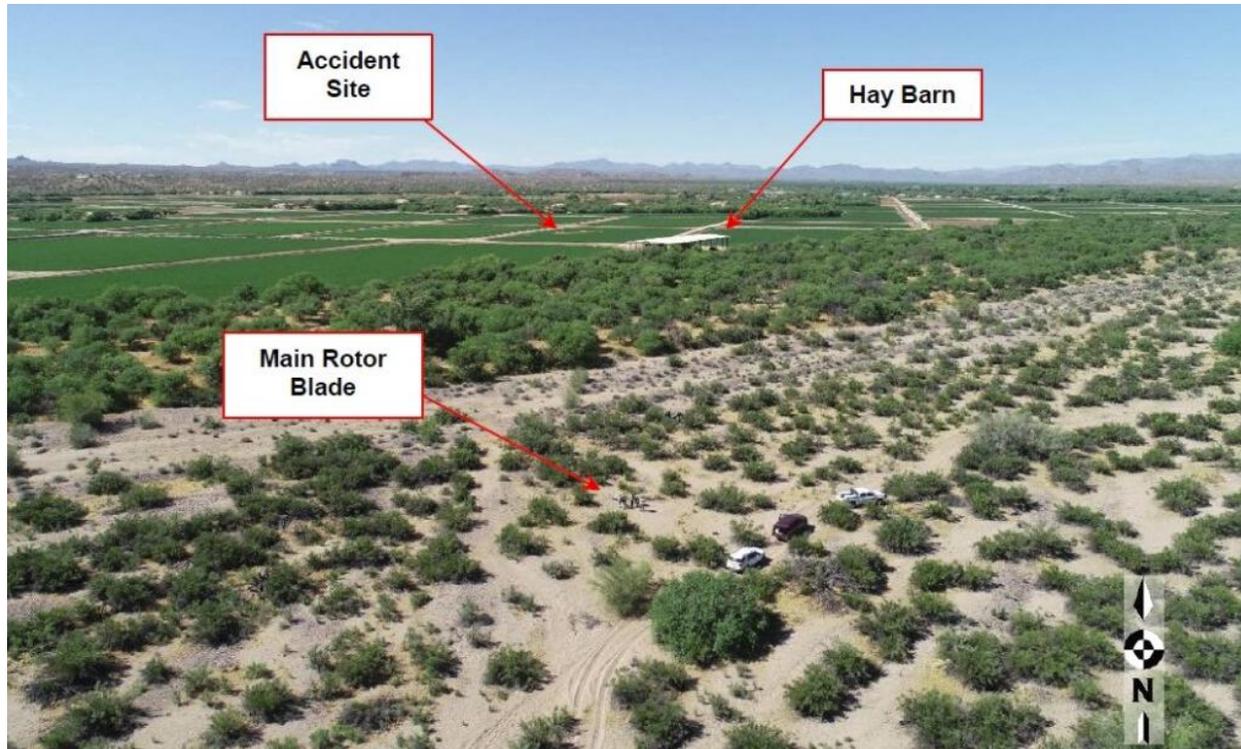
Figure 3: "Debris field" shows that the main rotor blade has separated from the NTSB WPR19FA109 Bell 206 and is some distance from the crash site. The aircraft was not complete upon impact. This was similar to the UH1 crashes in Vietnam that alerted the US Army to the mast bumping problem.

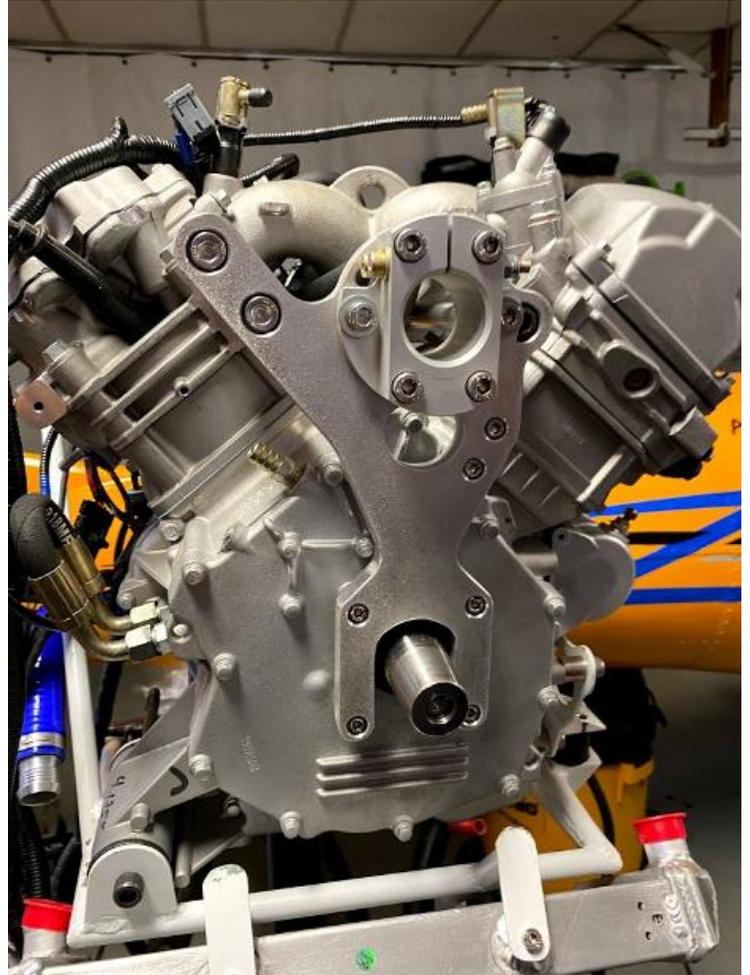
Original engine bracket

The engine started with the turn of a key, just like your ATV. The initial engine run ups indicated that the engine mount as designed for the ATV/Merlin wasn't fit for purpose on my application. There was too much vibration in the mount. The diagonal upper engine mount was replaced with a pair of diagonal mounts, one on each side of the engine. These shock mounts provided the rigidity necessary. The Merlin exhaust system wouldn't work with my cowl configuration, so I elected for a pair of straight pipes. The Mk1 stacks sounded like an angry Harley-Davidson, so these were modified to a single pipe feeding a cylinder with baffles and three stacks which made the sound acceptable. With these fixes in place, the first test flight was flown. The engine ran fine but required a pitch adjustment to reduce engine rpm and maximize thrust. With propeller pitch adjusted, subsequent flights demonstrated good performance from the propellor/re-drive/engine combination. A stabilizing bracket was added to each muffler stack, as it was found that the two attachment bolts were loosening after each flight.

After five hours of orbits around the field, the aircraft was performing well. During a slow flight practice, the engine hesitated on being asked for power, and a precautionary landing was undertaken. Inspection revealed a ring of oil inside the cowl in line with the re-drive. Further investigation then discovered that the engine crank seal was leaking oil. The spinner, prop, cowl and re-drive were removed. The front crank cover was removed where it was confirmed that the crank oil seal had failed. The failed oil seal was a symptom of a bigger problem: the design of the crank case cover. Instead of having a sealed bearing, this design used a bushing that supported the crankshaft. This bushing was in the process of failing. Investigation with LSA Aeromarine engineer, our own engine chap and our Argo guru indicated that the bushing was not designed to take a lateral load that the belt drive had imposed, as opposed to the ATV CVT. Clearly, this was a major engineering problem that required a fix.

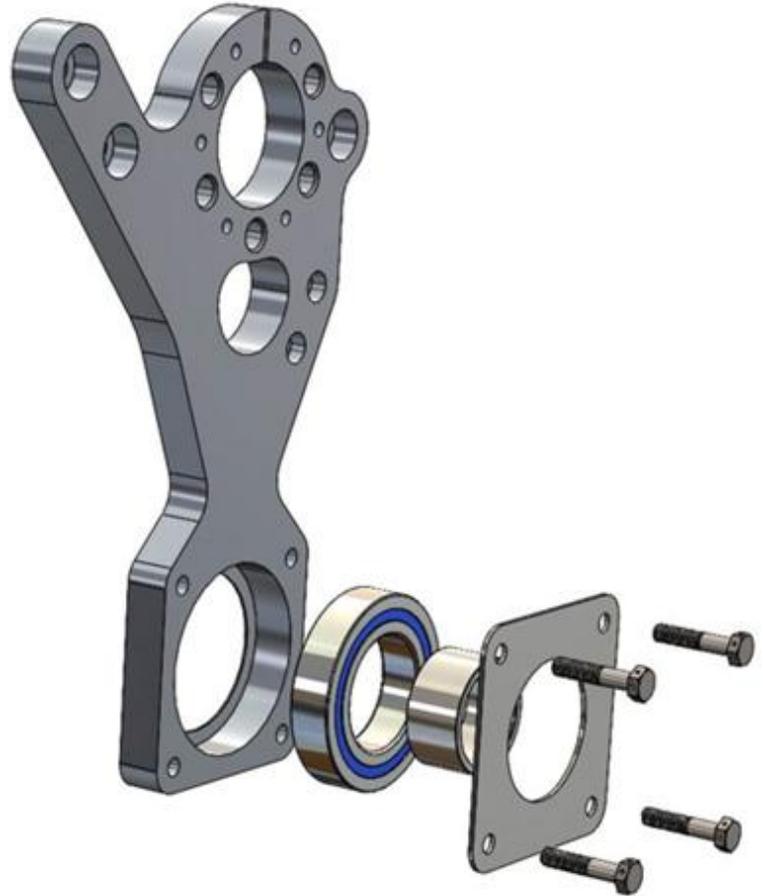
Re-designed bracket incorporating a bearing

With the new re-drive tower in place, I flew the a/c for another two hours before the new oil seal began leaking again. The engine was removed and returned to the distributor. The distributor has gone into production with their

A two-stage fix was developed by LSA Aeromarine. First, working with LSA Aeromarine engineer, Ben Bosma, the Ace Aviation re-drive was redesigned to incorporate a bearing to take the side load from the belt drive without touching the existing engine design. A mounting bracket holds the upper pulley. This bracket was modified to incorporate a bearing that sleeved onto the engine's crankshaft. This would eliminate the side load on the engine's original bushing. A new bracket was manufactured and incorporated into their aircraft and my aircraft. This modification has entered production for the companies Merlin aircraft. The proposed long-term fix was to get Gaokin, the engine manufacturer, to change the crank cover and incorporate a proper bearing for future engines being used in this application.

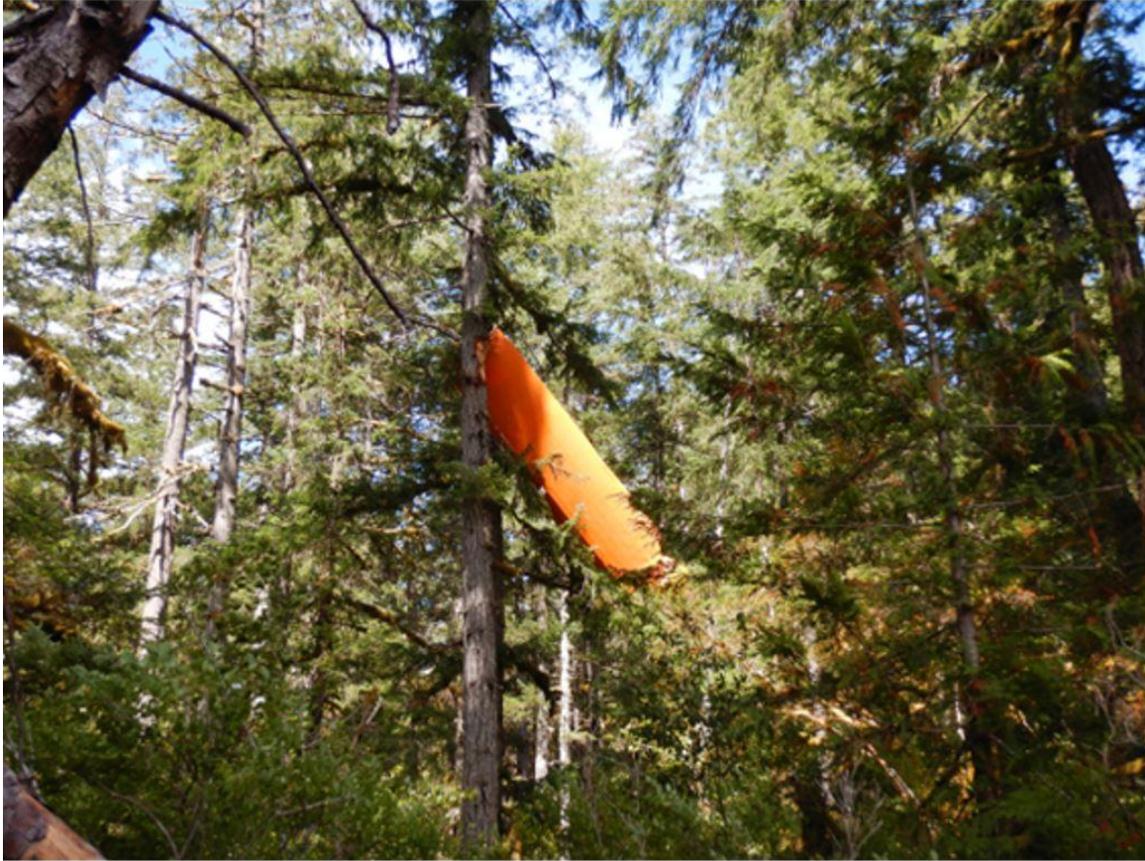
Based on examination and photographs of the site, the aircraft was proceeding westbound when it struck the trees. The aircraft's right wing separated from the aircraft and lodged in a tree (Figure 3).

The aircraft continued into the wooded area while rolling to approximately 90° of bank before impacting a large tree and coming to rest. The damage to the aircraft and the wreckage trail were indicative of a steep angled descent with low forward velocity, consistent with a stall.

Figure 3: Occurrence aircraft's right wing lodged in a tree (Source: RCMP)

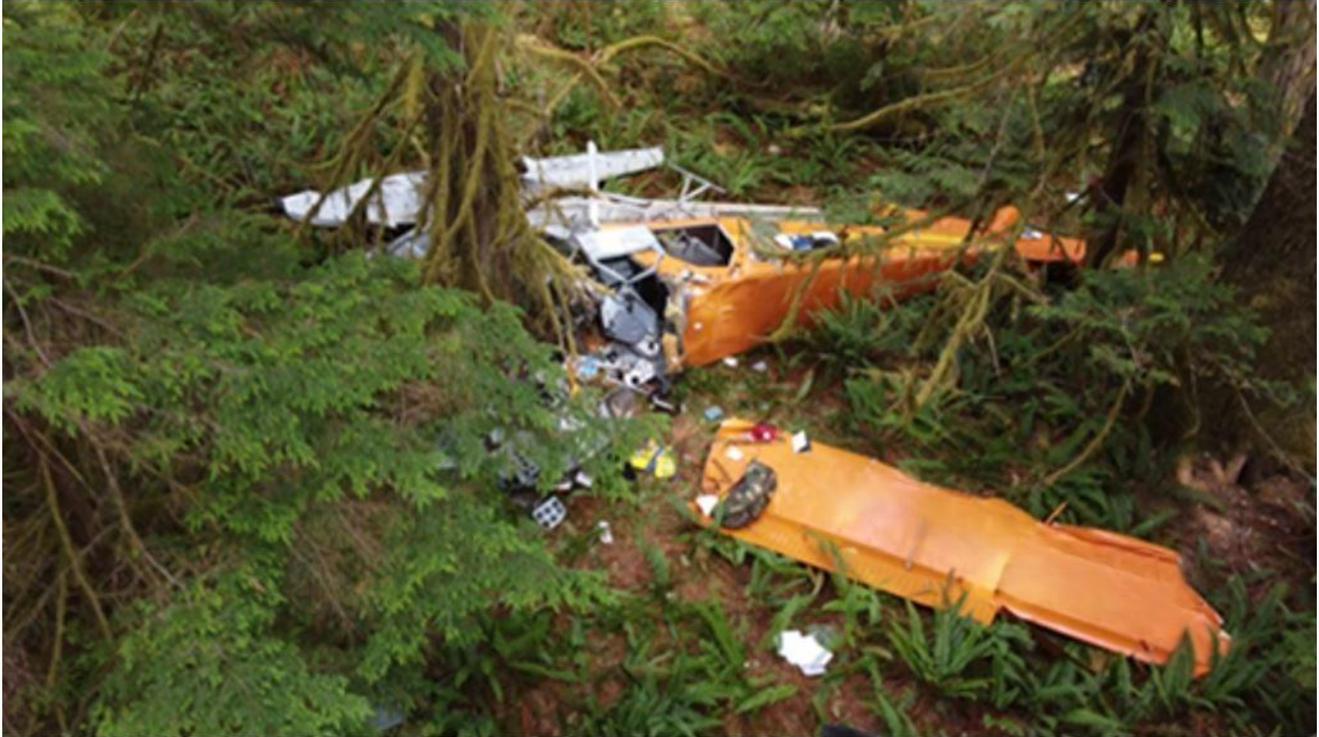
The three-blade propeller was significantly damaged, with one blade being ejected from the propeller assembly. All blades showed chordwise scratches with bending patterns consistent with an engine producing power at the time of impact.

Many of the flight instruments and engine gauges were significantly damaged as a result of the impact, and their examination provided little information useful to the investigation. Flight controls and associated linkages were examined, and no indications of failure before impact were noted. The observed damage was either consistent with impact or attributable to the recovery of the aircraft. There were no indications of a loss of control due to mechanical failure before impact.

Although the aircraft was significantly damaged, all major components were accounted for at the accident site (Figure 4).

Figure 4: Aircraft fuselage, floats, and left wing (Source: TSB)

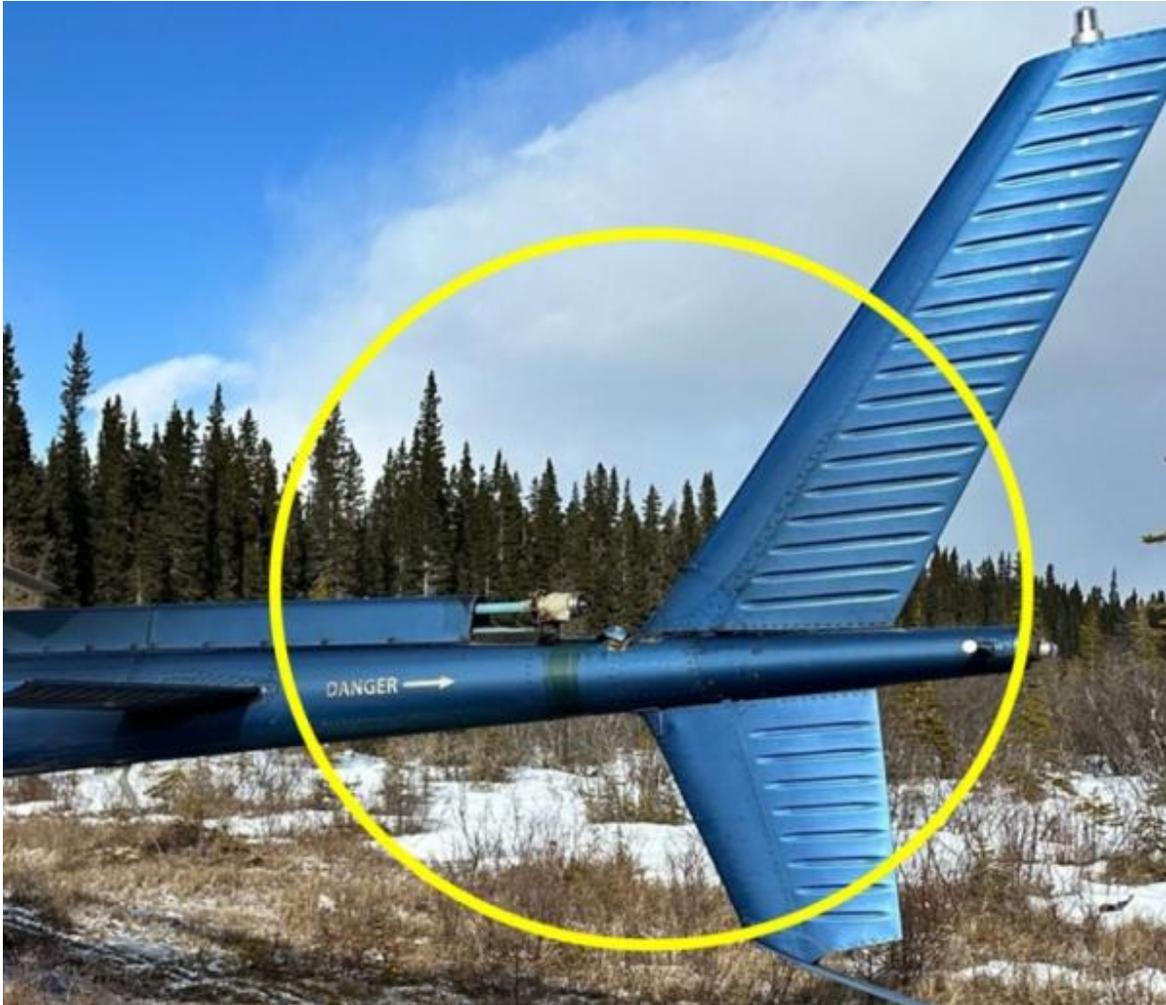
*Figure 4: Occurrence helicopter's tail boom, showing the "DANGER" and arrow markings as well as the approximate radius of the tail rotor arc
(Source: Heli Explore Inc., with TSB annotations)*

Following the accident, the company required that pilots shut down the engine while disembarking passengers for the remainder of the Goose Break flights during that season.

The company has revised its passenger guidance to provide more information and to warn of the danger of going near the back of a helicopter.
