INVESTIGATION OF TIE PLATE ICING/ICE JACKING for Transport Canada

P-22-011

October 24, 2022

Executive Summary

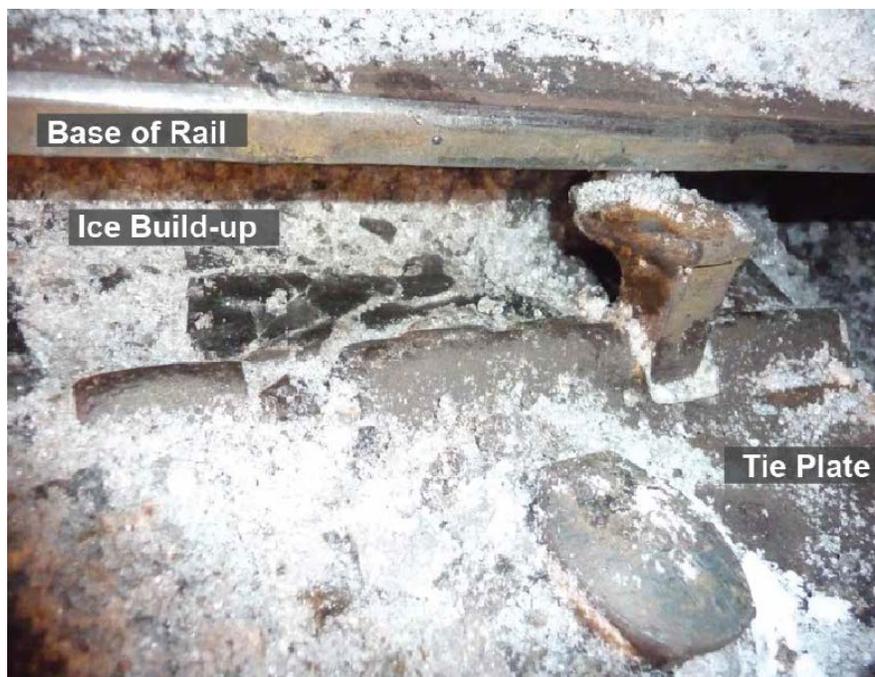
Snow and ice can impose hazards on the safety and integrity of both train operation and impact rail infrastructure. As a winter hazard, tie plate icing (also referred as ice jacking) has resulted in train derailments in the past¹⁻³ and needs to be thoroughly investigated and closely monitored. Tie plate icing occurs when ice builds up between the base of the rail and the tie plate. The ice buildup will cause the rail to sit vertically above the shoulder of the tie plate, leaving the fasteners as the primary means of providing resistance to lateral rail motion. Figure 1 shows the ice buildup lifting the rail and raising the spikes.

Figure 1. Ice buildup on tie plate¹

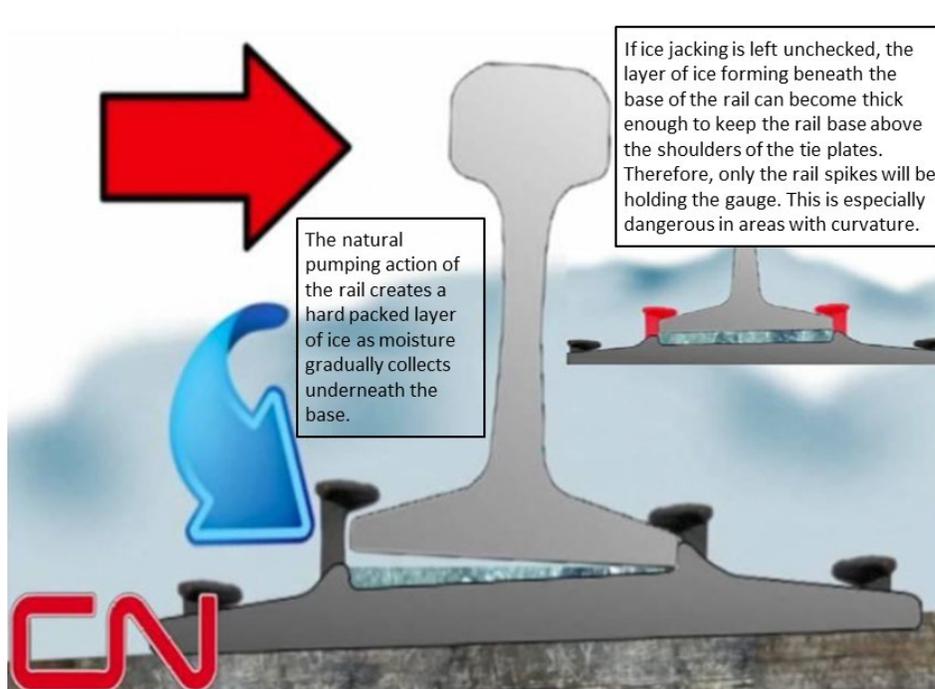
Tie plate icing is possible any time snowfall accumulates around the base of the rail and tie plates. According to the investigation by Canadian National Railway (CN), when the track is in a condition where the rail pumps up and down, creating a void under the rail and sucking snow around the base of the rail into the void. The snow in the void is then compacted and transformed into a layer of ice under the rail, lifting the base of the rail above the shoulder of the tie plate, placing the primary source of lateral restraint on the spikes. The spikes are not able to withstand the lateral loading, and they will eventually wear down, break, or fall out under load. The rail then pushes outward, allowing the wheels to fall between the rails. This process takes time to build up enough ice to lift the rail above the shoulder of the tie plate. Figure 2 presents this process as well as potential effects such as gage widening and reverse cant. In addition, CN

Figure 2. Development of ice buildup under the rail²

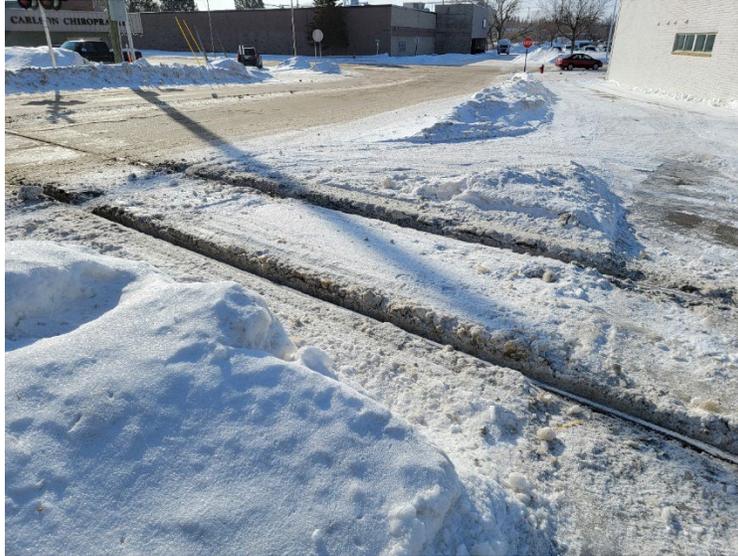
Figure 3. Grade crossing at 46.2802042, -96.0668825

On February 16, the inspection was performed at a grade crossing on a tangent track in Fergus Falls, MN (46.2802042, -96.0668825). The OTVR identified this location as the best potential site for tie plate icing since the area was a low track spot, and the track did not have good drainage. The rail size was 115 pound/yard, and the fastening system was made up of 14-inch plates with two rail spikes. The speed limit of the inspection site was 10 miles per hour. The inspection trip began around 9:30 a.m. The weather was sunny at the beginning and slightly snowy in the afternoon. The temperature varied from 11°F to 26°F during the day. The grade crossing was covered by snow/ice (Figure 3).

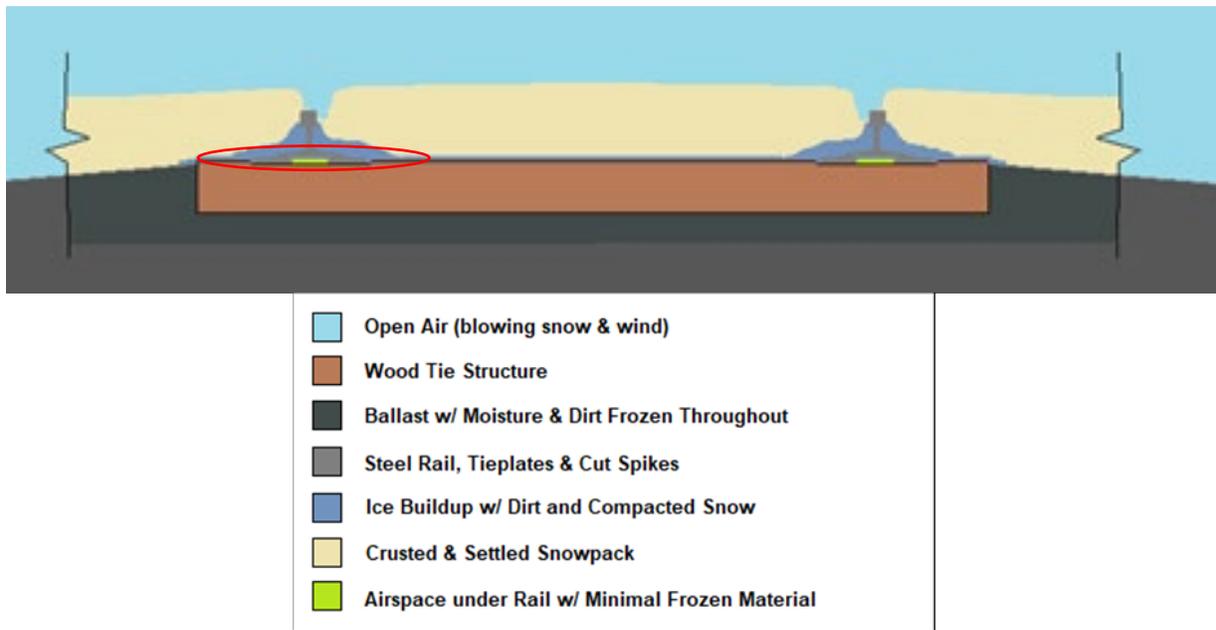
The top 3–5 inches of snow were easy to remove. However, a mixture of snow and dirt was packed solid near the bottom of the rail web (red circle in Figure 4). Since the grade crossing was at a low spot and near a busy in-town vehicle road, muddy ballast with very poor drainage was found at the location. Due to the frozen dirt and ice around the rail seat area, it was difficult to dig to the bottom of the rail and tie plate. Only one rail seat area was fully exposed for inspection.

Figure 4. Track conditions of the grade crossing at 46.2802042, -96.0668825

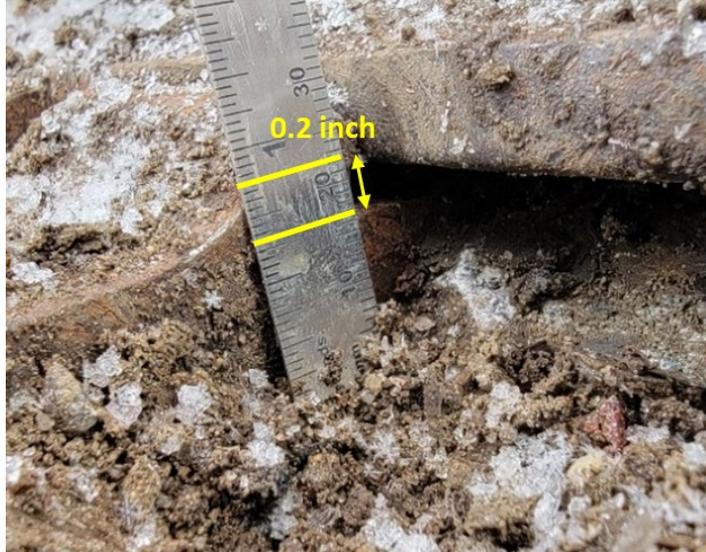
Minimum gap between tie plates and rails is expected for railroad tracks. However, for the one rail seat that was dug, a 0.2-inch gap was found between the bottom of the rail and tie plate (Figure 5), but there was no ice and dirt underneath the rail. Since the shoulder of the tie plate was 7/16 inch tall, the rail base was measured about halfway up the tie plate shoulder.

Figure 5. A 0.2-inch gap found at one rail seat

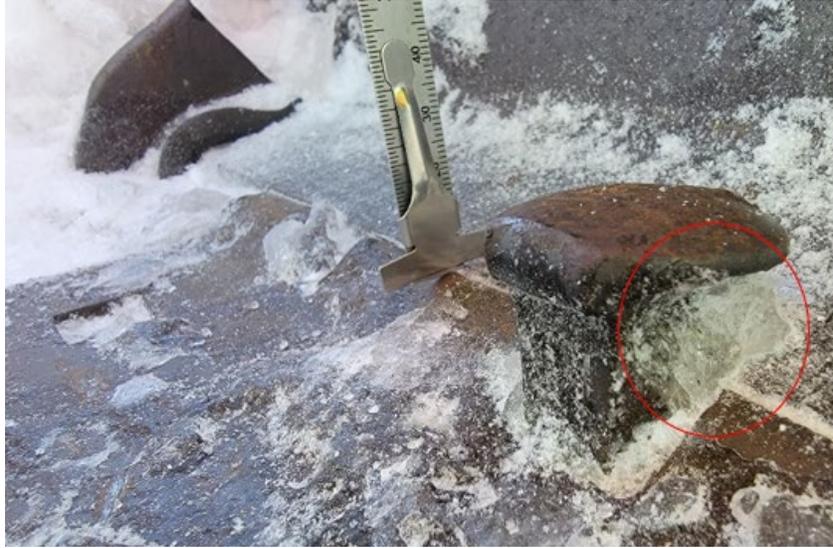
Figure 6. Grade Crossing at 46.3381161, -96.1666634

Another grade crossing (46.3381161, -96.1666634) outside the town was inspected on the second day. This grade crossing was on a tangent track as well and had better track conditions (relatively new ties, clean ballast, and good drainage). The snow and ice were removed relatively easily compared to the previous location, and about twelve rail seats were exposed and inspected. High spikes (~0.5 inch) were found but most tie plates did not have a gap at the bottom of the rail. Only one tie plate had about a 0.1-inch gap between the tie plate and rail, but no ice was built up in the gap. Ice was observed as having built up between the high spikes and the top surface of tie plates (Figure 6). This observation is informative because it confirmed that ice is able to build up in gaps in a fastening system if certain conditions were met. While the exact mechanism is still unknown, one hypothesis as informed by the OTVR track manager, is that ice is able to be built up in the gaps in the fastening system if melted snow and ice are able to drip down under the rail seat and refreeze.

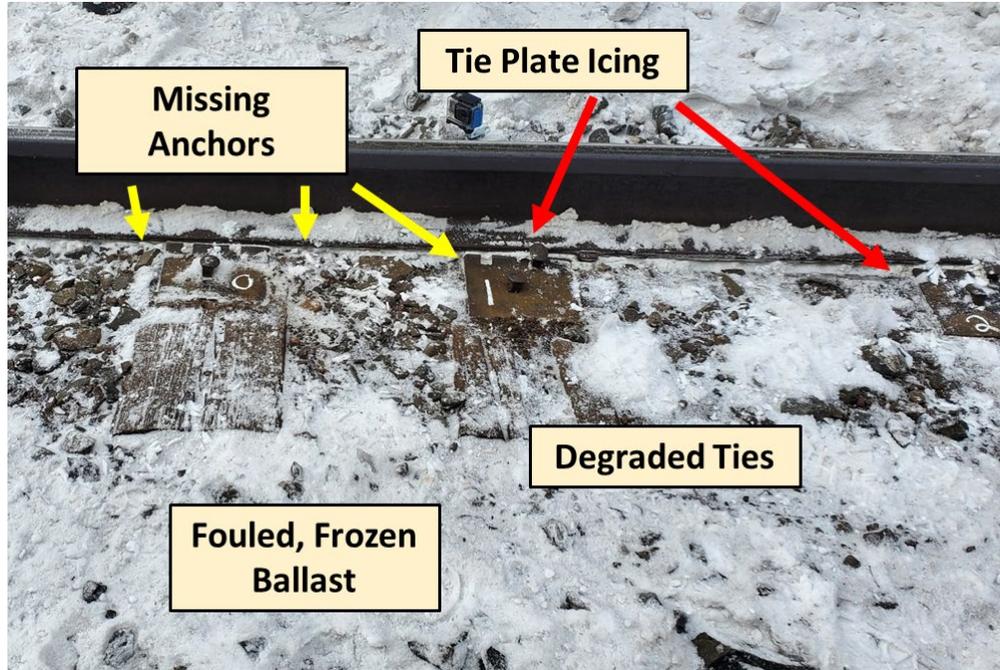
The problematic location generally had worse track conditions compared to the other locations without tie plate icing. As shown in Figure 7, the location where tie plate icing was found had missing anchors, degraded wood ties, and fouled ballast. The gaps between rails and tie plates were measured with a ruler and are listed in Table 2. The bottom of the rail at several ties (Tie# 4, 5, 6, 7) was above the tie plate shoulder on both sides. However, since the cut spikes in these locations were still in place, the track gage strength was not reduced.

Figure 7. Location with tie plate icing in Heron Bay Sub

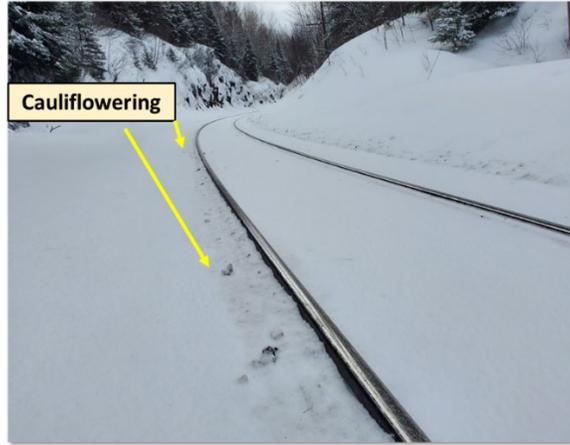
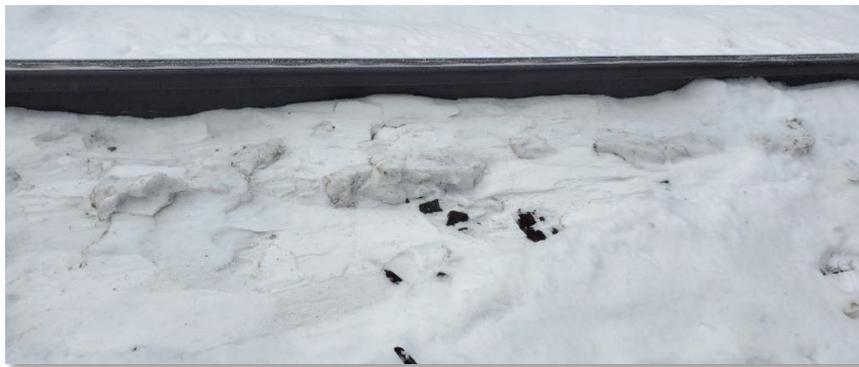
CP also mentioned that it does not need very low temperatures or heavy snowfalls to form tie plate icing. The hypothesis is that snow gets trapped in any gaps between the rail and the tie plate. Rail movement, especially on the outside rail in curves, packs down snow/ice in layers, until the rail is jacked above the tie plate shoulder. When the track is covered with snow, it is difficult to identify problematic locations. One possible indication of tie plate icing that can be seen during a visual inspection is called “cauliflowering” (Figure 8), i.e., cracked/moved snow or ice near the rail base, indicating rail movement.

Figure 8. “Cauliflowering” of snow/ice near rail: (a) entire curve; (b) close up view

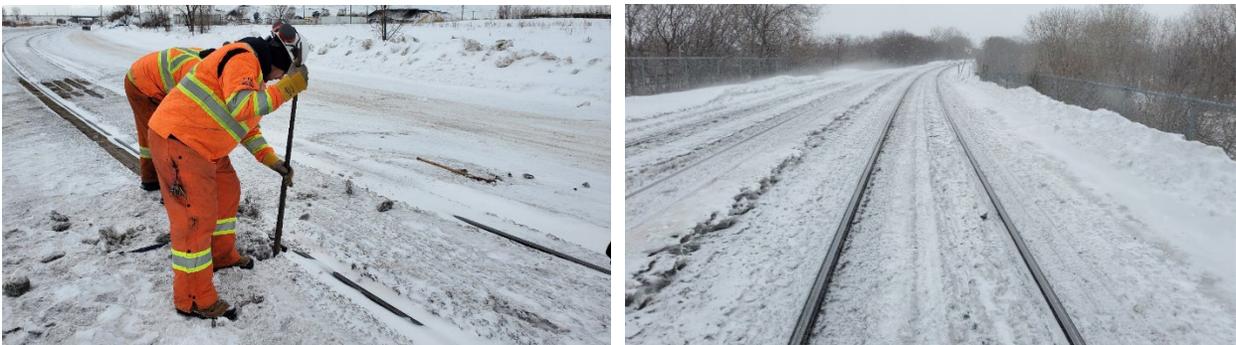
Figure 9. CN River Subdivision

On the third trip, the team inspected multiple CN track locations in the River Subdivision near Winnipeg, Manitoba, Canada. Out of the eight inspected locations, no ice jacking (CN’s term for tie plate icing) was observed. The tracks were frozen and did not show any track gage strength reduction.

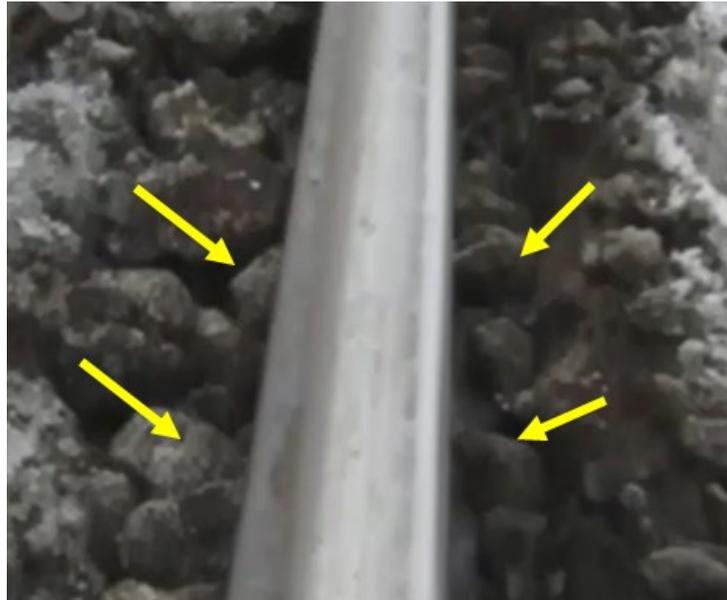
Representatives from CN stated that the ice jacking issue is possible any time snow is around the base of the rail and tie plates and can occur anywhere the rail is not tightly seated in the tie plate. Problematic locations are often associated with snow cover, high-degree curves, and poor ties and fasteners conditions. These representatives also mentioned “black marbling” (Figure 10) as an indicator of potential areas of ice jacking. This indicator also shows the rail movement around the rail base area.

Figure 10. “Black Marbling”

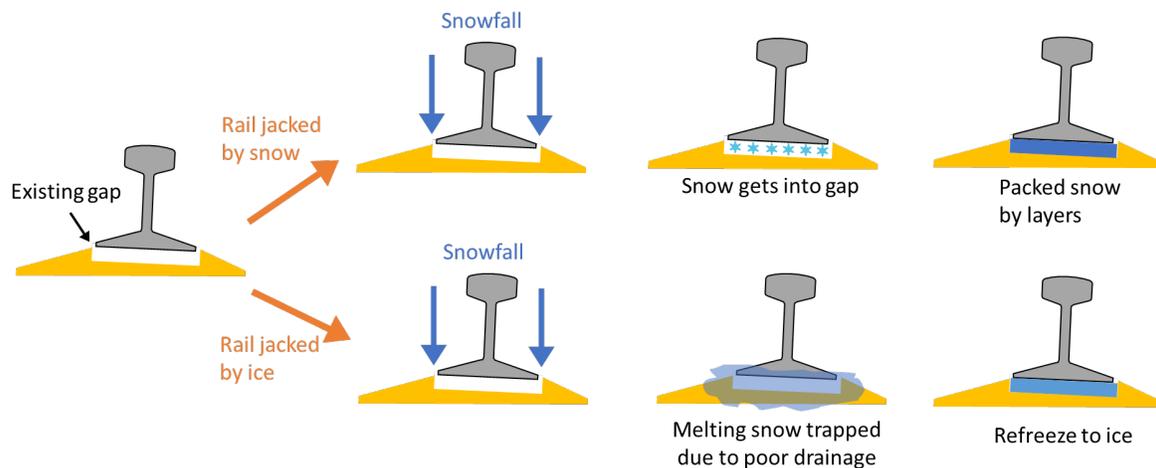
Based on the discussion with railroads, there are (at least) two conditions that could cause tie plate icing: rail jacked by snow and rail jacked by ice. The first condition is created by snow getting blown against the bottom of the rail and then becomes packed layer by layer to jack up the rail. The second condition is caused by weather conditions that create freeze-thaw cycles where snow/ice melts and becomes trapped in the gap between the bottom of the rail and tie plate and freezes again. Ice jacking is often associated with poor drainage. Figure 11 illustrates the two possible conditions for tie plate icing.

Figure 11. Two conditions for tie plate icing
