1016-22-1 (DFS) 12 July 2011

2010 Annual Report on Flight Safety

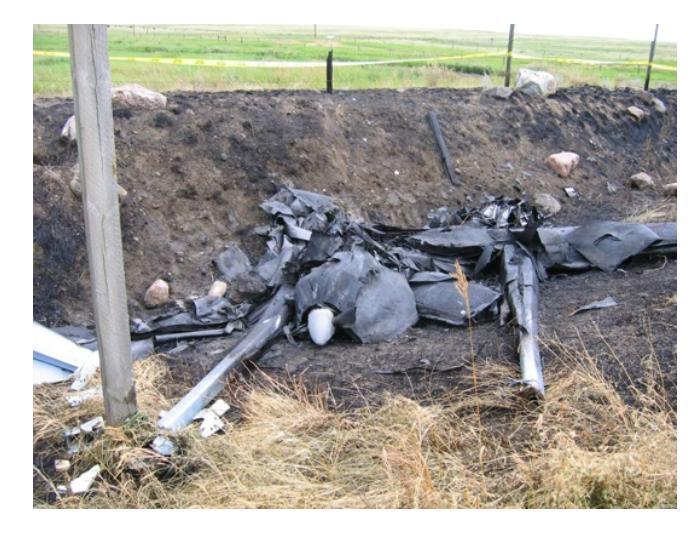
1.5.2.1 16 Jul 10, CU170 Heron 255, Accident, Cat 'A', Suffield, AB

outboard flaps remained in the down position with the associated "Servo Flap Right/OTR Fail" warning. This phenomena is a known issue with the Heron fleet and a Service Bulletin (SB MCM-026-2010) had already been released in an attempt to solve the issue. Throughout the circuit both the UAV and the Advanced Ground Control Station (AGCS) experienced multiple intermittent navigation systems failures. On final approach, the student Air Vehicle Operator (AVO) noticed the UAV flying too low and informed the AVO instructor, who immediately directed the student AVO to initiate an override altitude command to climb. The instructor noticed that the student AVO made an error in the screen button selection and immediately took control and gave the altitude override command. The UAV configuration was changing for the climb configuration when the UAV hit an electrical pole just east of highway 884. The UAV burst into flame and crashed on the west side of highway 884 approximately 800 metres north of the main entrance to CFB Suffield.

The focus of the investigation is on navigation system failures and human factors concerning operations within a ground control station environment.

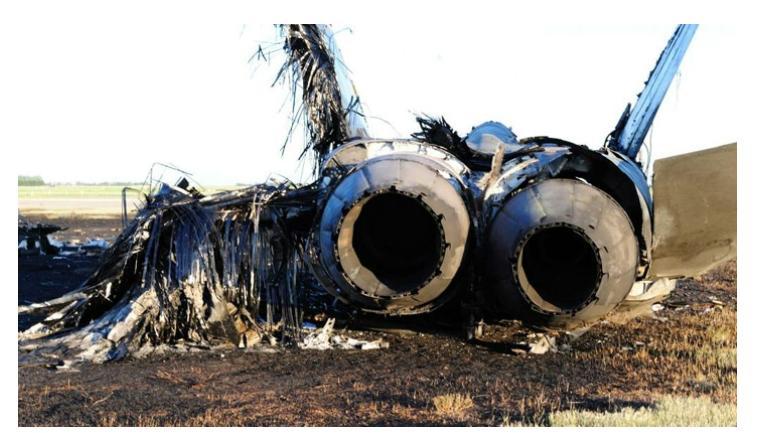
1.5.2.2 23 Jul 10, CF188738, Accident, Cat 'A', Lethbridge, AB

During an airshow practice at Lethbridge County Airport, Hornet CF188738 experienced a loss of thrust from its right engine while conducting a high alpha pass at 300 ft above ground level (AGL). Unaware of the loss of thrust but feeling the aircraft sink, the pilot selected military power on both throttles to arrest the descent. The aircraft continued to sink and the pilot selected afterburner on both

throttles. The aircraft immediately began to yaw right and continued to rapidly yaw/roll right, despite compensating control column and rudder pedal inputs. At approximately 150 feet AGL and about 90 degrees of right bank, the pilot ejected from the aircraft. The aircraft continued to yaw/roll right with its nose descending in a tight right descending corkscrew prior to hitting the ground nose first.

Field examination of the engines did not reveal any anomalies. Both engines were sent to the Quality Engineering and Test Establishment for a detailed inspection. Concurrently, photogrammetric analysis is taking place to ascertain certain flight and engine parameters which could not be recovered from the Advanced Memory Unit and other recording devices. Finally, modeling and simulation has been undertaken to better understand the factors (e.g., throttle splits, altitude) affecting the aircraft's recovery under various conditions. The on-going investigation is focussing on the loss of thrust experienced by the right-hand engine, the factors that precluded an in-flight recovery of the aircraft, and CF-18 demonstration pilot training.

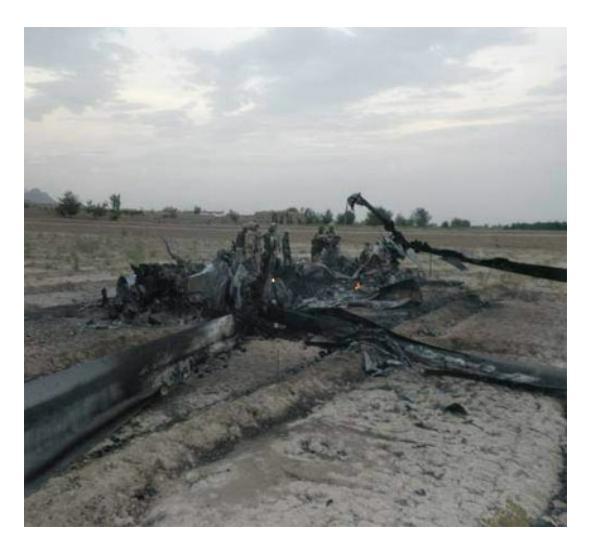
1.5.2.3 05 Aug 10, CH147202, Accident, Cat 'A', Near Armarah, Afghanistan

Chinook CH147202 was conducting a sustainment mission that involved carrying coalition troops and supplies to military installations outside Kandahar Airfield (KAF). While flying at low altitude from the forward operating base (FOB) Masum Ghar to the Panjwaii District Centre in Kandahar Province Afghanistan, the aircraft was forced down due to an in-flight fire. The source of ignition is linked to insurgent fire directed towards the aircraft.

Immediately following the sound of a detonation, flames and black smoke entered the cabin from the left side of the open rear ramp. Inside the cockpit, the smoke began to hamper the pilots' visibility.

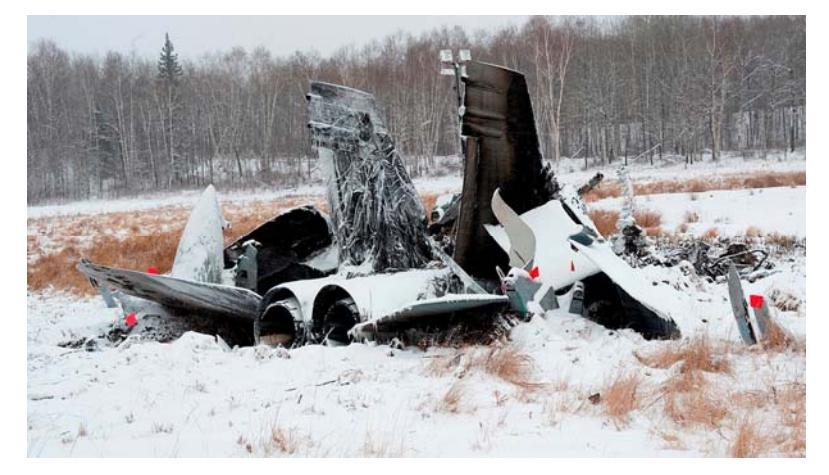
1.5.2.4 17 Nov 10, CF188789, Accident, Cat 'A', Near Cold Lake, AB

The single seat CF188 was flying as the second aircraft in a twoaircraft formation on a Night Vision Goggles (NVG) training mission. The prevailing weather was instrument meteorological conditions (IMC) and the accident occurred at night. During a radar trail instrument approach to runway 13L at Cold Lake, Lead called for the landing gear to be selected down. Upon selection of the landing gear, the wingman was almost immediately disoriented by the sudden rush of falling snow as it was illuminated by his landing light, which also reflected enough light through his Head Up Display (HUD) to washout the instrument references he used to control the aircraft. As a result of the visual inputs, the pilot perceived that he had entered a steep descent. In response, the pilot made an aft stick input and pulled the aircraft into a nose-high attitude. Still feeling that he was in a dive and thinking he was rapidly approaching the ground below, but unable to confirm his attitude using outside references or his HUD, the pilot decided to eject.

The ejection was successful and the parachute landing in a forested area was uneventful. The aircraft crashed in a nose-down, near wings level attitude and was destroyed. The uninjured pilot activated his personal locator beacon and used flares to direct the Search and Rescue helicopter to his location. The pilot was transported back to 4 Wing Cold Lake two and one half hours after his ejection.

The investigation also found numerous anomalies in the aircraft life support equipment practices and record keeping. Also noted, although not related to the accident, were areas of inconsistency in maintenance practices dealing with CF188 inlet icing cautions and de-icing procedures.

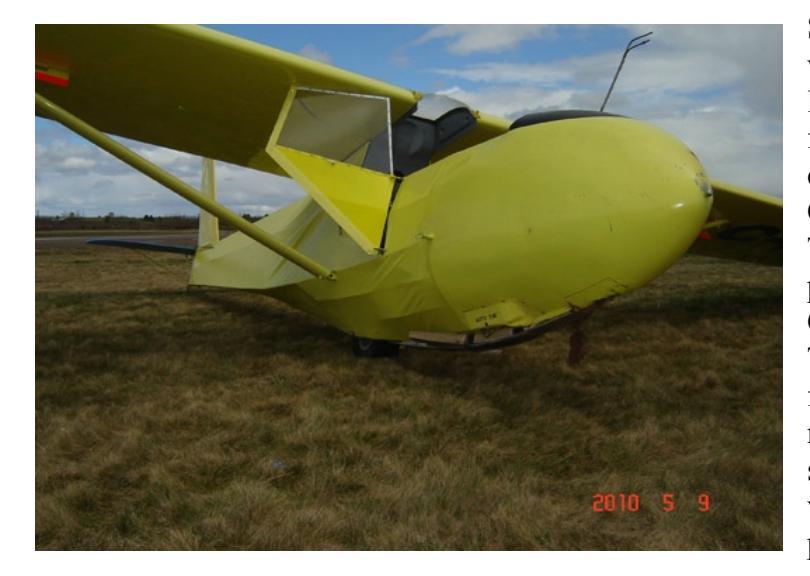
1.5.2.5 9 May 10, Schweizer SGS 2-33 C-FBJH, Accident, Cat 'B', Debert, NS

Schweizer SGS 2-33 Glider incurred very serious damage after a hard landing during an Air Cadet familiarity flight. The aircraft was crewed by a qualified Cadet Organizations Administration and Training Services (COATS) glider pilot in the back seat and an Air Cadet passenger in the front seat. The day involved numerous familiarization glider flights for members of a local Air Cadet squadron. Launches were conducted via auto-tow procedures using a pickup truck. The occurrence happened on the last planned flight as the weather began to deteriorate with isolated rain showers.

As the glider began its take-off roll, the wing walker, holding up the left and into-wind wing, inadvertently dropped the wing after a few paces. Although the outer wing wheel contacted the ground, the glider pilot was able to level the wings before the glider became airborne. Correcting for the left crosswind, the glider pilot allowed the aircraft to drift left of the runway, just over the grass. The initial left wing drop, followed by the left drift, gave the Observer in the auto-tow vehicle the impression that the launch profile was unsafe, prompting a decision to abort the launch by releasing the tow rope. The consequences of releasing the glider at a low altitude were not considered and the assumption was made that the pilot would simply land straight ahead. However, at that altitude there was no time for the pilot to recover the aircraft into a gliding attitude. The combination of a nose high pitch attitude, low altitude and sudden loss of forward speed caused the glider to stall and land hard on its main wheel and nose skid. The glider pilot sustained minor injuries and the cadet passenger, in the front seat, sustained serious injuries.

The investigation revealed that although all Air Cadet personnel are encouraged to call a "stop launch" when they observe a situation that may pose a hazard, within their training there was no delineation between ground or air hazards. Although the observer acted in accordance with standard procedures in reacting to a perceived risk, the decision to release at that critical point of flight left no time for the pilot to recover safely. It was clear that once an aircraft is airborne, only the pilot is in a position to determine the controllability and safety of the aircraft and whether continuing a launch poses a greater risk than aborting.

Recommendations were therefore made to enhance the training provided to cadets with clear direction and set limitations on when ground personnel can decide that a launch should be aborted. The investigation is on-going.

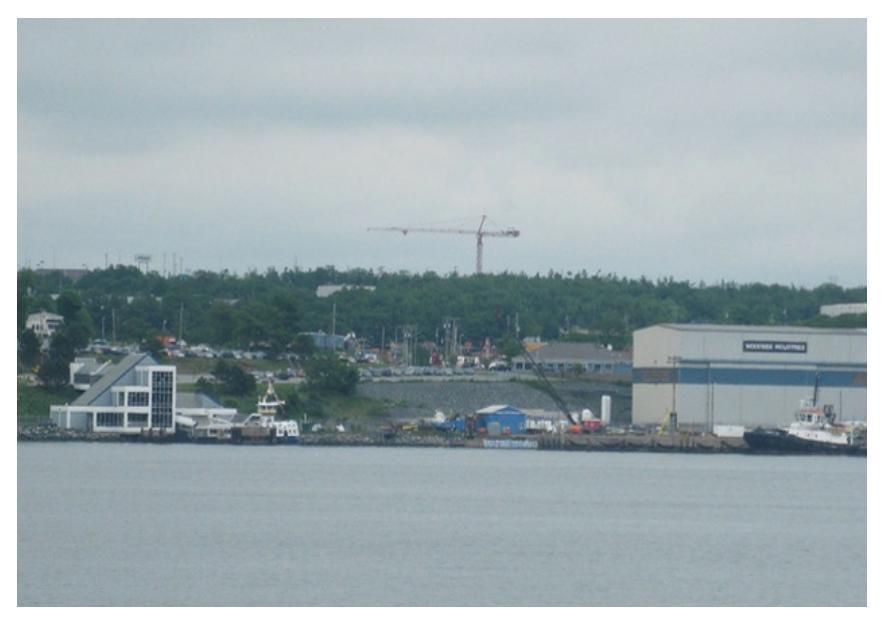
1.5.2.6 14 Jun 10, CH12416, Incident, Cat 'E', Shearwater, NS

On 14 Jun 2010, the crew flying CH12416 was returning from Greenwood under an Instrument Flight Rules (IFR) flight plan. After descending below a layer of cloud for a TACAN approach, the check pilot observed a newly erected construction crane that appeared to breach the safety boundary of the instrument approach corridor to runway 16. During the next approach, a Precision Approach Radar (PAR), the

The crane was erected for the construction of a four-storey building. An assessment had been conducted by the Halifax Regional Municipality, CFB Halifax, and 12 Wing Shearwater for the issuance of a building permit. As the plans showed that the completed structure did not encroach on the safety boundary, the proposed construction was deemed acceptable; however, the building plans did not include details about temporary structures (i.e., the crane) required during the construction. As a result of the missing information, the review did not identify the encroachment to the safety boundary.

To prevent future occurrences of this type, it is paramount that policies and guidance material be developed for the enforcement of the zoning regulations. It is also important that stakeholders be made aware of the information to be provided, and the approval process, for the installation and operation of a crane in the vicinity of military aerodromes. The investigation is on-going.

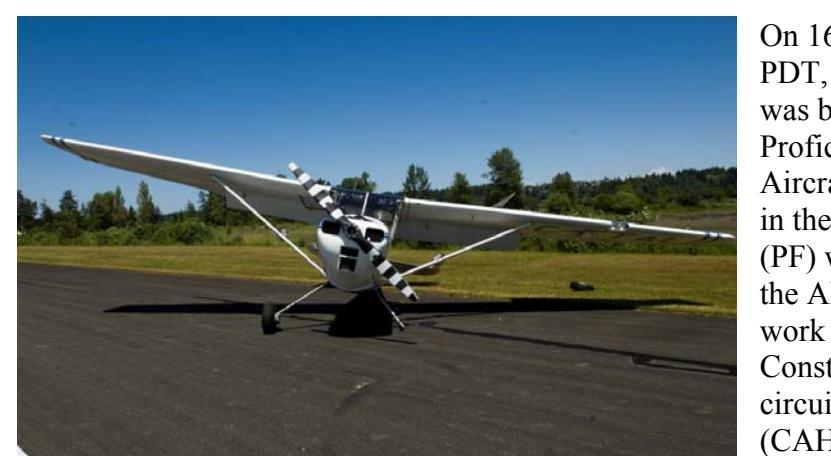
1.5.2.7 16 Jun 10, Cessna L-19 C-FTAL, Accident Cat 'B', Courtenay Air Park, BC

airfield, both pilots observed the windsock and determined that the wind was light and favouring Runway 31 with a right crosswind of less than 90 degrees. The PF joined the left hand circuit and configured the aircraft for a planned touch-and-go landing. The traffic pattern checklist was carried out and flaps were set at approximately 40 degrees. On final approach, both pilots again assessed the winds and noted that they had shifted slightly to a 90 degree crosswind. Both were comfortable that the wind was well within normal parameters for landing. The PF continued the approach and touched down in the first quarter of the runway. As the aircraft settled onto the runway it veered to the left of the centreline coming to within one meter of the edge of the pavement. The PF applied corrective flight control inputs to bring the aircraft to the right and back to the centreline. The aircraft responded appropriately and began to turn right; however, the turn rate accelerated beyond that expected by the PF. He applied left rudder and left brake aggressively to attempt to control the right swing; however, despite all efforts, his reaction was too late. He lost directional control and the aircraft entered a right ground-loop. As the turn progressed through approximately 90 degrees the left wheel axle mounting bolts failed in overload and the left wheel and brake assembly departed the aircraft striking the underside of the left wing on the way. Subsequently, the left-hand landing gear strut penetrated the asphalt runway surface and acted as a horizontal and vertical pivot point for the aircraft. The left wing tip and left elevator tip contacted the ground and the aircraft continued to rotate through approximately 220 degrees of initial heading before coming to rest.

Initial damage assessment revealed structural damage to the left wing, elevator, landing gear, landing gear box structure, engine mounting structure and possibly the rear fuselage.

The investigation is closed. Recommended preventive measures included the validation of Weight and Balance and Centre of Gravity charts for all L19 aircraft and improved training to provide crews better awareness of ground loop dynamics, aggravating factors, and prevention strategies.

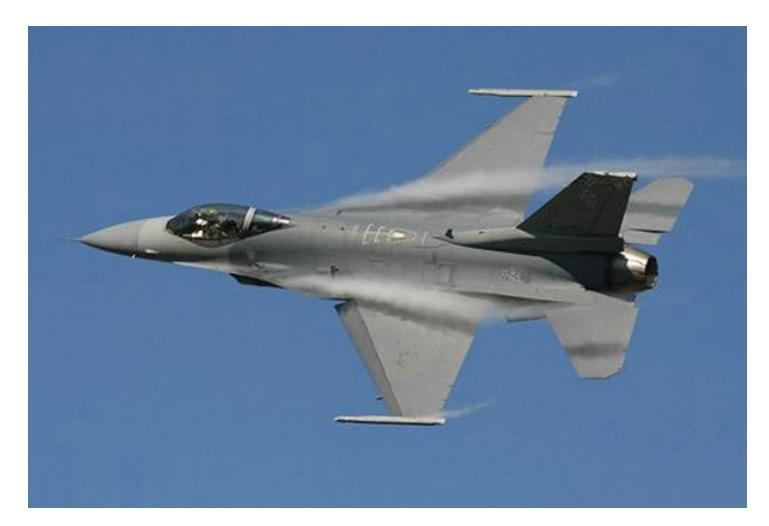
1.5.2.8 18 Jun 10, CT155 Hawk and F-16, Incident, Cat 'E', Cold Lake, Al

The near miss occurred when a single F-16 from a visiting force flew over the inner runway, where a CT155 formation was completing an "in stream" touch and go. The F-16 pilot requested a battle break to the outer runway but incorrectly aligned his aircraft over the inner runway. During the run-in, the maximum speed of the aircraft was inadvertently exceeded. ATC had cleared the F-16 pilot for a battle break to the outer runway even though battle breaks were not authorized for single aircraft. The

F-16, now moving at 580 knots, flew 200' above the number two CT155, which had just lifted off the runway from a touch and go. Midway down the runway, the F-16 pilot was surprised to sight the lead CT155 aircraft airborne and in his flight path. To avoid the lead CT155 aircraft,

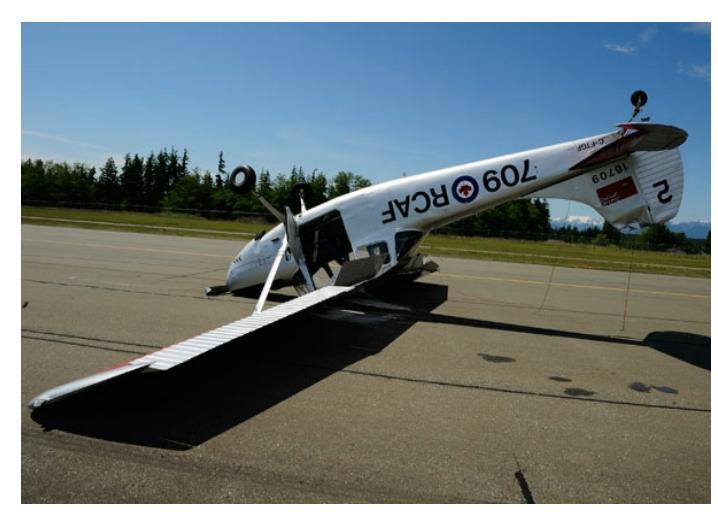
1.5.2.9 19 Jun 10, Cessna L-19 C-FTGF, Accident Category 'B', Comox, BC

The occurrence happened during tow plane operations in support of Regional Gliding School (Pacific) glider operations at the Comox Airport. The active landing surface in use was taxiway Alpha 30. The weather was good with Tower reporting surface wind of 010 degrees magnetic at 7 knots, resulting in a 6 to 7 knot crosswind from the right. The crosswind limit for the L-19 is 10 knots.

The pilot sustained minor injuries and safely egressed the aircraft. The aircraft was damaged beyond economical repair.

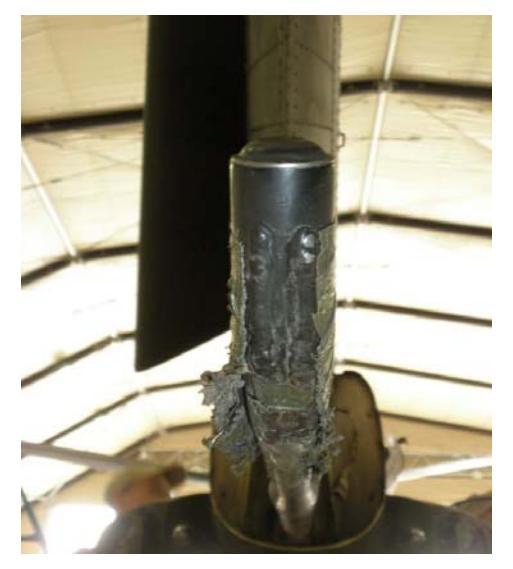
1.5.2.10 01 Aug 10, CH146425, Accident, Cat C, KAF, Afghanistan.

During final approach to the FARP, the number two aircraft of a formation of CH146 helicopters experienced an unusual landing during which the stinger struck the ground. The pilot turned 90 degrees to the left during the short final phase resulting in a 90 degree crosswind from the right. At that point the helicopter began a descent from a height of about 20 ft and bounced on the gravel a few times before skidding a distance towards the refuelling parking spot. During the second bounce the aircraft tail boom stinger hit the ground damaging one tail rotor blade in the process. There were no injuries. The investigation is ongoing.

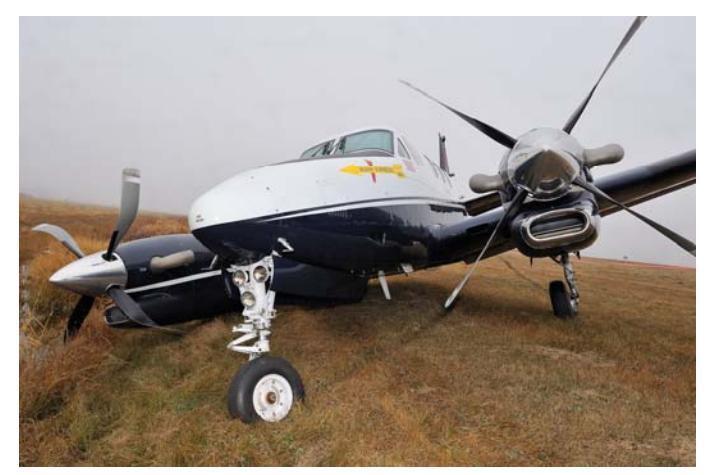
1.5.2.11 08 Nov 10, CT145/CFMFR, Accident, Cat 'C', Portage La Prairie, Manitoba

A CT145 King Air departed the hard surface of the runway at Portage la Prairie as the aircraft was performing a full stop. The aircraft was crewed by a Qualified Flight Instructor (QFI) in the right seat and a student pilot, under training as part of the Multi-engine Pilot Course, in the left.

Immediately after touchdown, the right wing began to sink due to failure of the right main landing gear. Attempts to maintain runway centreline proved futile

as the aircraft drifted right, departing the hard surface of the runway approximately 600 meters after touching down. The aircraft came to a full stop at the crest of a drainage ditch, 78 meters right of runway centreline. The right main landing gear was collapsed and forced aft, angled down the slope of the ditch. Both pilots were able to safely egress with no injuries. The aircraft sustained damage. The evidence indicates that the right landing gear collapsed when the drag brace bolt failed due to a pre-existing fatigue crack. This investigation is ongoing.

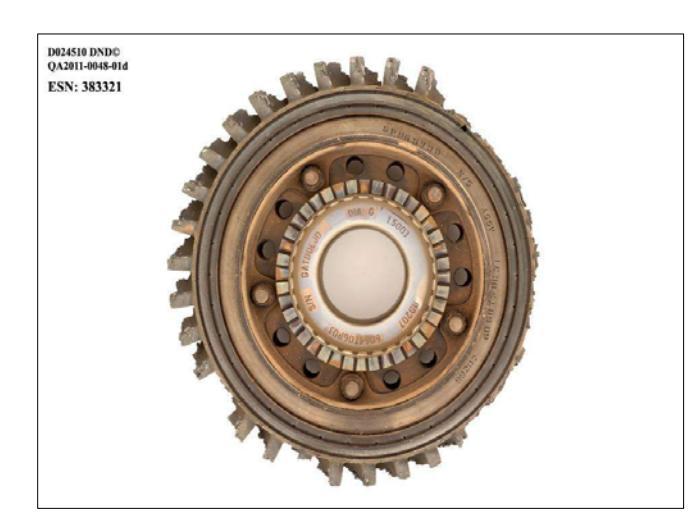
1.5.2.12 18 Dec 10, CH149907, Air incident, Cat 'D', 55Nm NNE of Comox, BC

Approximately 35 minutes into the outbound transit phase of a Search and Rescue mission, at 9400 MSL in level cruise at maximum continuous power, the number three engine failed. The aircraft commander immediately took control and started a turn back towards Comox. The flight engineer and first officer followed the prescribed emergency procedures to secure the engine. A run-on landing was conducted at Comox airport without further incident.

A borescope and subsequent teardown inspection revealed that a single stage 1

blade had separated from the shank below the platform. The blade separation was the result of fatigue cracking due to a combination of corrosion and damper distress. The investigation is ongoing.
