TP 6980E

Issue 4/2003

A Message for Aircraft Maintenance Personnel

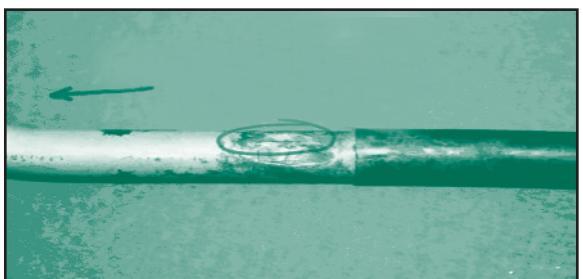
Fuel Lines Chafed

Fuel line, P/N 05001183, was discovered chafed during 200-hour inspection. It was determined that the fuel line was chafing on the steering rod mount. The submitter added that this is a very difficult area to inspect and extra care is required.

TC recommends close inspection of all lines in hard to see areas which require extra time and attention. Always expect the unexpected.

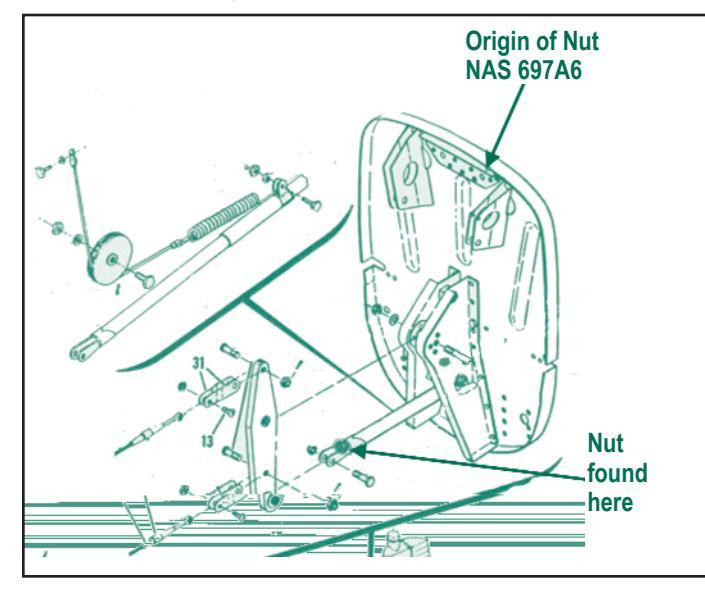
Elevator Controls Jammed

Elevator controls jammed on pre-flight function test. Maintenance technicians carried out a complete system inspection and found a nut, P/N NAS 697A6, stuck on top of the elevator push rod at the bellcrank assembly attachment. The nut was restricting elevator movement towards the lower stop.

This nut originated from the vertical fin forward installation bolt, P/N AN6-7A. The last suspected removal and reassembly of the vertical fin (with new nuts) was May 1990.

This stray nut appeared to remain undetected for 10 years!!

AMEs should not sign a maintenance release unless all tools and "lost" or "misplaced" hardware are accounted for.

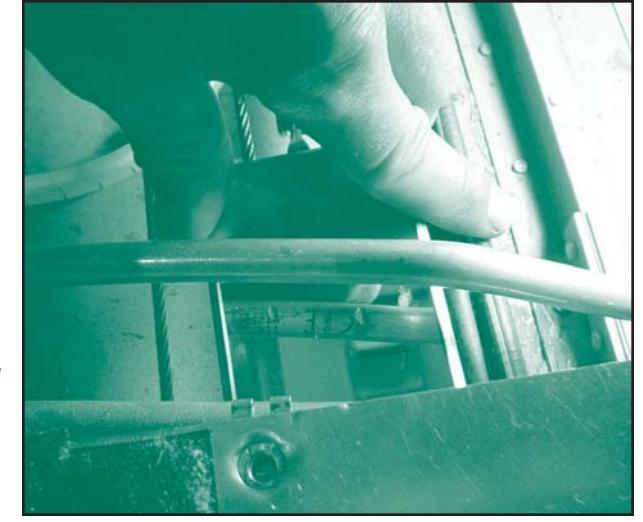
CESSNA 560 CITATION ENCORE Brake Lines Chafed

L/H and R/H elevator control cables were found chafing the hydraulic brake lines at F.S.178.00. This was the first time the floor panel had been removed and this discrepancy is believed to have occurred at the manufacturer. This area is the location where hydraulic brake lines run laterally across the flight control cables. Replacing both brake lines and repositioning the two adjacent Adel clamps to provide maximum clearance rectified the problem. The general area is 1.0 ft forward of cabin door under center floorboard.

This is a reminder to AMEs that new aircraft can also be susceptible to improper clearance of hydraulic lines and diligence should be taken during inspection.

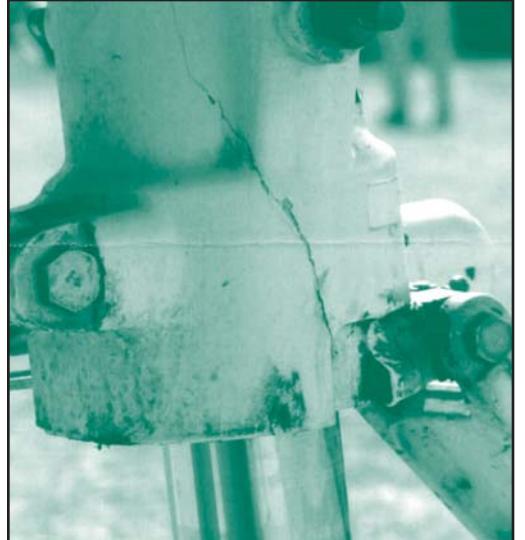
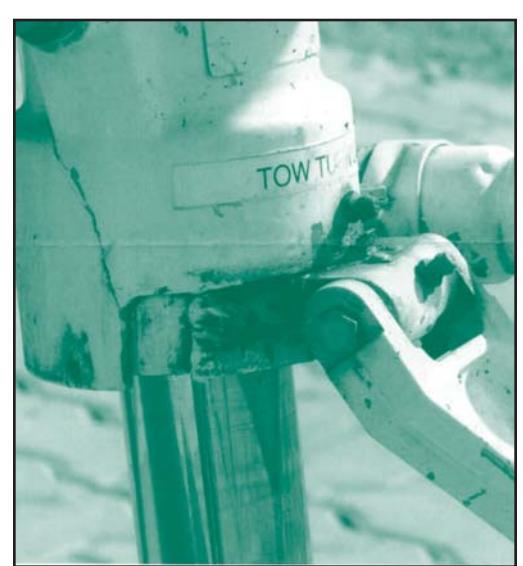
PIPER PIPER 31 350 Nose Landing Gear Housing Cracked

During a pre-flight inspection, the nose landing gear trunnion housing, P/N 40273-0, was discovered cracked. The crack was approximately 6 in from the right side steering stop, and continued upwards and to the back of the housing. The crack probably progressed to be visible on the previous landing. The submitter added that this type of cracking is the result of over-steering or excessive pull during ground handling.

TC discovered 14 similar SDRs in the SDR database. All defects were caused by improper ground handling or oversteering. The Piper 31 350 maintenance manual states under caution **"not to turn the nose gear in either direction beyond its 20-degree arc,"** because this will damage the nose gear and steering mechanisms. Control locks must not be installed prior to towing. A placard is installed on the nose gear strut indicating turn limits. TC reminds everyone involved in towing aircraft to follow manufacturer's instructions when conducting ground-handling operations.

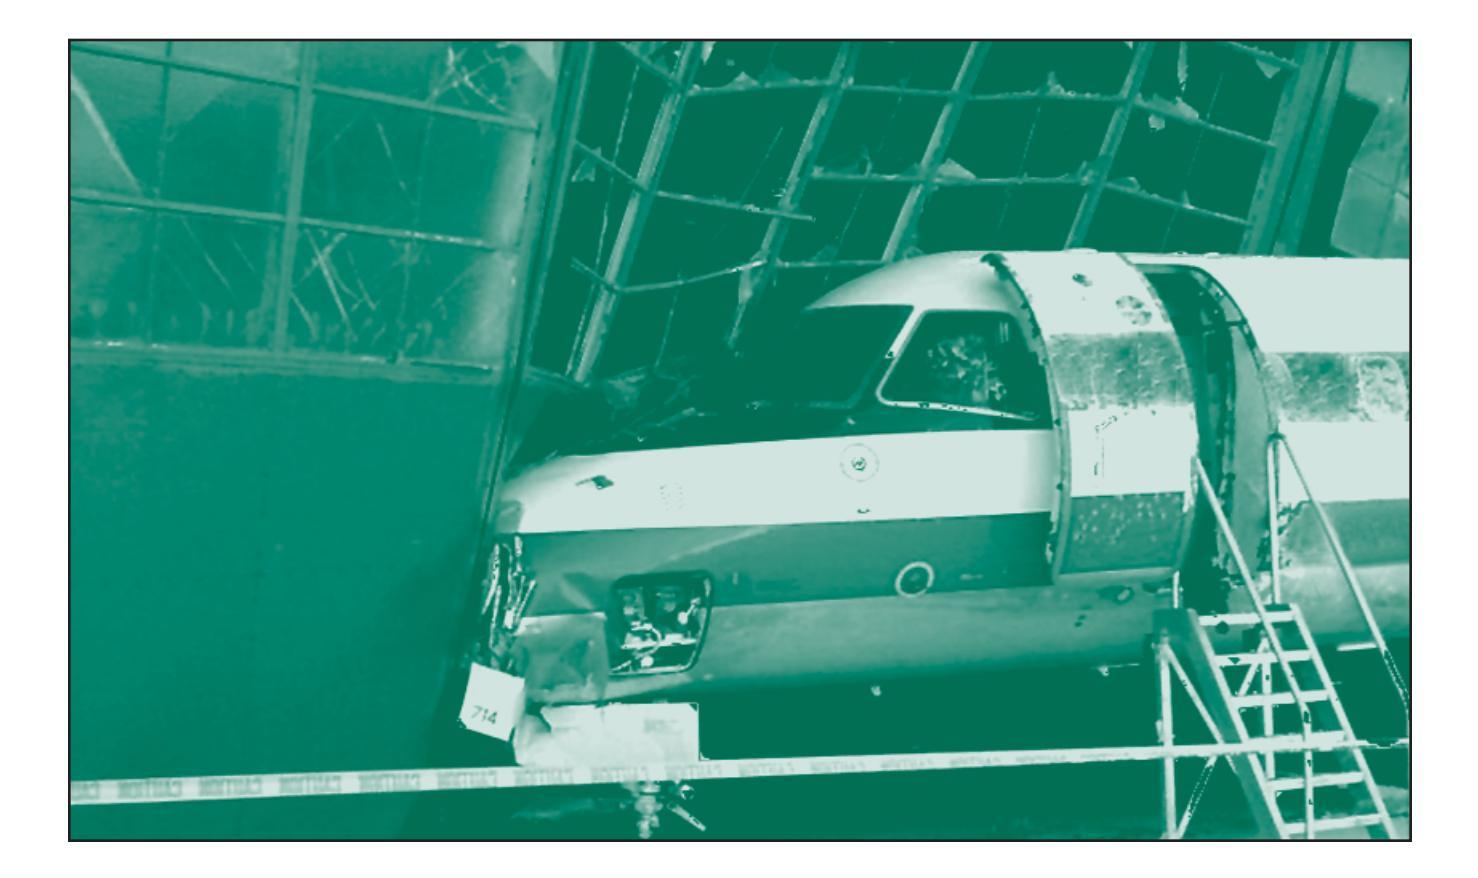
Every winter there seems to be the inevitable occurrence when an aircraft, due to a contaminated tarmac, moves forward during a maintenance ground run with the maintenance crew unsuccessful in their attempts to stop the aircraft prior to striking obstacles. There are often casualties and the aircraft involved causes substantial damage.

When an aircraft under power looses its braking ability and begins to slide, things start happening fast.

Don't let this happen to you!

Transport Canada (TC) encourages operators to review their maintenance organization engine ground run training policies, procedures and authorizations. The training syllabus should include a demonstrated knowledge and capability of the run-up crew to bring the aircraft to a stop under a variety of conditions. An otherwise appropriately trained and experienced technician from the "sunny south" who has never experienced a tarmac covered with snow and ice may not be familiar with the associated perils.

TC further cautions operators that only qualified personnel, in an appropriate area, clear of obstacles, should perform engine ground run-ups.

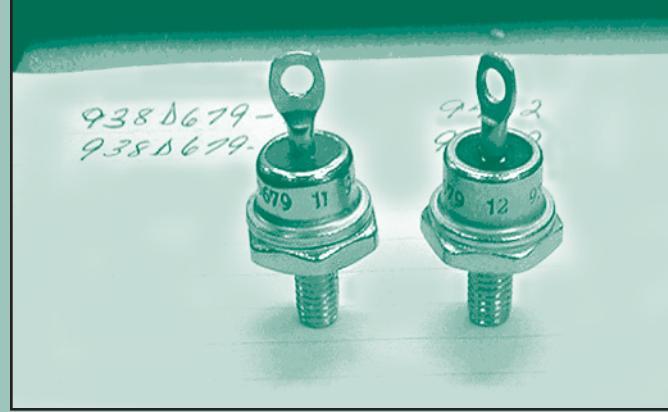
Information received during a Federal Aviation Administration (FAA) suspected unapproved parts (SUP) investigation revealed that TIC Electro, Ltd., and Gateway International Group, Inc., sold nonconforming diodes, part numbers 938D679-11 and 938679-12. These diodes were not produced by an approved source and do not conform to the specified Hamilton Sundstrand drawings. The diodes are not marked with the manufacturer's identifiers and lack the required symbol for the polarity code. The unapproved diodes can be identified by the following markings (see photograph):

938D679-11 9322	938D679-12 9322	
938D679-11 9422	938D679-12 9422

Regulations require that type-certificated products conform to their type design. Aircraft owners, operators, maintenance organizations, parts suppliers, and distributors should inspect their aircraft, aircraft records, and/or parts inventories for the above-referenced diodes. If an above-referenced diode is installed in an aircraft, contact the FAA Flight Standards District Office (FSDO) listed below for guidance regarding the appropriate action to be taken. If any of the referenced diodes are found in existing parts inventory, it is recommended that the diodes be quarantined to prevent installation until a determination can be made regarding each part's eligibility for installation.
