FLIGHT COMMENT

JANUARY · FEBRUARY · 1967

DIRECTORATE OF FLIGHT SAFETY

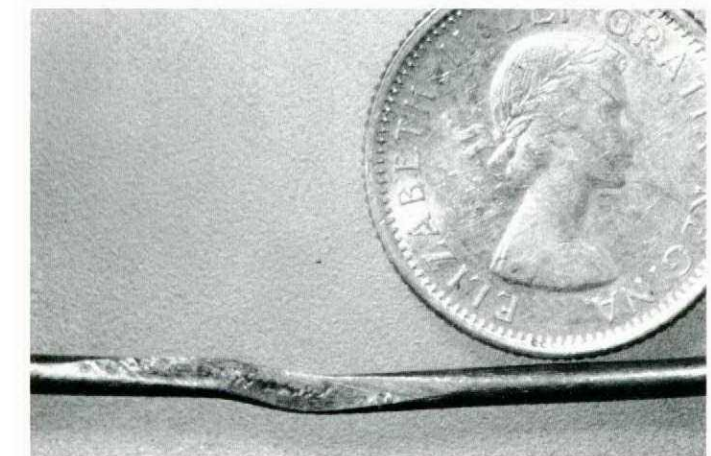
- Chafing of the outer sheath occurs when the cable is improperly installed and rubs against a surface. When the sheath is worn through it sets off a false alarm.

A detection cable badly chafed – a dime appears huge beside cable and damage which caused a false alarm.

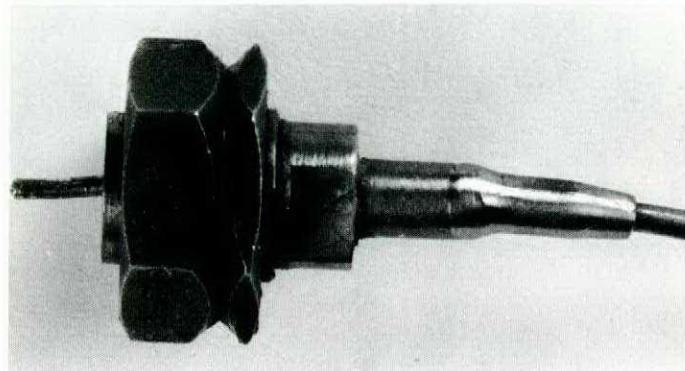
Bent pin on cable connector

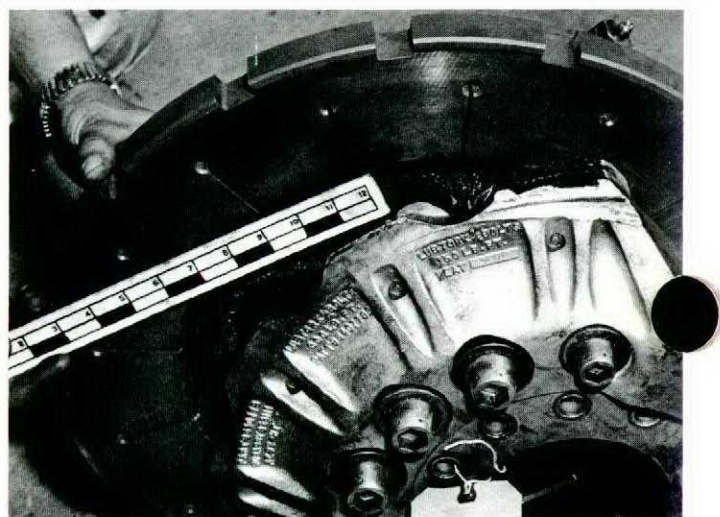
They hadn't towed the Hercules very far from the hangar following the removal and reinstallation of a brake assembly when a loud scraping noise was heard from the vicinity of the port wheel. The damage to the bearing and brake assembly is shown in the photos.

Earlier, the brake assembly had been removed from the axle and returned to the tool crib. A spacer, which "usually stays on the axle when the brake unit is removed" this time, stuck to the brake assembly. Assuming the spacer unit to have remained on the axle another unit was installed with the resulting damage.

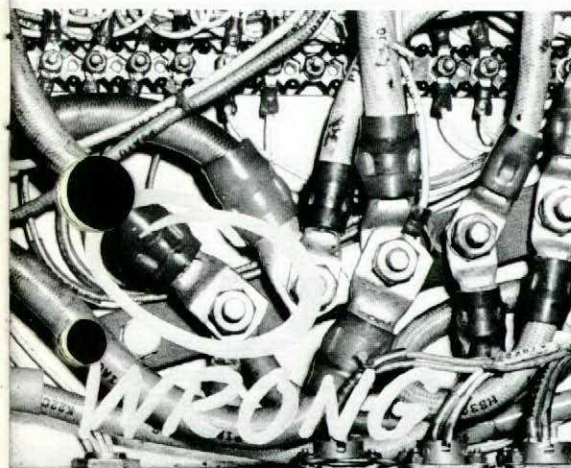
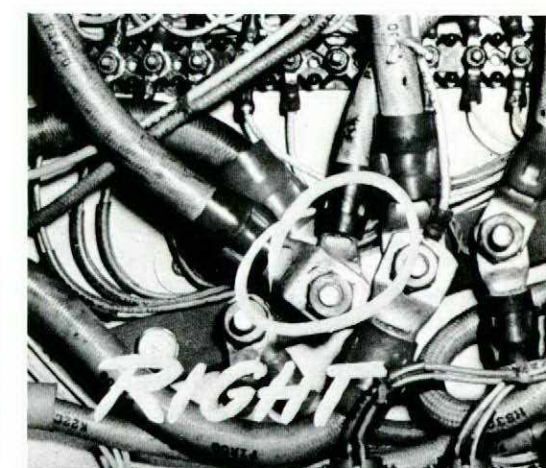
Murphy Again

Here are two ways to connect the positive generator lead on the Albatross. When incorrectly connected as in the picture it is linked to the propeller feathering circuit terminal. Be alert!

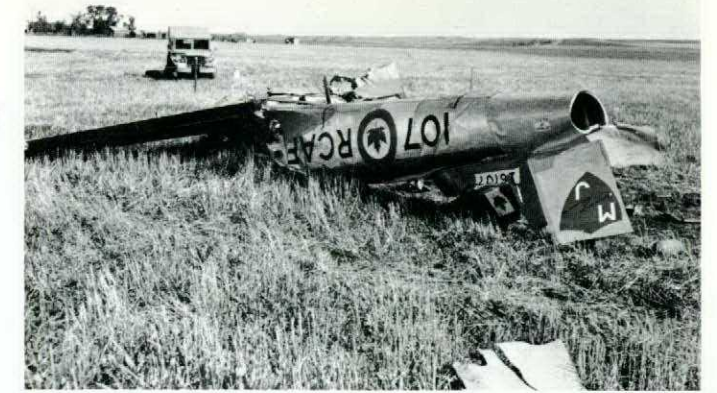
This fouling occurred because the aircraft was designed with insufficient clearance between the rudder pedal and the cockpit side panel. The military

specification requiring a minimum of 1.5 inches clearance between primary flight controls and aircraft structure was not met.
