# FLIGHT COMMENT

NOVEMBER • DECEMBER

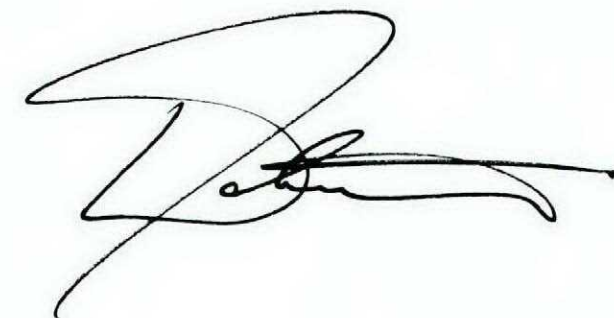
COL R. D. SCHULTZ  
DIRECTOR OF FLIGHT SAFETY

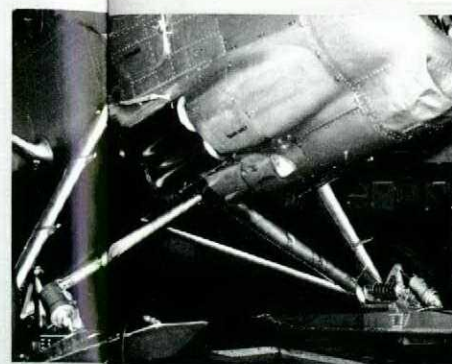
An Otter, a snow-covered field and a barbed-wire fence. Put them all together, make the snow surface wet and sticky, throw in an unexpected wind change, attempt to takeoff and...

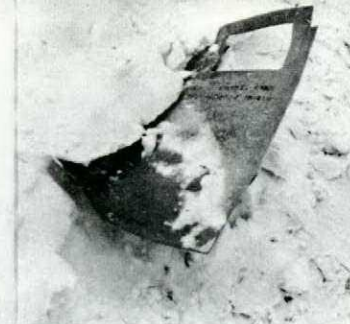
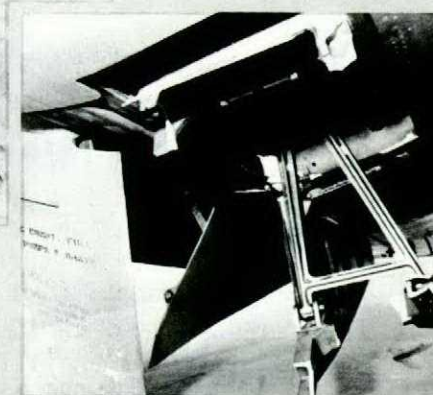
This T33 speedbrake contacted the last approach light leading up to the runway. The aircraft touched down 100 ft short of the threshold. Low airspeed combined with ice on the under-surface of the wings and tail caused this one to drop in short.

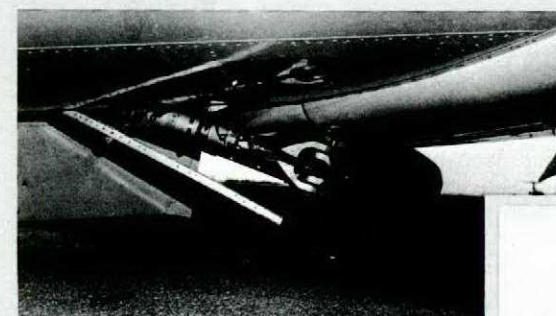
The cockpit indications showed three wheels down and locked. After a smooth touchdown the left wing began to drop and the left landing gear folded. A corroded downlock switch contained moisture which had frozen, preventing the switch from returning to the off position.

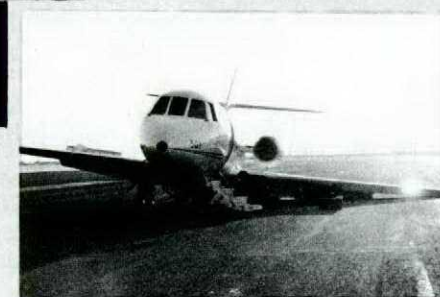
Not to be outdone, another CF 101 landed short after a steep glide path, high sink rate approach. Partial whiteout again impaired the pilot's depth perception as he wiped out a threshold light and picked up some styrofoam from the impression fence.

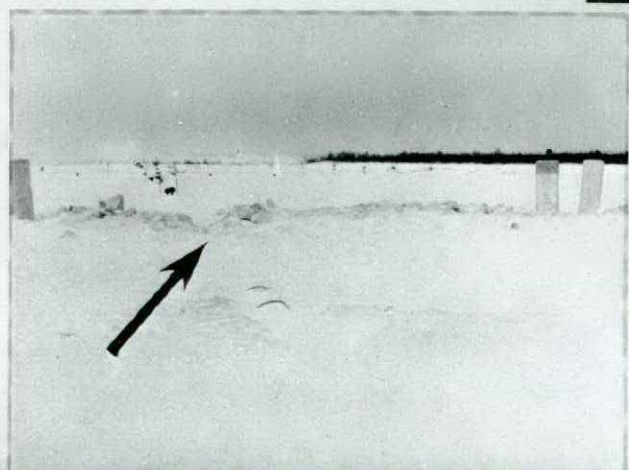
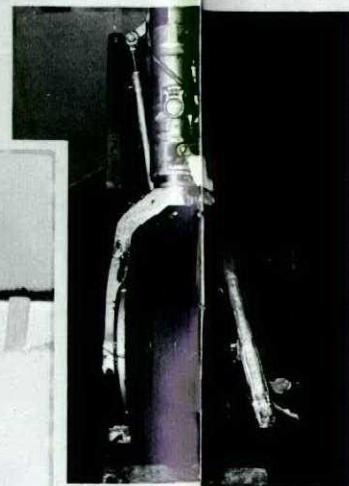
The weather conditions were marginal and the braking action was reported as "poor to nil", so the CF100 landed. The braking action report was found to be accurate and the Clunk refused to slow down. The pilot then raised the landing gear on his overweight aircraft as it approached the end of the runway. Only the right main gear retracted and the aircraft ground looped 70 ft off the end.

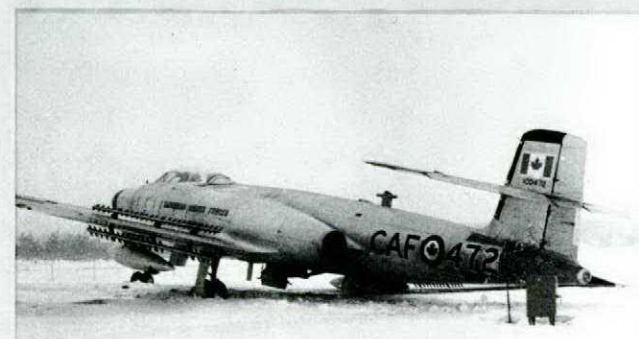
Voodoos got into the act with a bang last winter. The impression fence on the left was hit when the No. 2 in a formation dropped low on the lead. Falling snow and partial whiteout contributed to this off-runway touchdown.

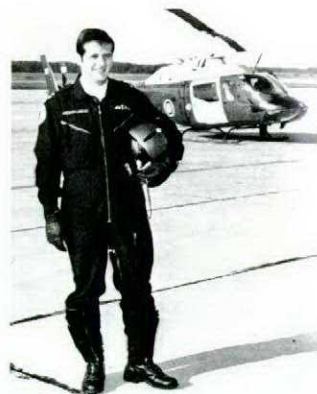
**Capt J.U.J. Montplaisir**

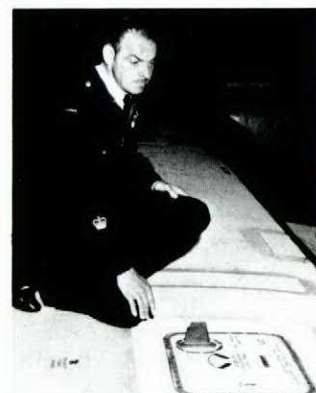
**WO N.C. Robertson**

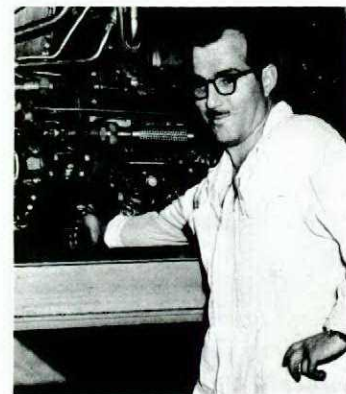
Cpl J.L.B. Plamondon

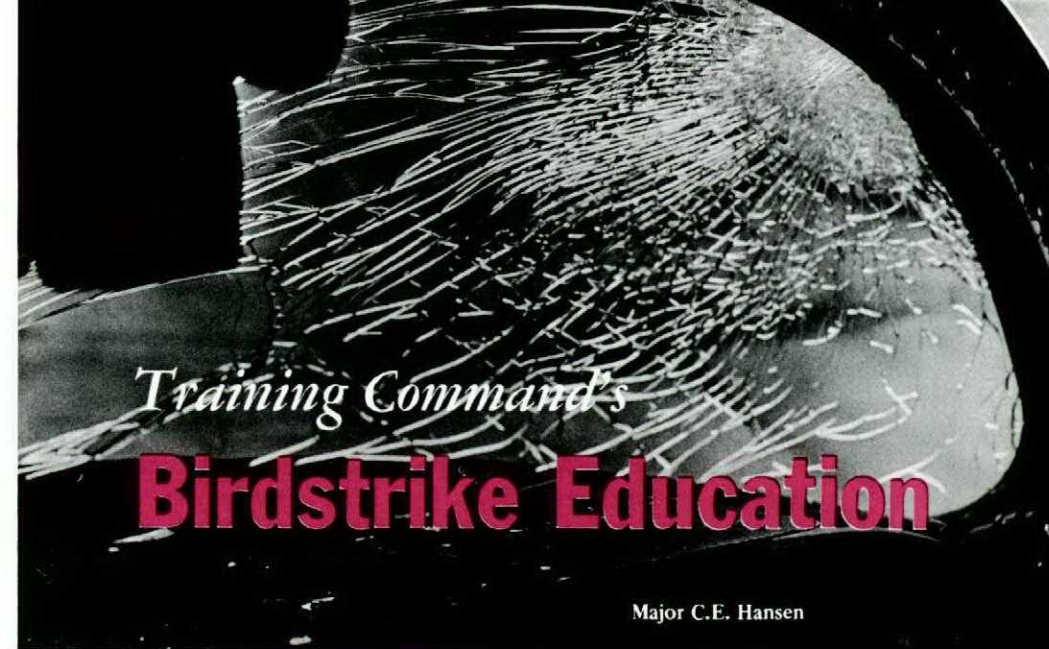
Cpl Quenneville's attentiveness and thorough workmanship averted a possible inflight emergency and he is commended for his attention to duty.

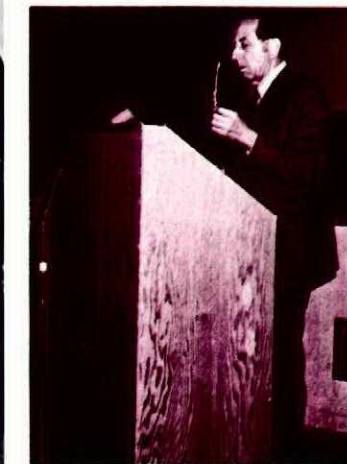
Dr. V.E.F. Solman, chairman of the National Research Council of Canada/Associate Committee on Bird Hazards to Aircraft illustrates the birdstrike hazard.

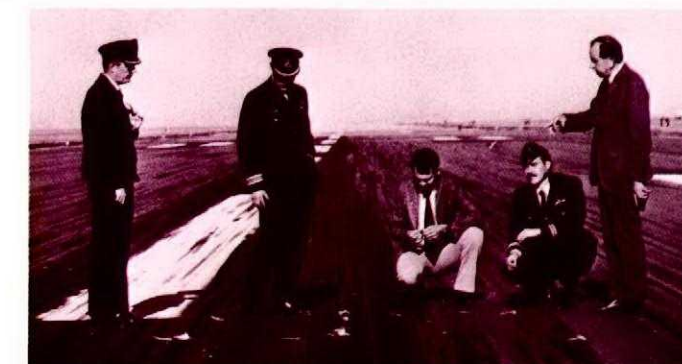
Dr. V.E.F. Solman and inspection team at CFB Moose Jaw view the scene of a recent birdstrike.

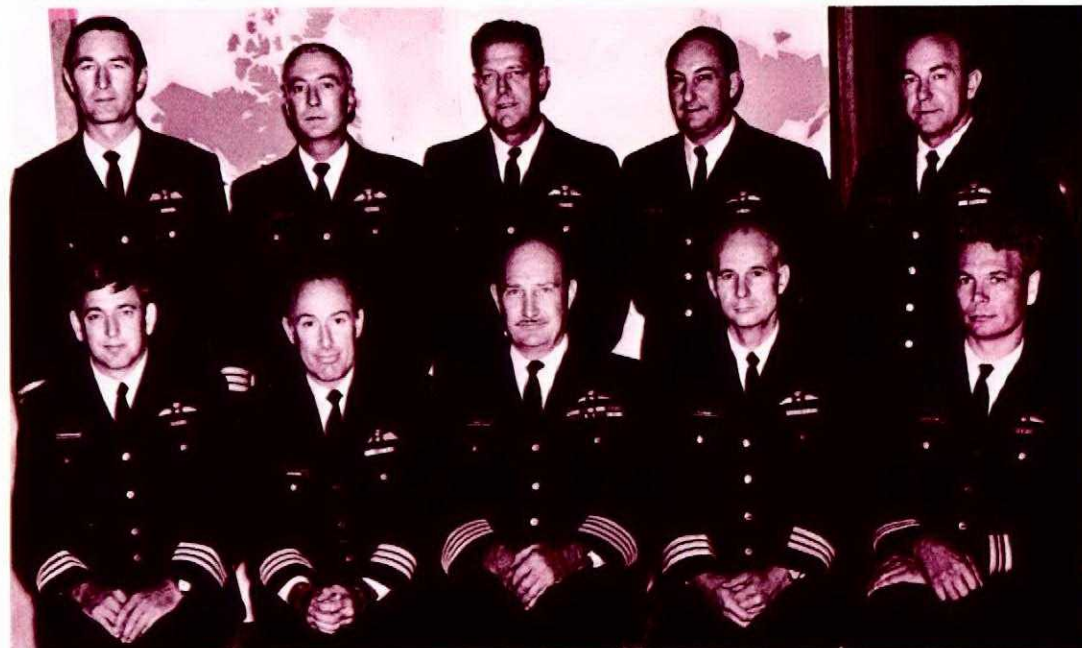
Nineteen newly appointed Squadron Commanders attended one-day Flight Safety seminars in September. The seminars were held at NDHQ under the chairmanship of Col RD Schultz, Director of Flight Safety. The aim of the program:

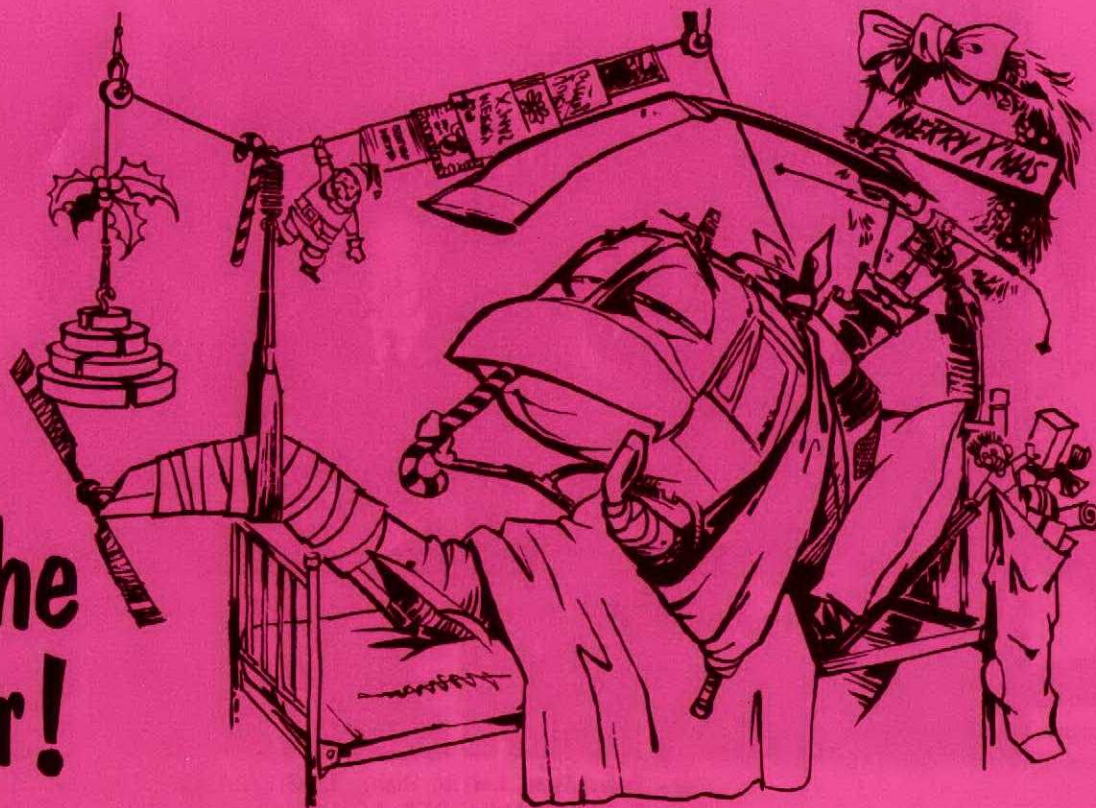
tell me about all the wonderful flying I was missing. Field operations sounded like lots of fun and I even heard that we were flying in cloud, in actual instrument conditions.

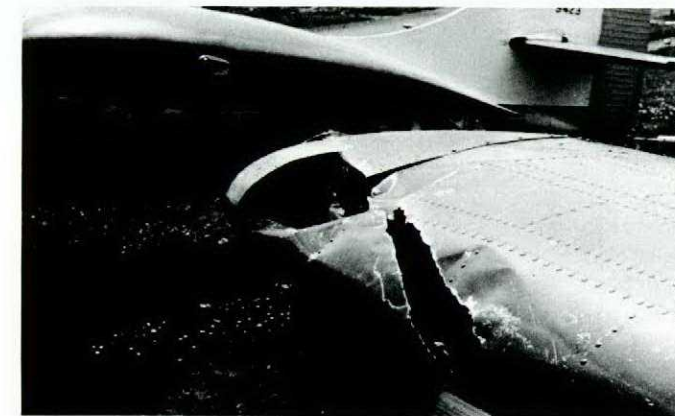
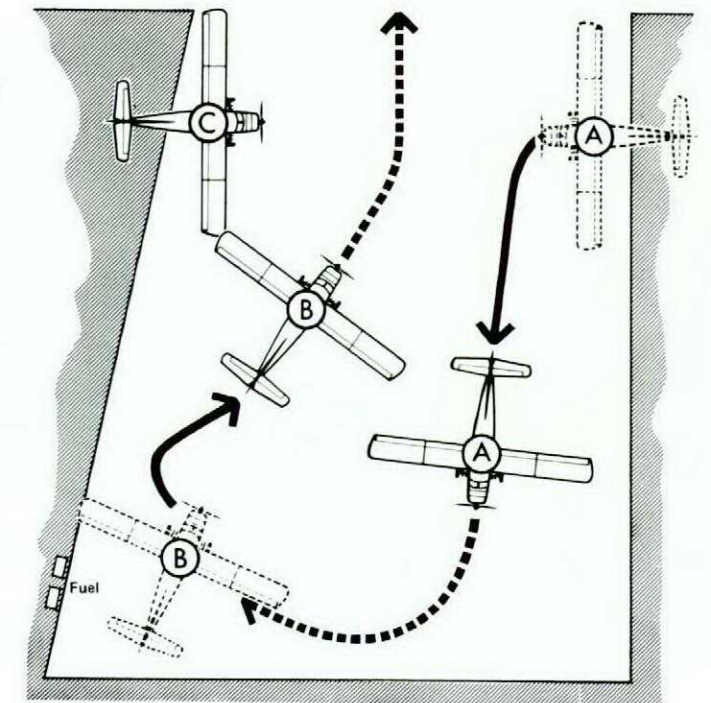
involved been in radio contact (as required by Sqn orders), they may have at least been aware of each other's intentions and possibly prevented this accident.

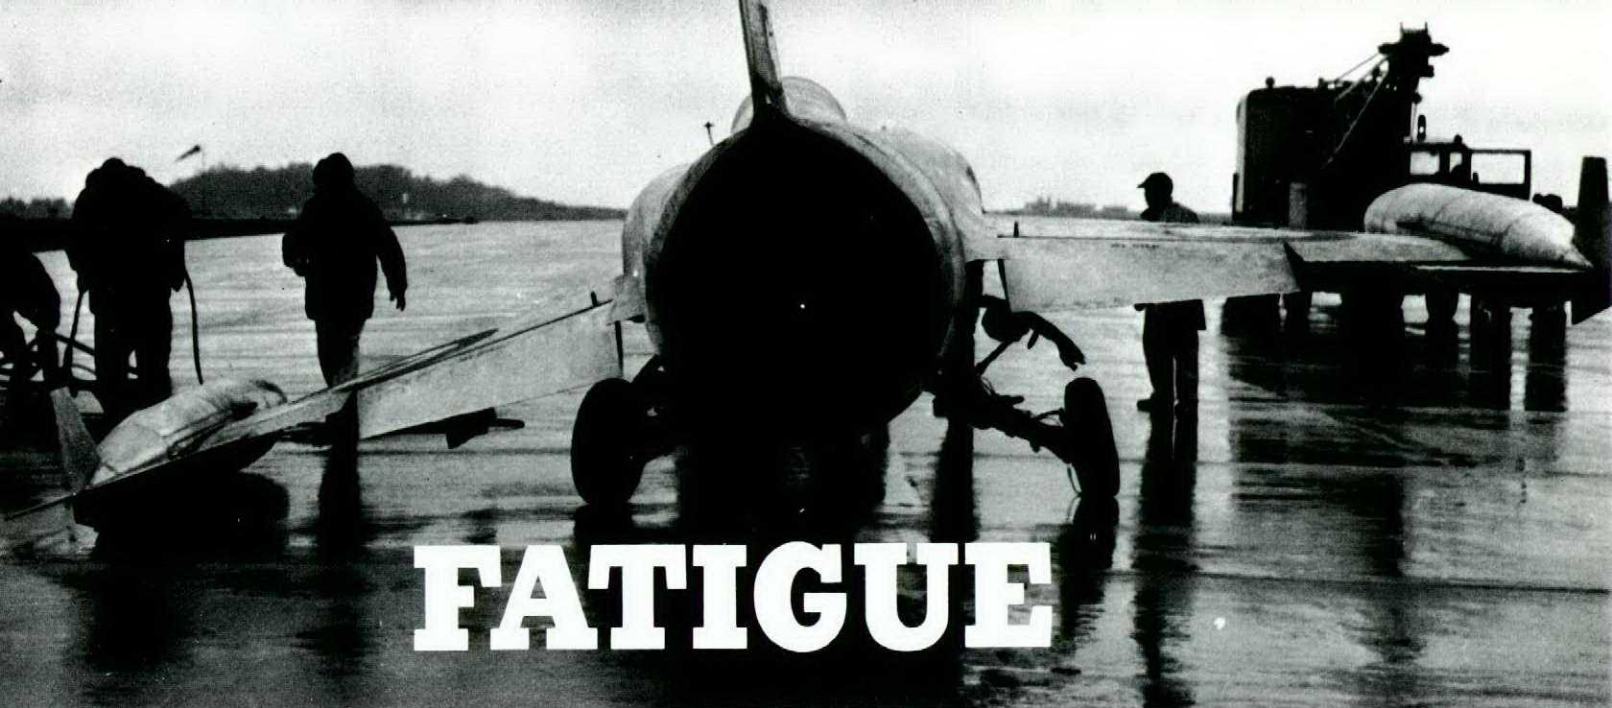
...aircraft component failure

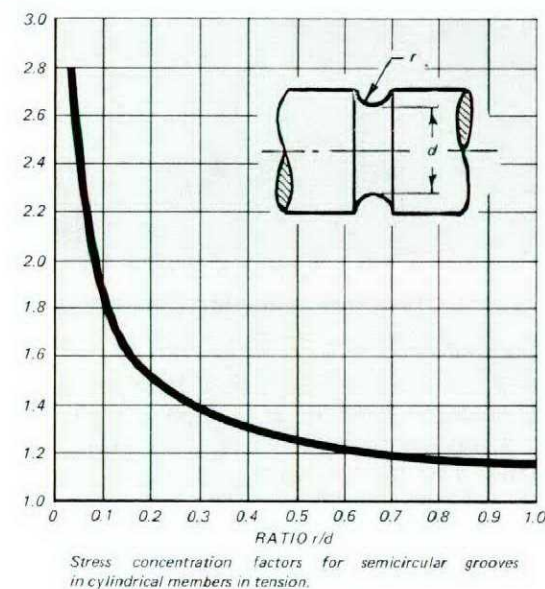
How long parts will survive before "fatigue" sets in is largely determined by the designer. Figure 2 shows a graph of

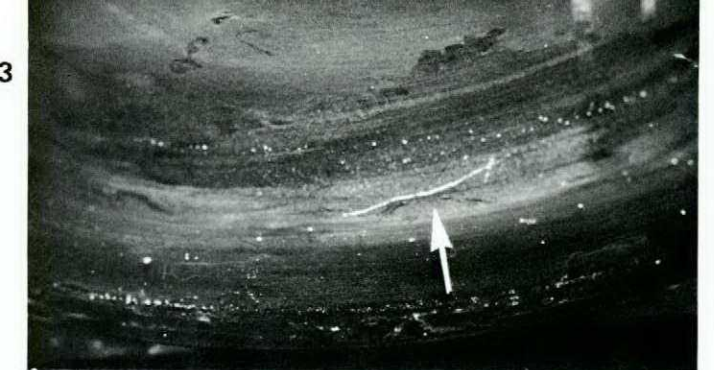
The appearance of a defect indication in an aircraft wheel using fluorescent liquid penetrant and ultra-violet light.

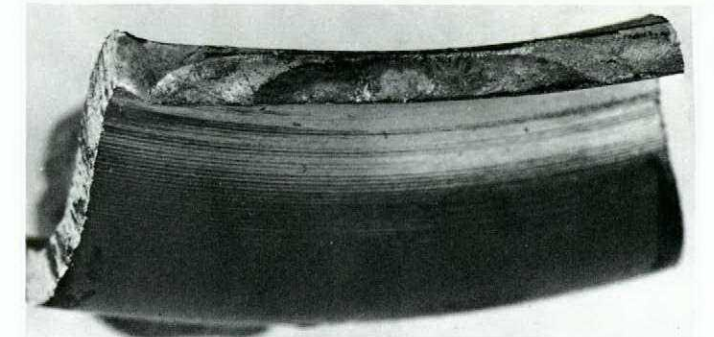
Figure 4 A view of the defect after cutting to the crack and breaking open.

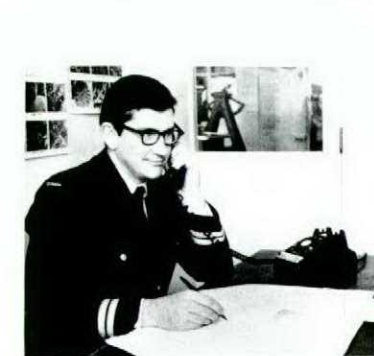
Captain Ross was born in South Africa, where he completed high school and part of his university training. He came to Canada in 1963, and finished his B.Sc. in mechanical engineering at the University of Alberta in 1967 under ROTP.

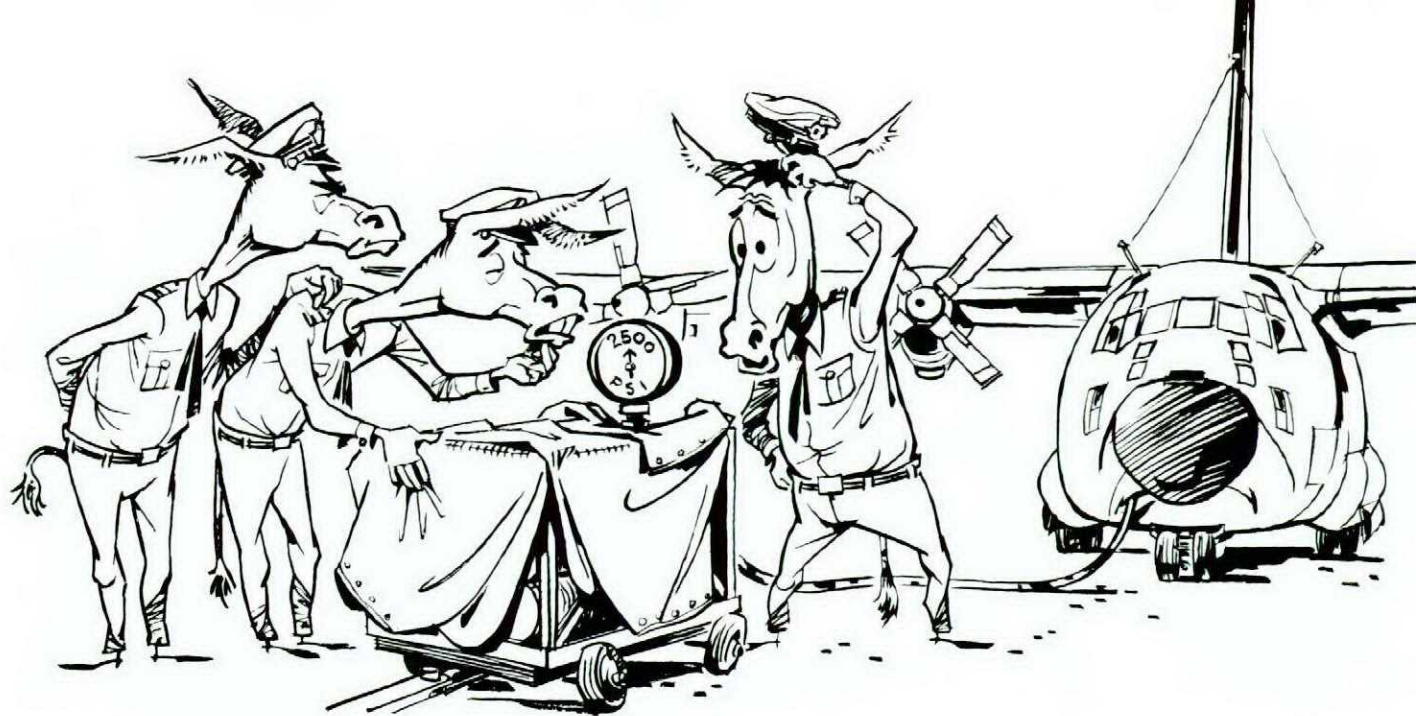
Before taking up his present position as Failure Analysis Engineer at QETE, Hull, Capt Ross completed a Master of Engineering degree at RMC Kingston.

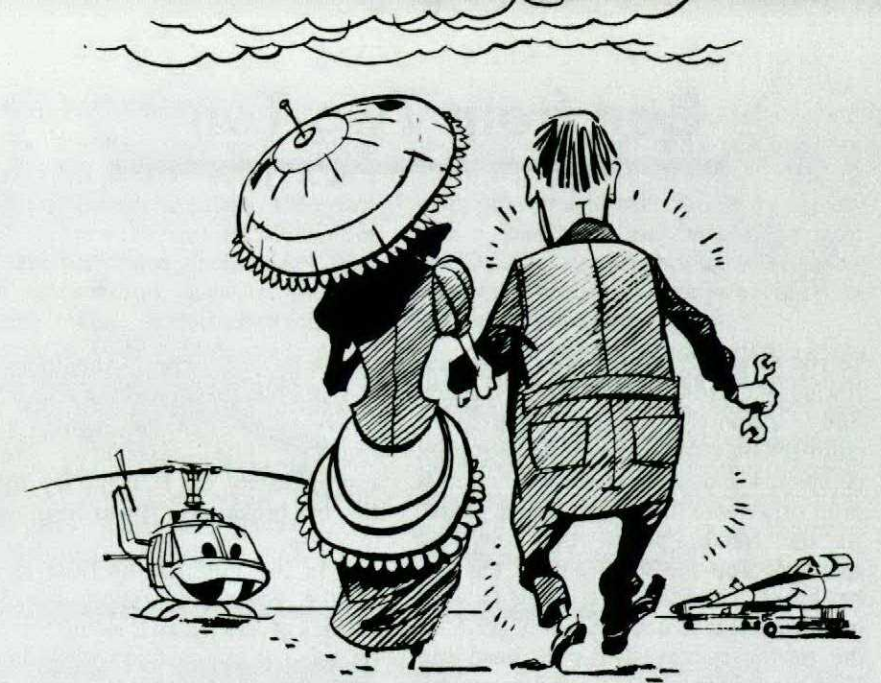
In February of this year the National Defence Committee on Dress and Clothing (NDCDC) formed a working group to tackle the problem of environmental clothing for tradesmen.

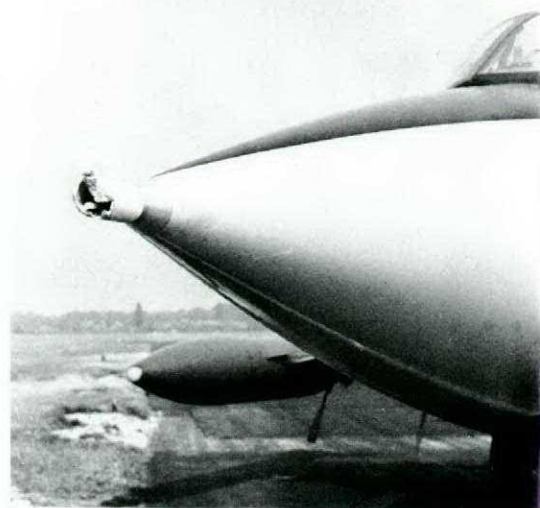
conditions and the driver did not reduce his speed in time to safely cross the bump.

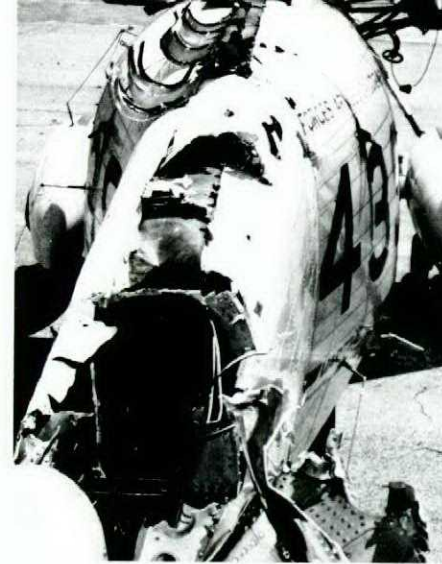
### SEA KING, TAIL CHOP

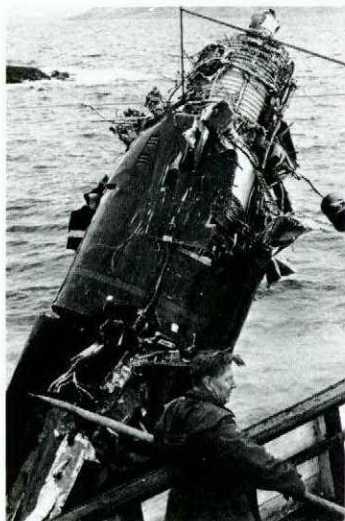
**CF 104, CRASHES INTO SEA** The detachment of five Starfighters was temporarily based at Bodo, Norway, conducting tactical and ACM training. Lead briefed a section of three for a mission which was to terminate with a tactical break and landing. The weather was excellent and the flight proceeded normally until the pilot in Number 2 experienced a momentary dizziness after an abrupt recovery from a manoeuvre. He checked his oxygen system and found it fully serviceable. He decided, however, to return to base, refusing lead's offer to accompany him.

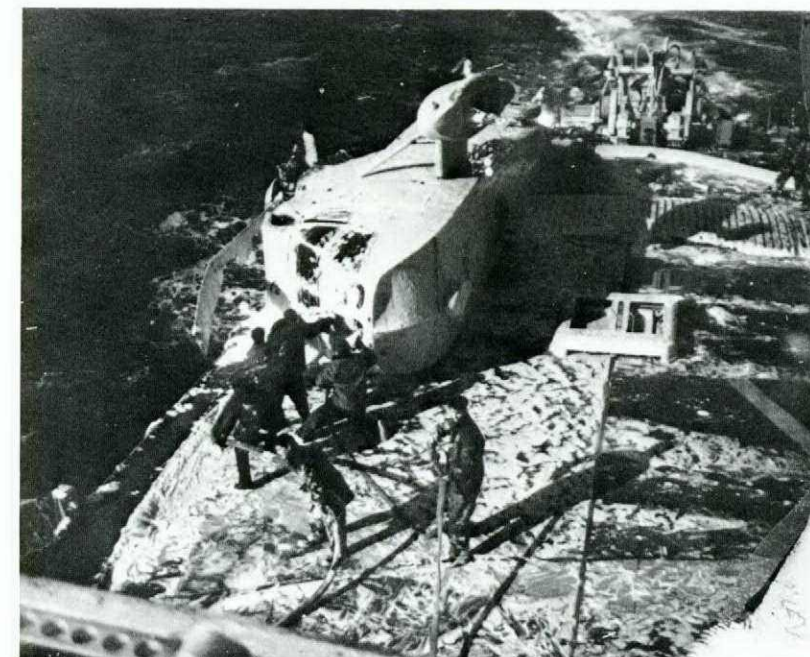
**SEA KING, ROLLOVER** After completing a mission which included a bell-mouth hauldown landing and a free deck landing on two other ships the Sea King returned to HMCS Fraser. Following the hauldown recovery in Fraser, the aircraft was trapped and disengagement procedure was commenced. The crew commander had just brought No 1 engine to ground idle when he heard a loud cracking sound aft of the cockpit. The helicopter then fell over on its right side as the starboard stub-wing separated from the fuselage. Both engines were secured and the rotor brake applied. The blades were turning, however, as the helicopter rolled. The disintegrating rotor wiped out the safety net and support stanchions. Flying debris also penetrated the hangar door. The crew escaped without injury through the port entrance door and the emergency escape window. The helicopter suffered "B" category damage.

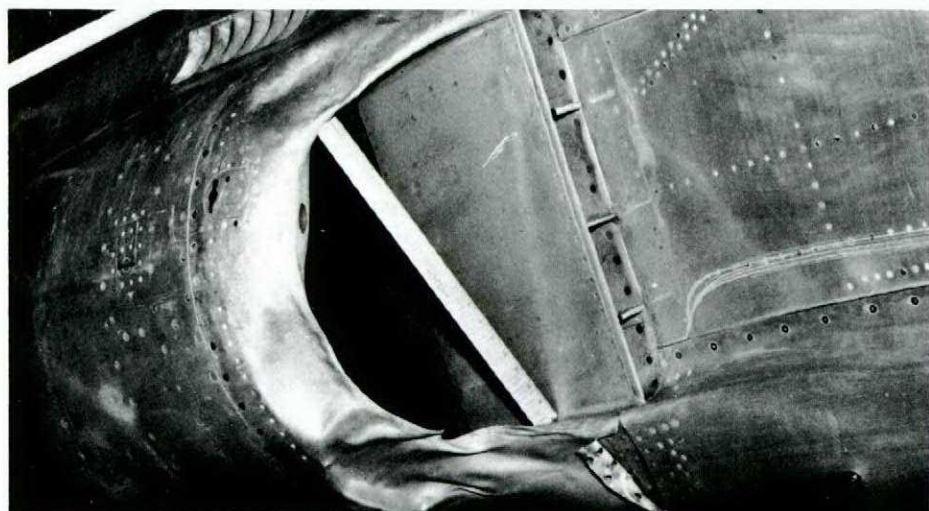
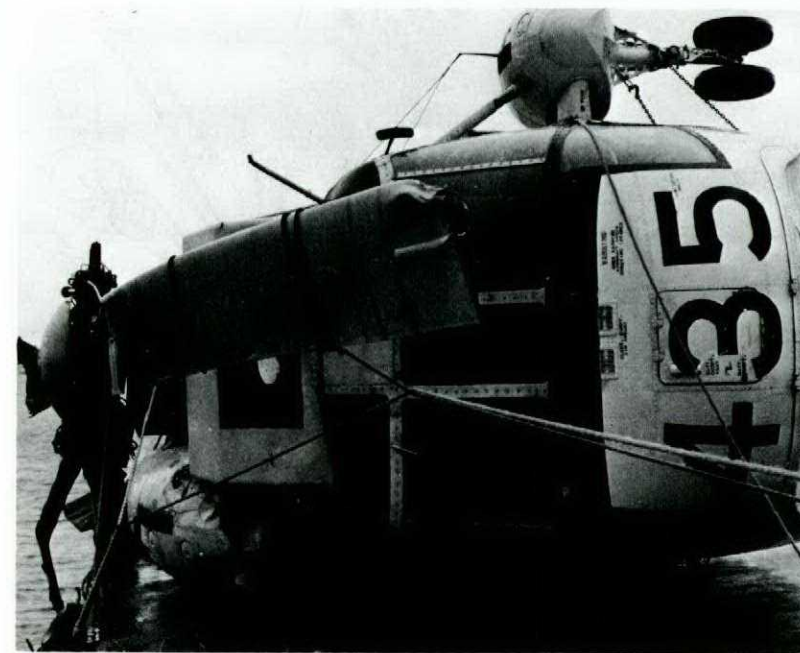
## Comments to the editor
