FLIGHT COMMENT

JANUARY FEBRUARY

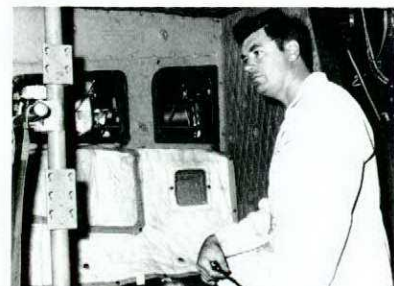
While carrying out an acceptance check on a CH118 aircraft, MCpl Gauthier removed a panel on the underside of the helicopter to inspect this area of the fuselage. With the panel removed, a section of the power lever control system was partially exposed. Although the acceptance check did not call for inspection of this section of the power lever control system, MCpl Gauthier thoroughly examined the bellcranks in this area. He found that three screws which secured a bellcrank mount had backed off approximately three turns. Further loosening of the screws during normal movement would probably have resulted in a disconnected power level control bellcrank mount with an accompanying loss of engine

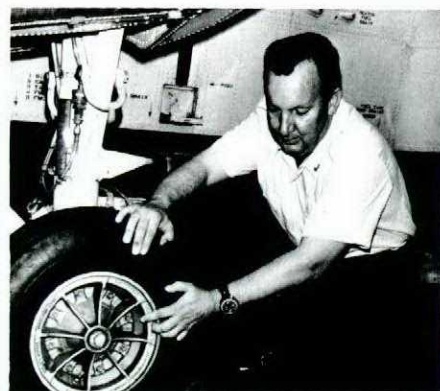
While removing the chocks from a Sea King at CFB Shearwater Cpl Rees noticed two sheared bolts in the helicopter's main wheel assembly and immediately advised his supervisor. Cpl Rees is a radar system technician and is therefore not normally responsible for landing gear inspection. His initiative and alertness in detecting this failure prevented a possible aircraft accident.

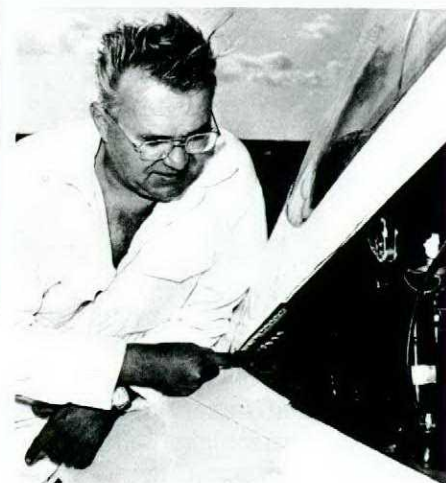
Cpl Patri has truly demonstrated a professional approach by detecting these problems on a routine inspection.

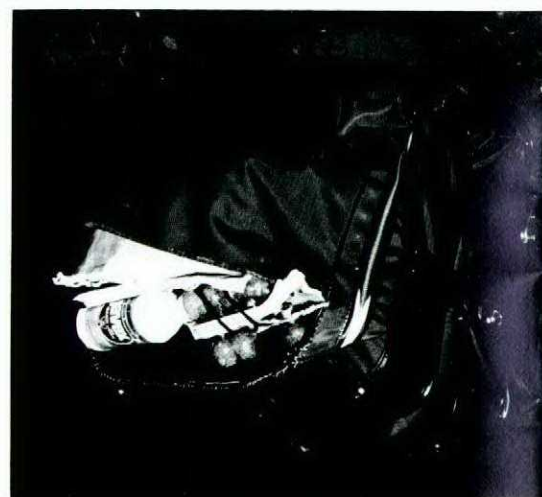
Pilot Factor Accidents

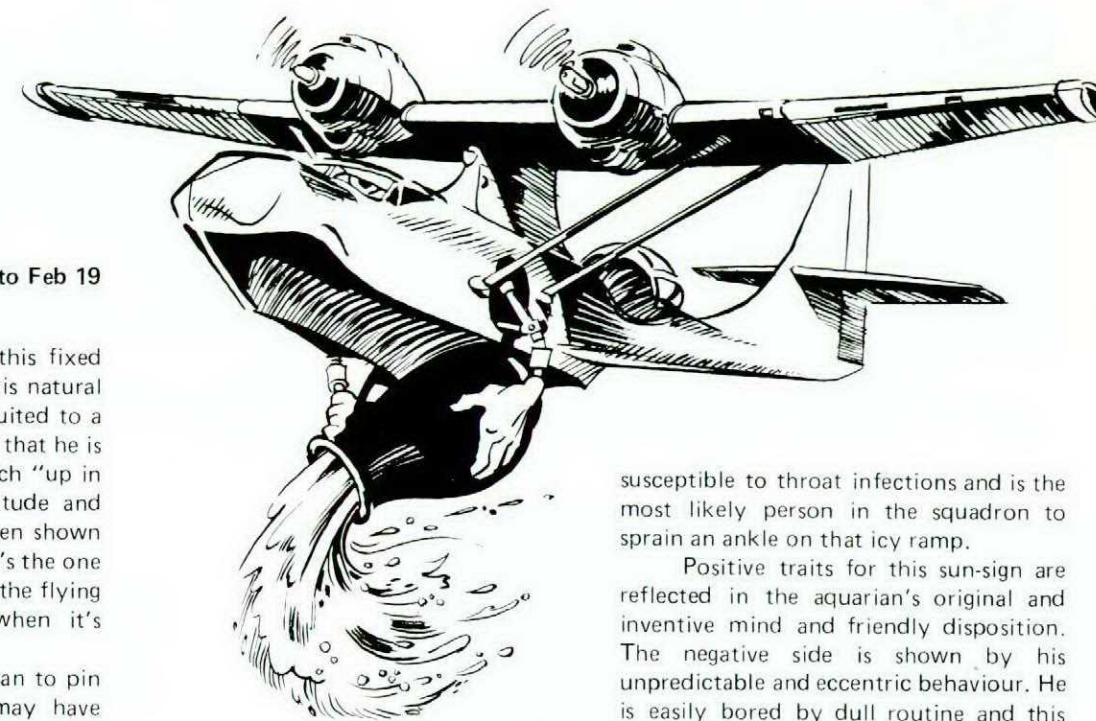
susceptible to throat infections and is the most likely person in the squadron to sprain an ankle on that icy ramp.

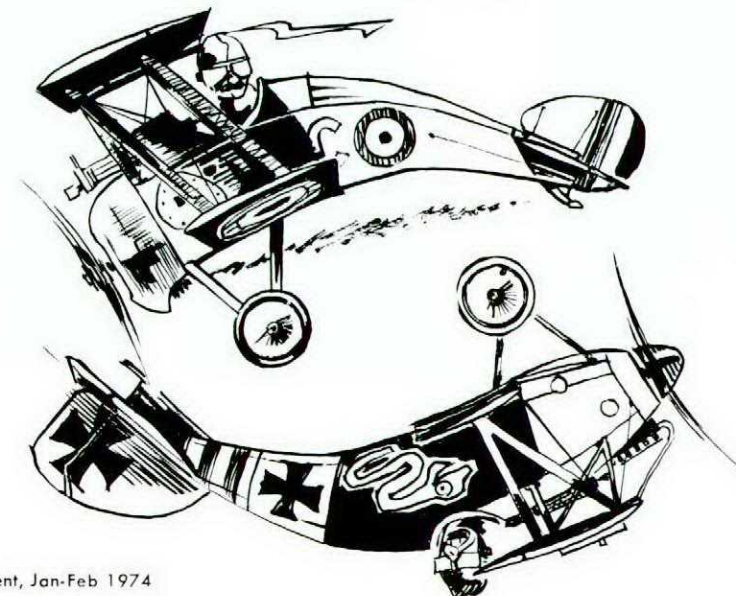
The symbol of the two fishes, joined together and pulling in reverse directions typifies the dual nature of the Piscean. His unworldly, artistic temperament sometimes shows up in a careless, indecisive attitude. He has difficulty conforming with discipline or routine and constantly seeks a changing scene. Yes, he's the guy who's always on TD. Look across the cockpit and you'll see him daydreaming, listening to music on the ADF instead of working out the groundspeed. If the Virgo influence is strong you can rely on his ability to organize and concentrate on details but the fish needs a definite challenge - he must swim upstream. He is naturally attracted to liquid and should feel at home in naval aviation but other, stronger fluids, hold a fatal fascination for him. The thirsty Pisces pilot should keep a careful watch on his natural inclination to excess.

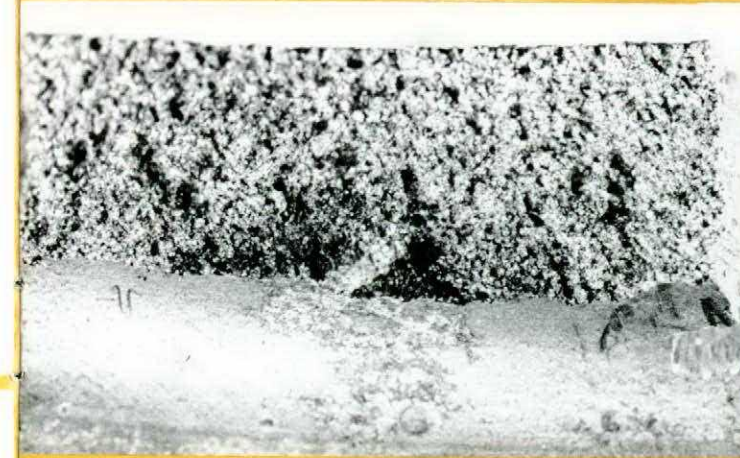
Photo 1
The granular appearance typical of stress corrosion in a cast aluminum alloy at low magnification.

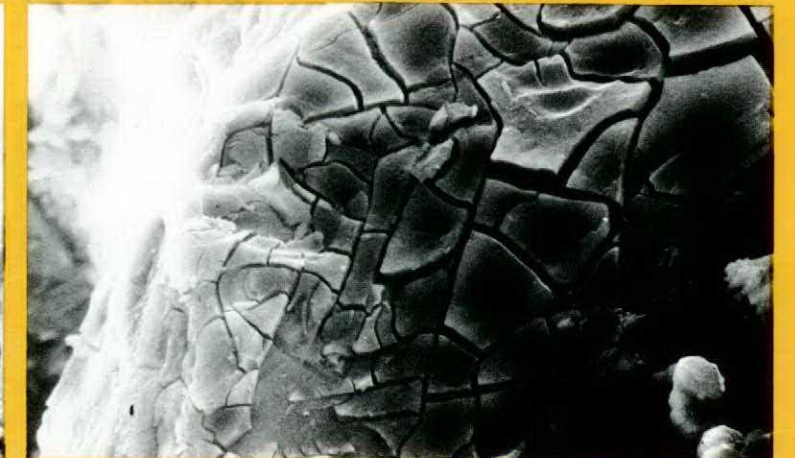
Photo 2
The "mud cracking" which characterises stress corrosion. Scanning Electron Microscope Fractograph at 2000X magnification.

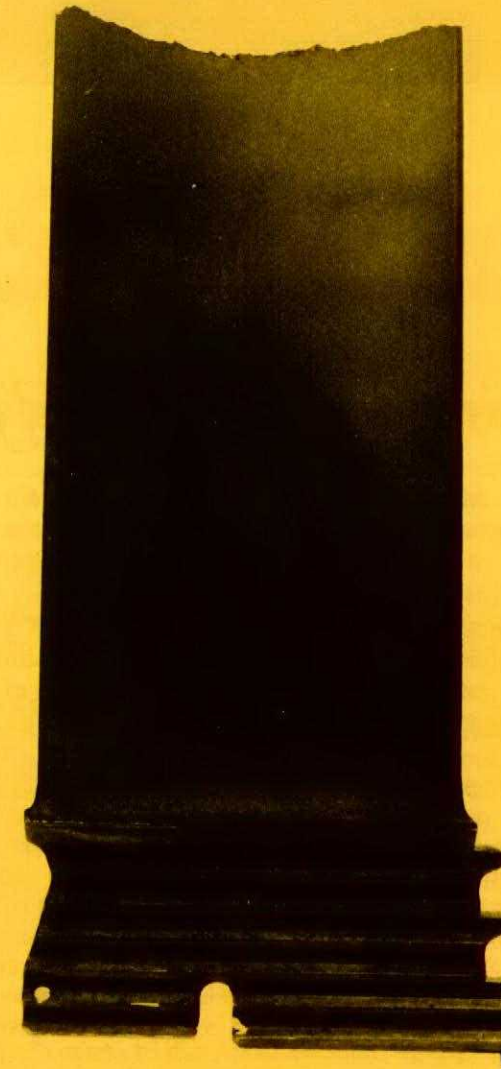
Photo 4
A turbine blade that has failed in "creep".

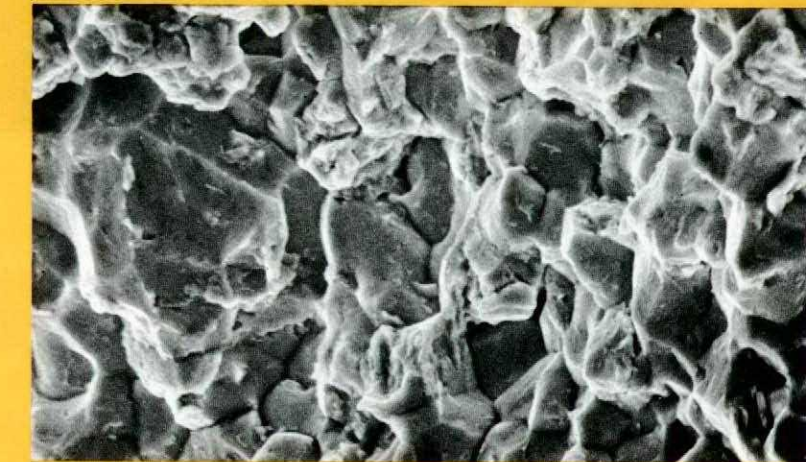
Photo 3
Scanning Electron Microscope view of the fracture face of a failure caused by hydrogen embrittlement; 2000X magnification. Intergranular cracking is visible.

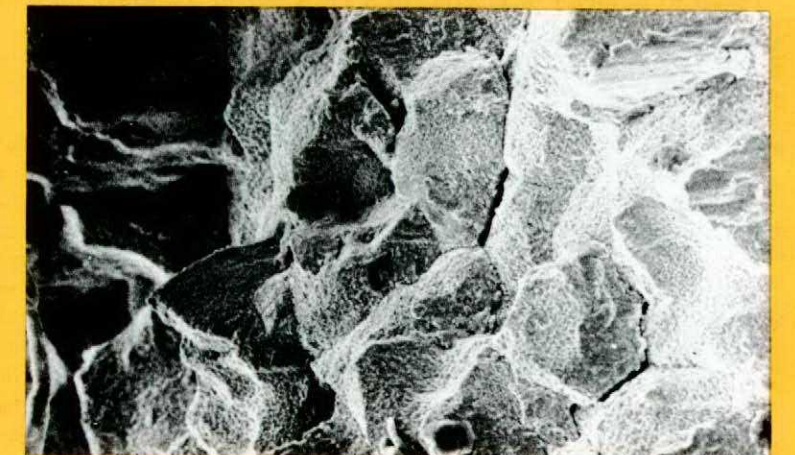
Photo 5
Scanning Electron Microscope view of the fracture face of the failed turbine blade at 250X magnification. The generally block-like appearance of the fracture is apparent as well as the dimples characteristic of ductile failure on the surfaces of the grains.

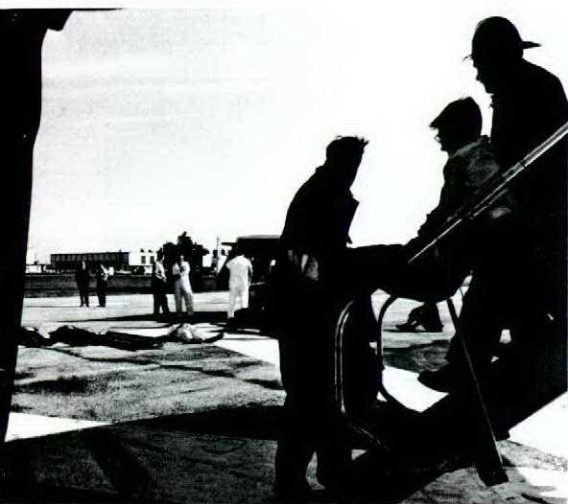
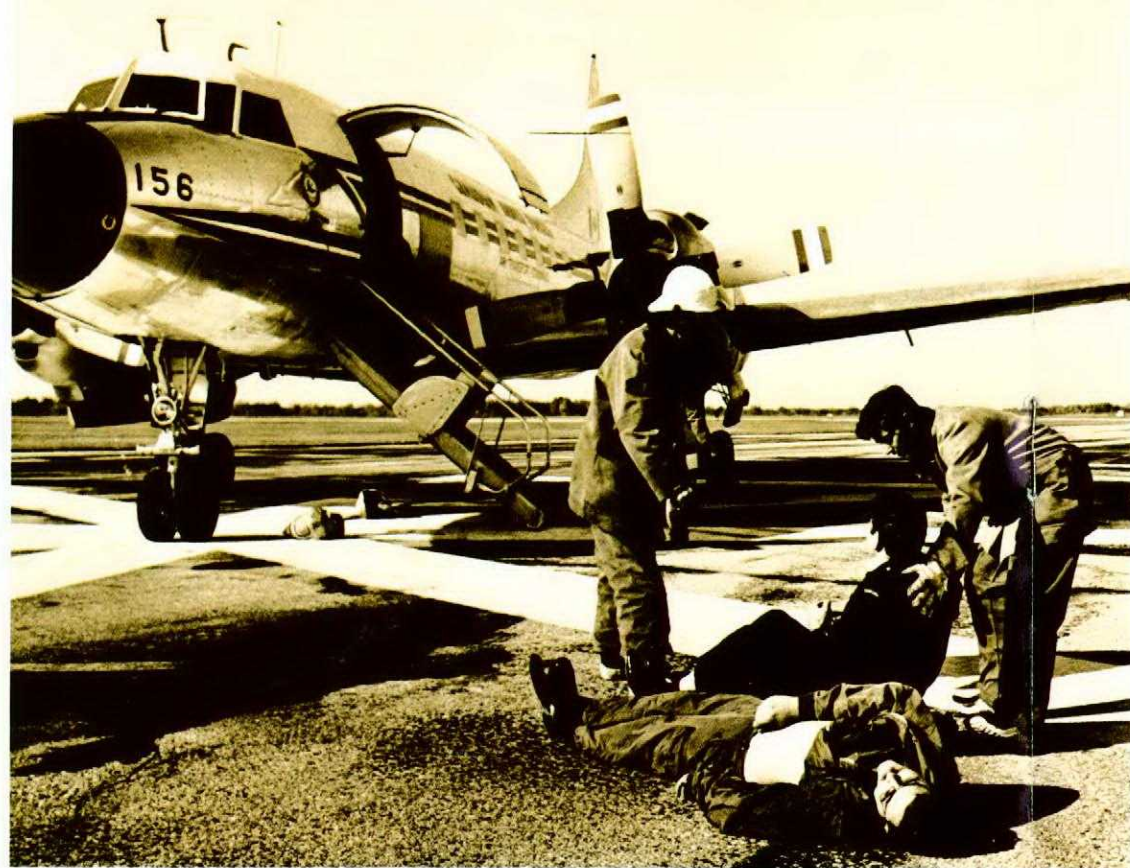
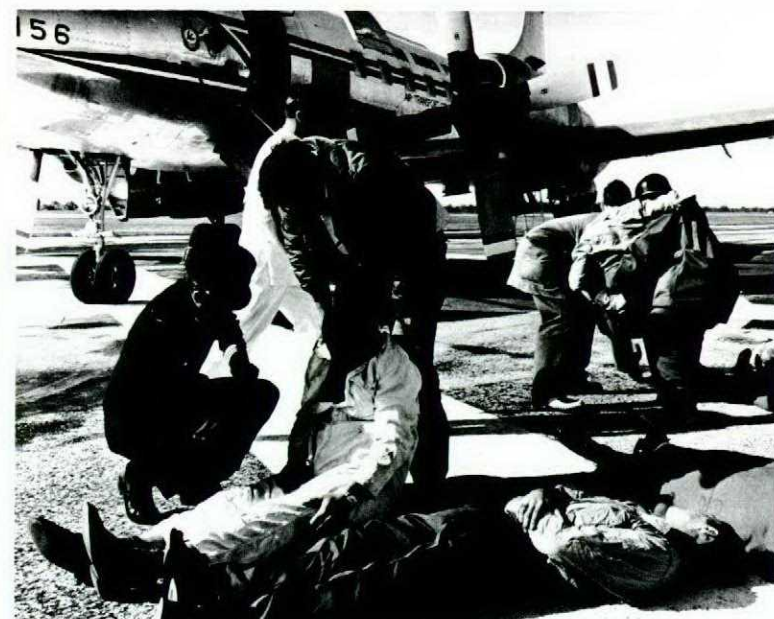
Photos by CFB Ottawa(S) Photo Unit

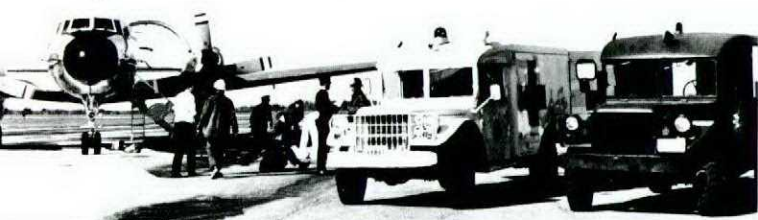
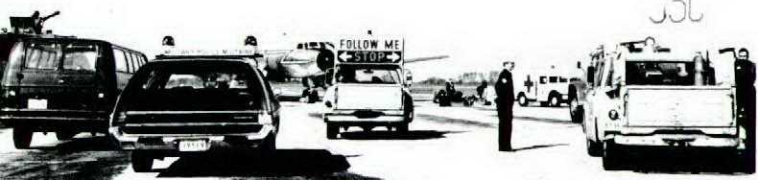
“Saguenay 51, what’s on your mind”?

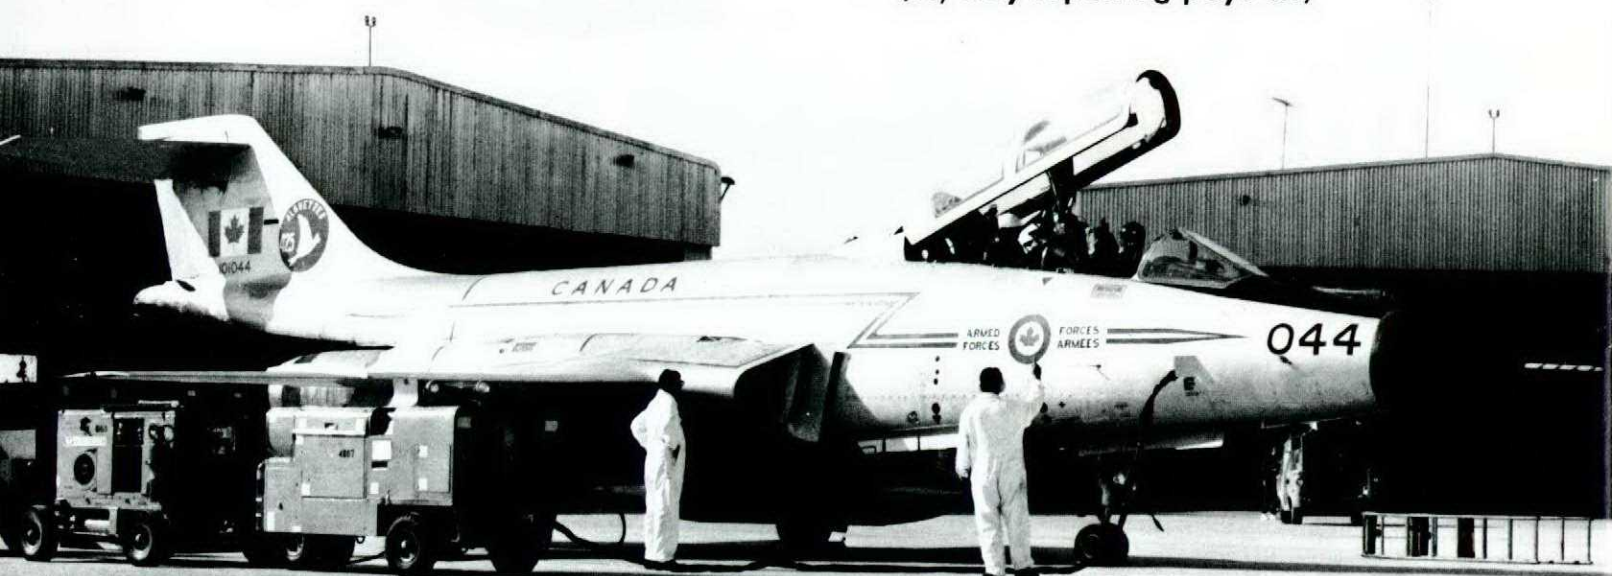
The main attitude indicator on a CF101 toppled during the start sequence and would not erect. The instrument was removed from the aircraft, bench tested, found serviceable and reinstalled. The displacement gyro was also serviceable but the rate switching gyro failed its bench test. A serviceable rate switching gyro was installed and after a complete ground check the aircraft was returned to service and flew without any recurring malfunction.

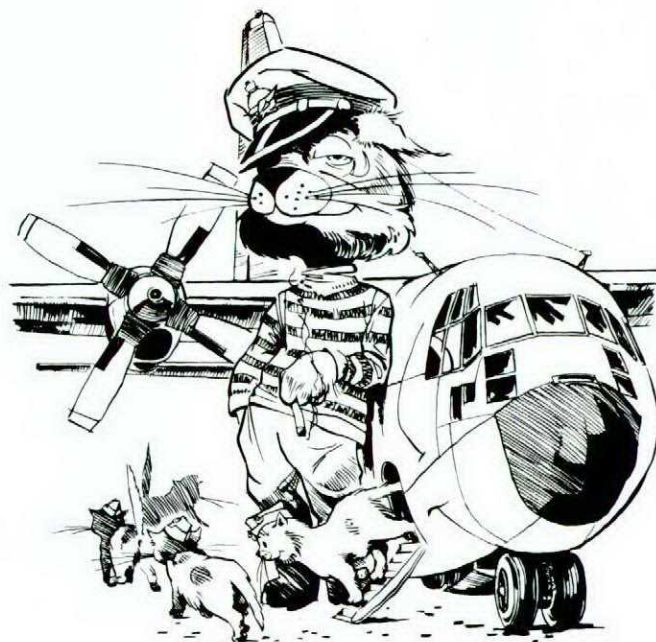
Cause: Feline promiscuity

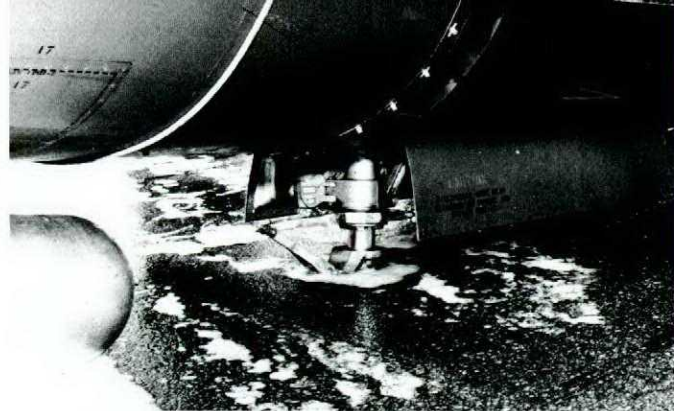
CF104, NOSE GEAR COLLAPSE The pilot completed a low level navigation mission and returned to home base for a radar fullstop landing approach. On landing the aircraft was seen to bounce into the air and subsequently porpoise down the runway. An abnormal landing attitude and heavy ground contact caused the nose wheel strut to collapse from overstress. The aircraft eventually settled on the bomb dispenser and forward fuselage. The drag chute was deployed and the aircraft brought to a stop on the runway. No fire or pilot injuries were experienced.

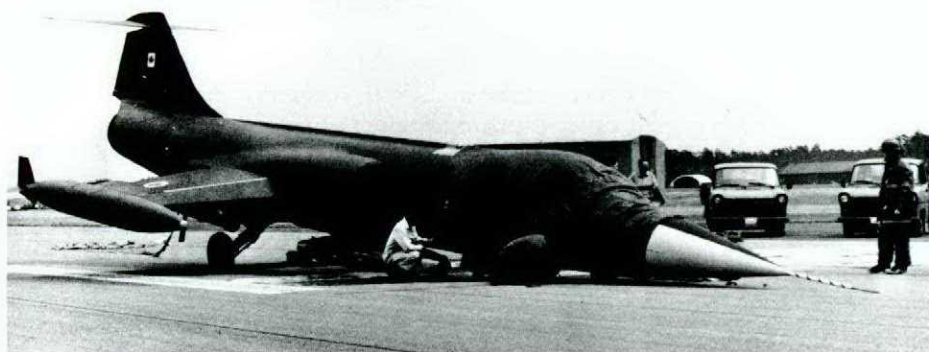
CH135, PRACTICE AUTO The CH135 returned to base for circuits and practice autorotations. A standard approach was carried out to a five foot hover. The aircraft was then climbed to 1000 ft AGL and following normal cockpit checks, the pilot initiated an autorotation.

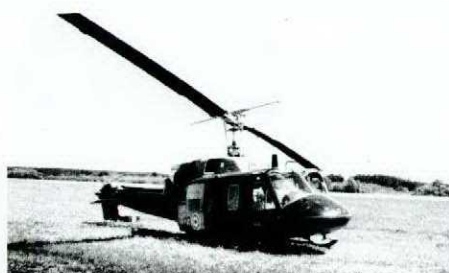
The autorotation appeared normal until power was applied for recovery at approximately 100 ft AGL. The crewman later reported that at this point he heard an abnormal high frequency buzzing: The pilot did not notice the normal requirement for left pedal to counteract the increase in torque. The low rotor RPM warning tone sounded at 92% and

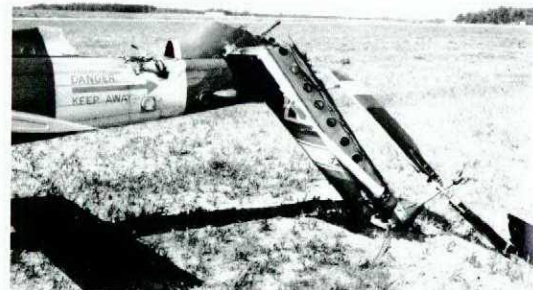
Intensive investigation revealed no evidence of engine unserviceability and mechanical malfunction was not a factor in the accident.

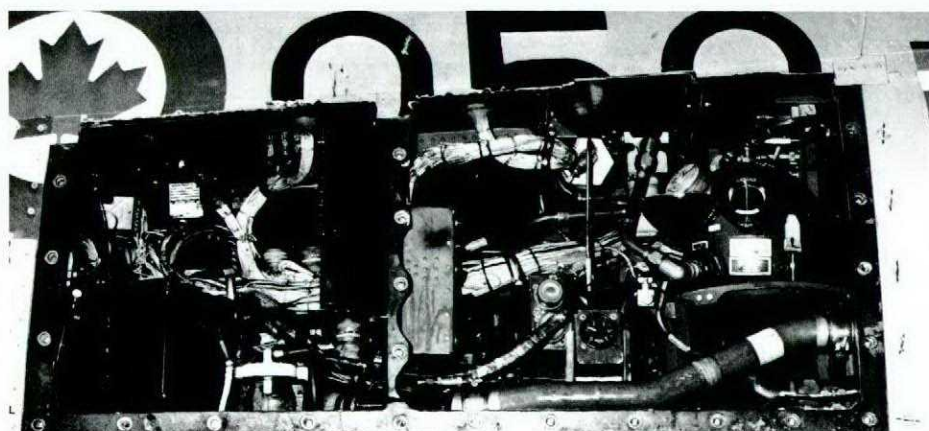
The aircraft, however, was fitted with external fuel tanks, so the snag crew technician went for supper while defuelling and tank removal was taking place. No CF349 entry was made to indicate that the panel was opened to check the circuit breaker.

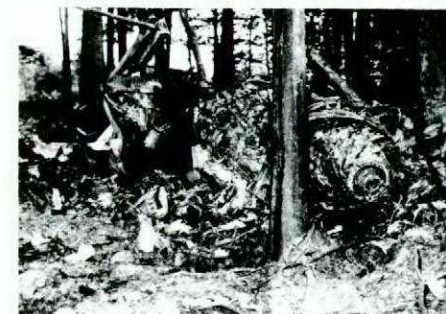
CF104, WRONG TARGET The mission profile called for a low level navigation route to a manned equivalent target followed by a simulated attack on a manned tactical target, then to a bombing range for live practice weapons deliveries.

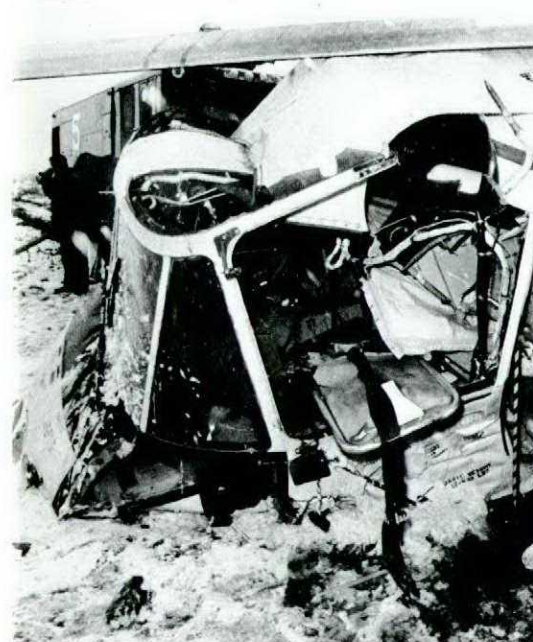
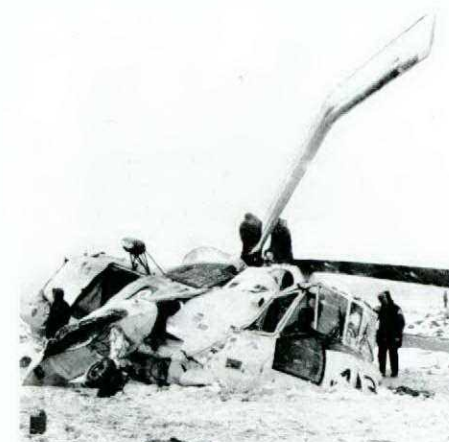
wind. "Tail rotor buzz" was encountered with 75% pedal input and a relative wind of 060 to 080 degrees (the reported surface wind at the time showed gusts of 25 to 34 mph). Right pedal was introduced in an effort to get out of the buzz but effectiveness was lost and the helicopter entered a series of uncontrollable pitch, yaw and roll motions. When it started to climb, the engines were secured and some measure of apparent control was regained. However, the rotor RPM was decaying with high blade coning angles. The aircraft plunged to earth making contact in a slightly left nose/wing down attitude. Although the co-pilot, in the right seat, was able to quickly free himself, the aircraft captain and the crewman were trapped in their seats. Fortunately there was no fire as it took rescuers 1½ hours to free the crewman.

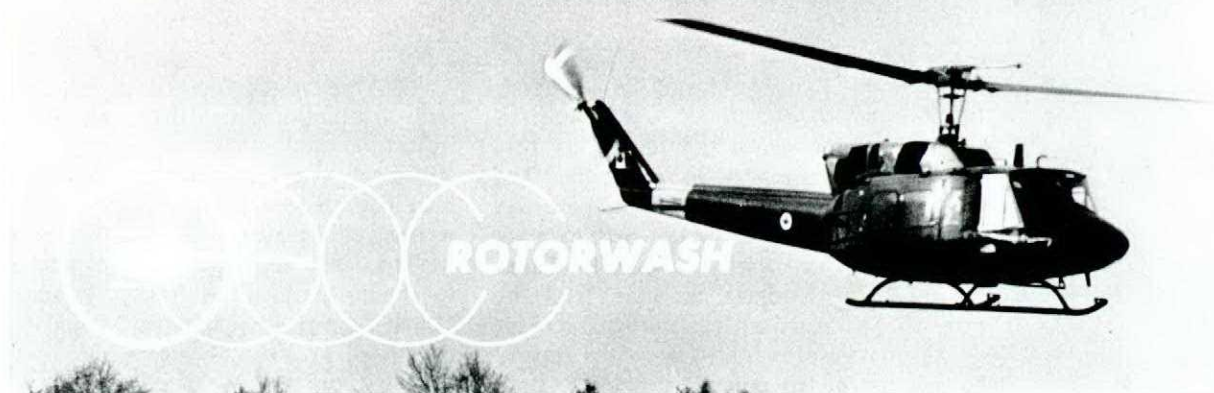
Practice Autorotations

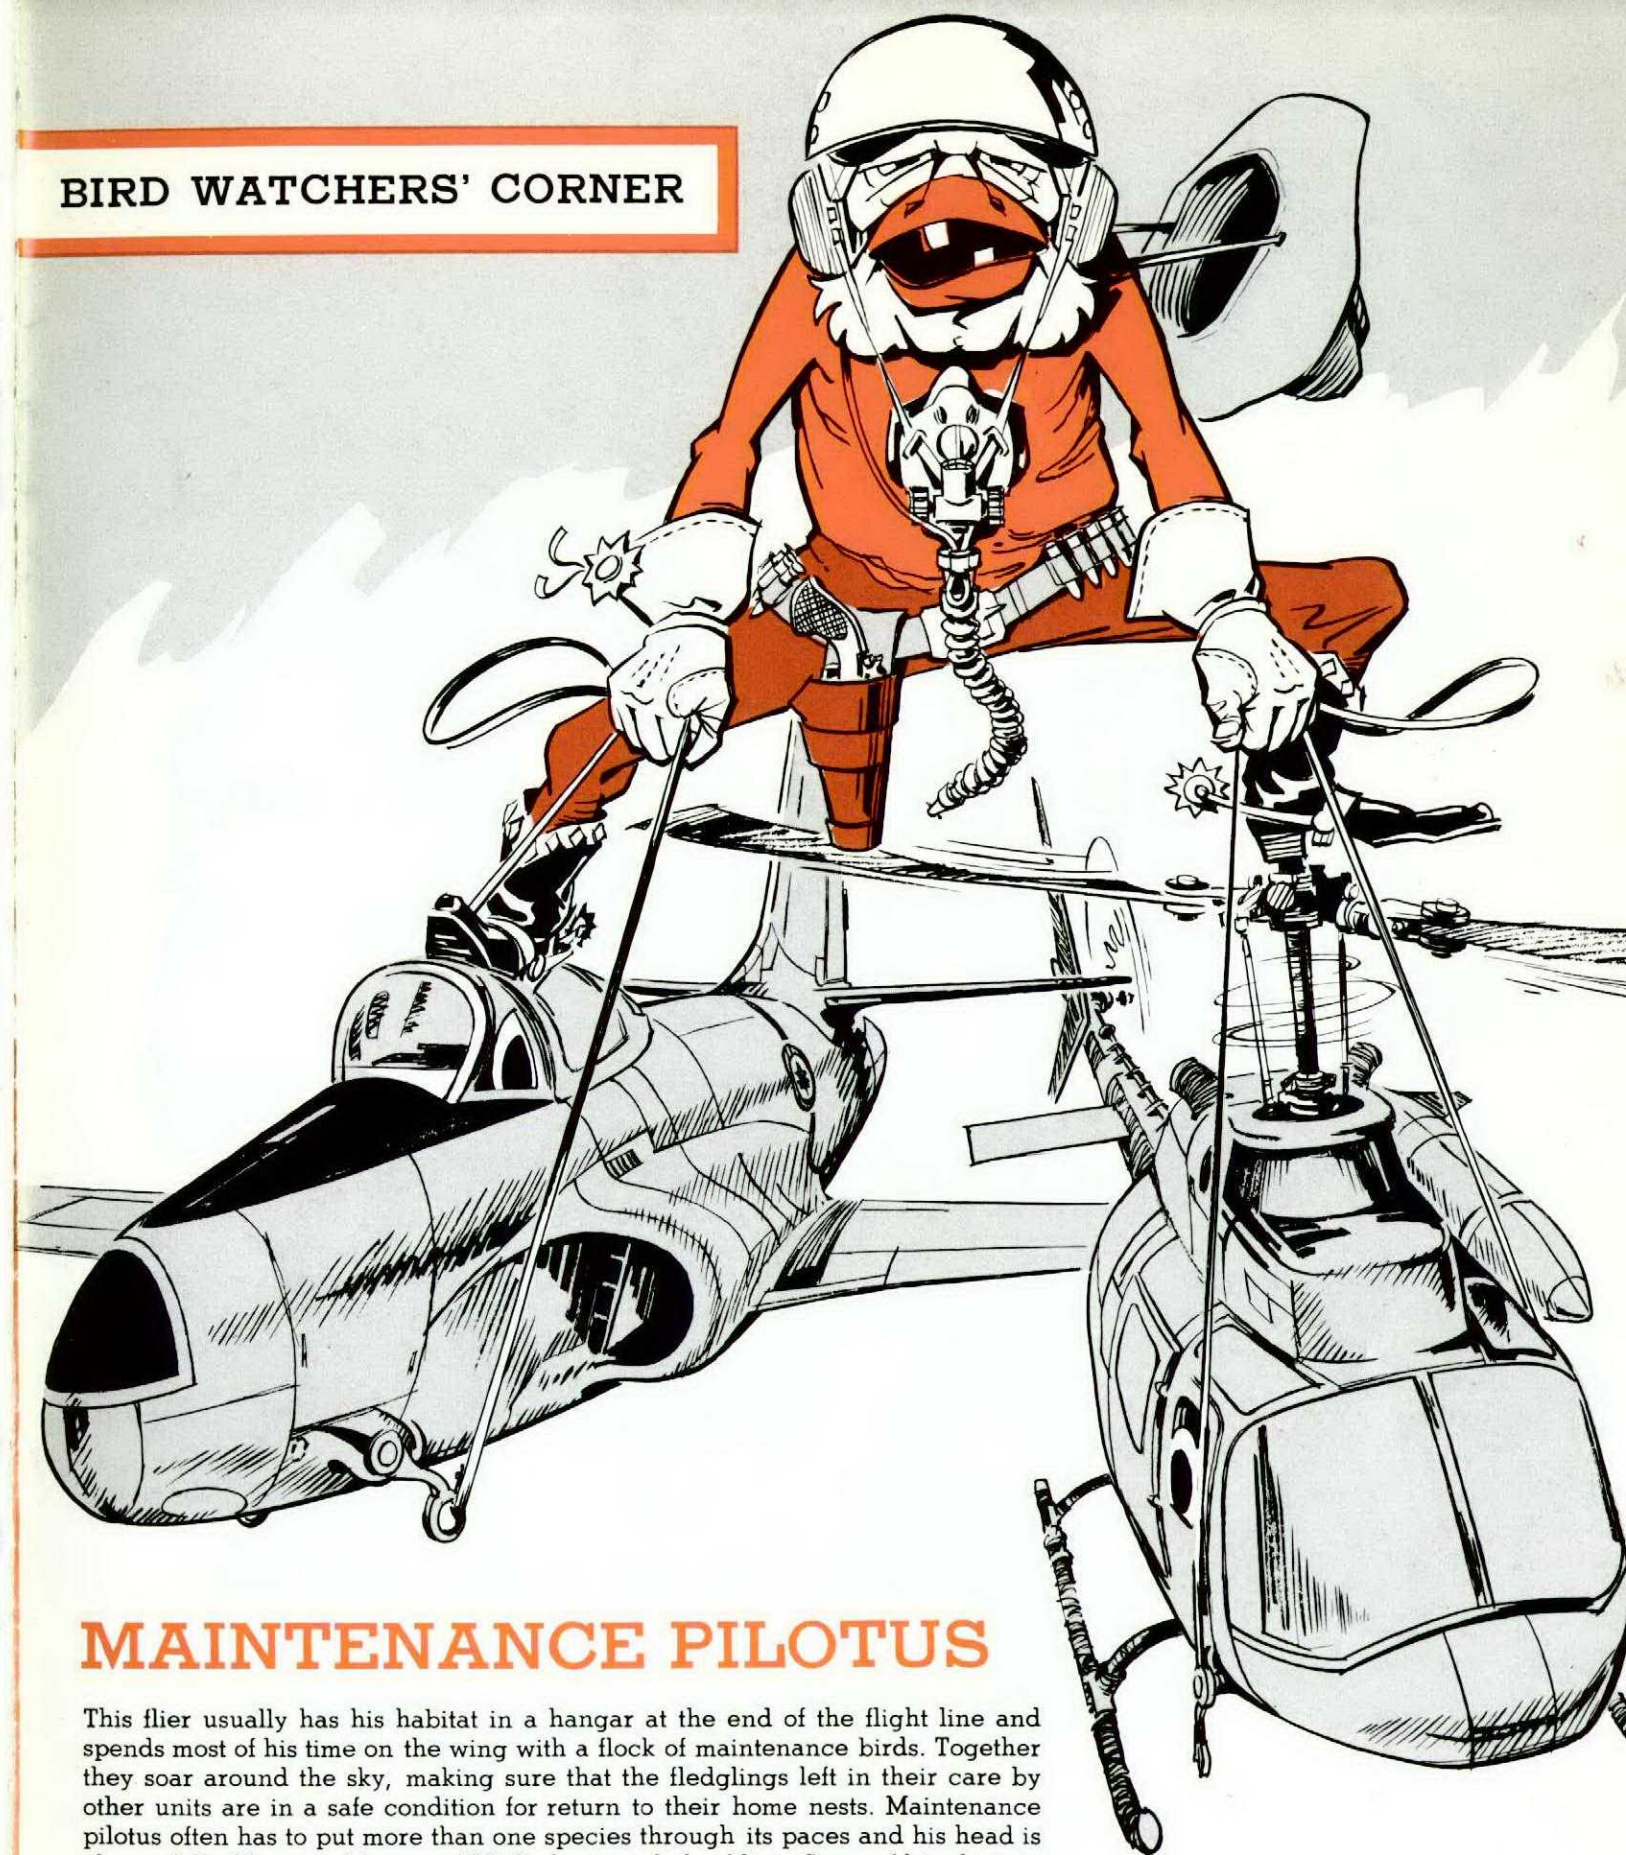
BIRD WATCHERS' CORNER
