Evaluation of Emerging Non-Destructive Inspection Techniques to Characterize Damage Beneath Polymeric Tiles on VICTORIA Class Submarine Hulls

James Owens Owens Aerospace Inc

Contract Report DRDC-RDDC-2014-C42 May 2014

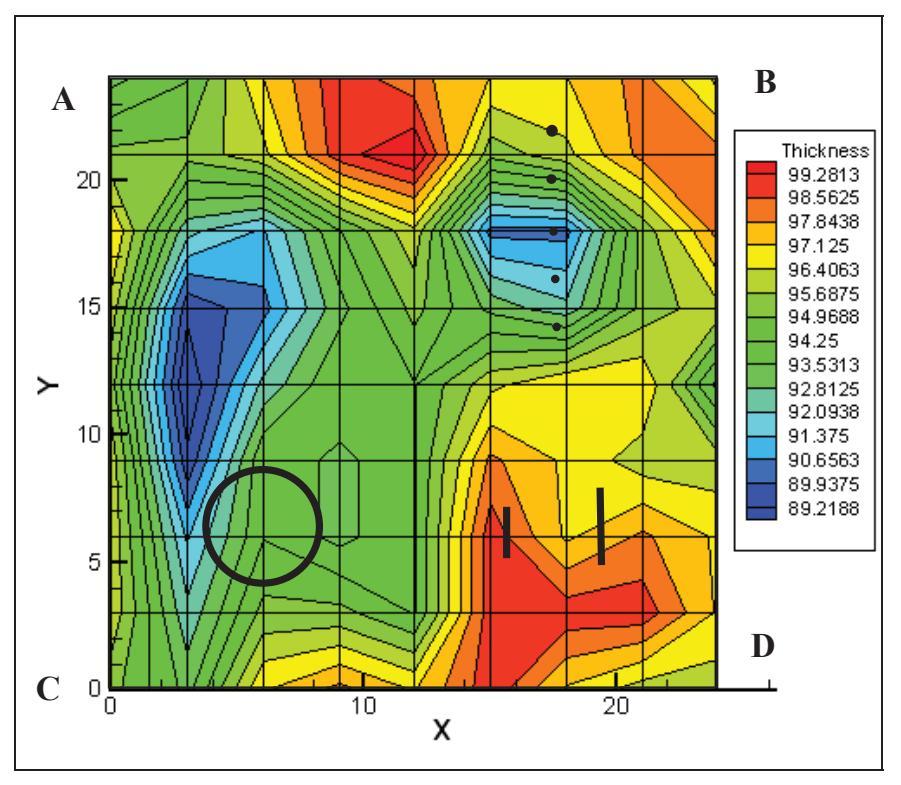
Figure 6: Plate 1 – Contour plot of % of Normalized plate thickness- Data set 1

In quadrant D it appears that there could be an indication of wall loss due to the two slots cut into the plate since there is a dramatic shift in the contour lines in their immediate vicinity. If in fact there is an indication, it is very gradual and not qualitatively comparable to those shown near the other defects. If in fact the tests are providing an indication for the slots and the drill-pits, they are not readily discernable on the plots. This may be due in part to the coarseness of the grid, but it is more likely due to the relatively large footprint of the probe which tends to provide an average indication of damage.

While there are significant defects close to the areas where the anomalies are observed, the anomalies appear to be somewhat offset from the actual damage areas. In addition the shape of the anomalies appears to be significantly different from those of the actual damage geometry. One observation which is somewhat odd is that the main anomaly region overlaps into quadrant A which is supposed to be defect free. In both of the contour plots for plate 1, there appears to be a significant drop in the contour lines as the edge of the plate is approached. It is suspected that this edge effect is due to either a shortened eddy current path due to the edge, or that there is significant heat damage due to a flame cutting or machining of the plate edge.

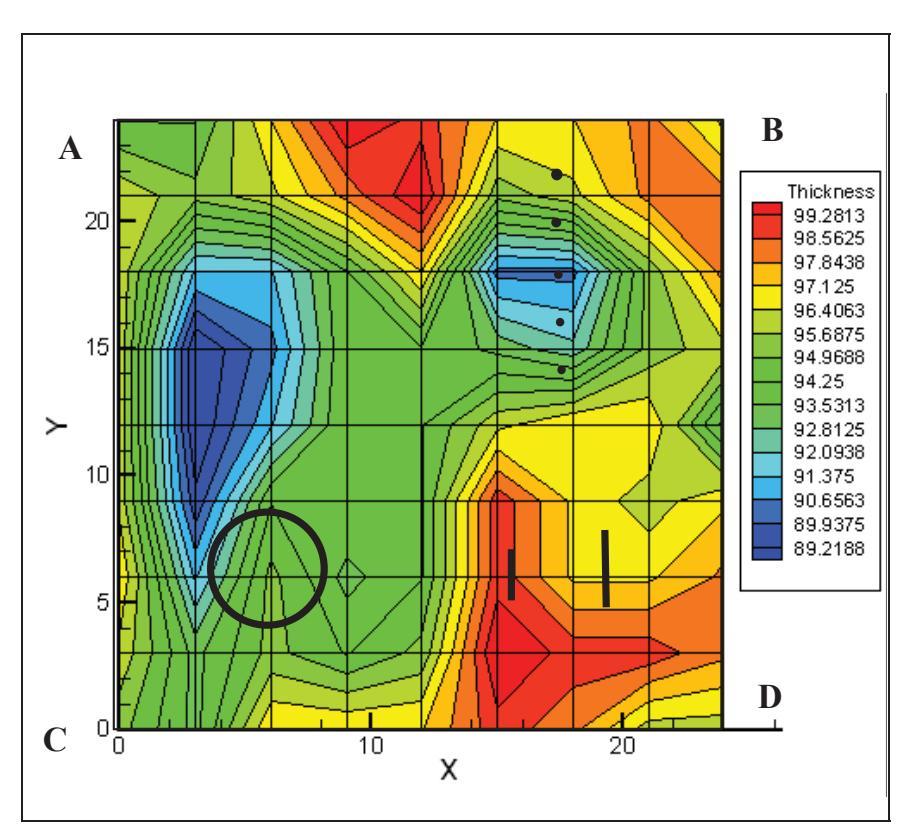
Figure 7: Plate 1 – Contour plot of % Normalized plate thickness- Data set 2

<u>Note:</u> lower Right Hand quadrant (D) was measured and normalized against a different reference value.

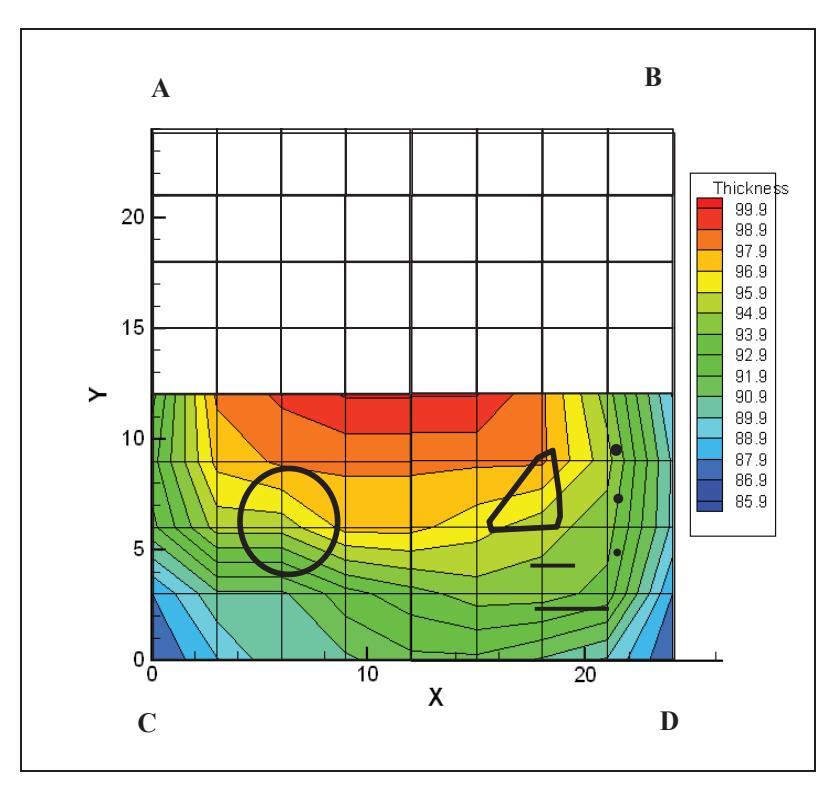
Figure 11: Plate 2 – Contour Plot % of Normalized plate thickness-Data set 1

The damage location in Plate 2 has been superimposed on Figures 11 and 12 to help determine if an actual damage location was detected. In these two figures, it can be seen that there are no sharp anomalies in the thickness contour plots. This may be due to the fact that the footprint is much larger in the unfocused mode which was used in these tests. Again it is interesting to note that the average wall loss indication in the area of the defects is approximately 10% which correlates well with the actual defect sizes.

It can be observed, that there is a more dramatic sharper drop off in the reported plate thickness in the lower left corner of quadrant C than in quadrant D. This is evidenced by the tight spacing between the contour lines in quadrant C as compared to the large spacing between those of quadrant D. This may indicate a correlation between the actual loss in plate volume which is more concentrated in quadrant C than in quadrant D. It can also be observed that like the contours for Plate 1, there is a pronounced edge effect indicated which may be due to material edge or heat effects due to torch cutting

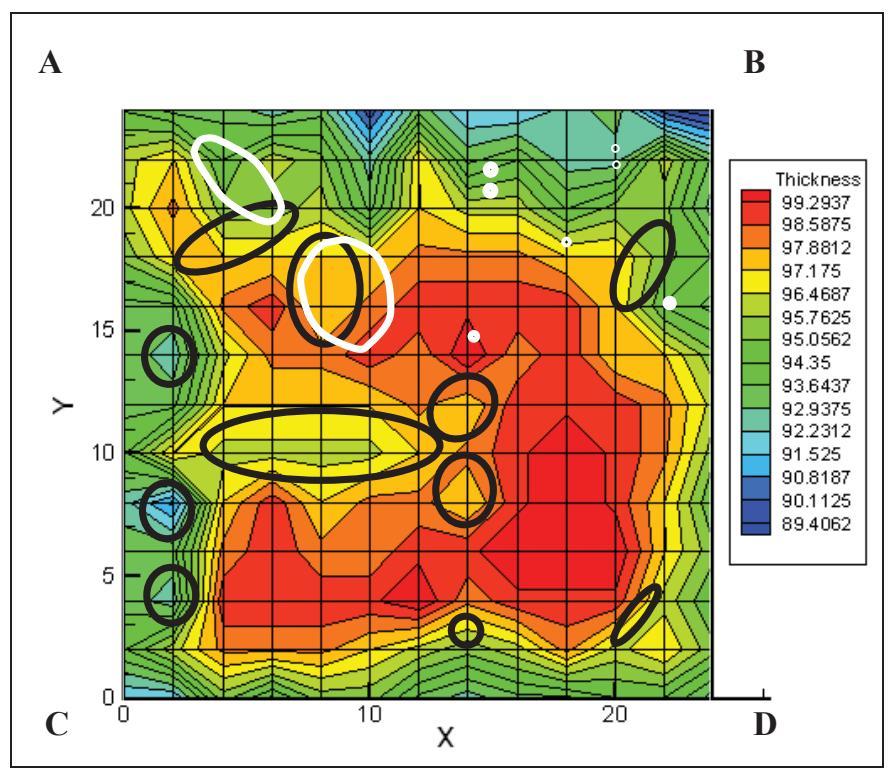
Figure 17: Plate 3 – Contour plot of % of Normalized plate thickness- Data set 1

As observed for Plate No.'s 1 and 2, there appears to be a significant drop in the contour lines as the edge of the plate is approached. Again, it is suspected that this edge effect is due to either a shortened eddy current path near the edges, and/or that it is due to significant heat damage caused by flame cutting or machining of the plate edges.

In Figures 17 and 18, the areas with black circles and ellipses are the areas identified as anomalies in the contour plots. The white circles and ellipses are the outlines of the actual simulated damage in the test plates. Two or three of the anomalies seem to coincide very closely with the actual damage locations. However, there are also 7 or 8 other areas of anomalies identified on the plates at locations where there isn't any damage on the plates.

There are therefore significant discrepancies between the anomalous areas in the contour plots generated with the INCO-Test data and the actual damage. These discrepancies may be an indication that the INCO test is very sensitive to something in the test panels other than basic wall thinning. According to the RTD Level 3 NDI specialist, the presence of machining in the surfaces can severely affect the magnetic permeability of the metal. This change in permeability is allegedly the reason why there are anomalies in the thickness readings.
