**EVALUATING TEST EQUIPMENT FOR
AIR TIGHTNESS OF CONSTRUCTION
DETAILS**

By Kevin Knight, Retro-Specs Ltd

PROJECT FILE # 6521-12-95

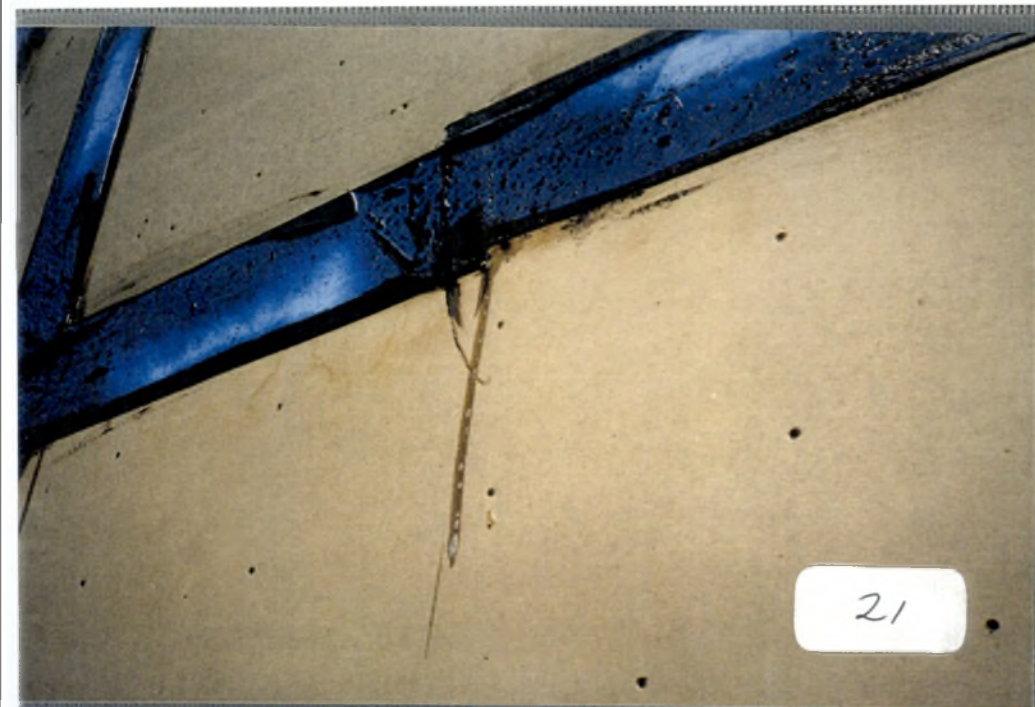
21

- 21) Torch-grade membrane installed at junction in drywall seam. Bond of membrane deficient and leak found at junction of membrane.
- 22-26) Details not testable with PACTS machine. Visual inspection adequate to determine deficiencies.

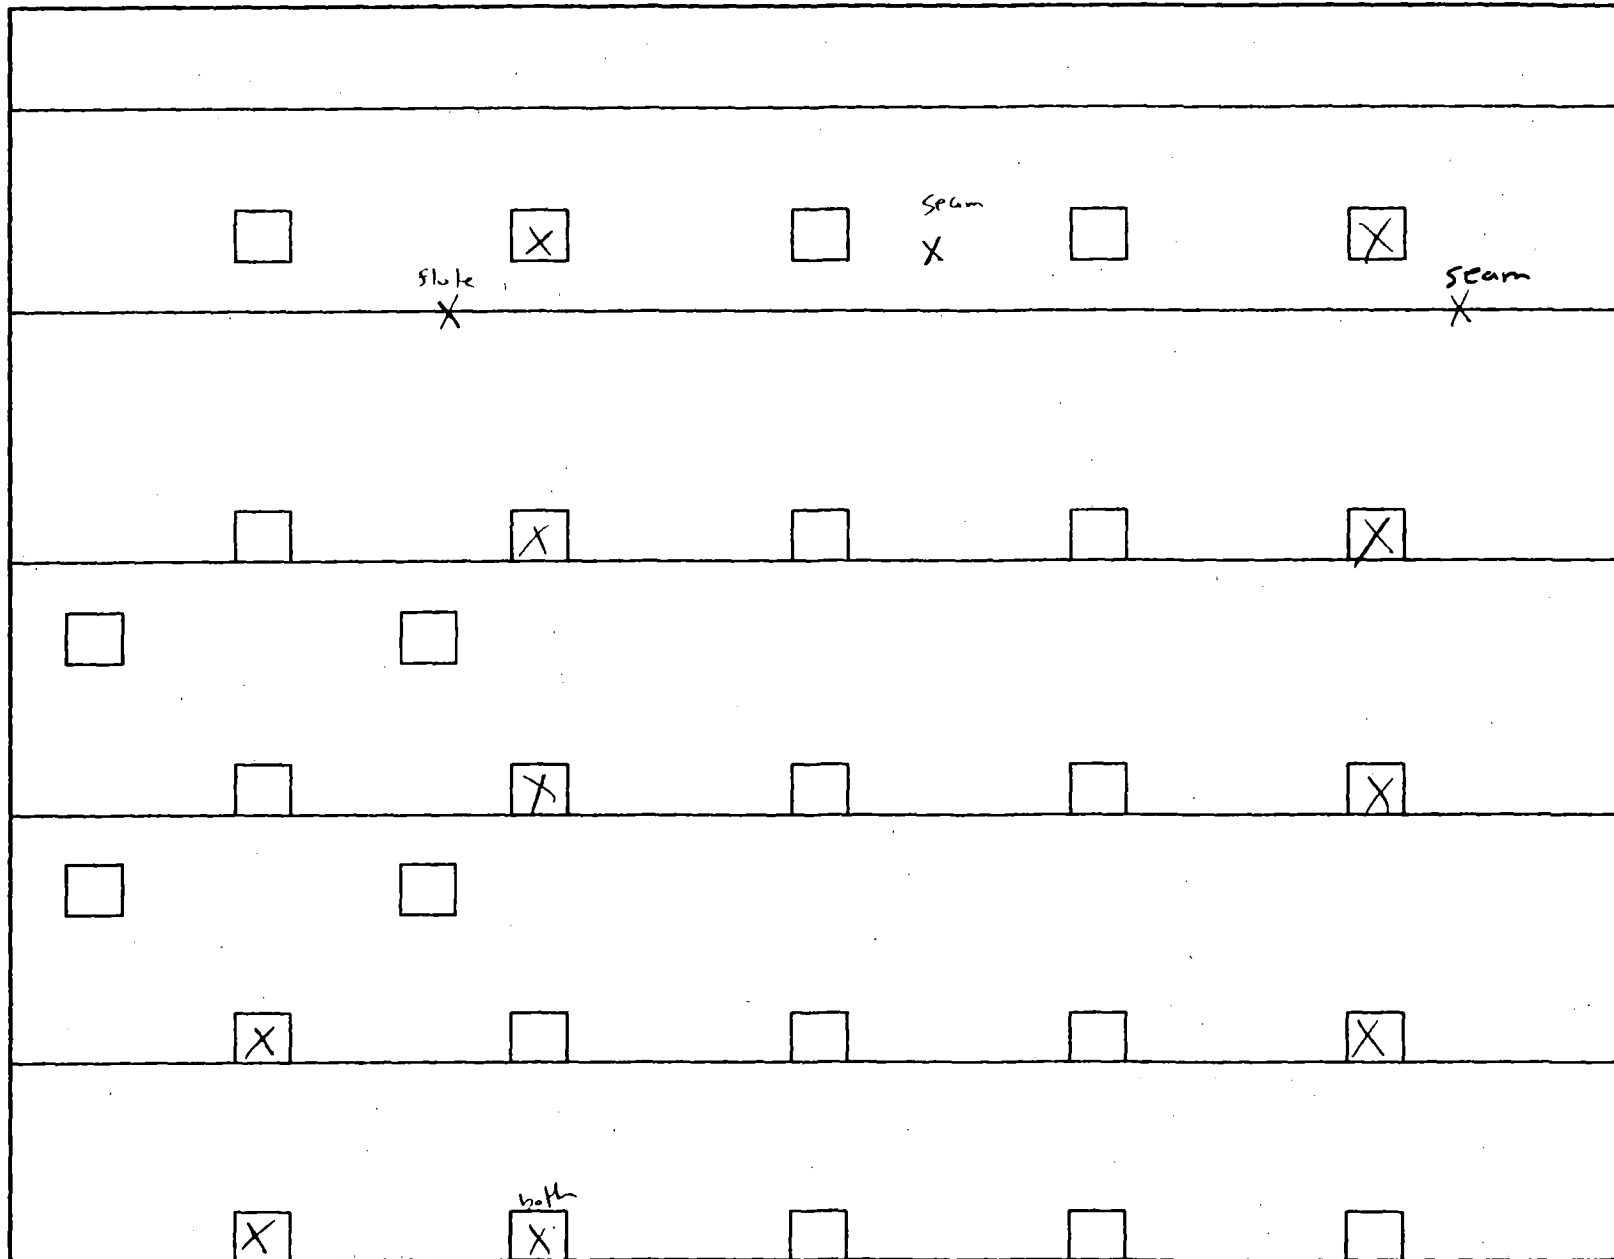
150 Pa

Figure #3 and Figure #4 show the results for the smoke test on the masonry test chamber at 0.6in of water (150Pa) and 4in of water (1000Pa) respectively. The leaks found are marked with an 'X'.

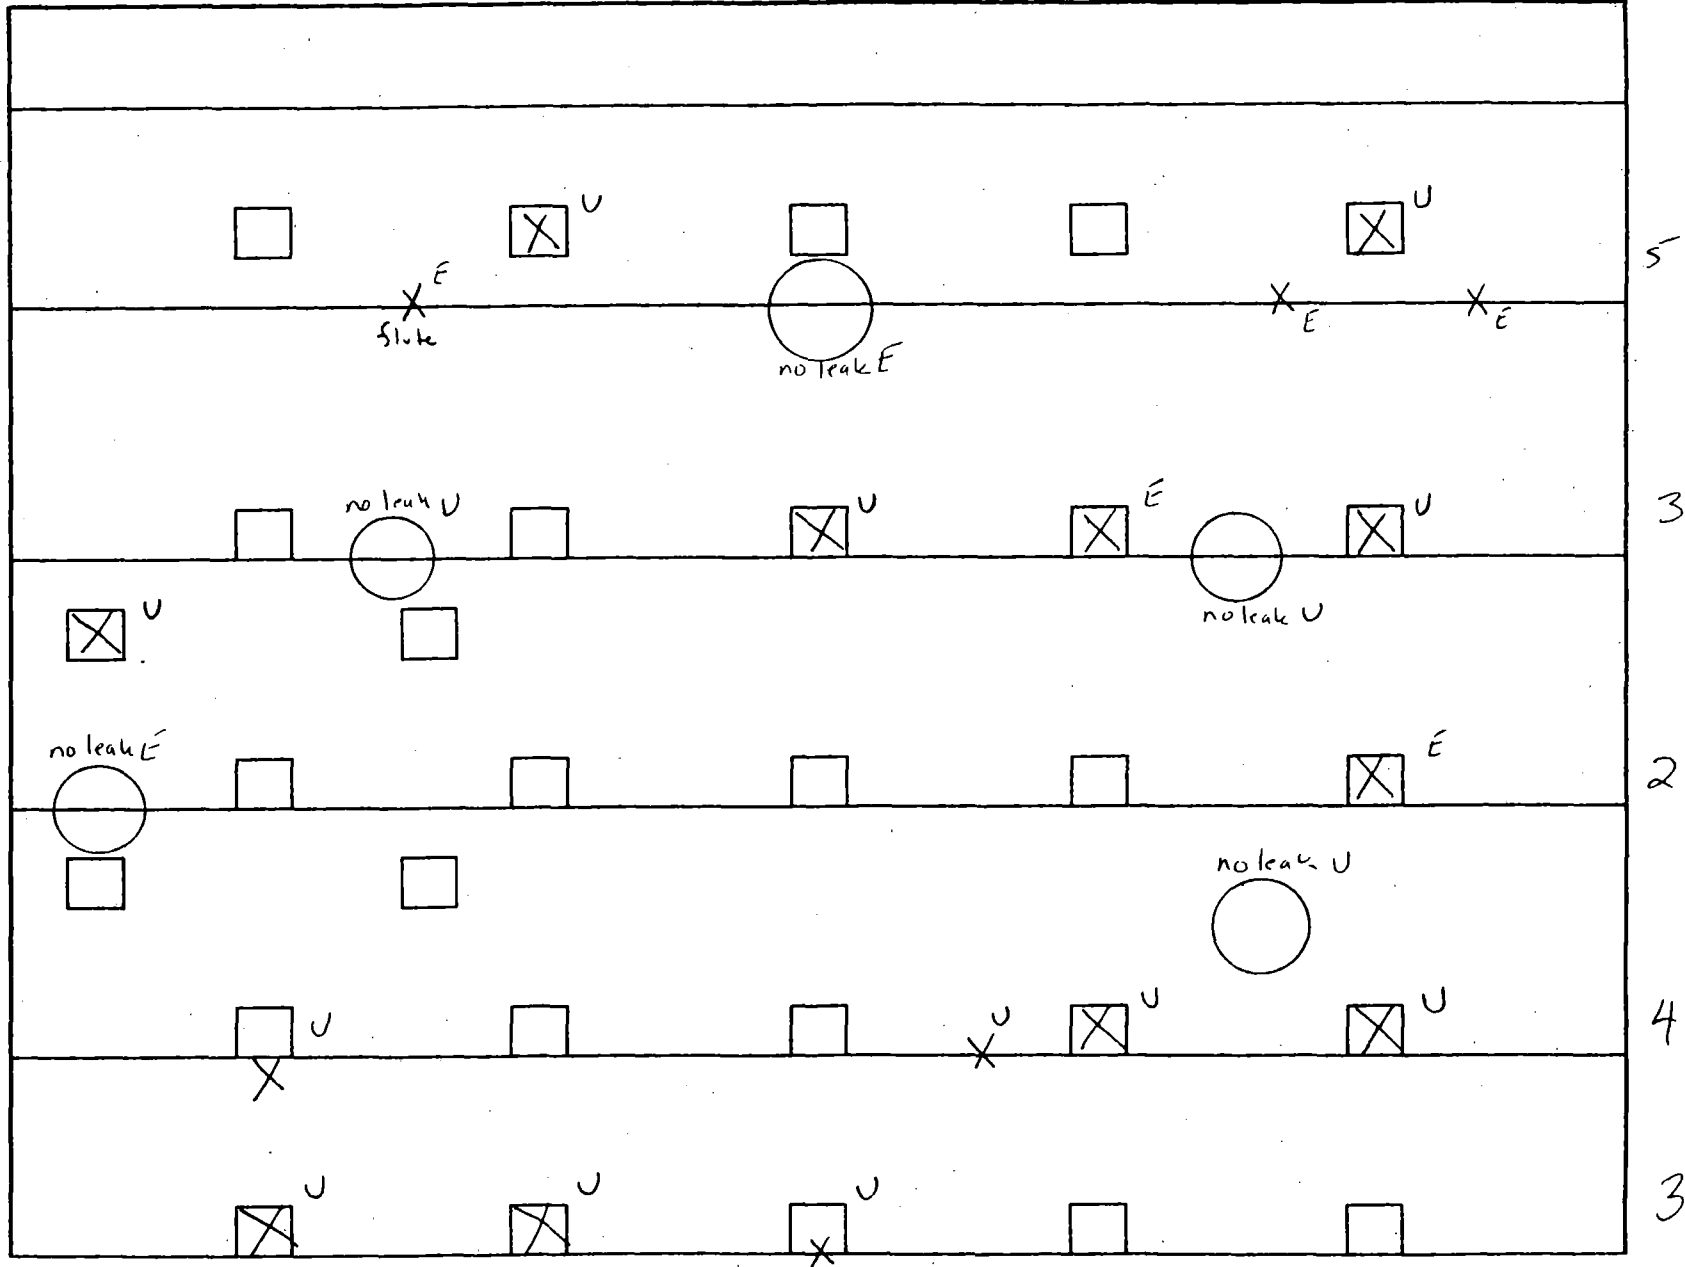
Figure #5 shows the leaks detected with the PACTS by the inspector. The pressure indicator light was set to switch on at 1.8in of water (460Pa). The circles mark areas which were tested and no leak was found. All ties, which are indicated by the squares, were tested by the inspector. The leaks marked with a 'U' indicate that the inspector thought it unlikely that detail would leak based solely on a visual inspection. The leaks marked with a 'E' indicated that the inspector expected that the detail would leak based on visual inspection..

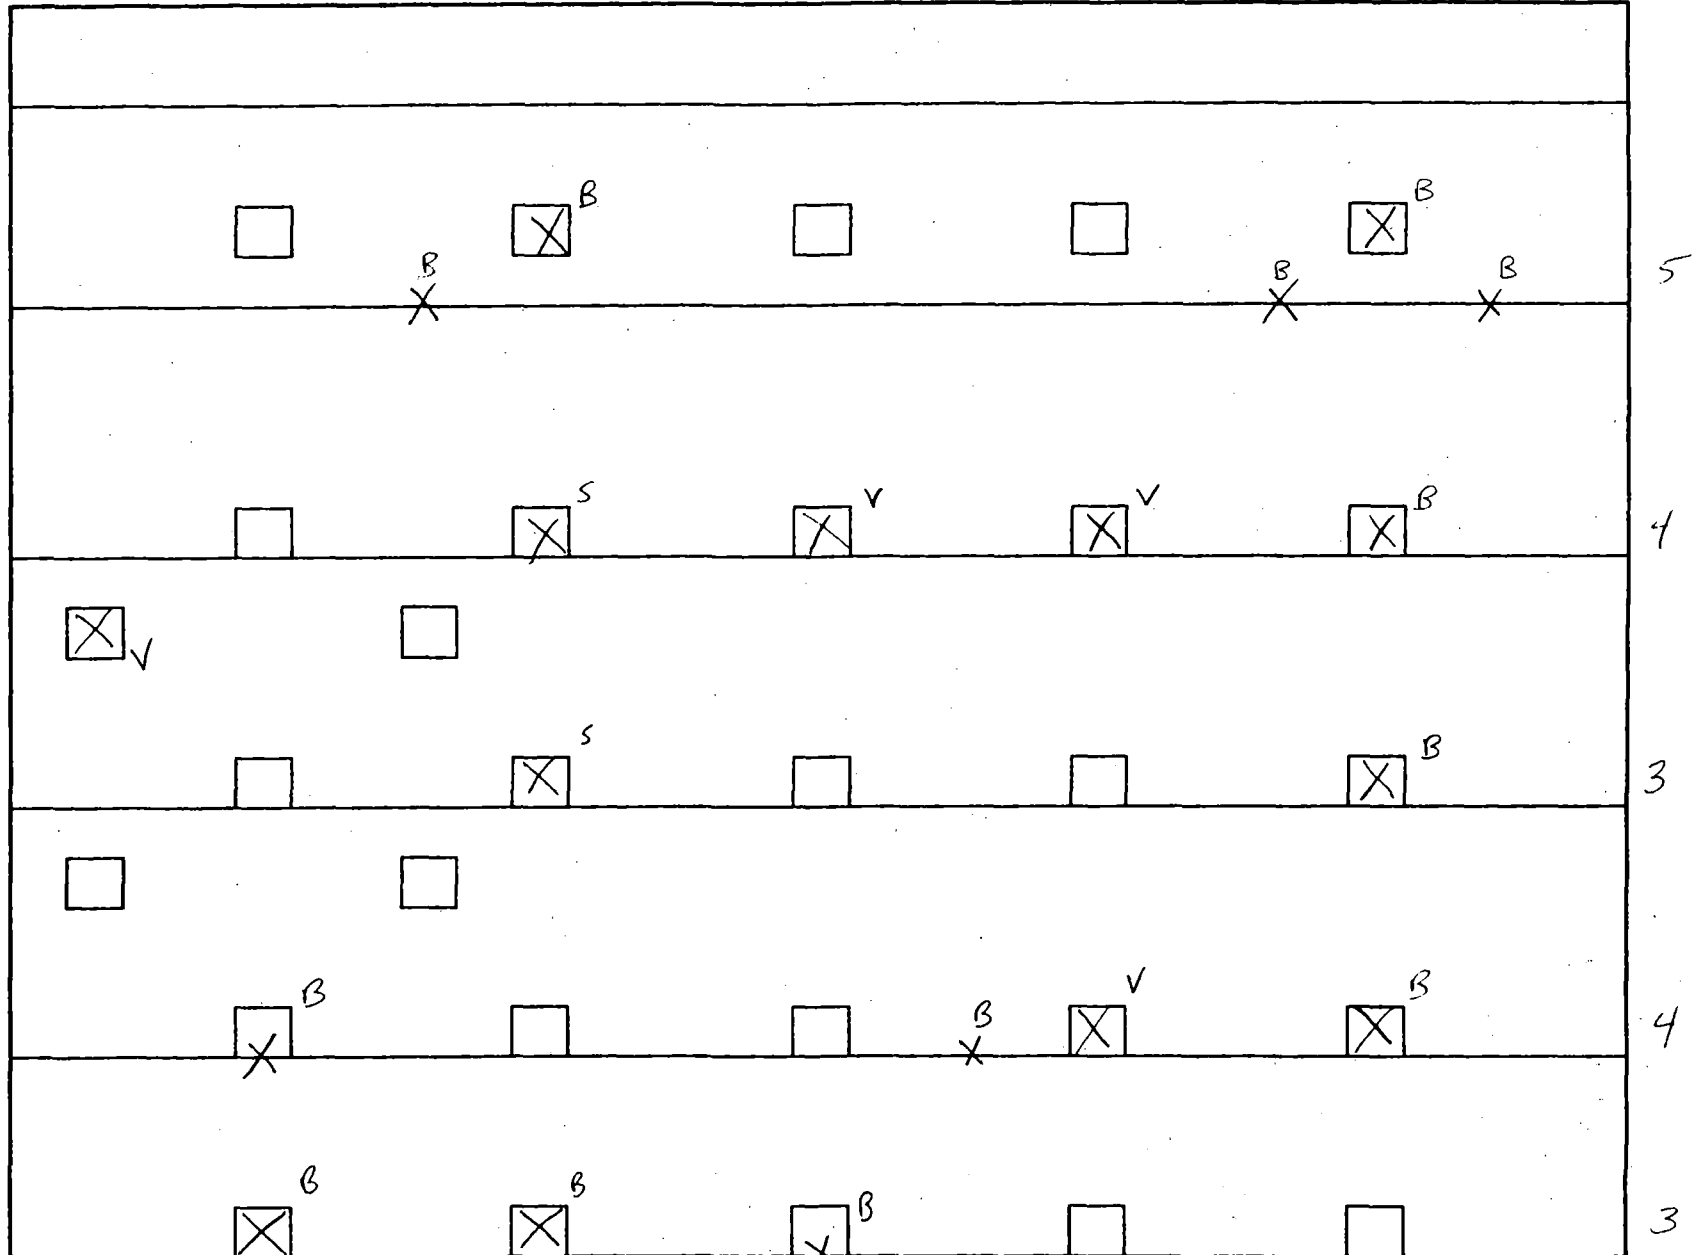
Total Leaks - Smoke & Vacts

Figure #6 show all leaks found by all three tests. The 'B' indicates the leak was found by both the smoke trace and the PACTS, the 'V' indicates the leak was found only by the PACTS device, and the 'S' indicates that the leak was found only by one or both of the smoke tests.

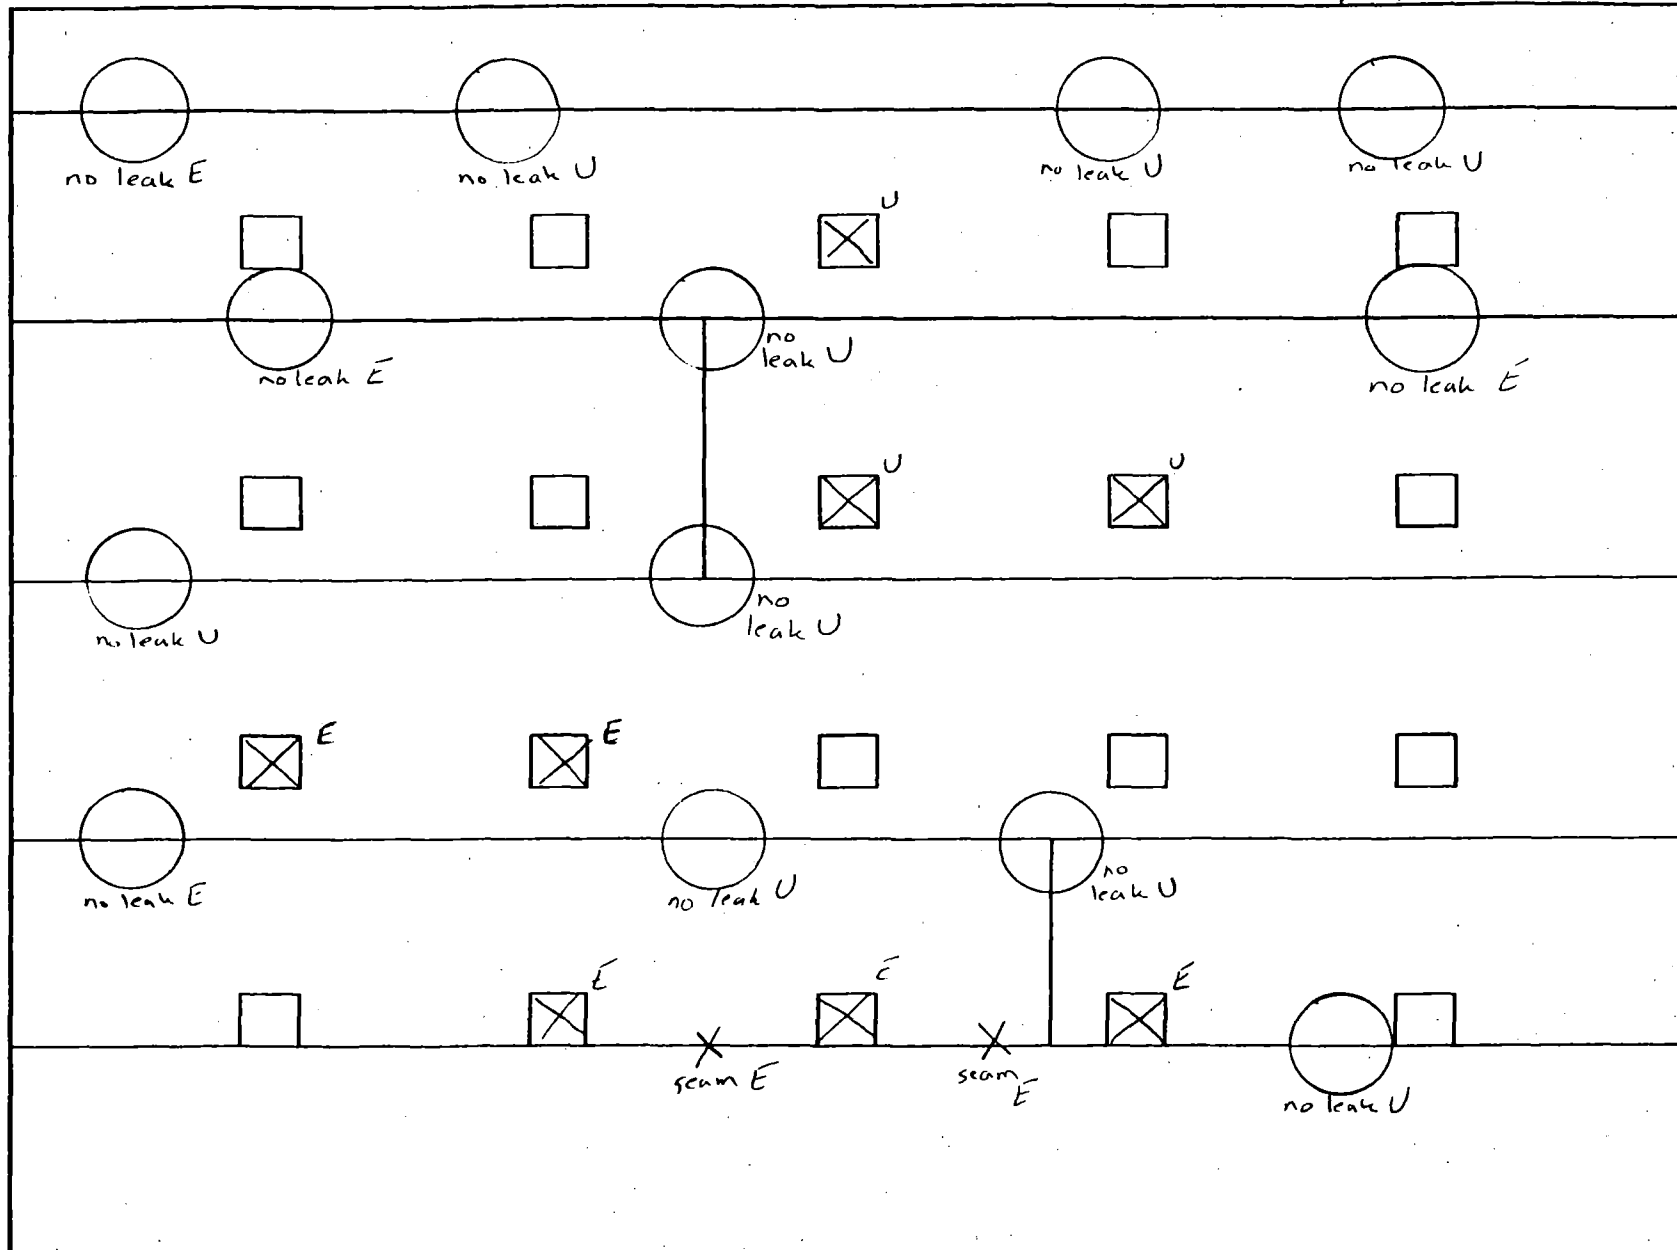
440 Pa

Figure #9 shows the leaks detected with the PACTS tester by the inspector. The indicator light switched on at about 1.76in of water (440Pa).
