ARCHAEOLOGICAL INVESTIGATIONS AT

LOWER FORT GARRY, 1971

W. J. Folan and Peter J. Priess

MARCH 1972

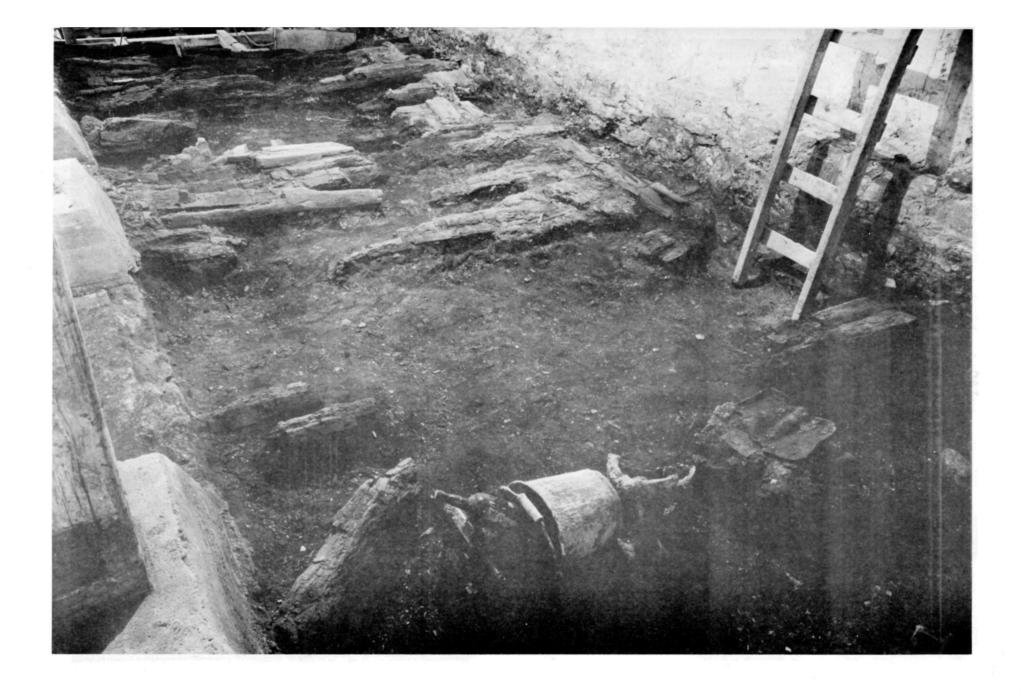
In 1971 the complex was in very poor structural condition. The lower sections of the northern and western stone foundation walls associated with the cells were generally in worse condition and therefore less stable than the upper sections; the lime had almost leached out of what little remained of the mortar in them and most of the spalls had fallen from place. This prohibited excavating to determine their depths. The base of the northern foundation wall protruded not only near the eastern wall of the complex, but also in front of cells 1 and 2 (Figs. 20-21). (The cells are numbered 1 to 4 from west to east.) The double-brick floor abutting it helped keep other sections of its base in place. Its general bearing capacity is still fair although it may not withstand further The western foundation wall also bulged considerably. The resulting pressure had damaged cell 1: part of its western wall, almost all of its rear wall and the forward section of its vault had collapsed (Figs. 15, 19-24, 66). Sections of the brickwork appeared to be stable, but the mortar had lost all binding power and the entire complex was bent out of shape. The brick eastern wall of the complex was only a few courses high at the front wall of cell 4 due to pre-excavation collapse. Almost three feet of water lay in the cells, but repeated pumping for several days removed it and continuous pumping was not necessary to keep the floor relatively free of water thereafter. The field situation was potentially dangerous and

13 The lower part of the bulging section of the northern foundation wall (in front of cell 4) as photographed prior to completion of the excavation. The area is adjacent to the eastern wall of the passageway in the cell complex. (NHSS 1K-160 M)

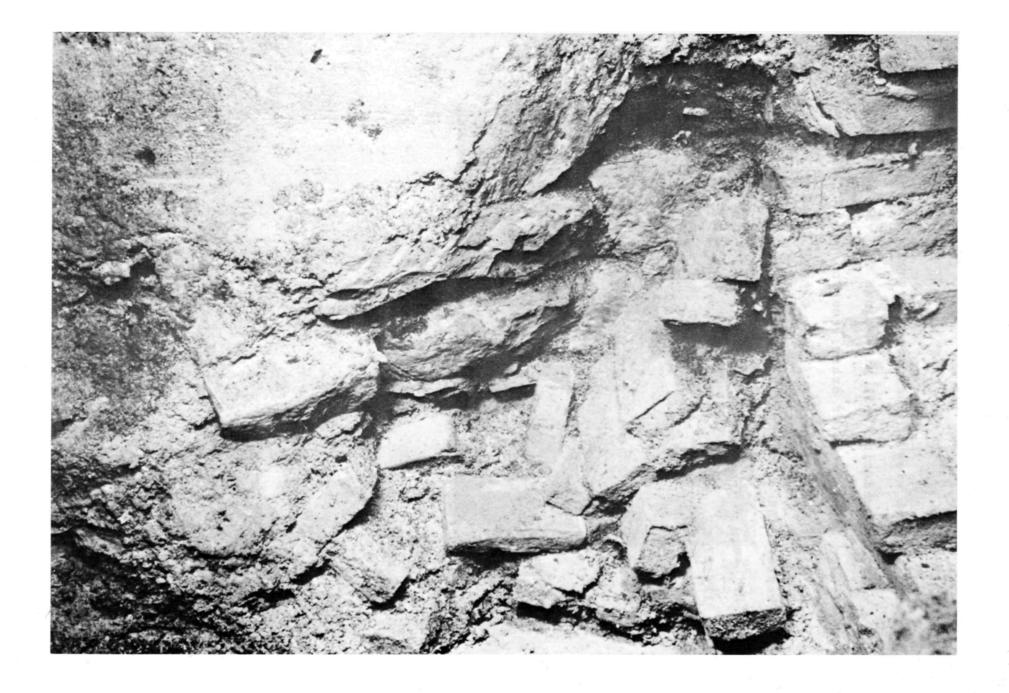
The general view of the upper northern end of the western foundation wall also shows the vault of cell 1 (lower left), a later drain (centre) and the highest point of the brick wall (lower right) forming the western end of the passageway in front of the cells.

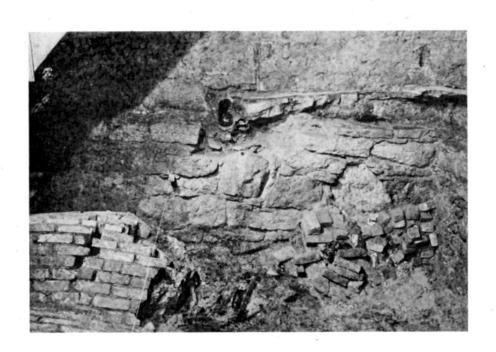
15 The vaults of the subterranean cells were photographed (looking west) in 1971. The wooden forms and braces abutting the front walls of cells 3 and 4 were placed there after the 1968 excavation before the area was backfilled with sand. (NHSS 1K-9 L)

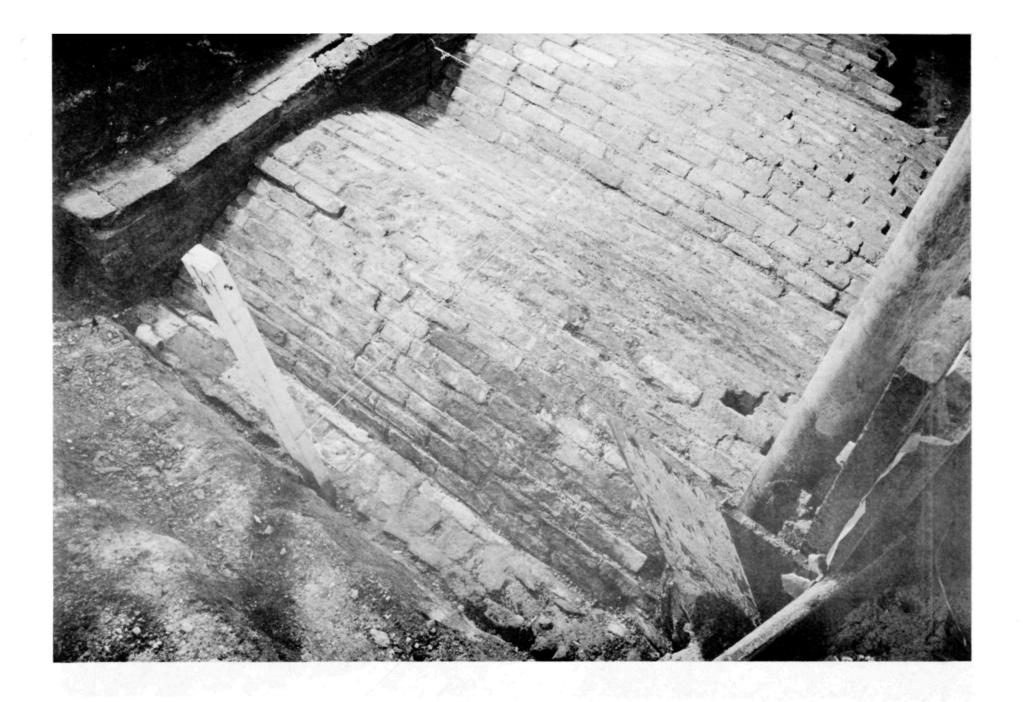
The excavation of cell 1 (Figs. 14-15, 19-24, 65-7), was difficult for several reasons. The rear wall of the cell had collapsed into the interior of the cell fairly recently. Its eastern wall was weak, bowed in due to the pressure from the buckling western foundation wall (which protruded approximately 16-3/4 in.) and the buckling northern foundation wall. Only a small section of the vault still stood.

The unstable condition of the vault of cell 1 (on the right) is evident in the photograph of the vaults of cells 1 and 2 (looking south). The rear wall of cell 1 collapsed before excavation. (NHSS 1K-13 L)

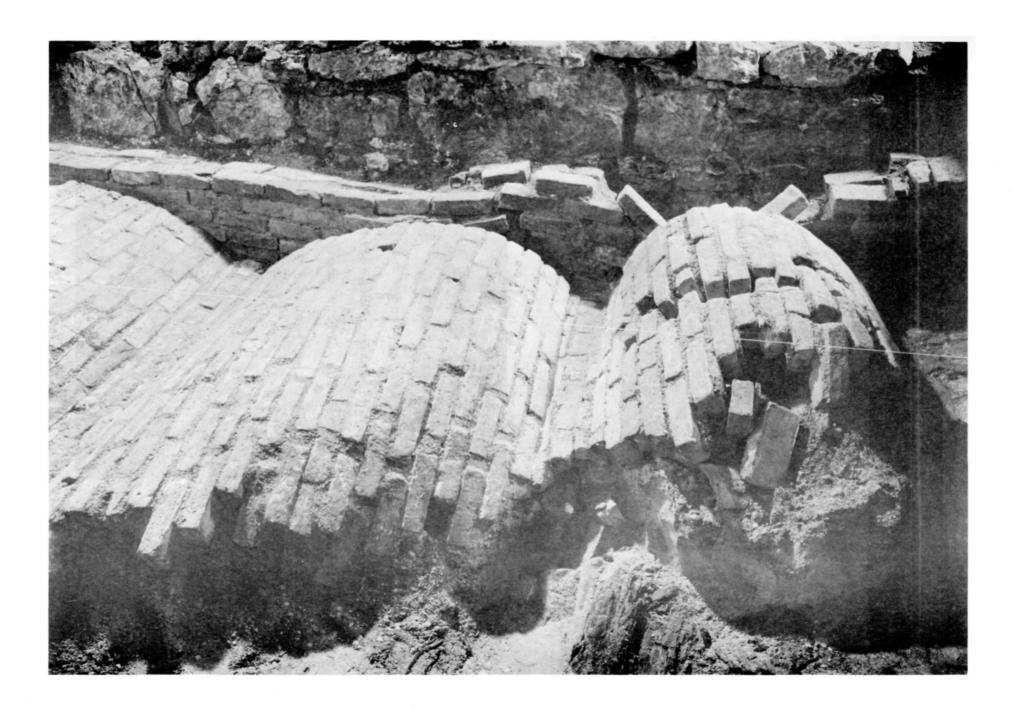
The photograph (taken from above) of the jambs at the entrance to cell 1 as uncovered shows how much the heaving foundation walls had altered the original structure. The inner surfaces of the jambs almost touched at the bottom of the doorway. The eyebolt to which the hasp was secured protruded from the eastern jamb. (NHSS 1K-138 M)

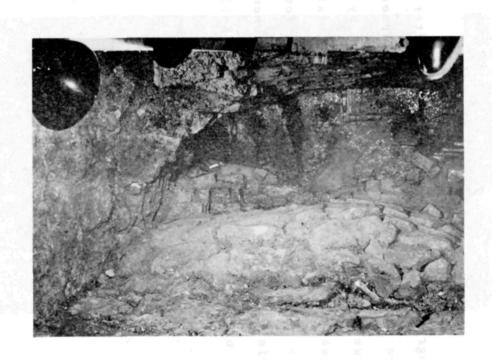
21 The photograph of cell 1 (looking north) shows the broken western jamb leaning against the eastern jamb, the remains of the western and eastern walls and the bulging northern and western foundation walls. The lower hinge and remains of the door are barely discernible north of the jambs. (NHSS 1K-135 M)

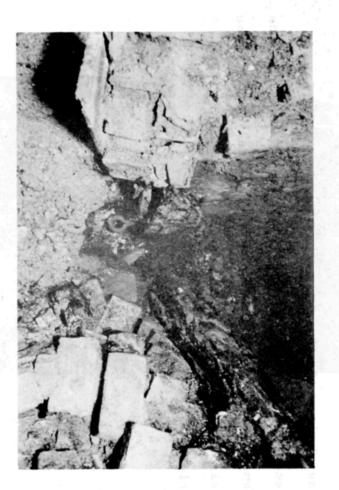
The photograph of cell 1 (looking south) after excavation shows its bowed eastern wall (left), the remains of its collapsed rear wall (centre) and the bulging section of the western foundation wall (right). (NHSS 1K-151 M)

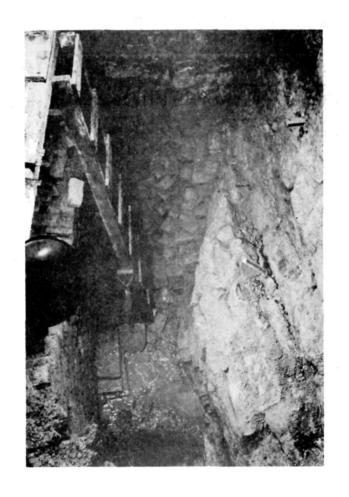
23 The photograph (looking south) of cell 1 after excavation shows what remained of its collapsed rear wall and western wall which was pushed out by the bulging western foundation wall, partially visible on the right. The bottom of the stone central foundation wall is visible in the upper background between the remaining bricks of the rear wall. (NHSS 1K-134 M)

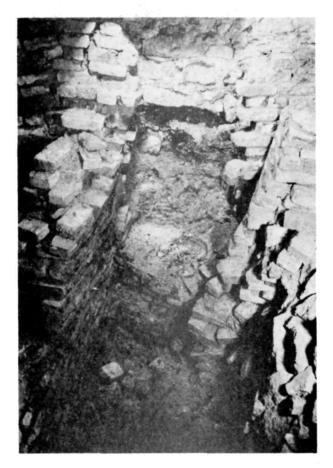
The remains of the collapsed rear wall and dismantled western wall of cell 1 and the bulging section of the western foundation wall are evident in this photograph (looking southwest). (NHSS 1K-114 M)

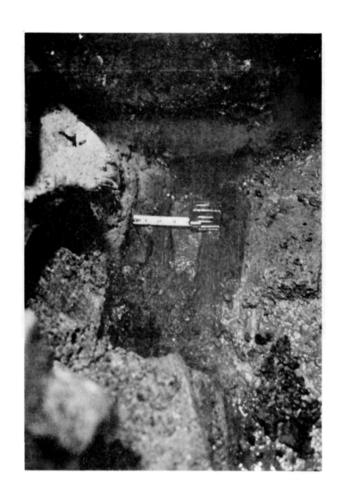
27 After excavation, sand bags were placed against the rear and side walls of cell 2 in an attempt to preserve as much of the masonry as possible. The photograph was taken looking south. (NHSS 1K-152 M)

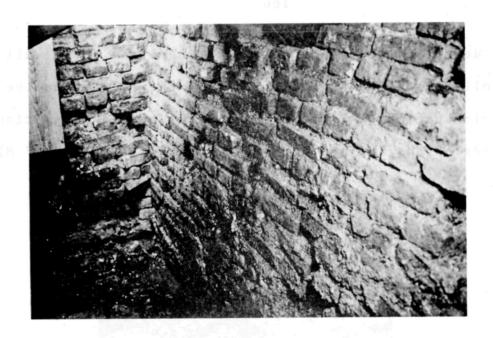
31 Little remained of the area where the western wall of cell 3 joined the front wall of the cell. (NHSS $1K-144~\mathrm{M}$)

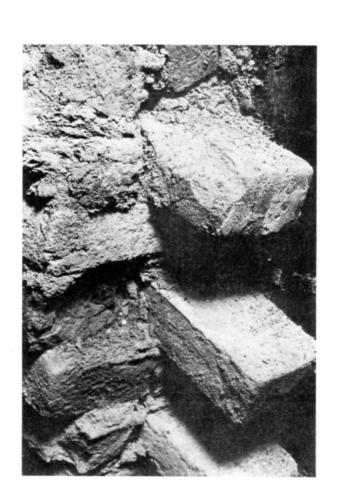
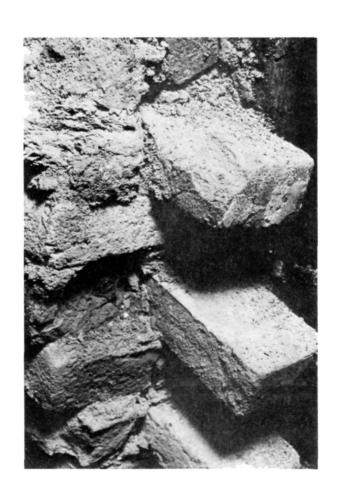
33 Cell 4 as photographed in 1968. Traces of plaster remained on the walls. Both the eastern and rear walls of the cell were then bulging under pressure.

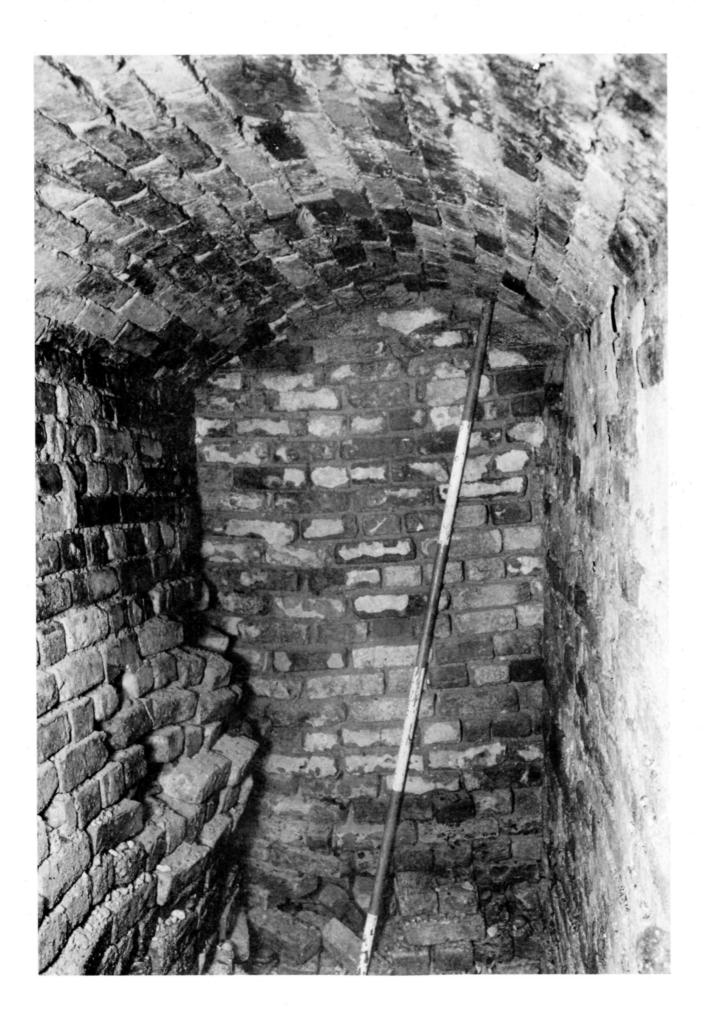
The photograph of cell 4, taken after its eastern wall collapsed, shows its eastern wall, fragments of its rear wall and the floor. (NHSS 1K-148 M)
