ISSUE 3/2019

AVIATION SAFETY LETTER

TP 185E

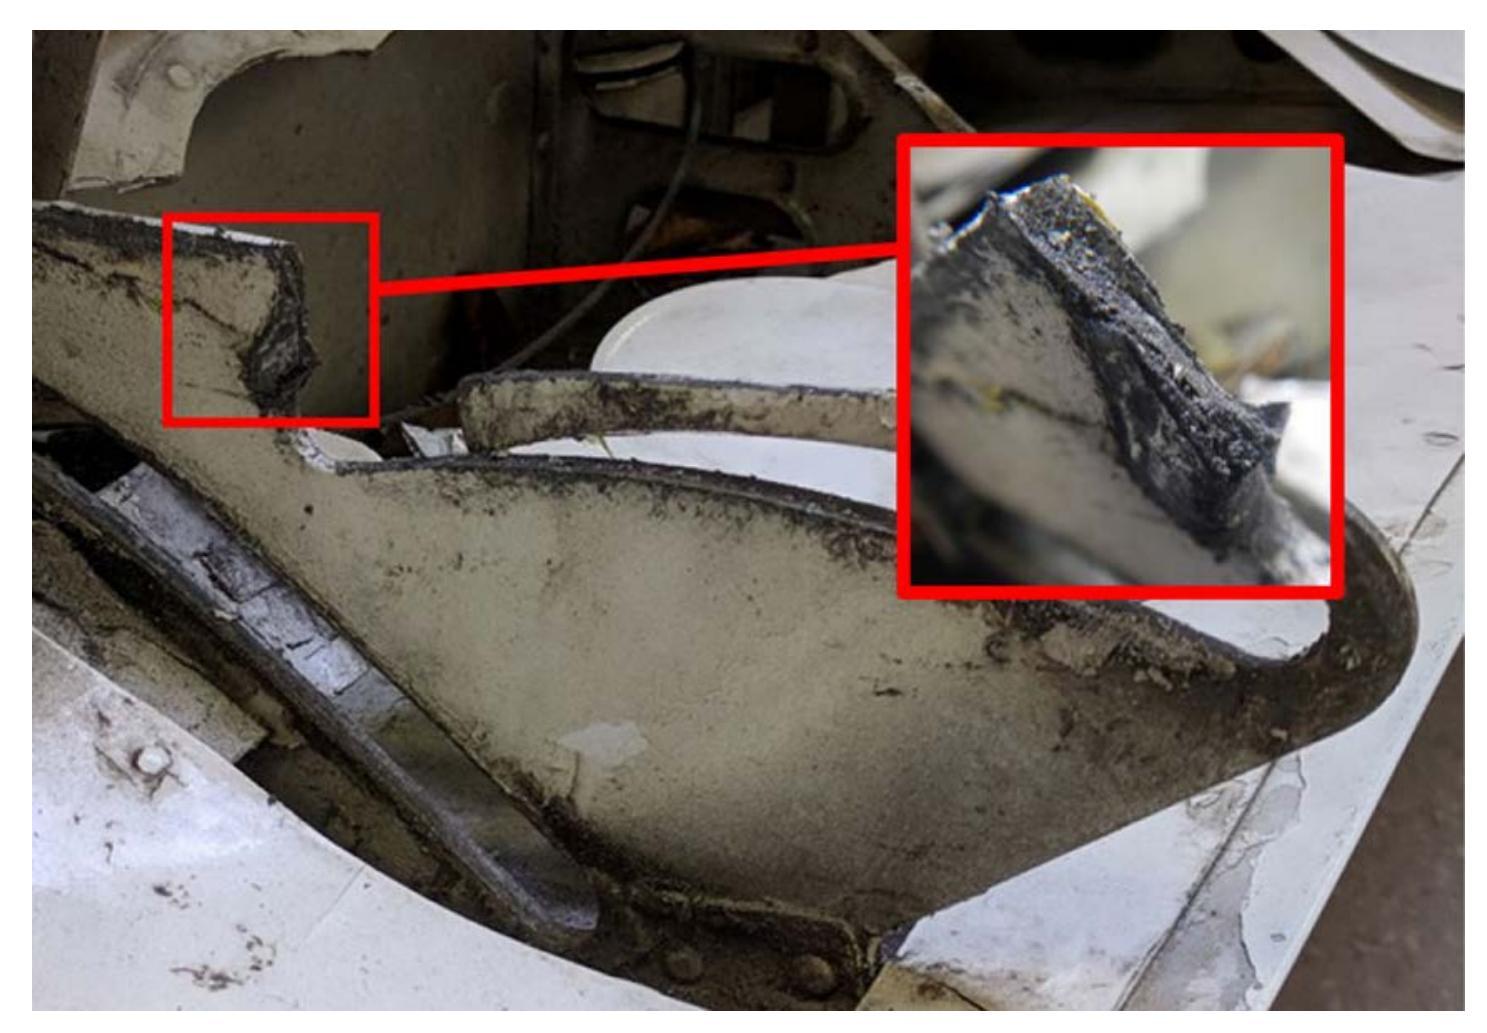
The left wing flap sustained damage to the inboard end as a result of the impact. The surfaces of the flap were otherwise undamaged.

The forward section of the left wing inboard aft flap track was fractured (Figure 1). As a result, the left flap inboard aft roller, which is normally positioned inside the associated flap track, was located outside of the broken flap track.

Figure 1. The fractured flap track, with an expanded view of the fractured area

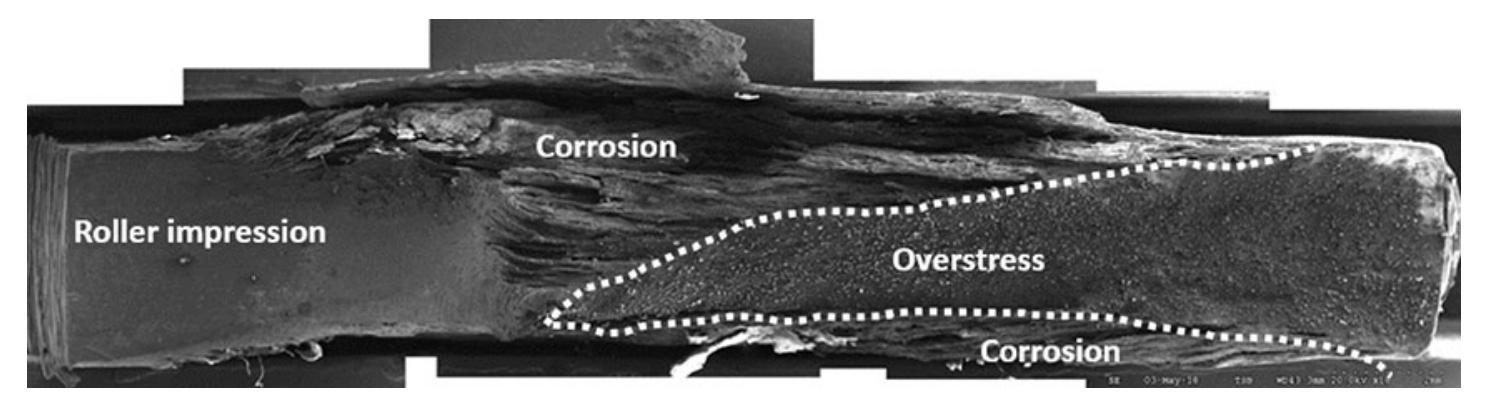
The fractured surface of the inboard flap track was examined with a scanning electron microscope. It was determined that the damage was caused by corrosion, which gave the appearance of delamination (Figure 2). The corrosion had been present prior to the occurrence; however, when or how it began could not be determined. Corrosion has a detrimental effect on the strength of an aluminum component and can significantly diminish the structural integrity and life expectancy of an aircraft component.

Figure 2. Scanning electron microscope image of the fractured flap track, showing areas of corrosion, overstress, and the flap roller impression on top of corrosion

The fracturing of the non-corroded portion of the flap track was caused by overstress from a combined shear and tension load. However, it could not be determined whether this happened before or during impact.

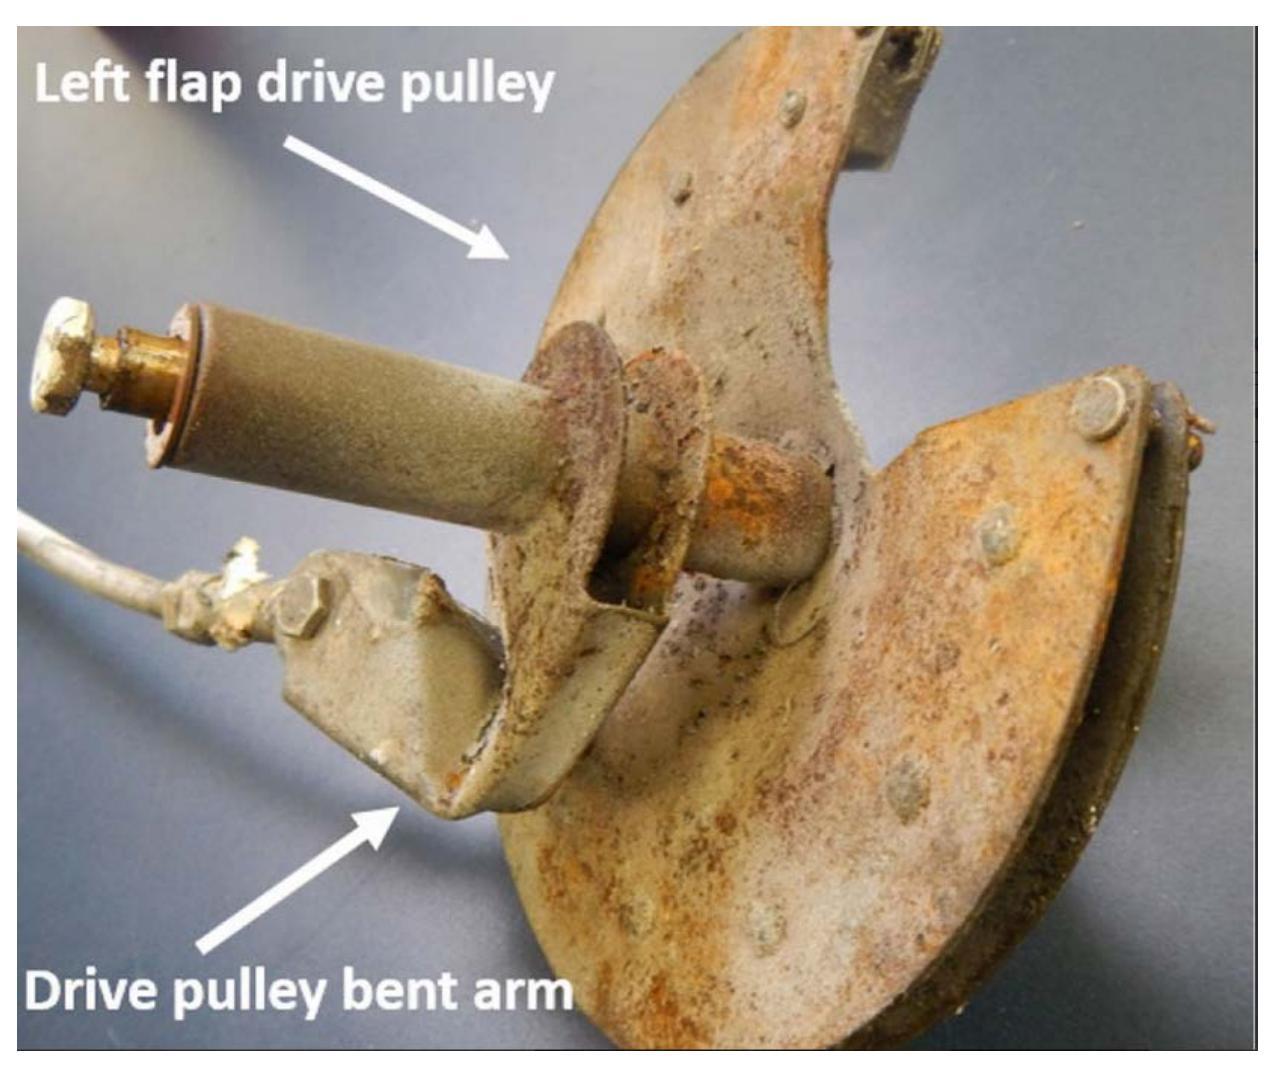
The arm attached to the flap drive pulley in the left wing was bent almost 90° from its original position as a result of tensile overload (Figure 3). It is possible that this damage occurred during the impact sequence. However, there was no corresponding damage to the left flap, which is connected to the drive pulley arm via a push-pull rod. It is also possible that the bending of the drive pulley arm occurred during operation of the flaps. If the left flap was unable to move, the arm may have been bent from the cable tension produced by the flap actuator.

Figure 3. The left flap drive pulley
