Air Transportation Safety Investigation Report A19Q0073

LOSS OF CONTROL AND COLLISION WITH TERRAIN

ULM Québec Inc. DTA Voyageur II 912S (basic ultralight), C-IULM St-Cuthbert (ULM Québec) Aerodrome, Quebec 24 May 2019

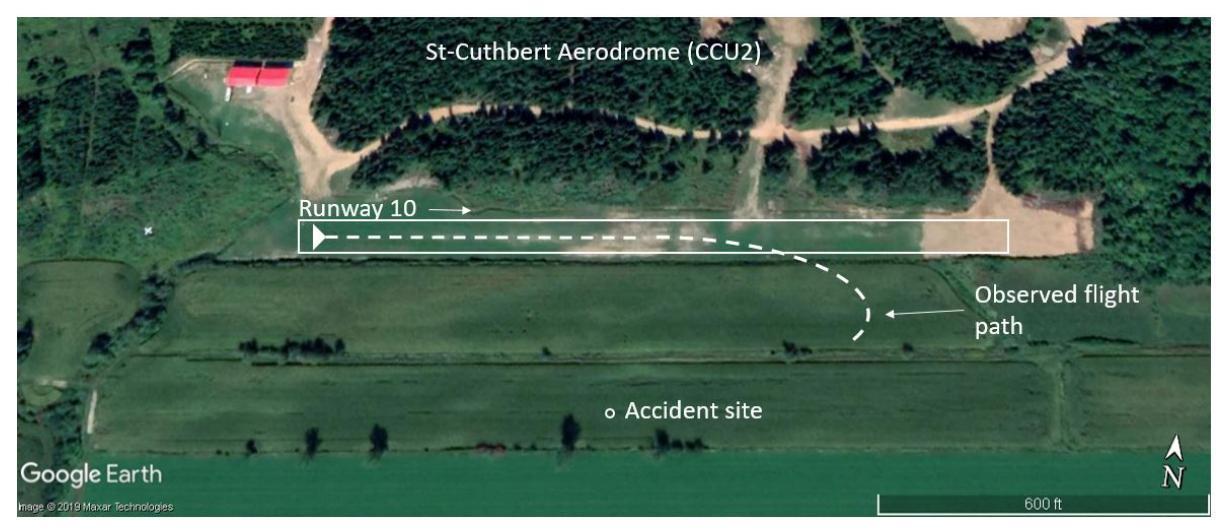
At approximately 2008, the aircraft commenced a takeoff on Runway 10. During the initial climb over the runway, several engine backfires² were heard. The aircraft then commenced a steep right turn and entered a dive before it disappeared behind a pile of hay bales. The aircraft struck the ground in an agricultural field south of the runway (Figure 1).

Figure 1. View of the aerodrome and the occurrence aircraft's observed flight path (Source: Google Earth, with TSB annotations)

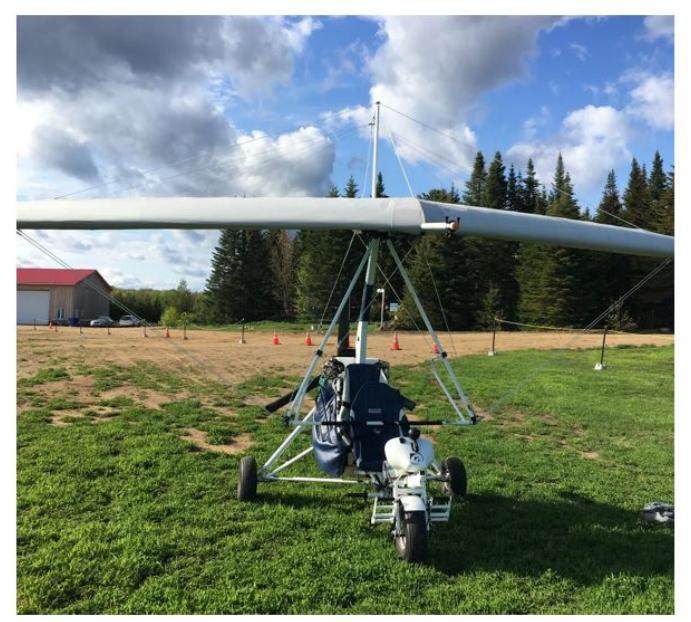
The DTA Voyageur II 912S is a single-engine, 2-seat ultralight trike which uses weight-shift as a means of flight control. It is powered by a 100-horsepower, 4-stroke Rotax 912 ULS engine and a fixed-pitch carbon fibre 3-blade propeller (Figure 2). The occurrence aircraft was equipped with optional dual controls and a DTA Diva wing allowing for a 472.5 kg maximum take-off weight. Dual controls are provided by extensions bolted to the rear of the flight control bar, which allow the pilot providing

Figure 2. Occurrence aircraft (Source: pilot)

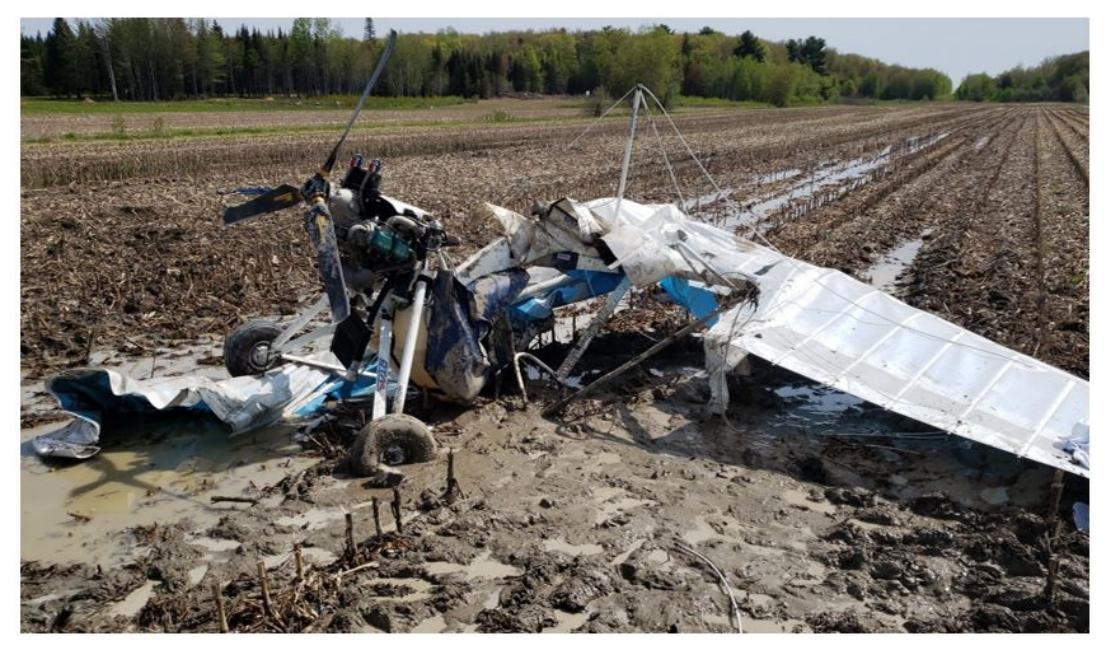
The collision with terrain occurred at CCU2, approximately 375 feet south of the Runway 10/28 centreline, in an agricultural field parallel to the runway. The recent snow thaw had left several inches of mud and water in certain areas (Figure 3).

Figure 3. Wreckage of the occurrence aircraft (Source: TSB)

The tricycle, wing, engine, and propeller were examined at the accident site. Damage to the tricycle indicated that it collided with the ground in a right-bank slip and steep nose-down attitude. The impact forces caused the front of the main frame member of the tricycle to bend left and upward several degrees. The nose wheel and steering mechanism was displaced aft and turned several degrees past its normal maximum deflection. On the occurrence aircraft, engine throttle could be controlled by the right pedal for the front seat or by a small lever located on the right footrest for the

The wing tubular structure was found to have several deformed and fractured components. On-site examination of the wing revealed that it impacted the ground on the nose and left leading edge. Tearing damage was present on the left-wing trailing edge as a result of contact with the rotating propeller. Damage to the control bar and the position at which it was found were consistent with the pilot attempting to recover from the dive with a left turn before impact with the ground. All damage to the wing, including that caused by the rotating propeller, was found to have been a consequence of the impact with the ground.

The engine showed very little impact-related damage, but the tips of the propeller blades had impact marks. Wing-covering material was found wrapped around the propeller shaft. On-site examination of the engine, the fuel system and the ignition system did not reveal any anomalies. The engine, along with several other components,¹⁰ was removed and sent to Rotech Flight Safety Inc. in Vernon, British Columbia, for further examination and testing in the presence of the manufacturer and a TSB investigator. The engine was installed on a test stand, started and operated at various settings. All test results were normal. The engine tachometer was examined at the TSB Engineering Laboratory in Ottawa, Ontario, but no pointer-to-face witness marks were noted. Therefore, the engine rpm at the time of collision with the ground remains unknown. The investigation could not determine what caused the reported engine backfires during takeoff.
