SIDE SCAN SONAR OPERATIONS
1974

BY: R.J.C. ROBITAILLE

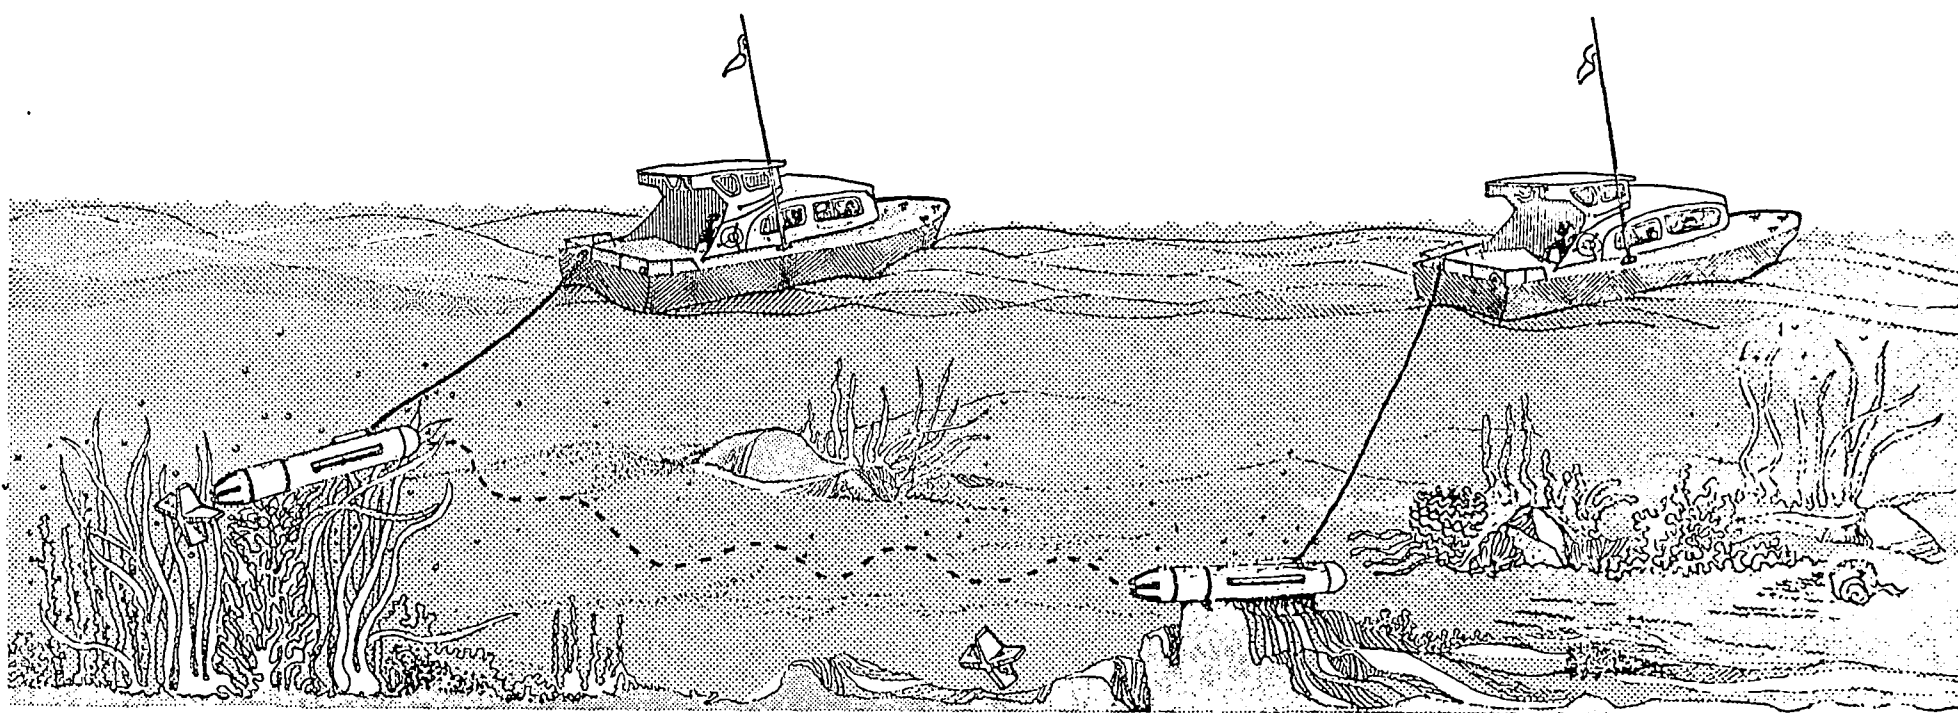
Fig. 1 The Break-away Tail Fin

During the trial period, the tail fin design caused some problems. First the tail fin retaining cone, made of gray plastic, fractured. Klein replaced this cone with one made of polypropylene. It is indestructible. The tail fin retaining line also presented problems. The original line was composed of a stretchable cord, Bungie Wire, with attachment ends made of copper electrical terminals shaped as drawn.

These connectors are too brittle and break after a few bends. Thus, the tail fin, valued at \$200, is lost soon after the tail fin breaks away. It is interesting to note that a gas engineer on one of our field parties made a replacement for this tail fin out of scrap aluminum in less than two hours. I tried to make a more serviceable retaining line using 3/8" diameter, high tension steel cable welded to larger, more durable terminals. This design was proved unsuccessful. So, a short, small diameter rope was added as an additional recovery line, but no collisions with the bottom have occurred since to test this design.

The break away tail fin design should be discarded. This should be done not merely because of the less than 50% recovery rate of the tail fin but because the complete detachment of the tail fin allows the fish to fluctuate erratically. This fluctuation can take the fish to depths 2 to 3 metres below the normal towing depth. Under these conditions, collisions with the bottom may occur on the sides of the fish where the instrument is more susceptible to damage.

Figure 1 illustrates this problem. Perhaps a plastic or fiber glass tail fin with a low horizontal shear strength could be used.

Two physical design modifications could improve the sonar. First, split the recorder into two more manageable components. Carrying the present heavy, awkward recorder over slippery boats and docks is dangerous. Second, the break-away tail fin design should be discarded. The complete detachment of the tail fin can jeopardize the fish. In addition to these physical design modifications, our technicians have suggested that the fish circuit boards be modified. More protection should be given to the S.C.R. component.
