# **Communications Research Centre**

THE STRUCTURE OF HCl DOPED SILICON OXIDES AND  
OF THE OVERLAYING METALLIZATION

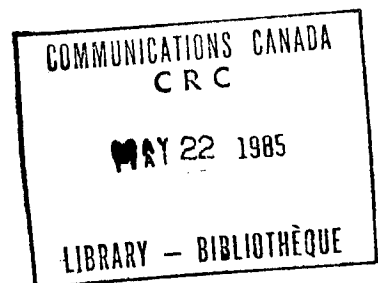
# THE STRUCTURE OF HCl DOPED SILICON OXIDES AND OF THE OVERLAYING METALLIZATION

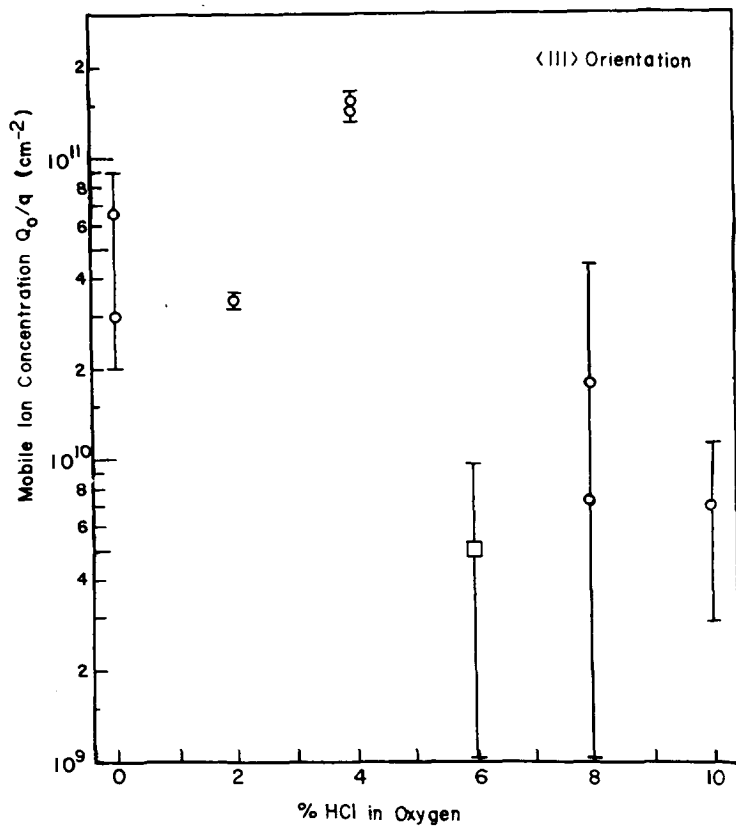
(a) For oxides on <111> wafers. □ values of  $Q_0/q$  obtained by alternate method discussed in Section 3.1.1.

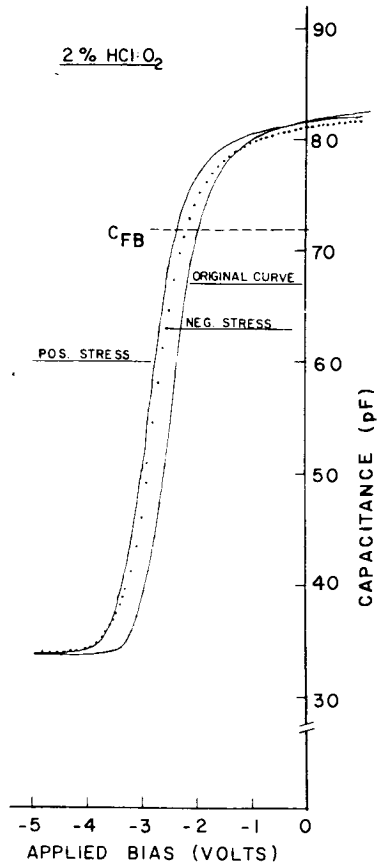
(a) For 2% HCl:O<sub>2</sub> concentration.

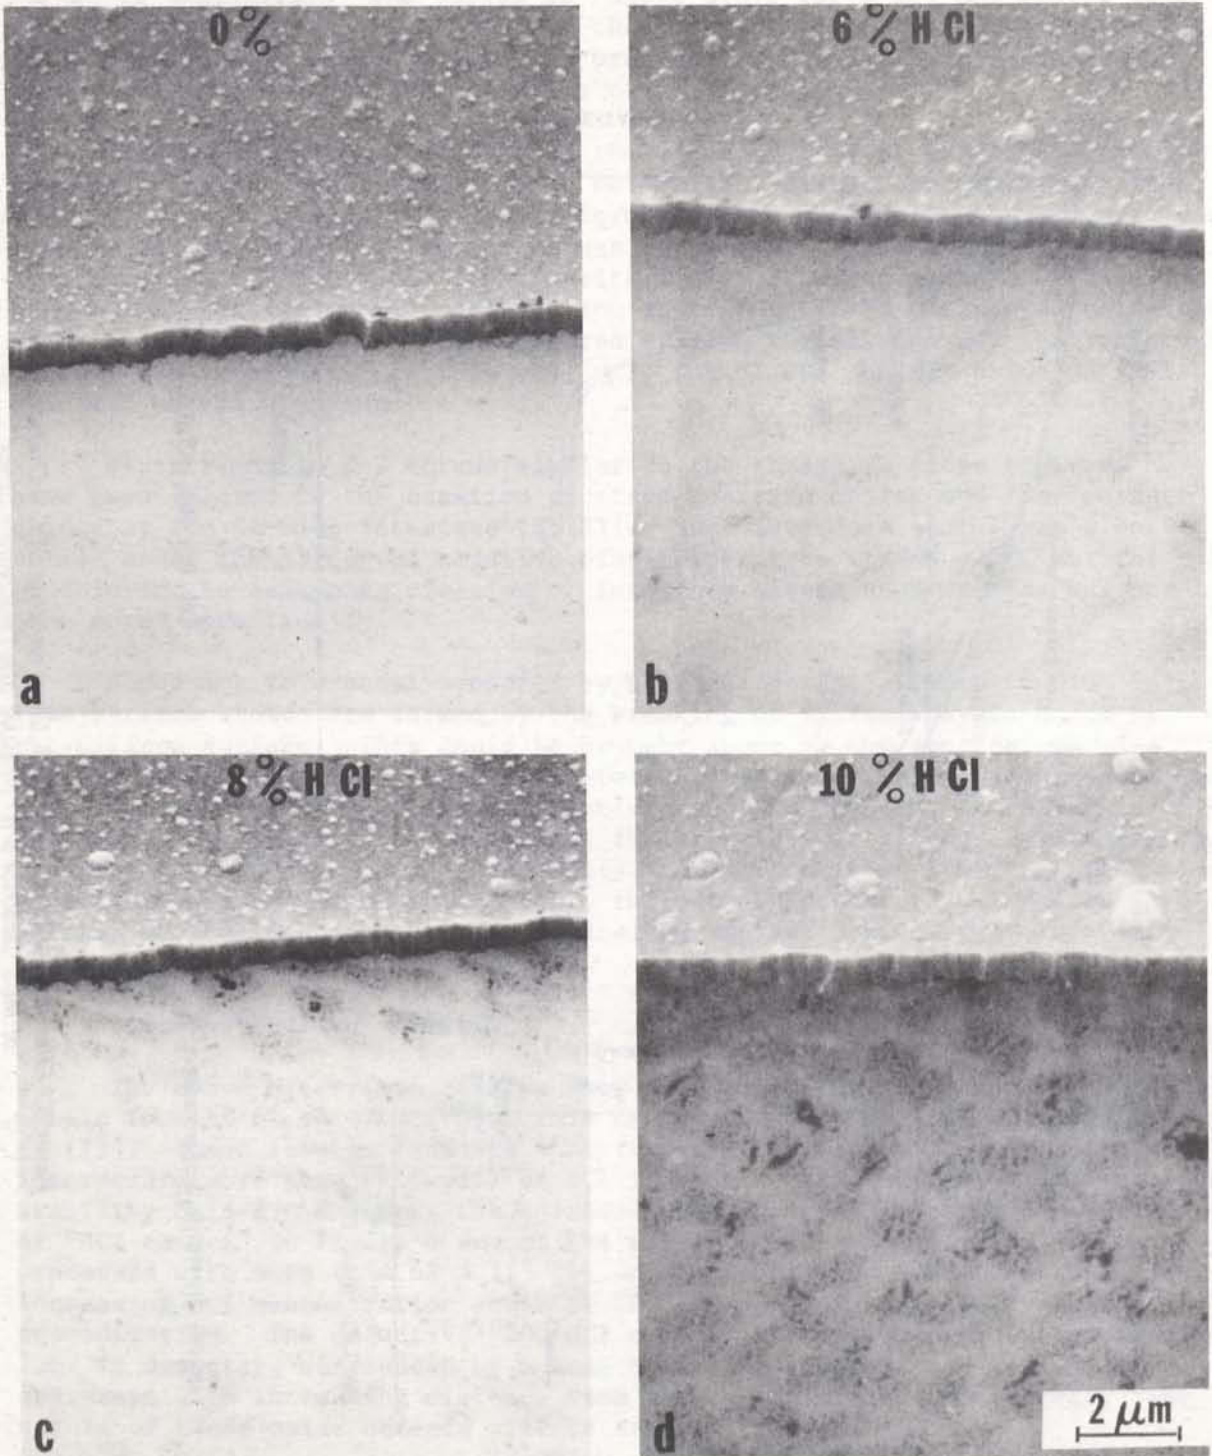
Figure 4. SEM photographs of oxides (lower part) processed with increasing HCl:O<sub>2</sub> volume ratio metallized with 5000 Å thick aluminum (upper part). Note the heterogeneous oxides at high-HCl concentration.

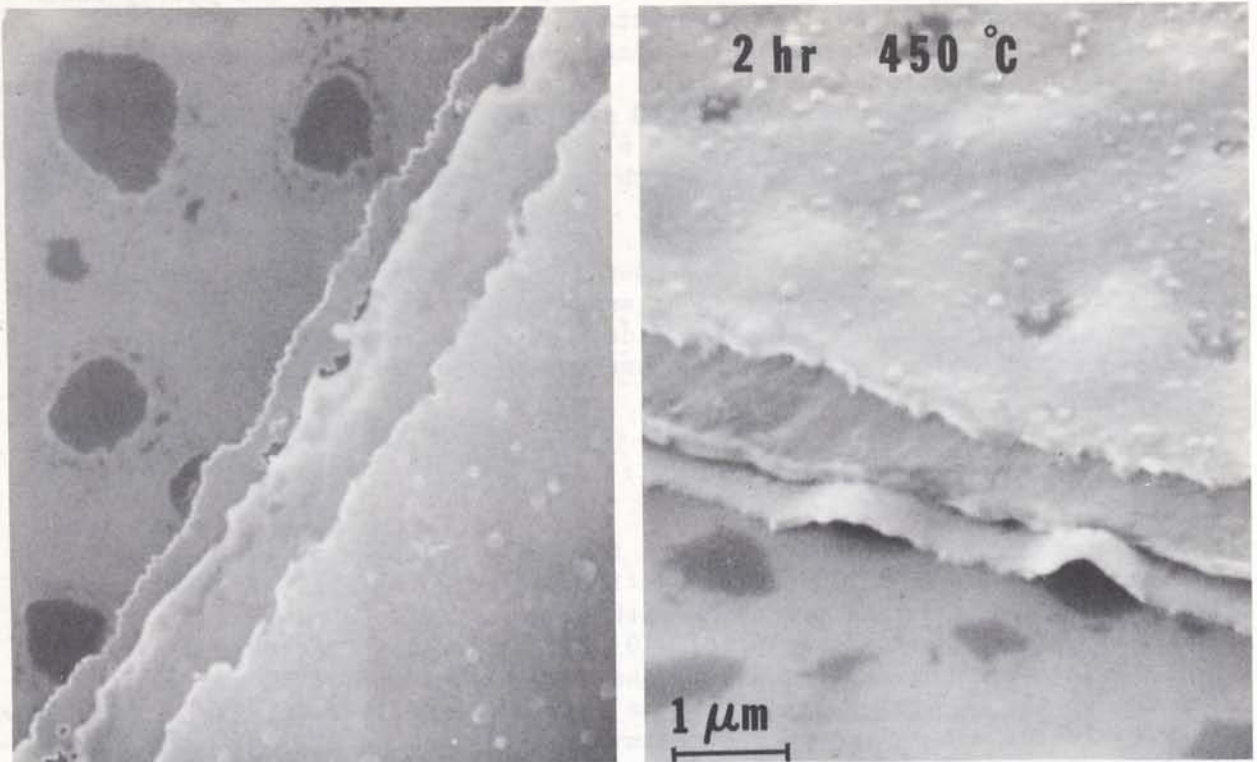
Figure 5. SEM Photographs of a 10% HCl 18/10/2/10 Oxide and the Overlaying Ti-Al-Ti Metallization Showing (a) the absence of metal lifting before annealing and (b) the local lifting and pitting of the metallization after annealing.

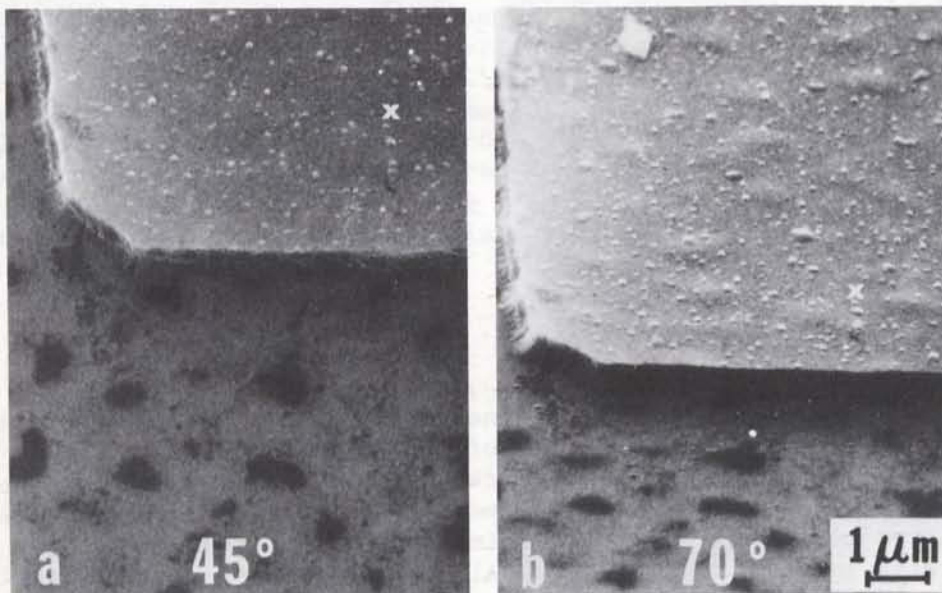
Figure 6. SEM Photographs of a 5000 Å Thick Aluminum Metallization Covering a 10% HCl 18/10/2/10 Oxide and Showing the Same Area (Marked X) at Two Angles of Observation in the SEM. The Blistering is Only Visible when Observed at 70° in the SEM (see (b)).

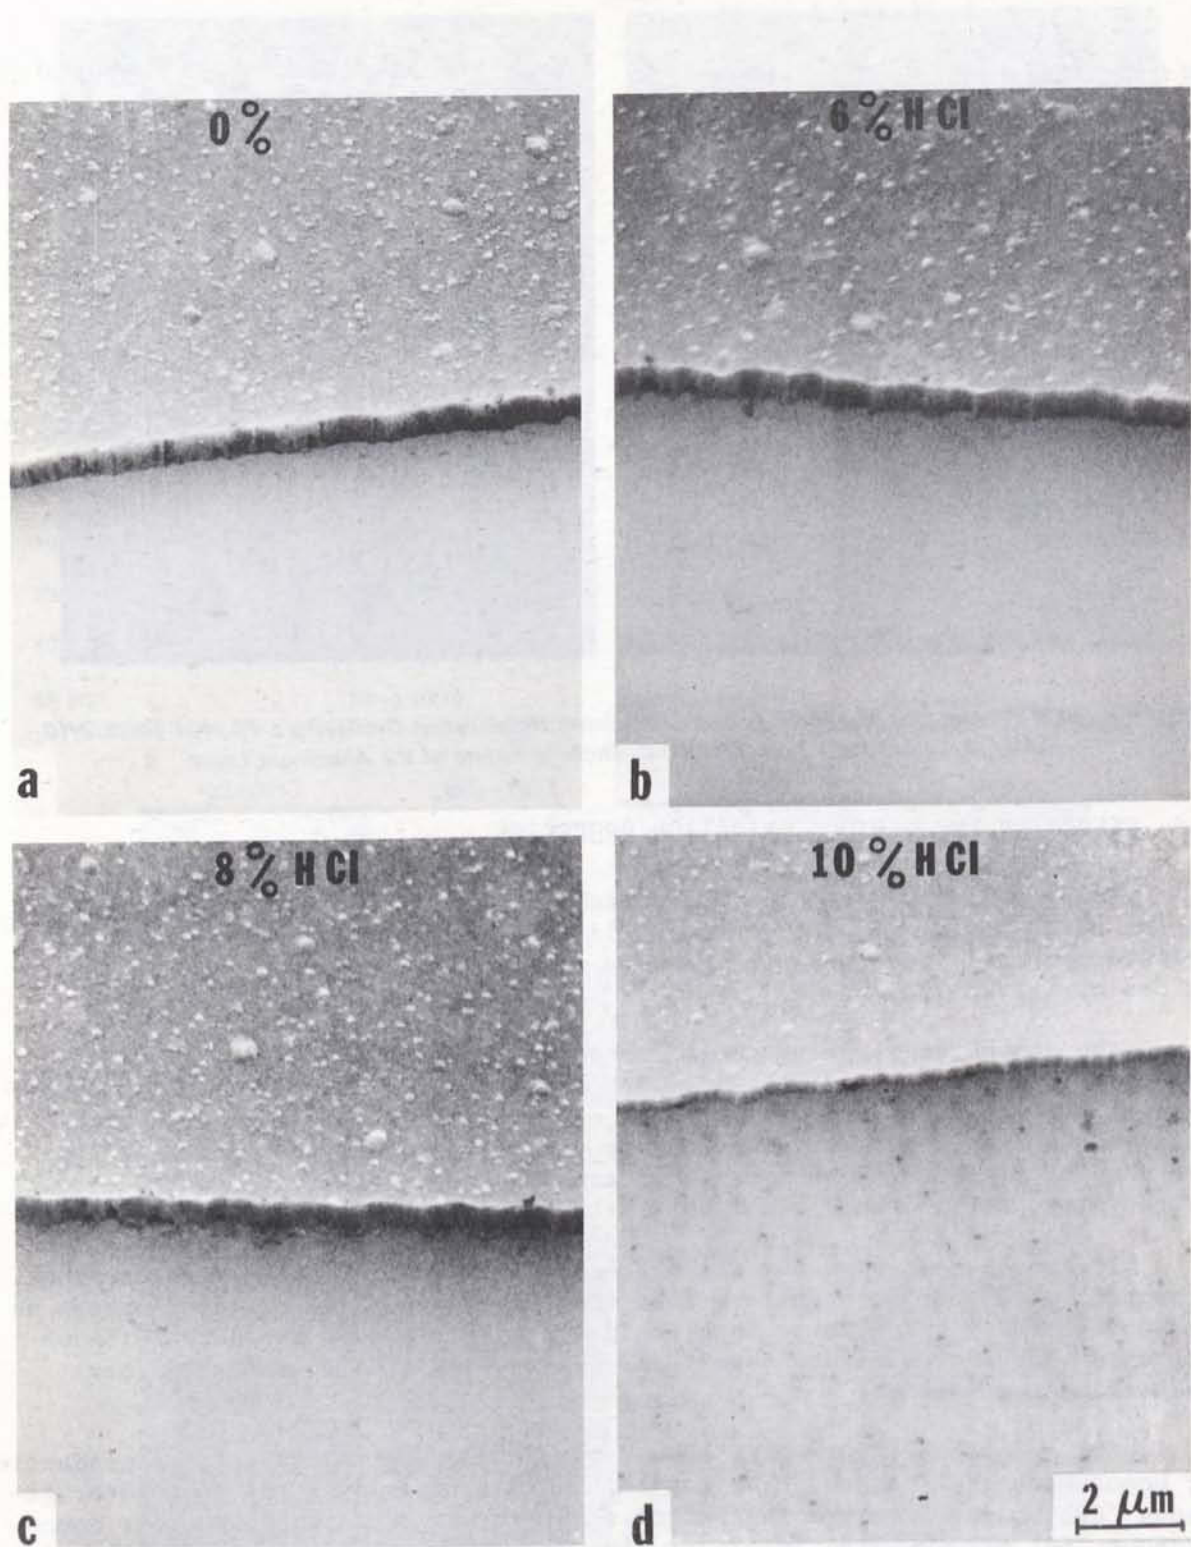
Figure 7. SEM Photographs of <100> Wafers Oxidized Using the 18/10/2/10 Process with Various HCl Concentrations from 0 to 10% (Vol.). Defects in the Oxides are only Observed After the 10% HCl Process

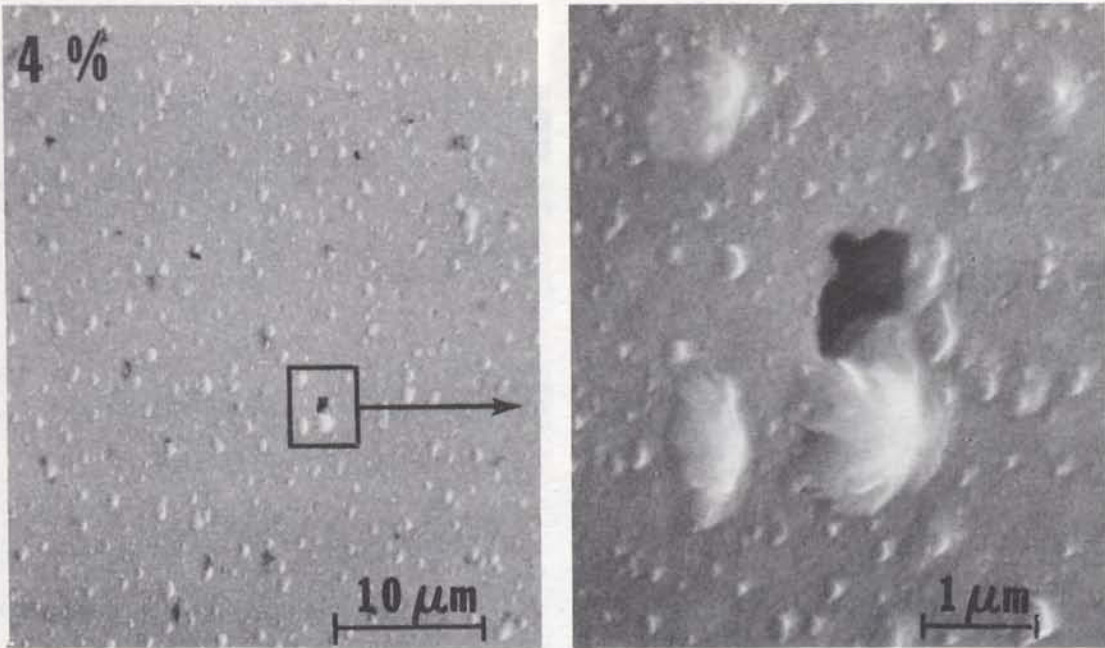
Figure 8. SEM Photographs of a 5000 Å Thick Aluminum Metallization Overlaying a 4% HCl 10/18/2/10 Oxide, Annealed for 1 Hour at 450° C, Showing Pitting of the Aluminum Layer.

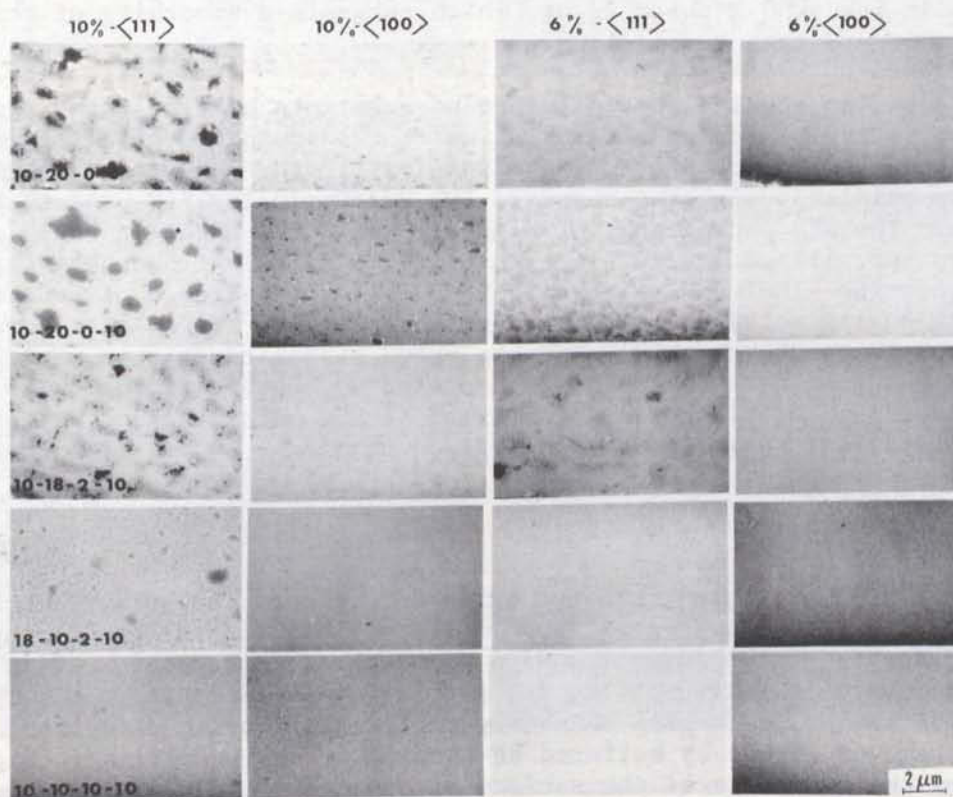
Figure 9. SEM photographs of HCl oxides on <111> and <100> wafers processed according to the indicated HCl concentration and oxidation sequence.

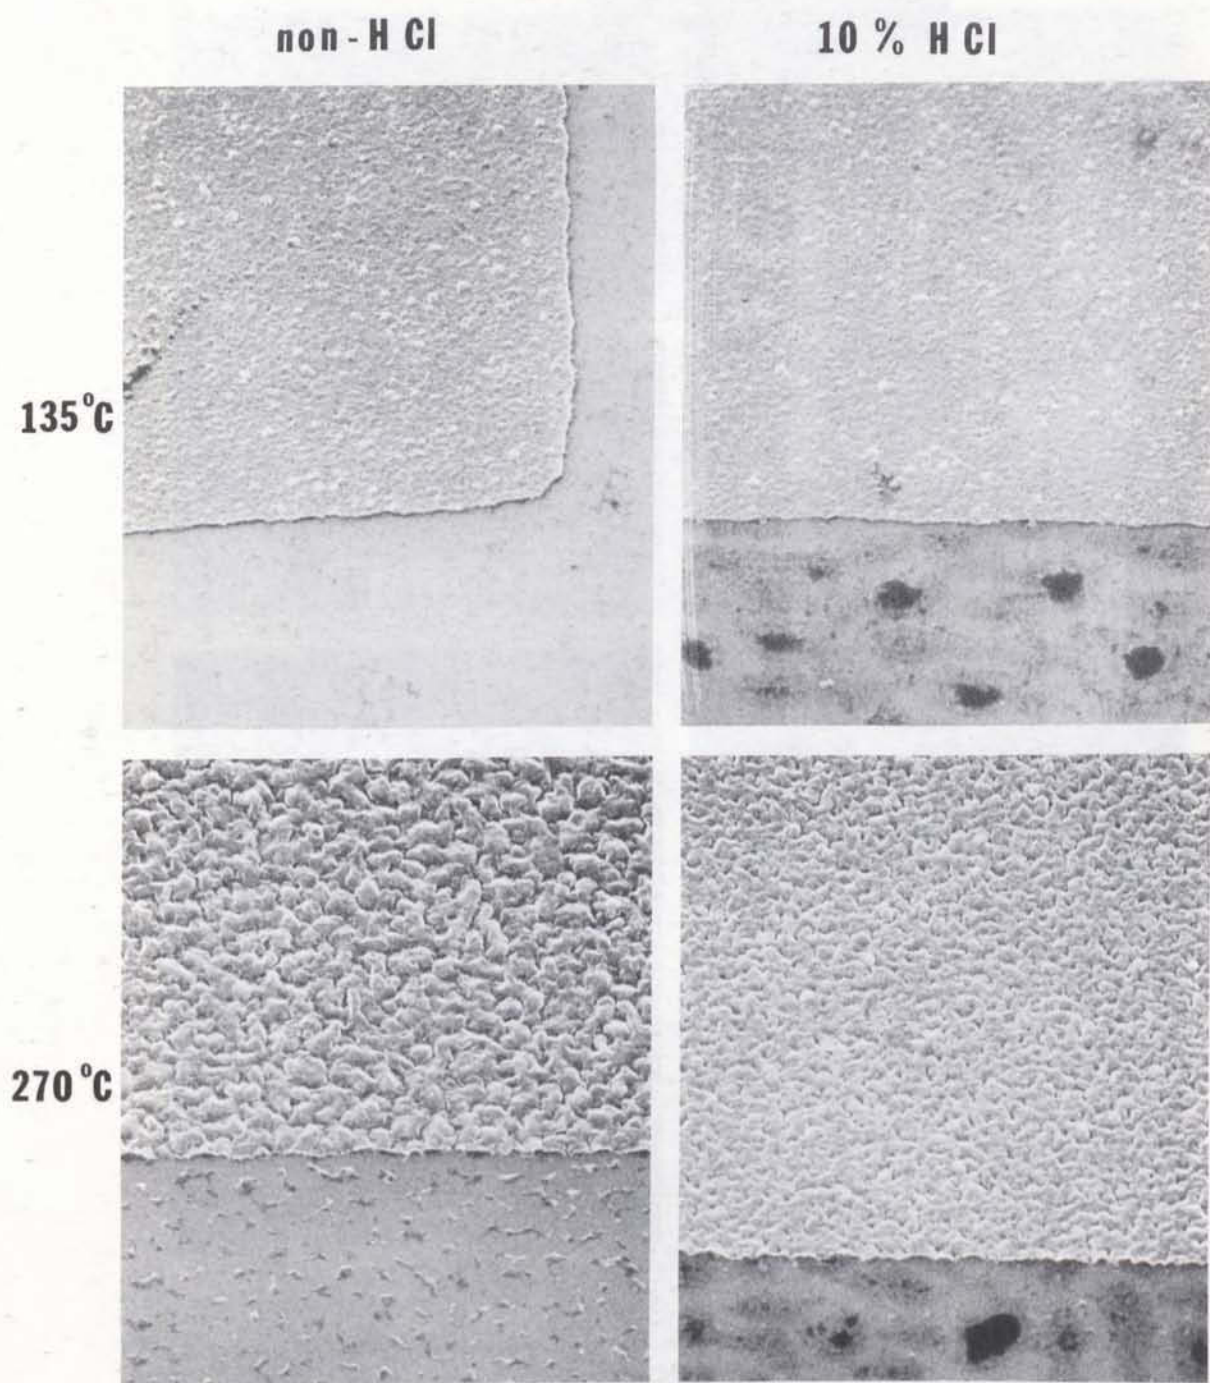
Figure 10. Effect of wafer temperature during deposition of aluminum metallization on non-HCl oxides and 10% HCl:O<sub>2</sub> 10/18/2/10 oxides on <111> wafers.

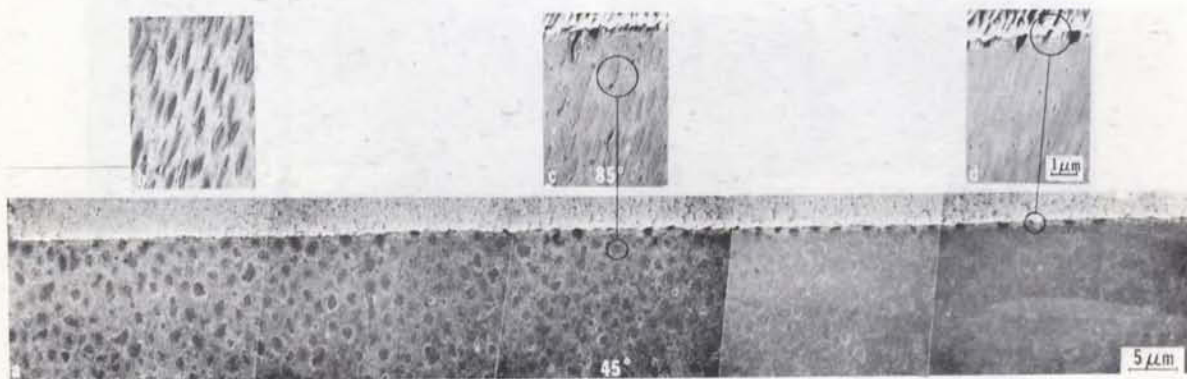
Figure 13. SEM photographs showing a thin  $\text{SiO}_2$  layer obtained by chemical etching for 95 seconds in buffered HF (<111> wafer and 10%  $\text{HCl}:\text{O}_2$  10/20/0/10 oxidation process).  
 (a) The thickness of the irregular oxide decreases to zero from left to right.  
 (b), (c) and (d) Selected areas of region shown in (a), obtained at higher angles of incidence.

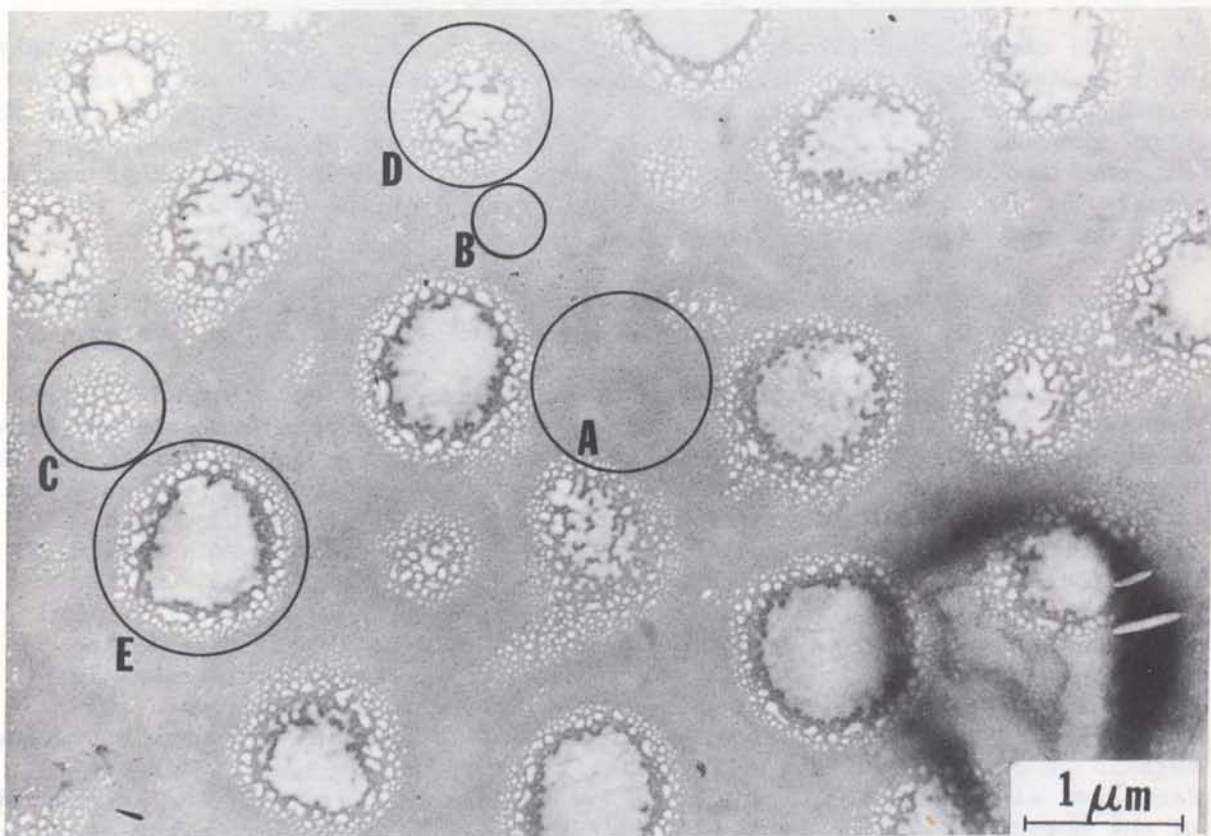
Figure 14. Transmission electron micrograph of a 10% HCl:O<sub>2</sub> 10/18/2/10 oxide on <111> silicon wafer, showing the nucleation and the growth of the chlorine-rich defects.

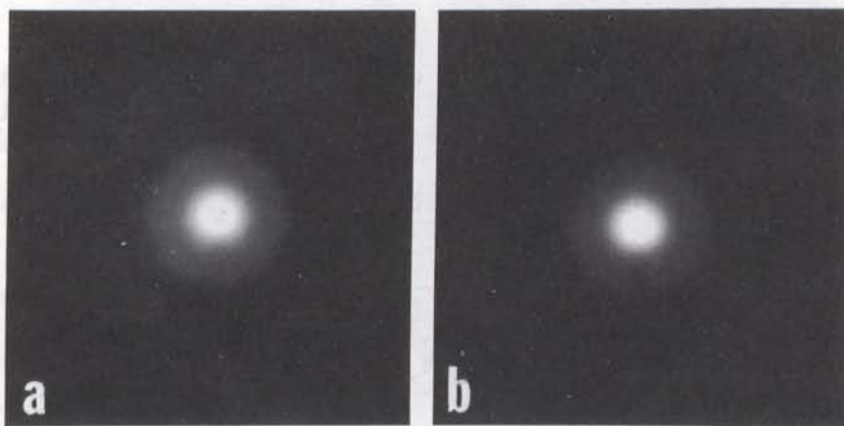
Figure 15. Diffuse diffraction rings obtained from the same sample as used for Figure 19.  
 (a) From within the chlorine-rich defect.  
 (b) From region outside the defect.

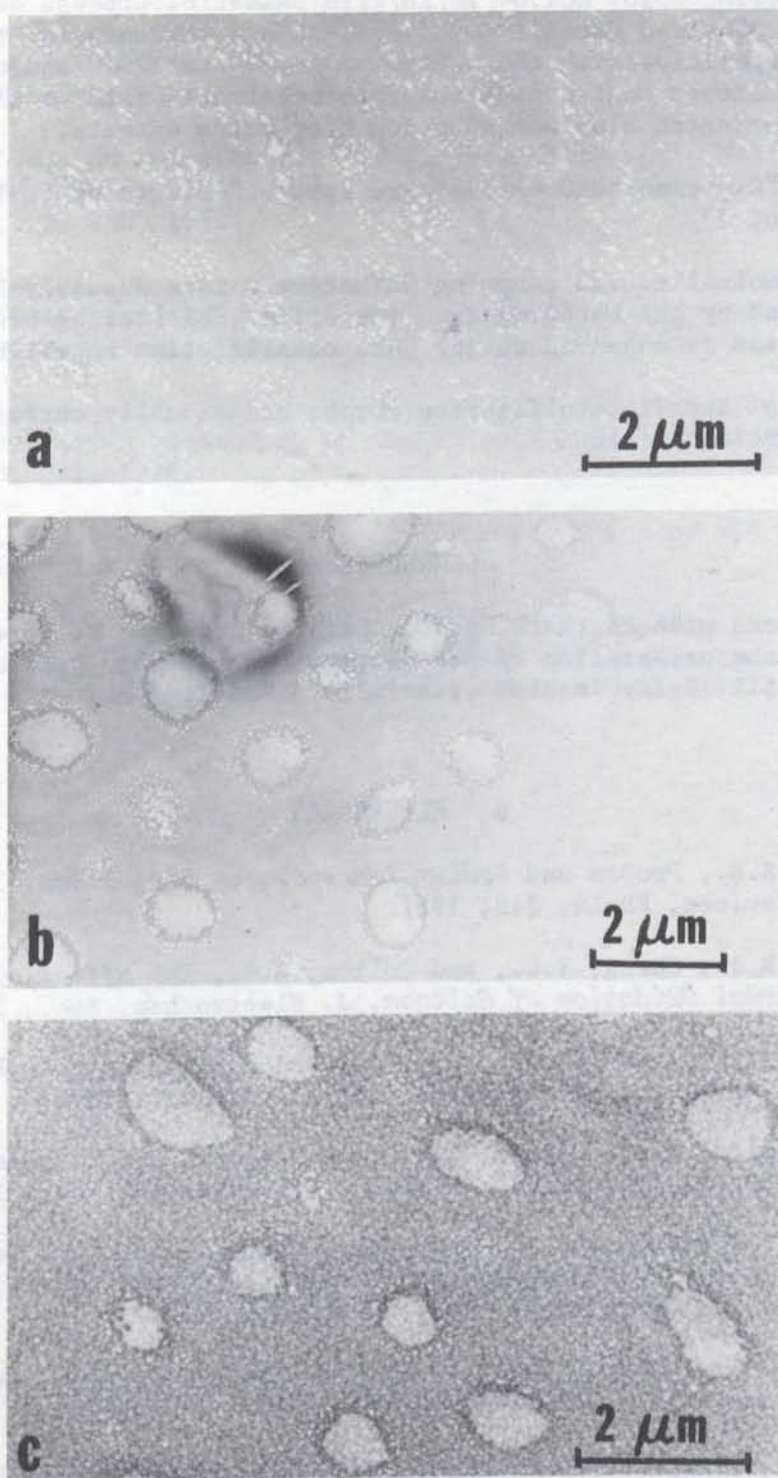
Figure 16. Transmission electron micrographs of similarly-processed 10% HCl:O<sub>2</sub> 10/18/2/10 oxides on <111> oriented wafers, cooled from the oxidation temperature 1150°C to room temperature at different rates. Cooling times are:
