ISSUE 3/2021

AVIATION SAFETY

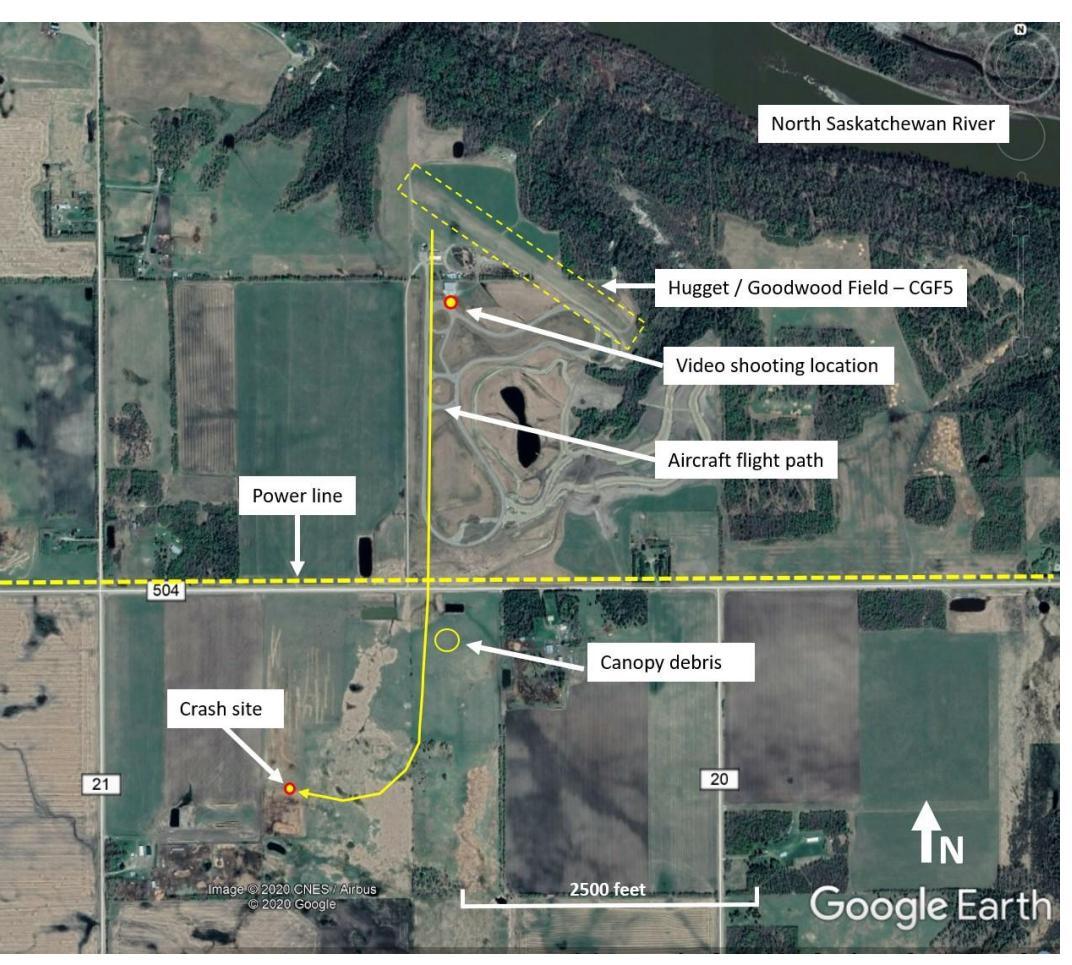
Figure 1: Map showing the occurrence aircraft's flight path, the power line and the accident site (Source: Google Earth, with TSB annotations)

When the aircraft collided with the power line, the aircraft contacted the upper wire just over the nose, and then it slid up the cowl until it struck the leading edge of the canopy. The canopy fractured and immediately separated

from the airframe, landing in the field south of Township Road 504. The remainder of the airframe struck the ground in a high-energy state, approximately 2 000 ft to the southwest of the power-line strike. The fuselage, from the instrument panel to the tail, was consumed by fire. The outer portions of the wings, flaps and ailerons remained outside of the burn area. The rudder, horizontal stabilizer and elevator were mostly consumed by fire but still recognizable. Because the cables connecting the rudder were made out of stainless steel and withstood the fire, control continuity to the rudder was established. However, control continuity to the flaps, ailerons and elevator could not be determined given that the aluminum push/pull tubes were all destroyed by fire. A video of the flypast just before the wire strike showed the aircraft responding to flight control inputs.

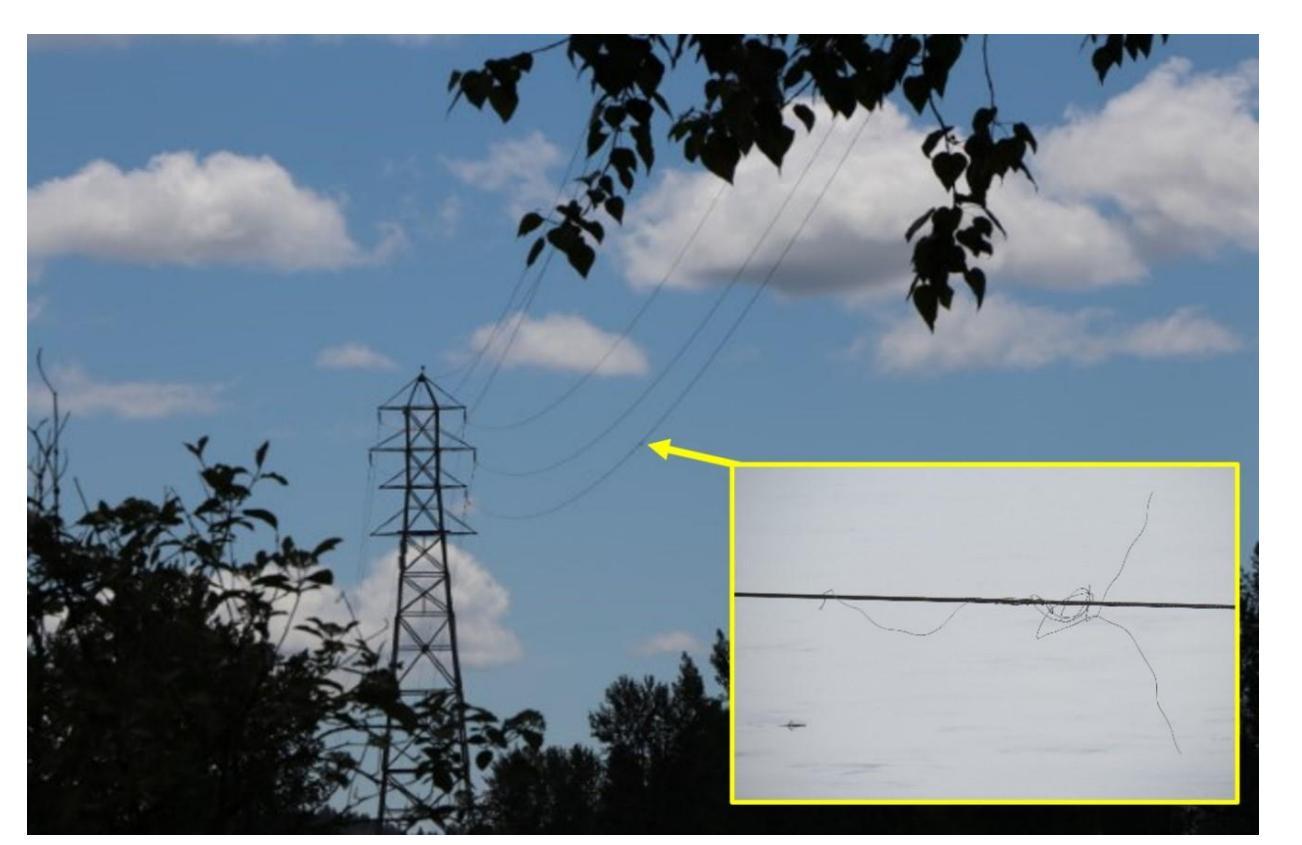
The aircraft collided with the span between the north and the middle suspension towers, which is 2 077 ft long and was approximately 125 ft above the river at the time of the occurrence. The lowest line was damaged and was disabled by circuit protection (Figure 2).

Figure 2: South-facing view of middle suspension tower with inset image of damaged transmission line (Main image source: TSB. Inset image source: BC Hydro)

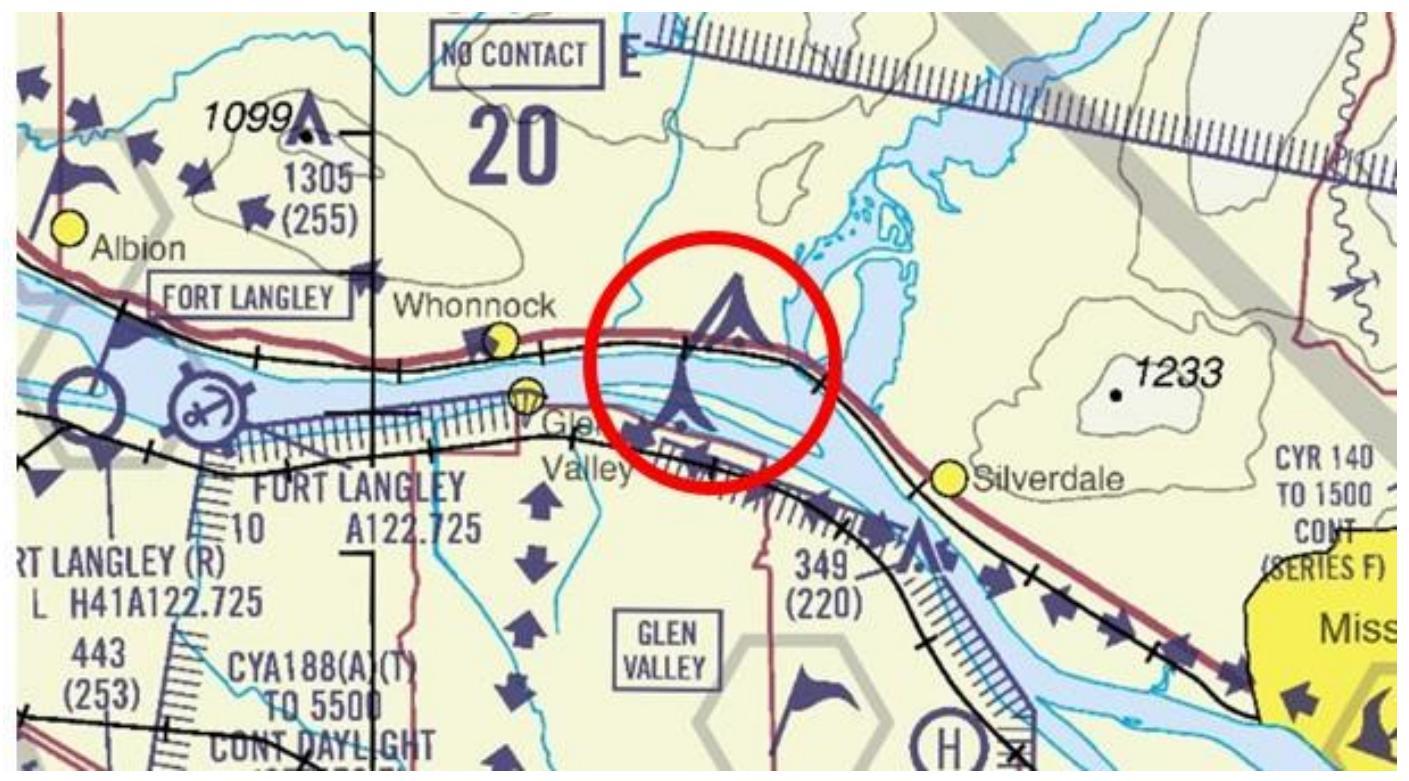
Therefore, given their height above the water, the power transmission lines did not constitute an obstacle to air navigation according to that regulation; however, at an undetermined date prior to 2008, Transport Canada (TC) deemed the crossing to be an obstacle to navigation as the power lines were in close proximity to the VFR route through the Glen Valley practice area. As a result of this determination, lights were installed on the suspension towers, and the power transmission lines were depicted on the VFR navigational chart for the area (Figure 3).

Figure 3: Visual flight rules navigational chart for the area. The power lines crossing the Fraser River are circled. (Source: NAV CANADA, with TSB annotations)

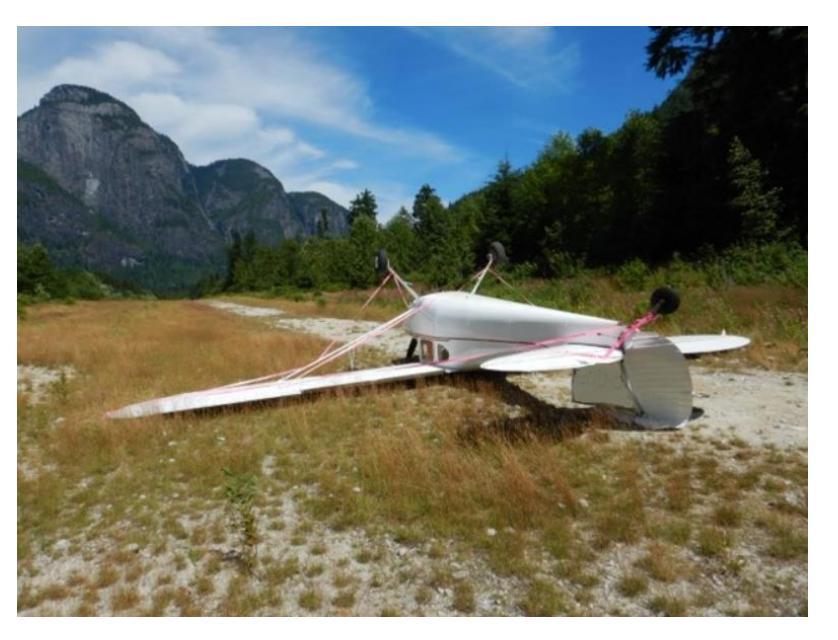
Figure 1: Wreckage site (Source: TSB)

The aircraft did not become airborne. When the aircraft was approximately 200 ft from the end of the runway and at approximately 40 mph, the takeoff was rejected. While braking, the aircraft rapidly nosed over and came to rest inverted on the runway. The pilot in the left seat sustained minor injuries and the PIC, who was the pilot flying, was fatally injured. The aircraft sustained substantial damage (Figure 1). There was no post-impact fire.

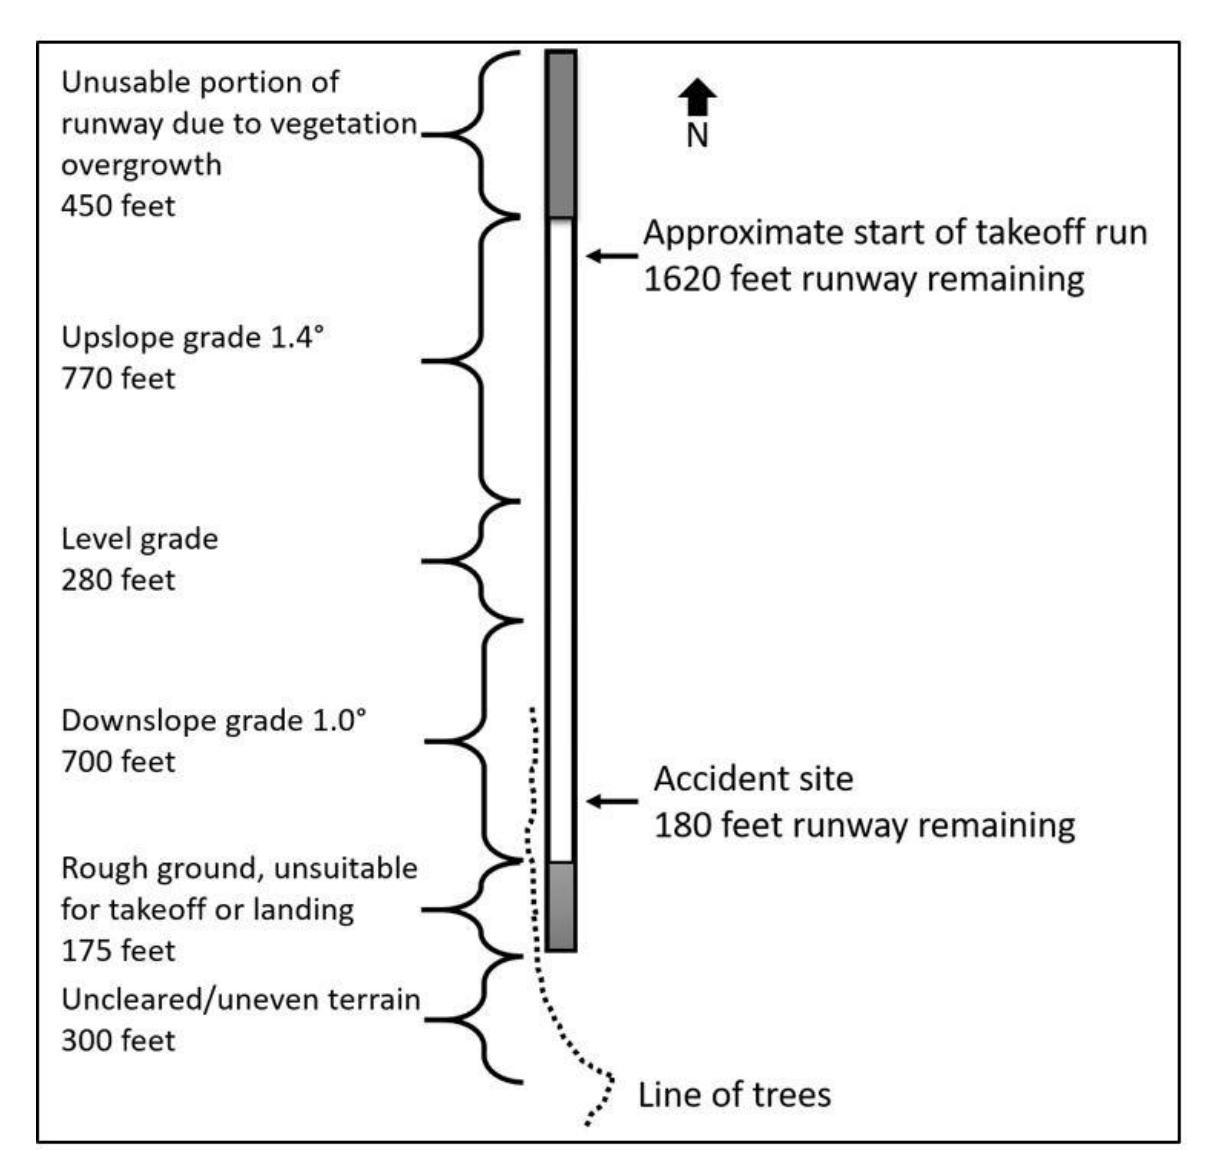
On the day of the accident, there were numerous areas of grass covering more than half of the runway's width, with much of the grass taller than 8 in. The remaining width, approximately 20 ft of the eastern side of the runway, was rough, loose gravel.

Figure 2: Diagram of the gravel airstrip at the Stave Lake abandoned aerodrome (Source: TSB)

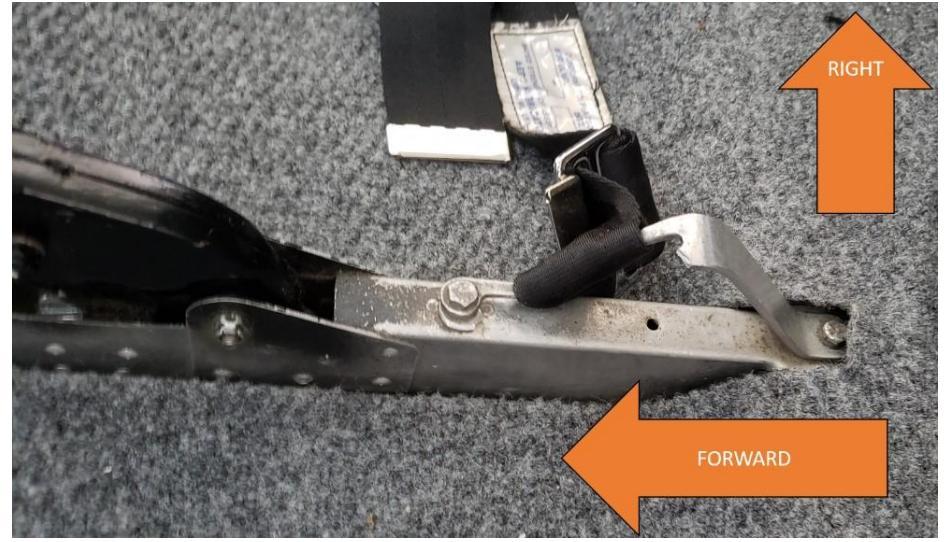
At the time of the occurrence, both occupants were wearing their safety belts. The lap belt and shoulder harness used by the pilot in the left seat were intact and secure. However, the inboard portion of the lap belt for the pilot in the right seat was found detached from the lap belt's centre bracket, which was found broken (Figure 4). The broken centre bracket allowed the PIC to

Figure 3: Lap belt centre bracket on the occurrence aircraft (Source: TSB)

become unrestrained during the accident. During the examination of the wreckage, the investigation noted that the lap belt worn by the pilot in the left seat was twisted where it attached to the bracket, indicating that the pilot in the left seat had been using a portion of the lap belt intended for the right seat occupant.

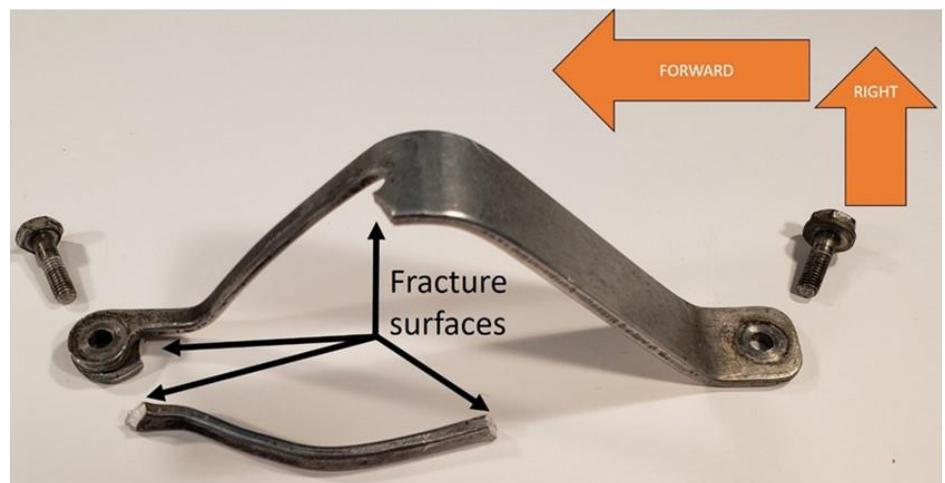
The lap belt centre bracket was removed from the aircraft and sent to the TSB Engineering Laboratory in Ottawa, Ontario. It was determined that the bracket failed due to shearing overstress during the accident.

This lap belt centre bracket was used in both Cessna 120 and 140 aircraft. During the manufacturing life of both aircraft, the Cessna Aircraft Company issued an engineering drawing change notice in which the bracket material was changed from aluminum alloy to steel alloy, increasing the yield strength of the component by approximately 40%.

Figure 4: Fracture surfaces on the lap belt centre bracket (Source: TSB)

Similar to the 2014 accident in the United States, this occurrence shows that without the incorporation of the steel lap belt centre bracket in Cessna 120 and 140 aircraft, failure of the aluminum lap belt centre bracket during accidents may continue, potentially resulting in serious or fatal injuries.
