**GEOLOGICAL SURVEY OF CANADA
OPEN FILE 8773**

**Geological hazards off Cape Lazo, eastern
Vancouver Island**

J.V. Barrie, K. Douglas, and B. Molloy

2021

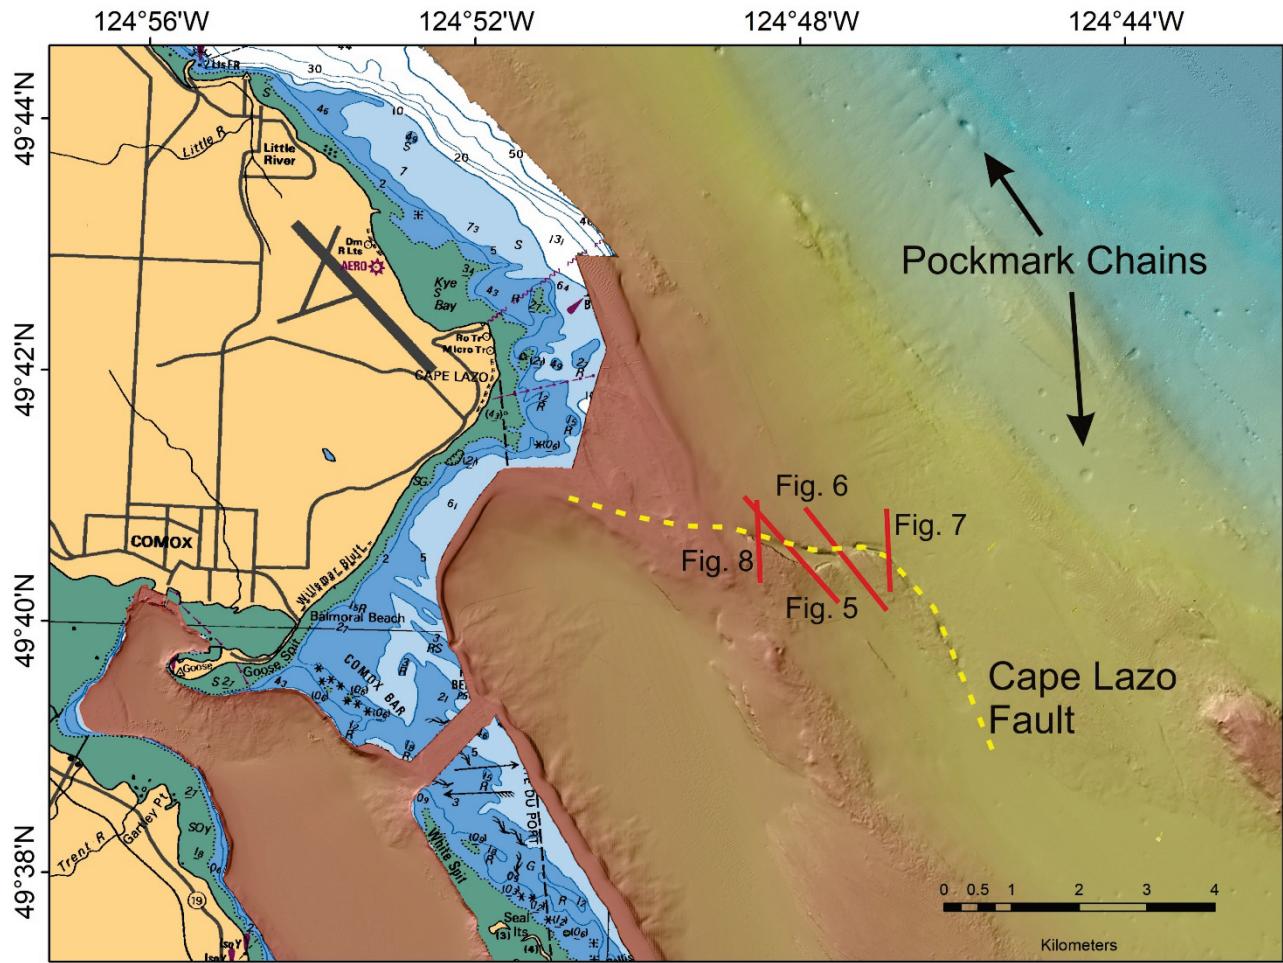
Located 4.0 km from Cape Lazo, Comox, British Columbia (Figures 1 and 2), there are several morphological features observed from multibeam swath bathymetry that may be related to marine hazards and, in particular, active crustal faulting. The main features are a northwest – southeast trending scarp, possibly the surface expression of an active crustal fault and a linear series of pockmarks or pockmark chain (gas escape features) that often reflect the trace of an active fault (Figure 2).

Figure 2. Multibeam swath bathymetry image from Cape Lazo region that illustrates morphology related to potential geohazards including the Cape Lazo Fault and linear northwest – southeast trending pockmark chains. Location of Figures 5, 6, 7, and 8 are shown.

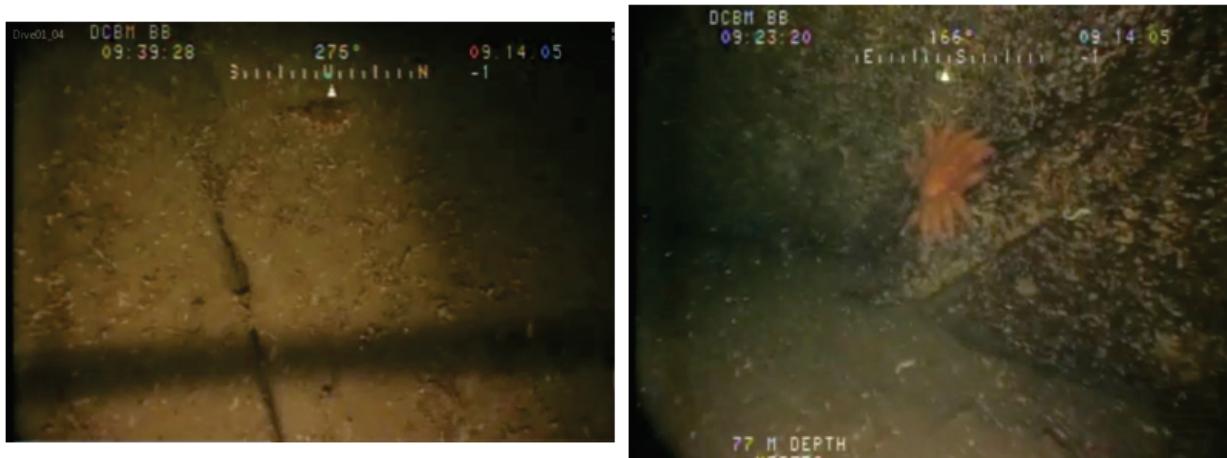
The surface expression of the scarp feature is ~2 km long with a near vertical north facing wall, and 15 to 25 m of relief between the top of the scarp and its base. Visuals collected during an ROV dive in 2005 reveal bedrock outcrop on a clean scarp wall (Figure 4). Multibeam bathymetry also shows an adjacent surface depression north of the scarp wall, a steeply dipping south facing wall, all giving the appearance of a rift (seabed pull-apart). Video data from the ROV dive clearly display fissures in the sea floor within the base of the scarp feature (Figure 4).

Figure 4. Images collected near scarp feature during an ROV dive in 2005 (2005011PGC ROV Station 1, Photos 1 and 2, National Expedition Database (https://ed.gdr.nrcan.gc.ca/index_e.php)). Left image shows seafloor with fine grained sedimentation - note the presence of fissure. Right image shows bedrock outcrop on wall of scarp.

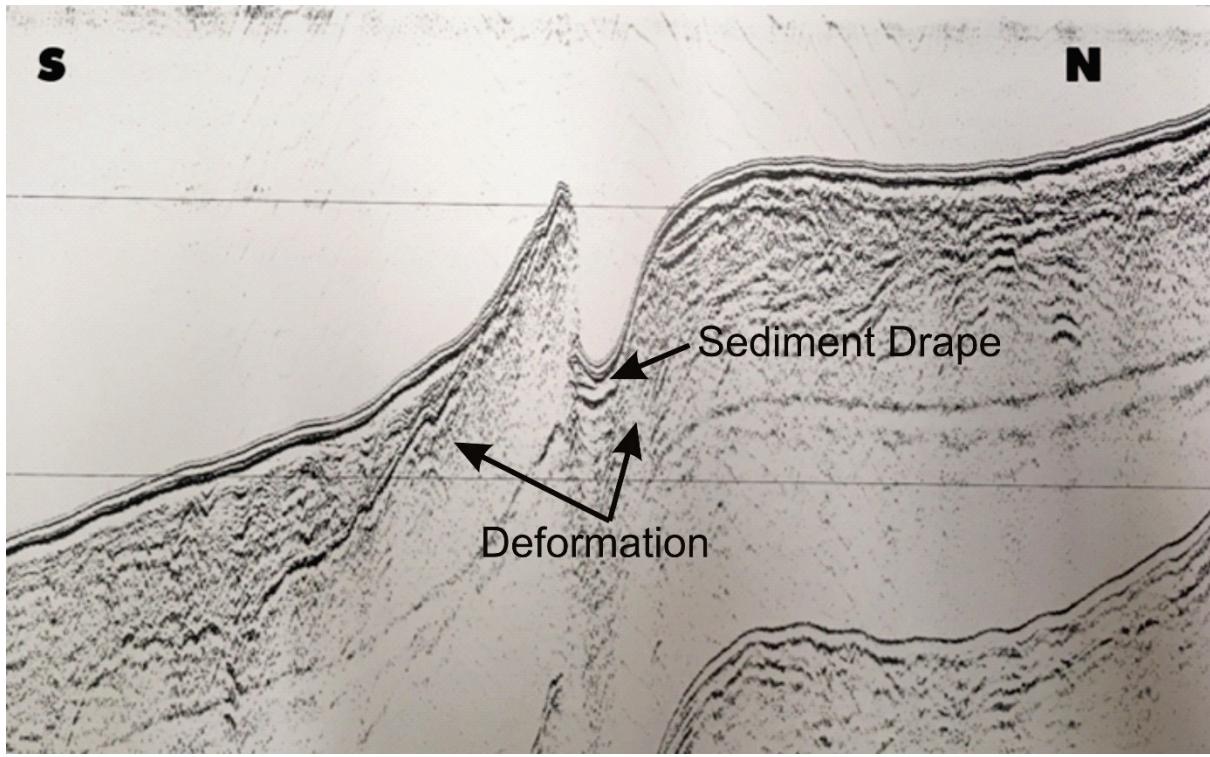
Sub-bottom seismic-reflection survey lines from previous marine surveys in the region by the Geological Survey of Canada in 2000 and 2005 are shown in Figures 5 and 6. Deformation can be observed in Figure 5 within both the south facing and north facing walls. In both Figures 5 and 6 sediment fill is draped within the depression between both walls.

Figure 5. Sub-bottom seismic-reflection profile collected in 2000 over scarp feature. Note deformation associated with north facing and south facing walls, as well as sediment draped in depression. Profile location shown in Figure 2.

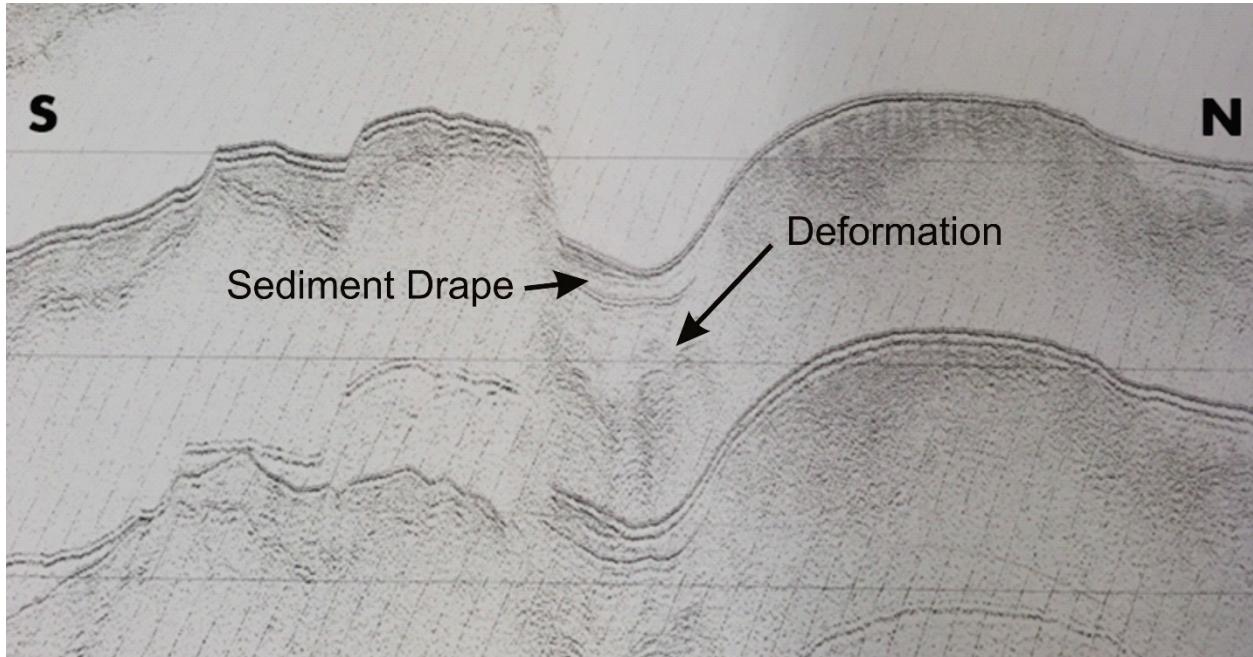
Figure 6. Sub-bottom seismic-reflection profile collected in 2005 over scarp feature (see location Figure 2). Note deformation in north facing wall and sediment draped in depression

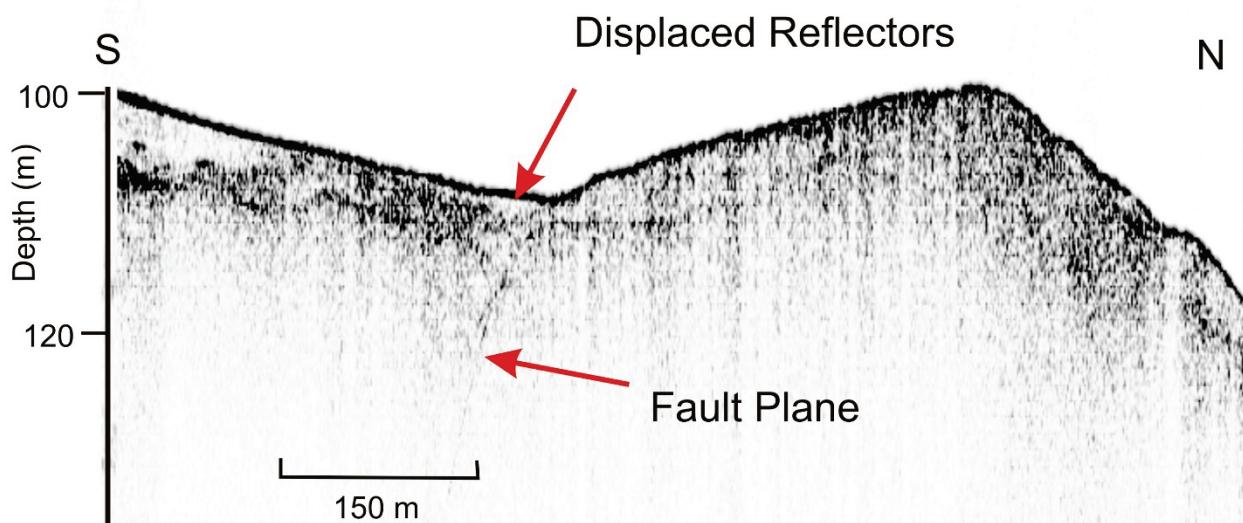
Though the September survey was limited, there is a strong indication of active fault deformation along the northwest – southeast trending scarp. For example, a survey line running normal to the structure shows both displaced reflectors and deformation along a steeply dipping fault plane (Figure 7). Another cross-section normal to the scarp displays an almost vertical face with deformation and displacement of reflectors (Figure 8), all strong indications of an active fault.

Figure 7. CHIRP seismic-reflection profile across the Cape Lazo Fault showing the near surface deformation and the steeply dipping fault plane. Profile location shown in Figure 2.

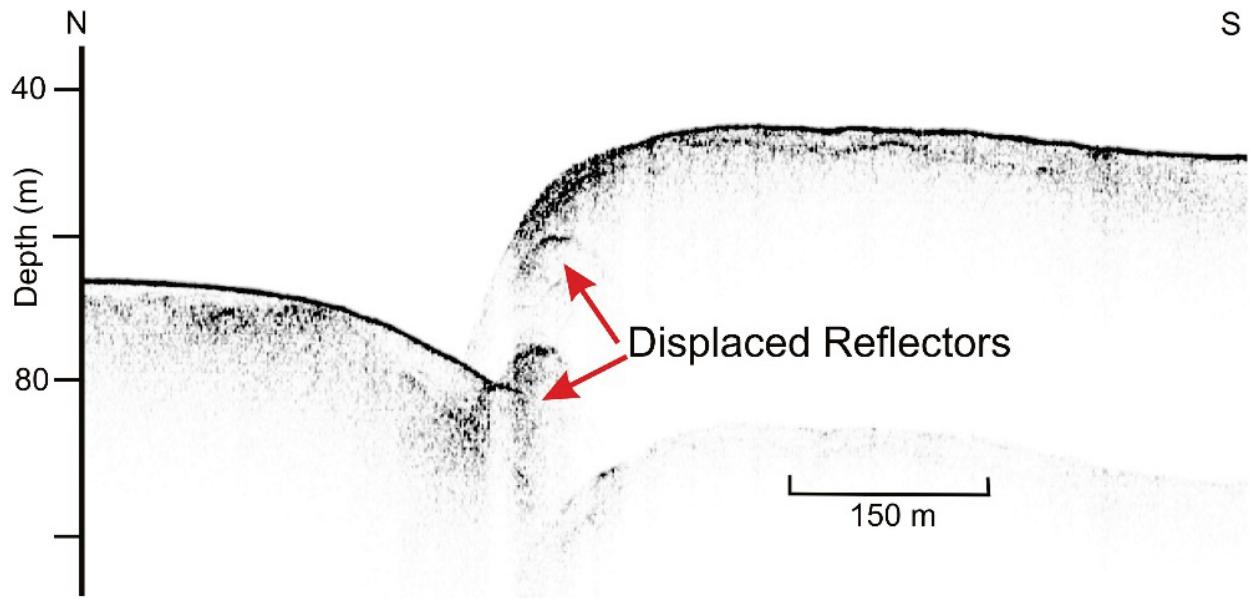
Figure 8. CHIRP seismic-reflection profile across the scarp that forms part of the Cape Lazo Fault, displaying the near surface deformation and near vertical south wall. Profile location shown in Figure 2.
