## Contaminated Aircraft Takeoff Tests for the 1998-99 Winter

**Transportation Development Centre**  
On behalf of  
**Civil Aviation**  
**Transport Canada**

October 1999

Peter Dawson and  
Medhat Hanna

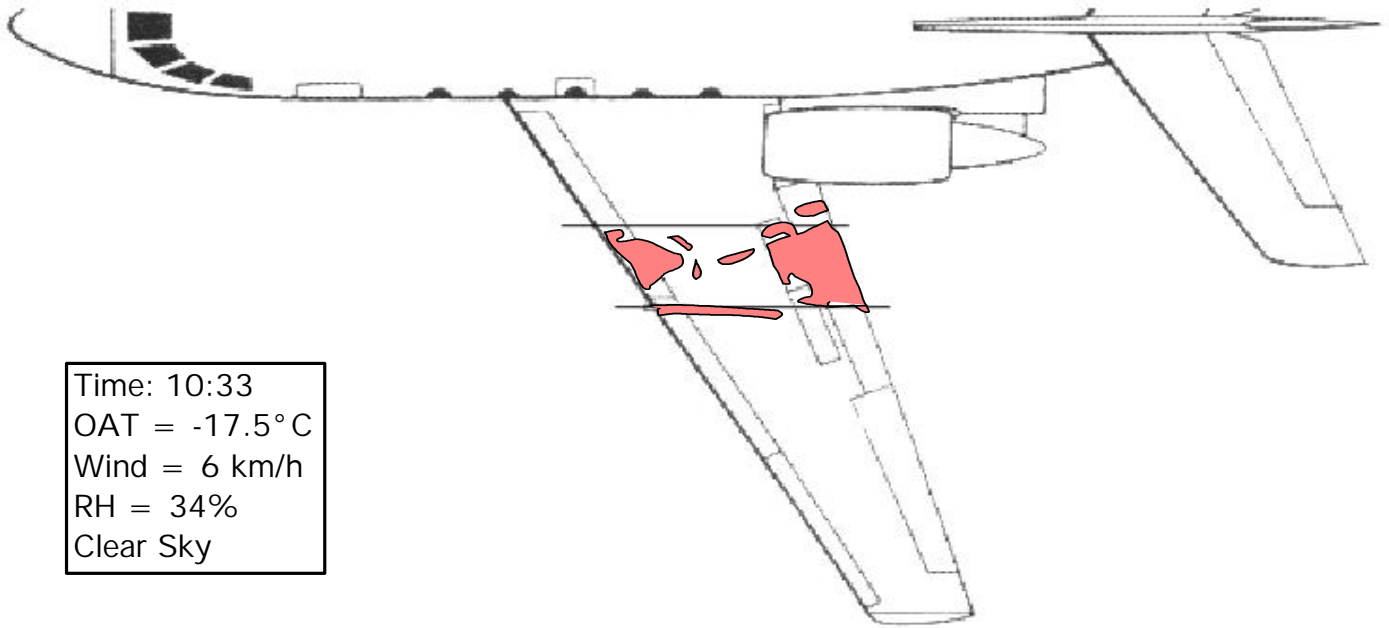
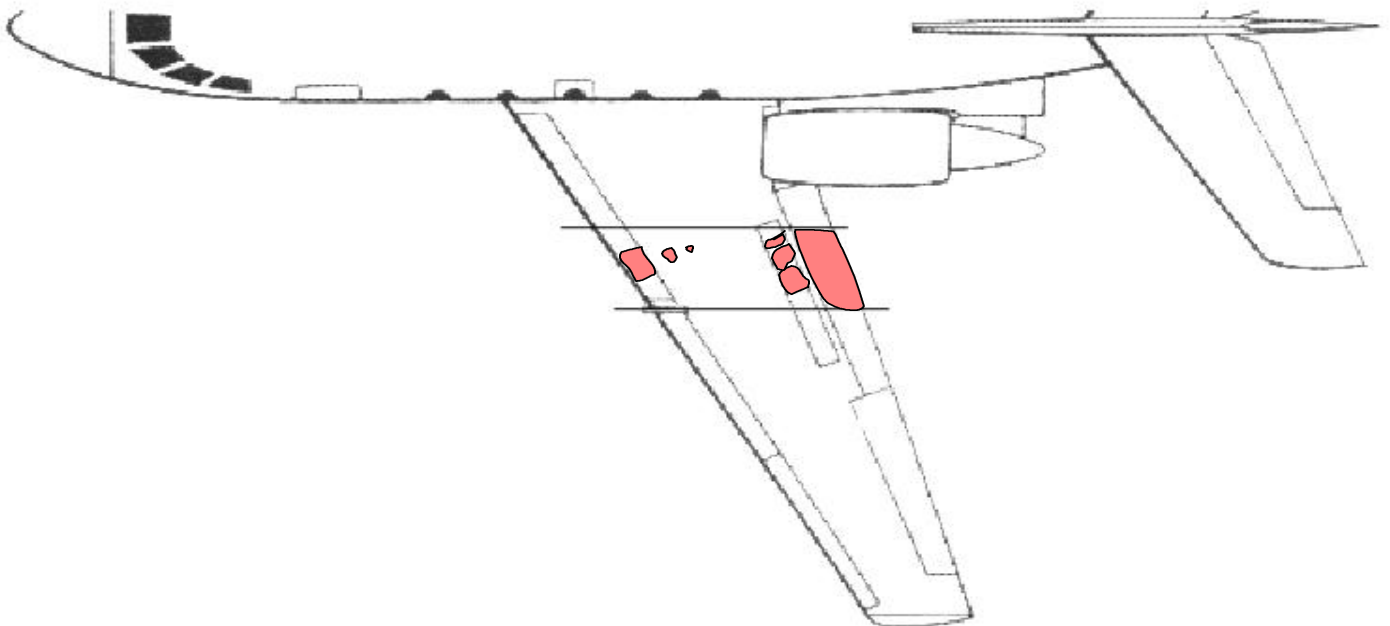
FIGURE 4.5

**Run 2 - Failure Pattern After Takeoff Run**

Ice formations at the rear of the wing remained adhered to the wing surface. Ice formations at the front of the wing could still be moved about on the wing surface and showed no evidence of adhesion.

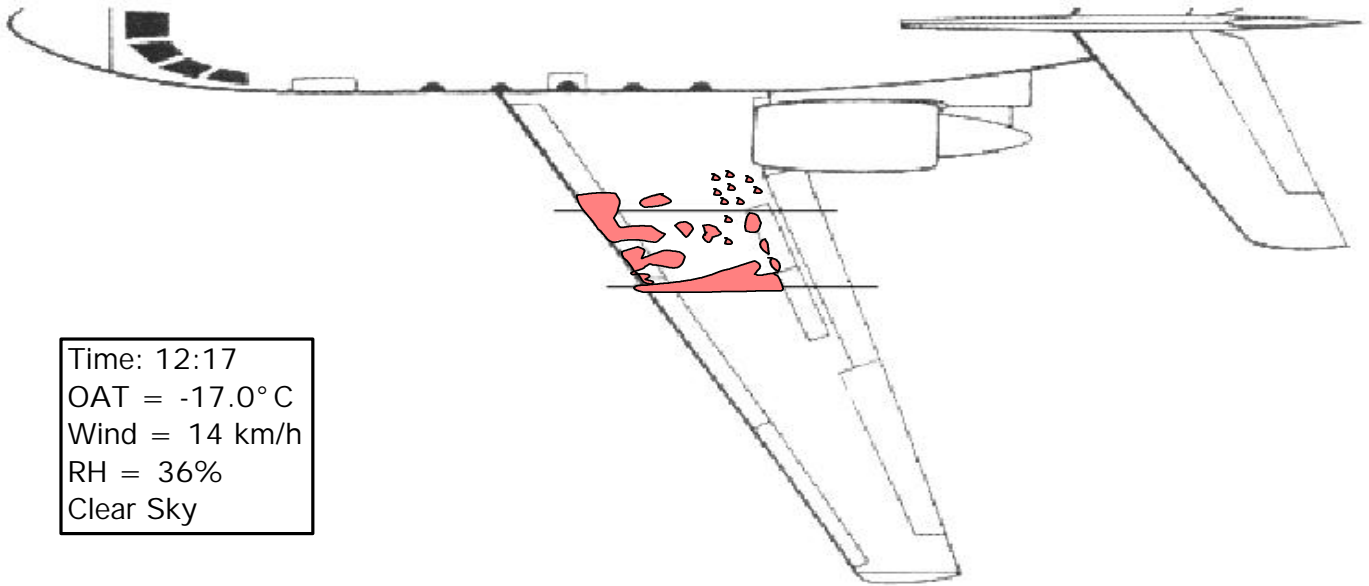
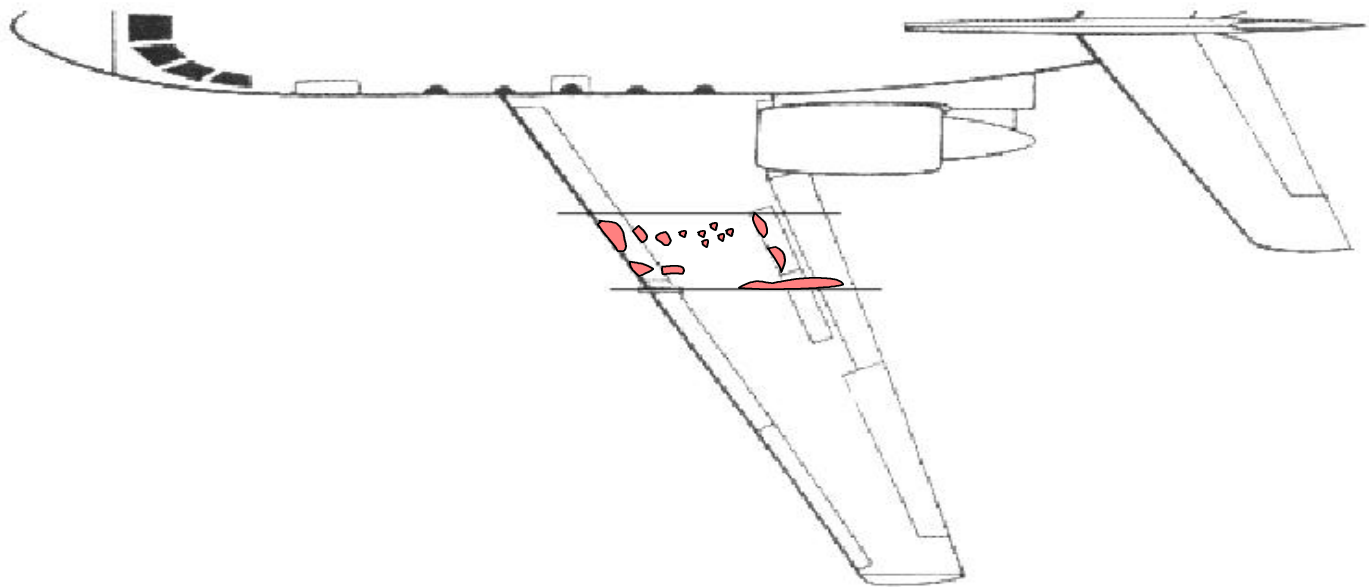
FIGURE 4.9

**Run 3 - Failure Pattern After Takeoff Run**

Where there had been no adhesion prior to the takeoff run there was now evidence of adhesion to the wing surface. This was the case both on the leading edge and farther back on the wing, just forward of the spoiler panel.

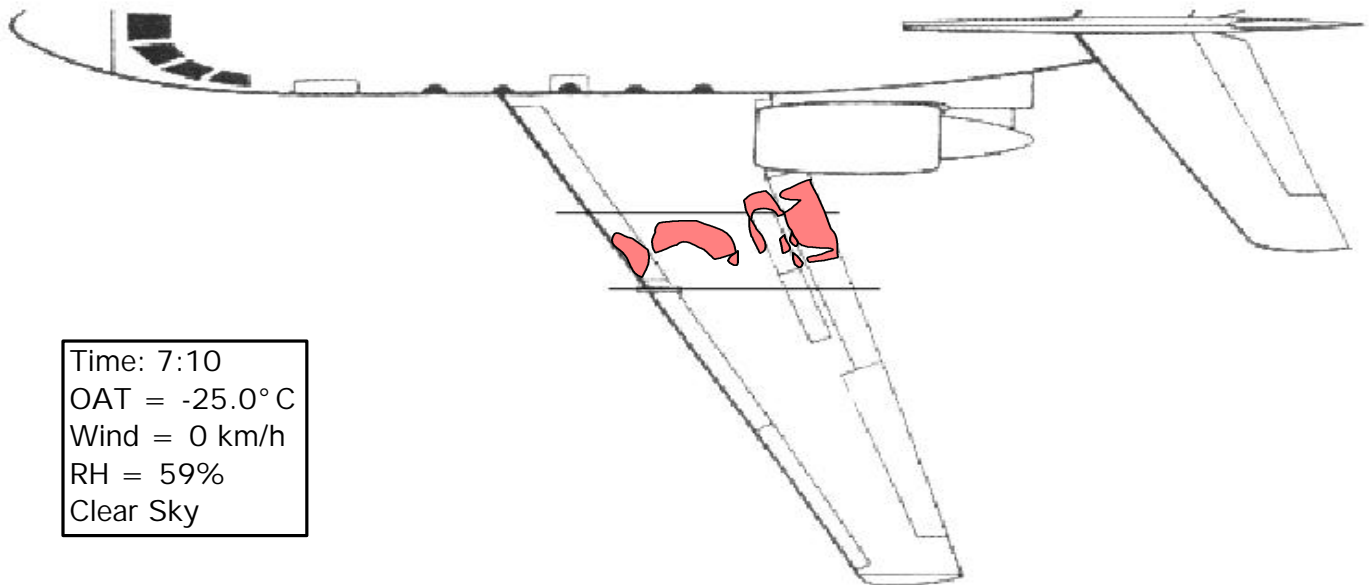
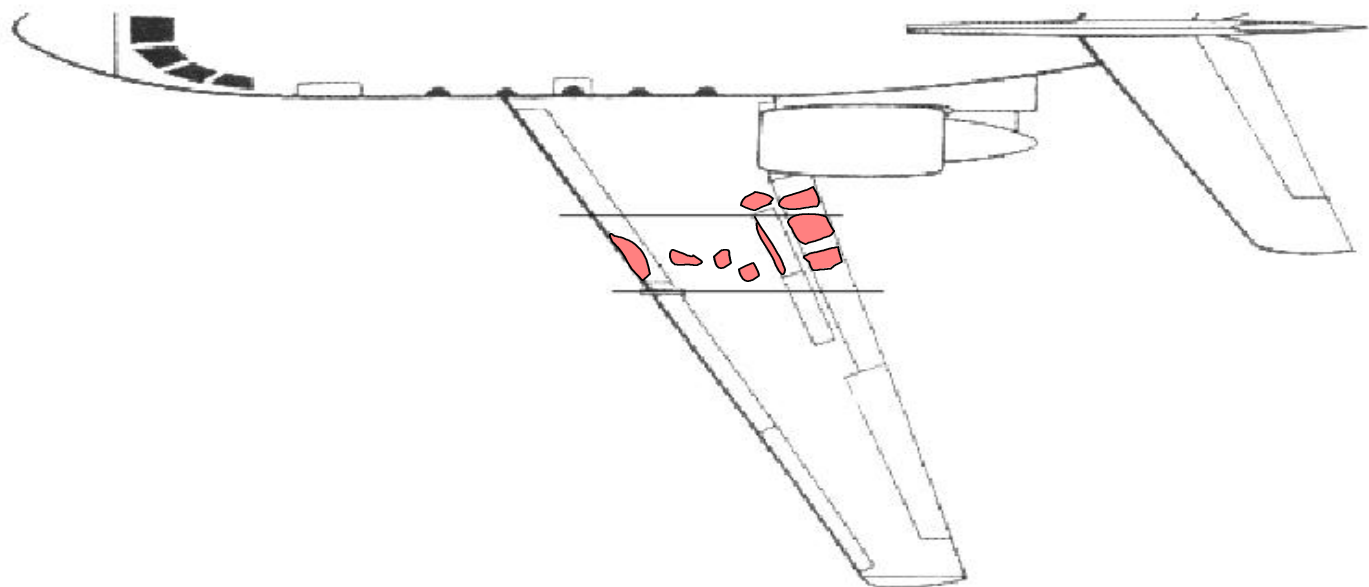
FIGURE 4.14

### Run 5 - Failure Pattern After Takeoff Run

Some contaminant adhesion was noted following the takeoff run. In general, the adhesion test instrument experienced more difficulty in carving through iced areas after the takeoff run.

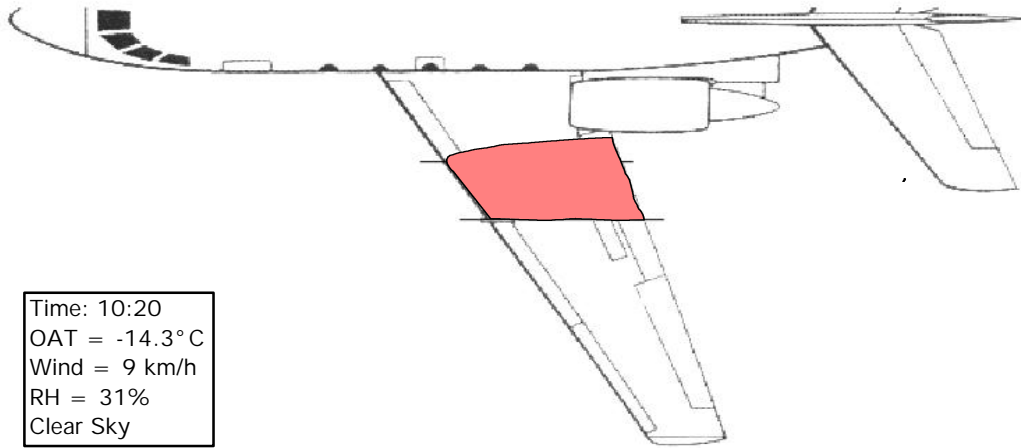
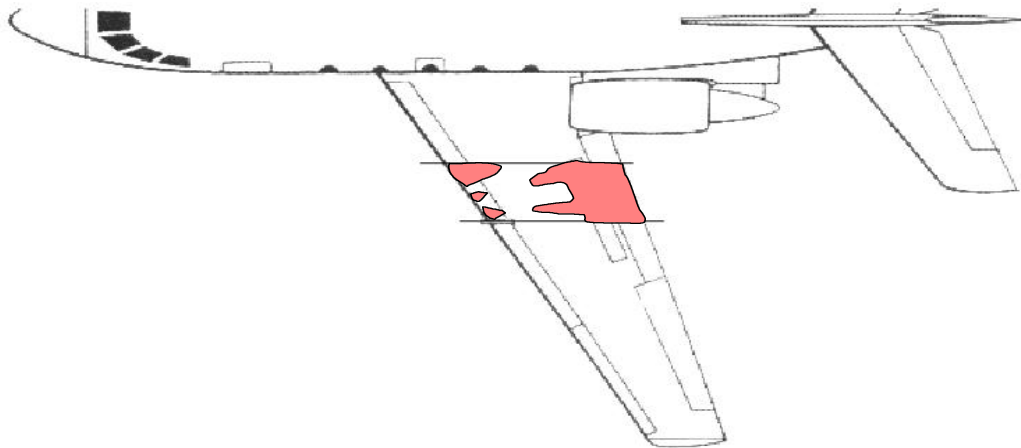
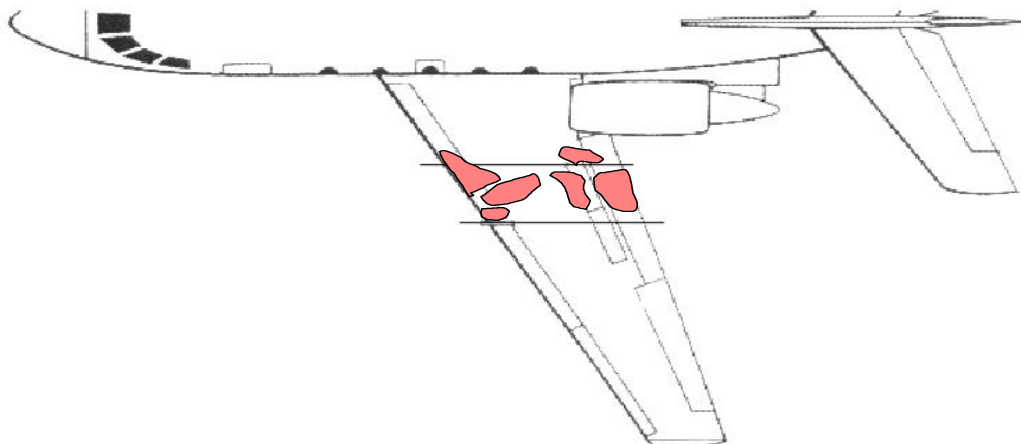
The pilot record indicates patches of ice distributed over the entire test area.

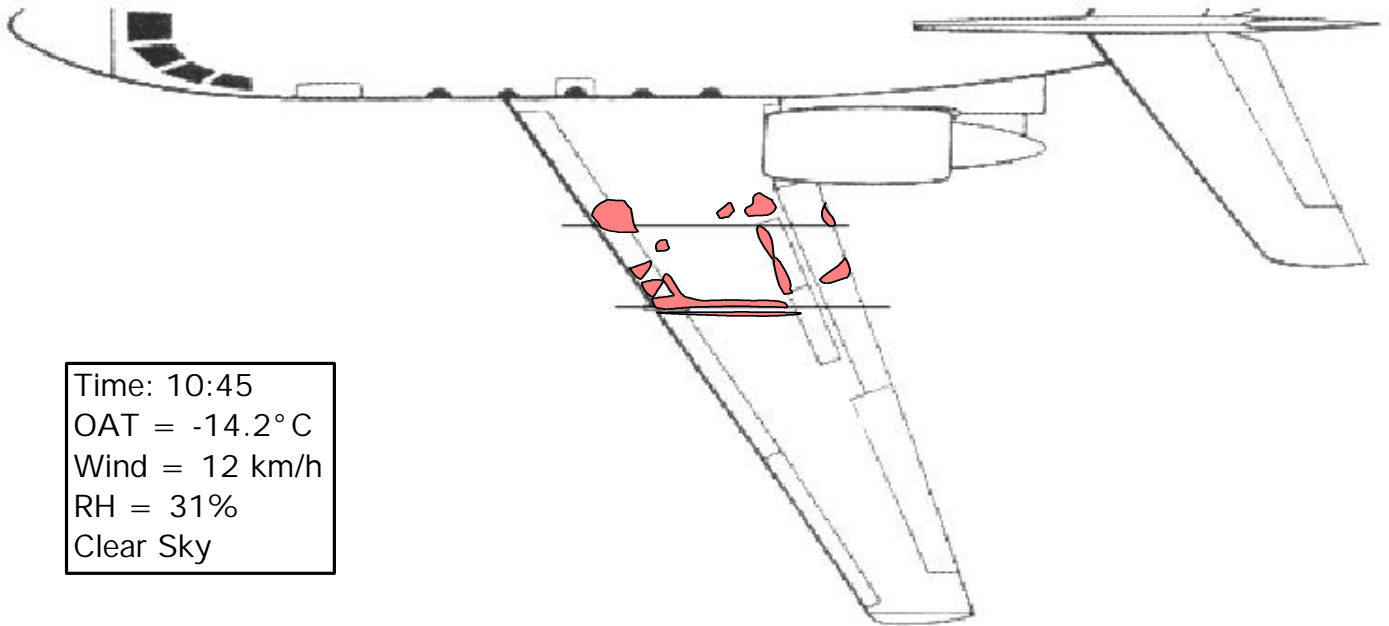
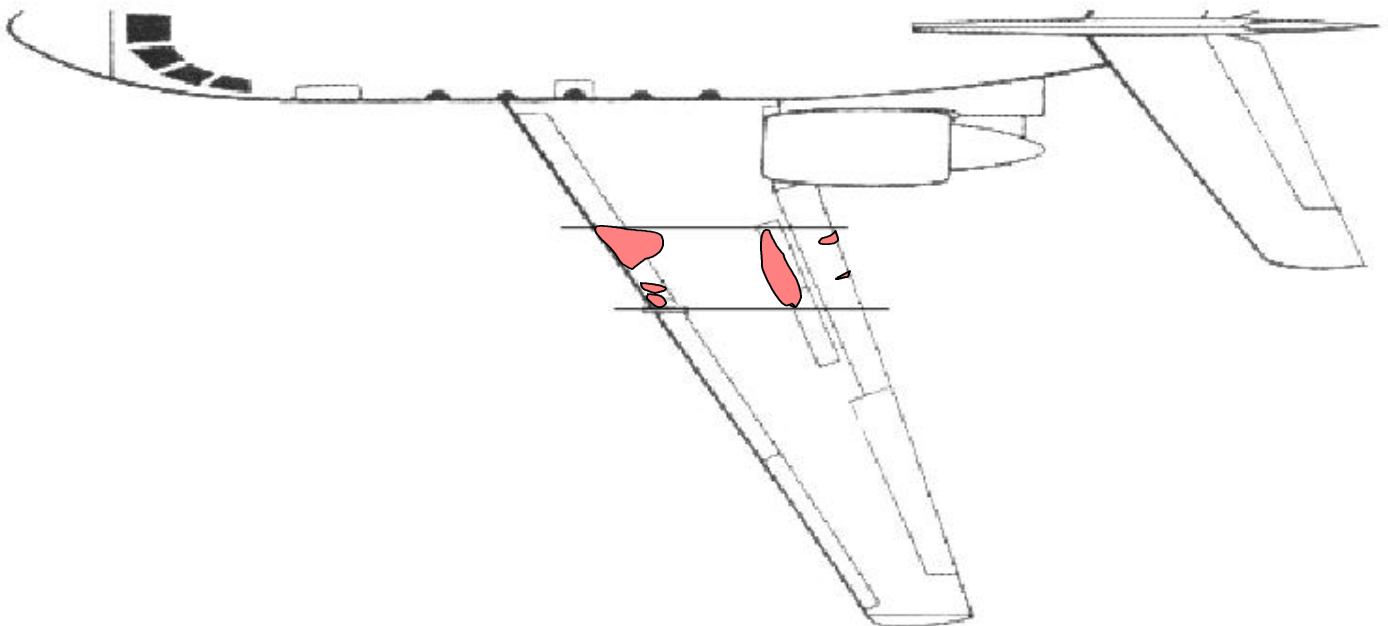
FIGURE 4.30

**Run 9 - Failure Pattern After Takeoff Run**

The cabin observer recorded the ice remaining on the wing surface as very similar to that recorded by the ground observer.

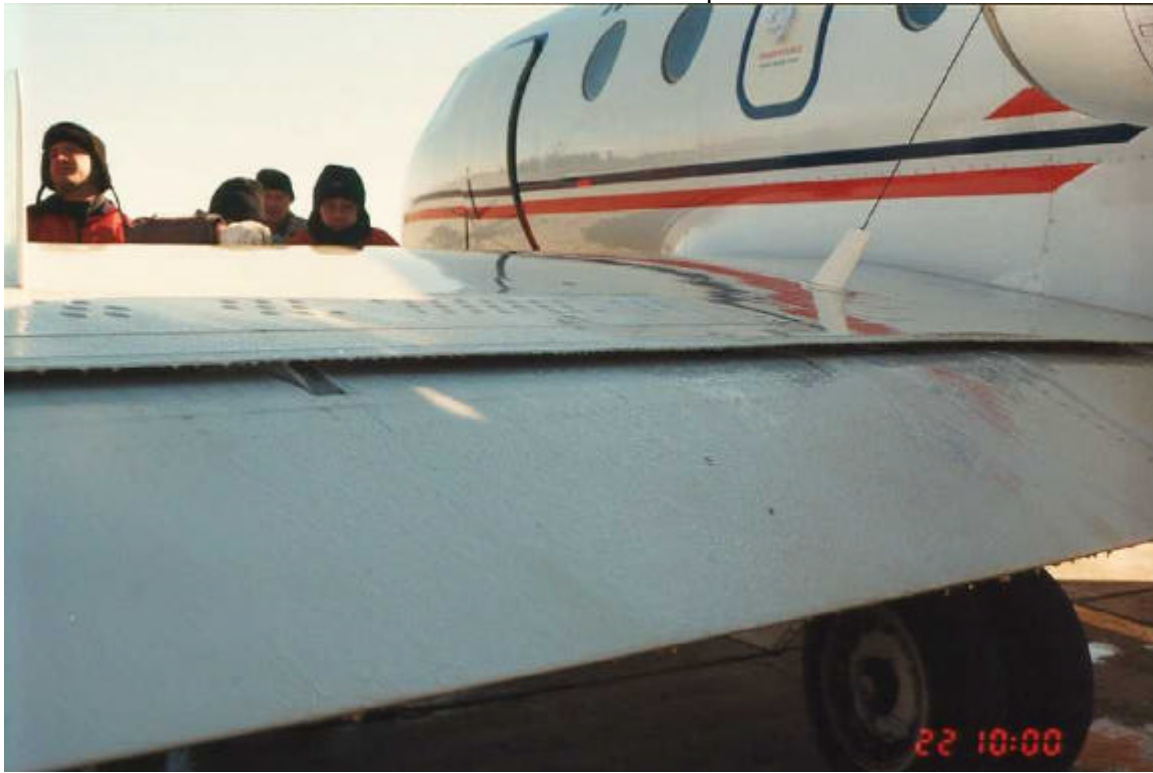
Photo Set 4.3  
Run 2 - Appearance of Fluid Prior to Takeoff Run  
Ethylene Glycol-Based Type IV Fluid at 25 Percent Contamination  
Failed Fluid on Flap

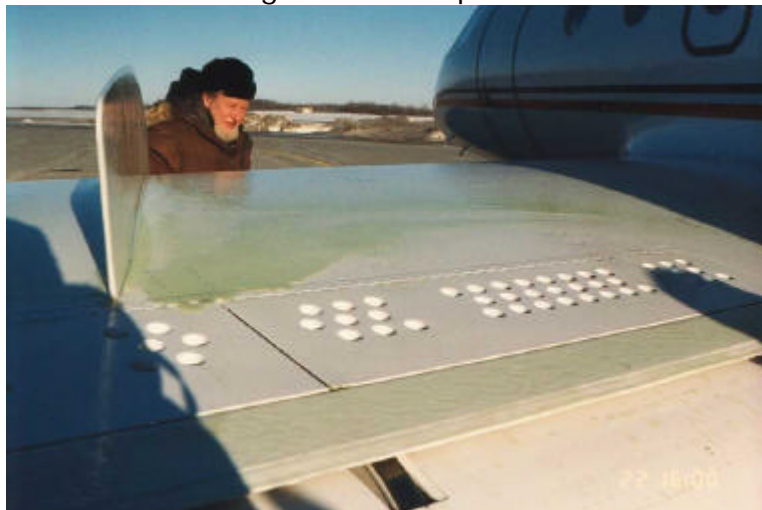
Puddling Ahead of Spoiler Panel

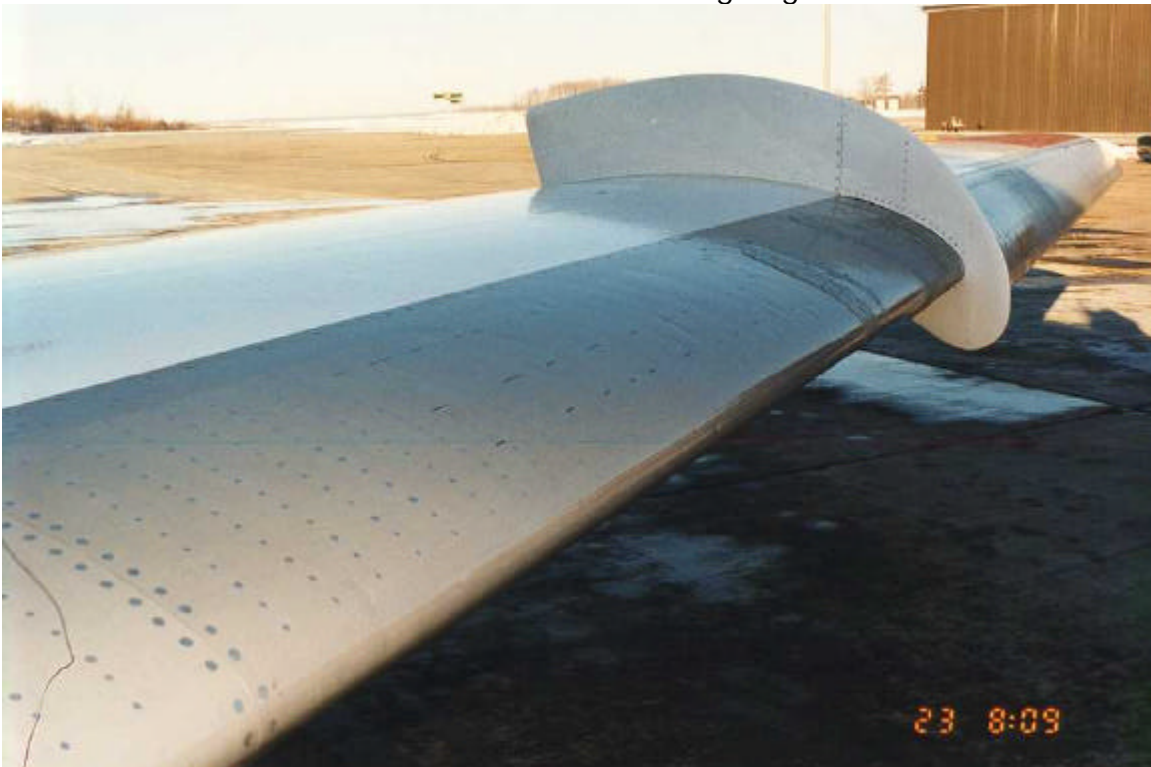
Ice Patches on the Leading Edge

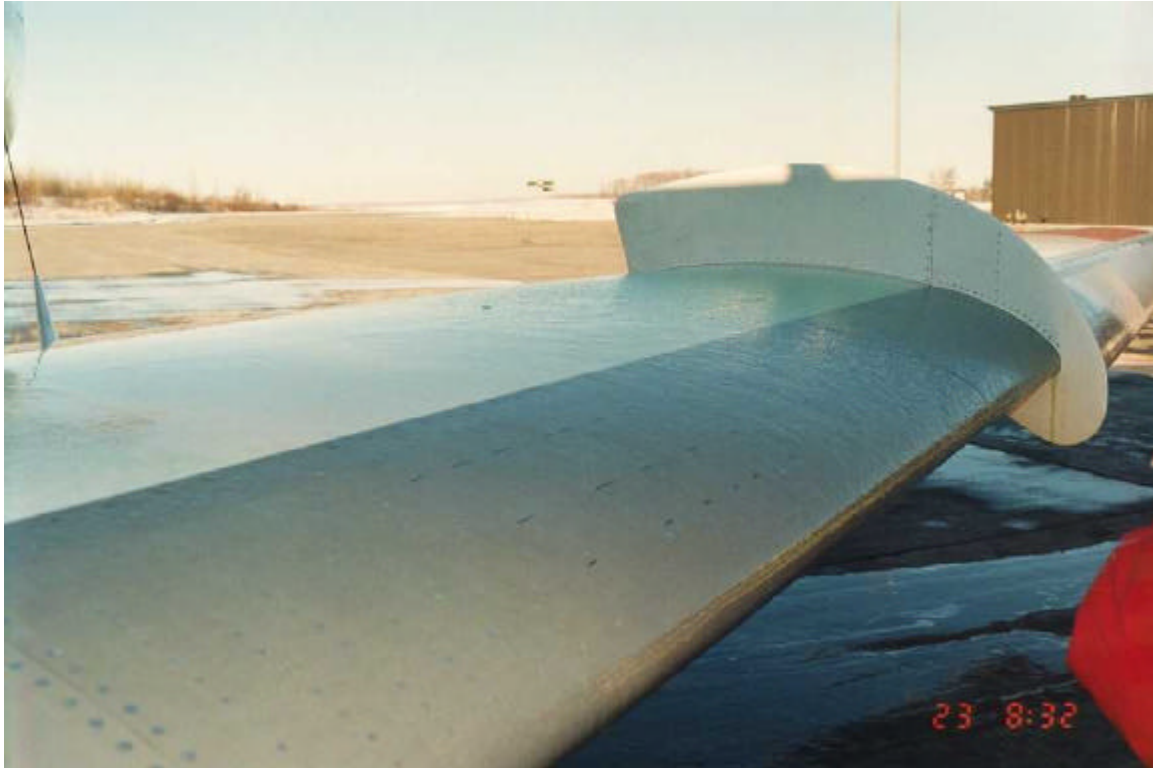
Photo 4.13  
**Run 7 - Appearance of Fluid Prior to Takeoff Run**  
**Propylene Glycol-Based Type IV Fluid at 100 Percent Contamination**

Fluid at 100 Percent Failure

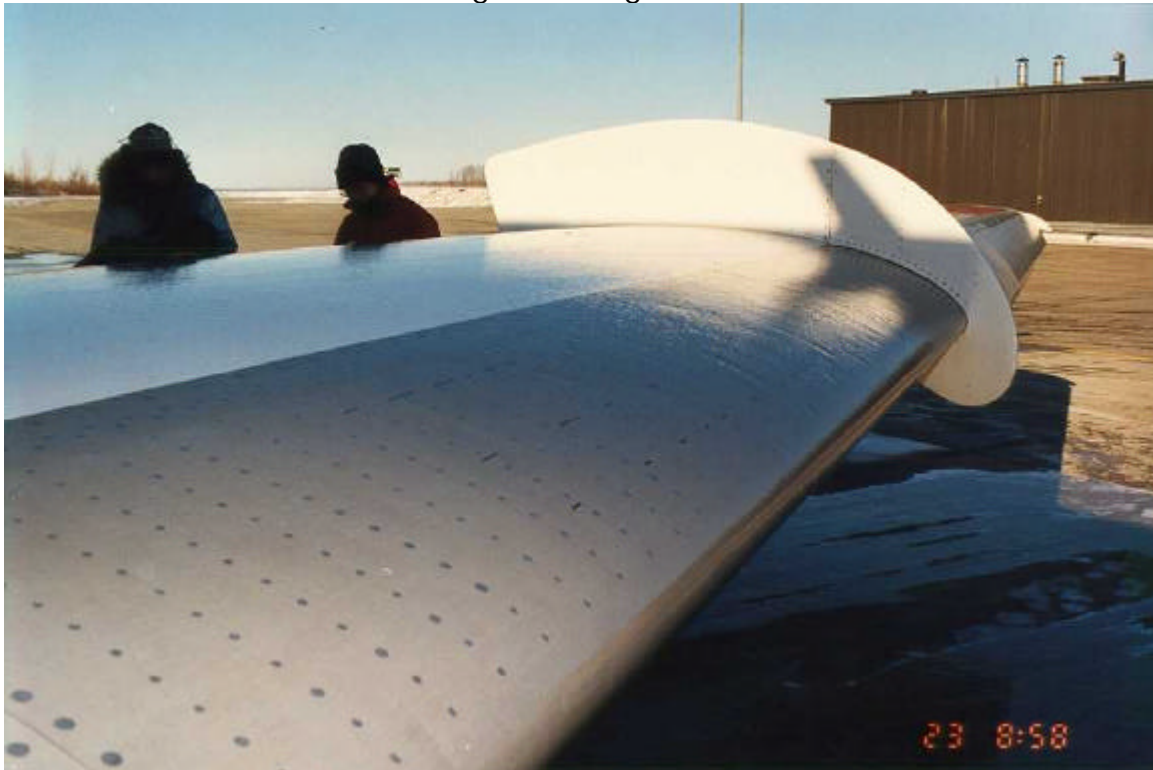
Photo 4.14  
**Run 7 - Appearance of Fluid Following Takeoff Run**

Clear Wing Following Takeoff Run

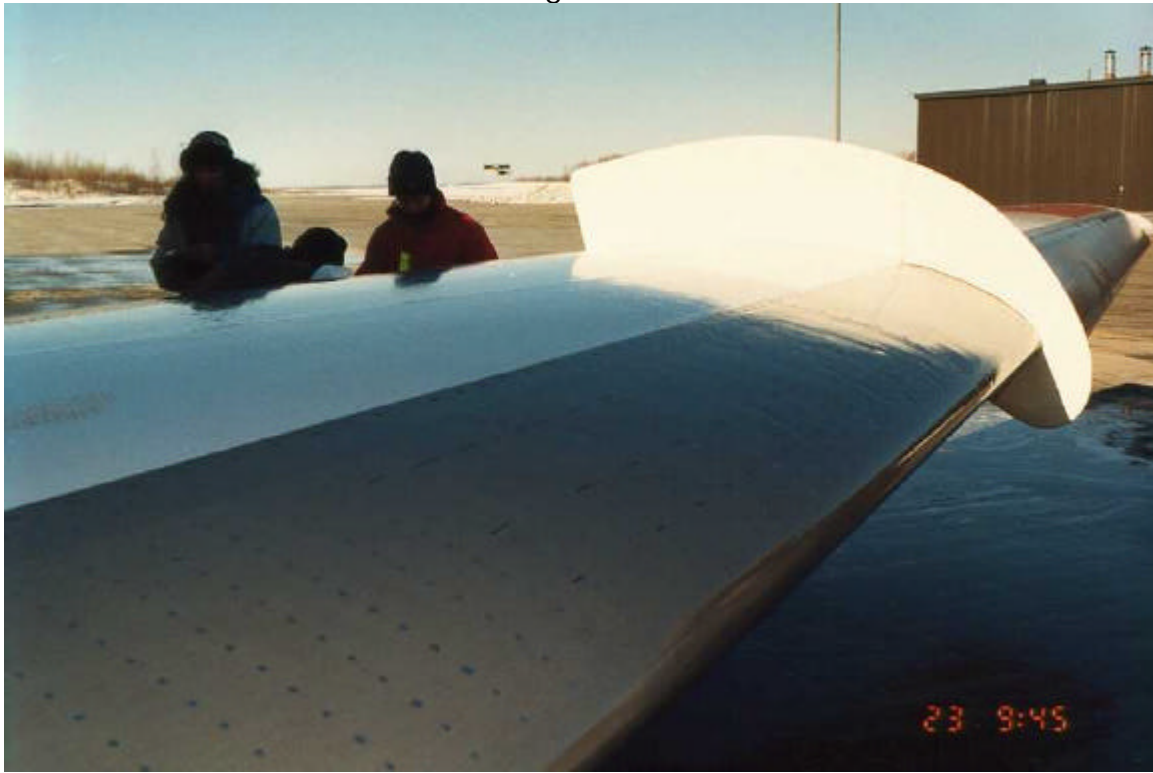
Photo 4.16  
Run 8 - Appearance of Fluid Following Takeoff Run

Remaining Ice at Seam
