Nanaimo River Chinook Salmon Recovery Plan Habitat Assessment Report

D. R. Clough

Canadian Contractor Report of Hydrography and Ocean Sciences 59

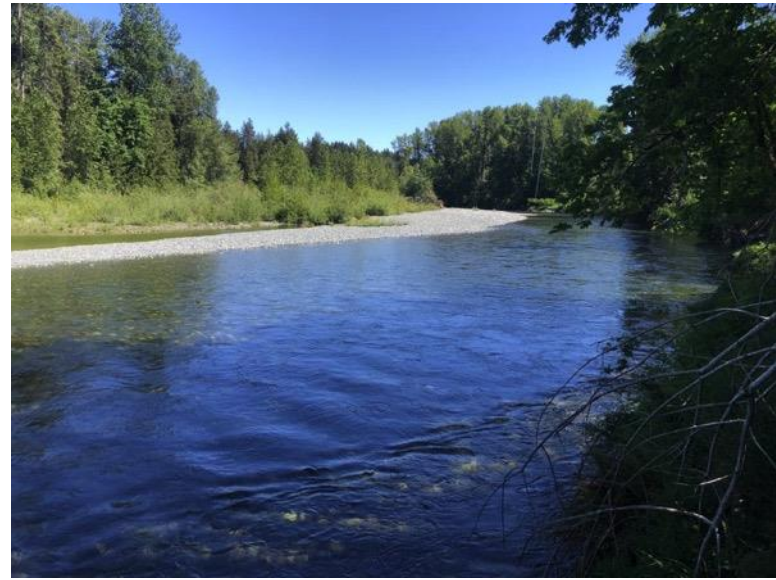
1.) Riffle 1 Placemark 7, Morden Trail head, clean gravel

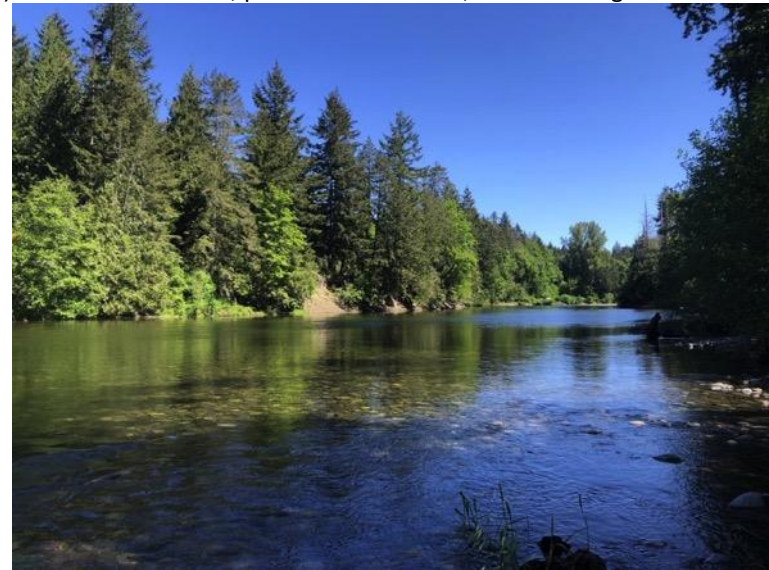
3.) Riffle 2, right bank island with dry flood channel and LWD.

A lack of LWD. There were only five second growth fir/cedar washed on to bars (Photo 3) in the 1679m survey length. These logs offer bar stability but little fish cover. No old growth size logs were observed.

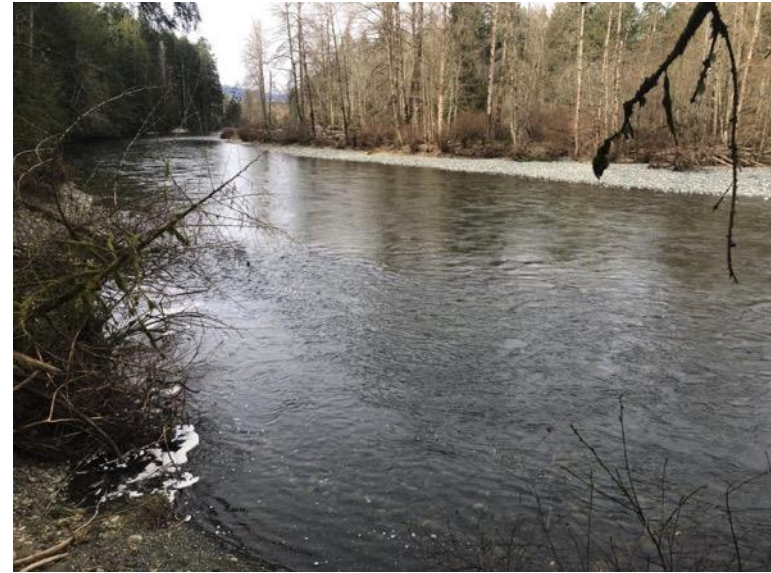
1.) Riffle 1 looking downstream with Haslam Creek on right

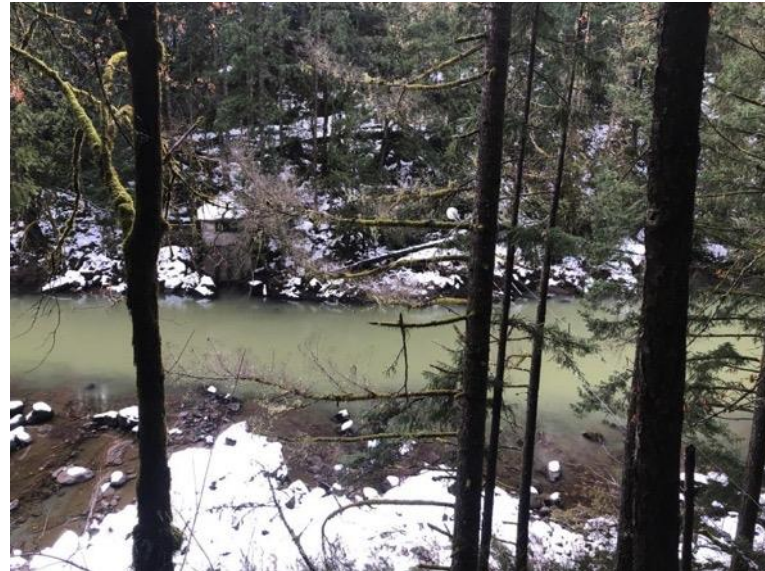
3.) R4 – Glide 2 at potential spawning gravel site.

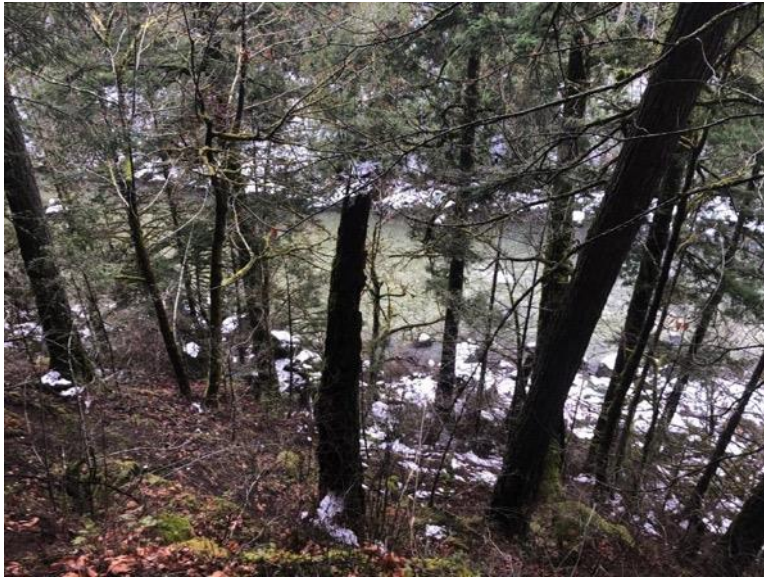
5.) R4-Glide 1 along steep but stable riparian zone left bank

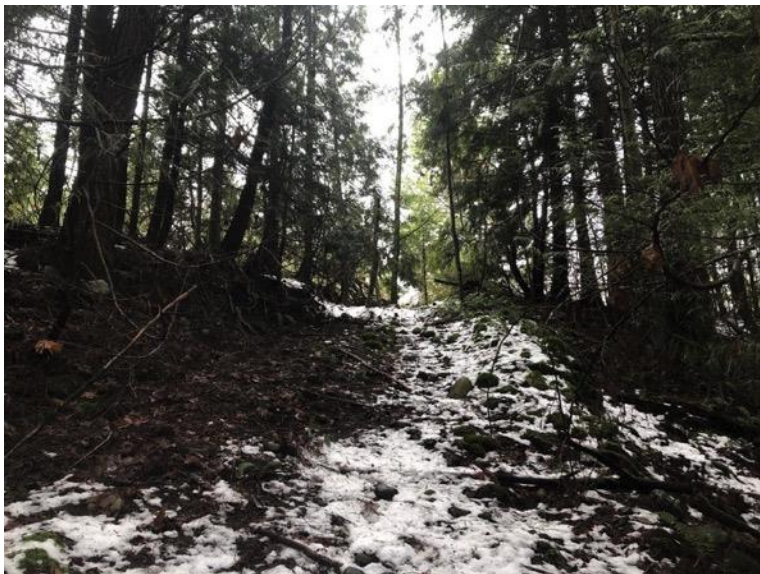
7.) R4-One of two old logging roads on left bank along the trail.

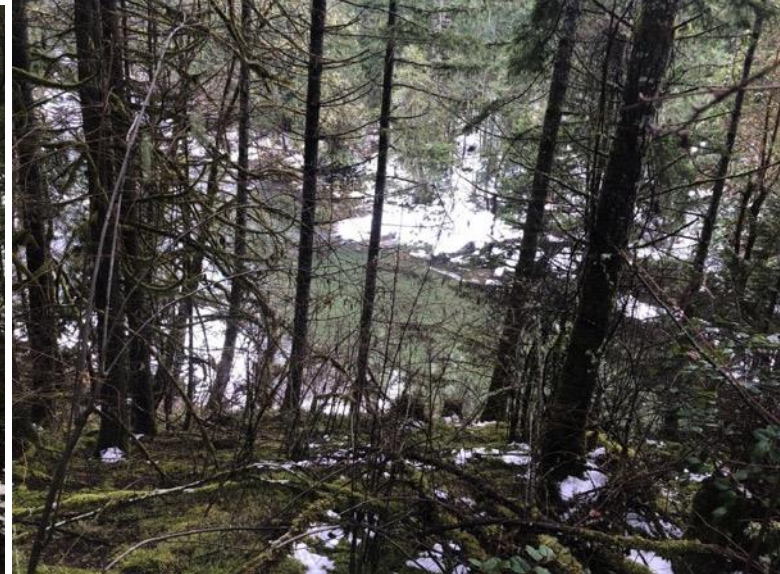
8.) Reach 4 – Pool 1 at top end has steep banks.

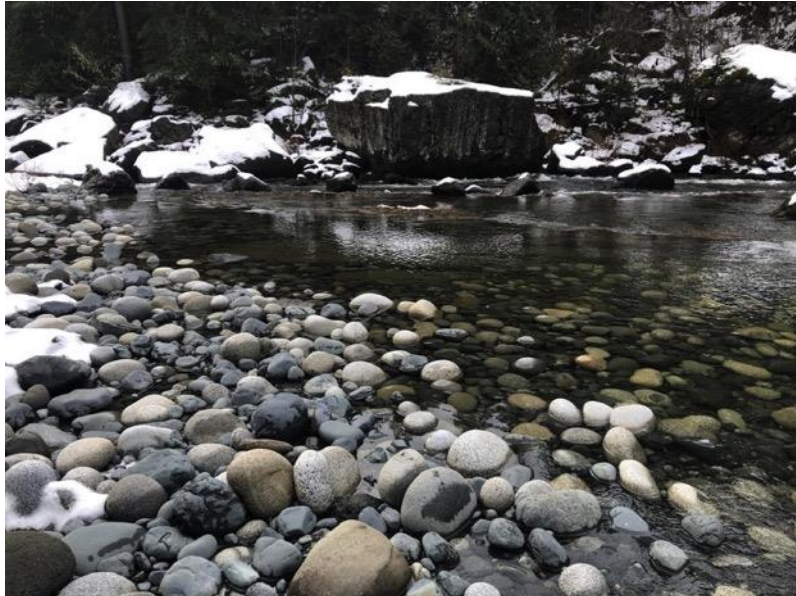
3.) R5 –Riffle 1 start has cobble/boulder crest, no gravel, no silt.

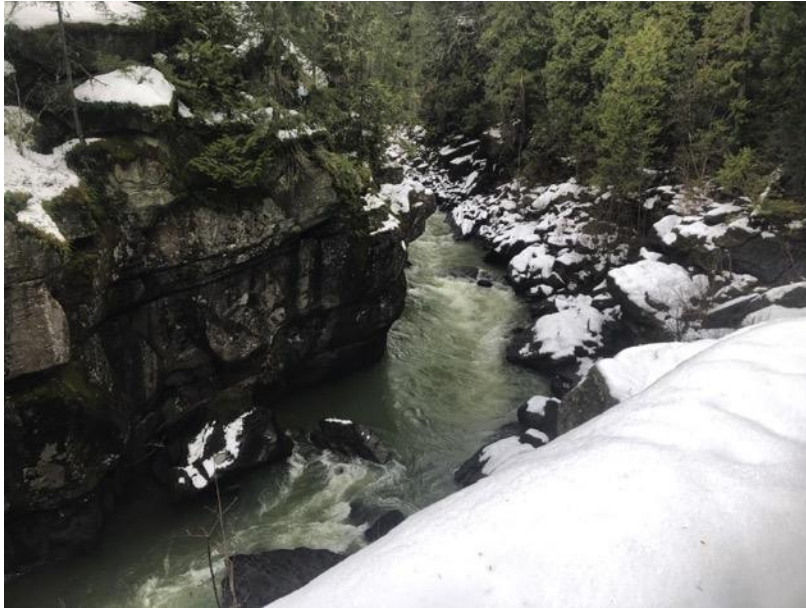
5) R5 – Pool 3, note 15 m high scour line on bedrock walls

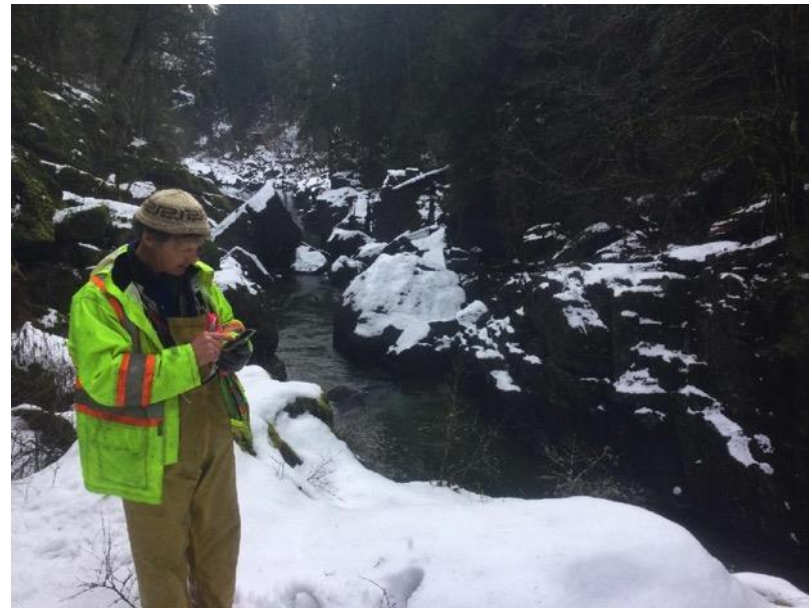
6) R5 - Glide 1 is 100m long narrow (23m) confined in bedrock.

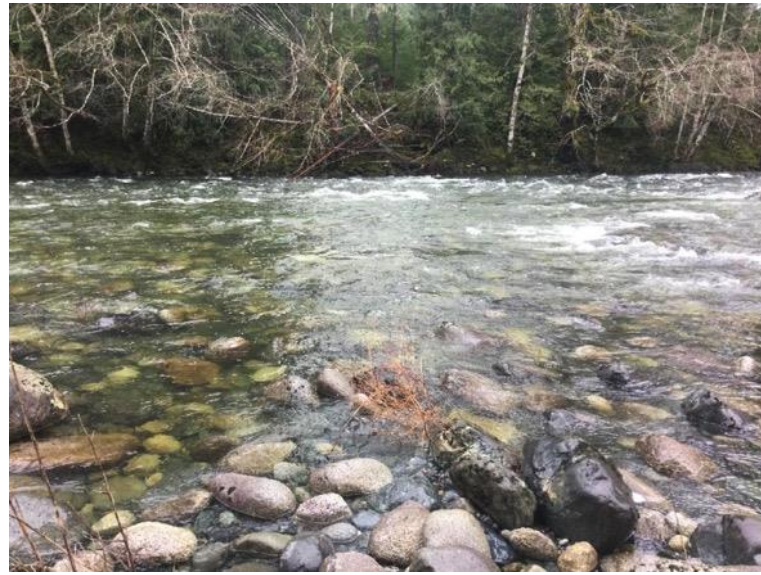
2.) R12 –R1-Riffles were 0.5m deep, some boulder cover

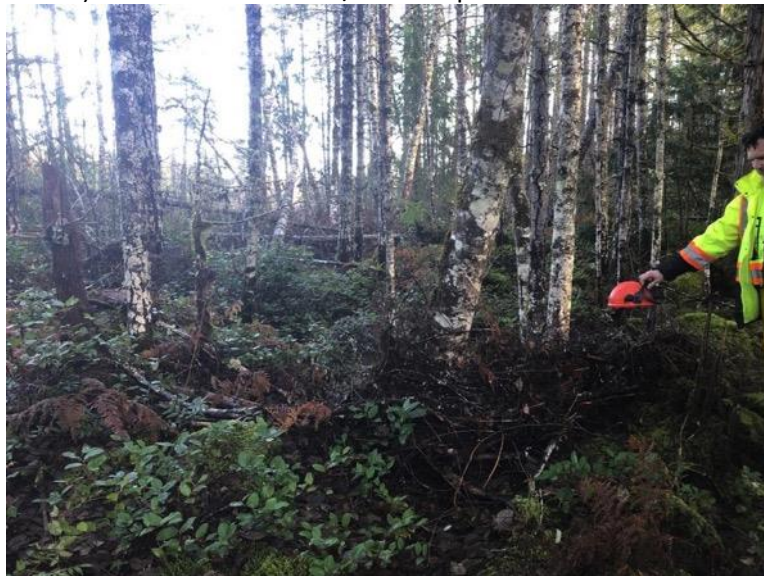
3.) R12- Glide 2 -LB riparian is flooded to 1.0m, uprooting trees.

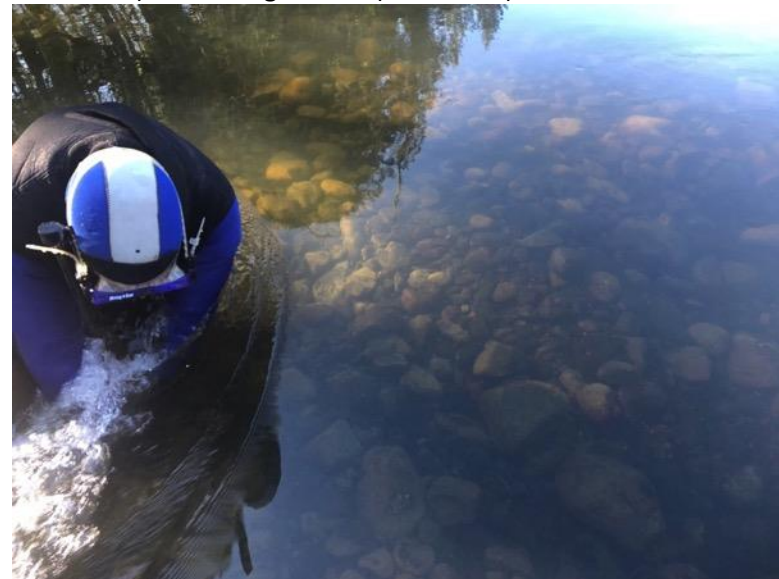
3.) R14 – Pool 3 had the highest LWD Count (4)

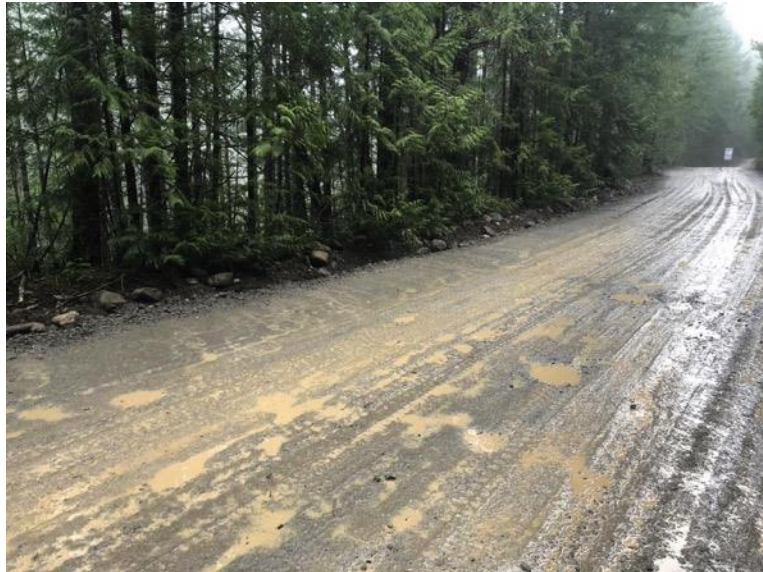
3.) Road is 10m from river, note grader berm on river side

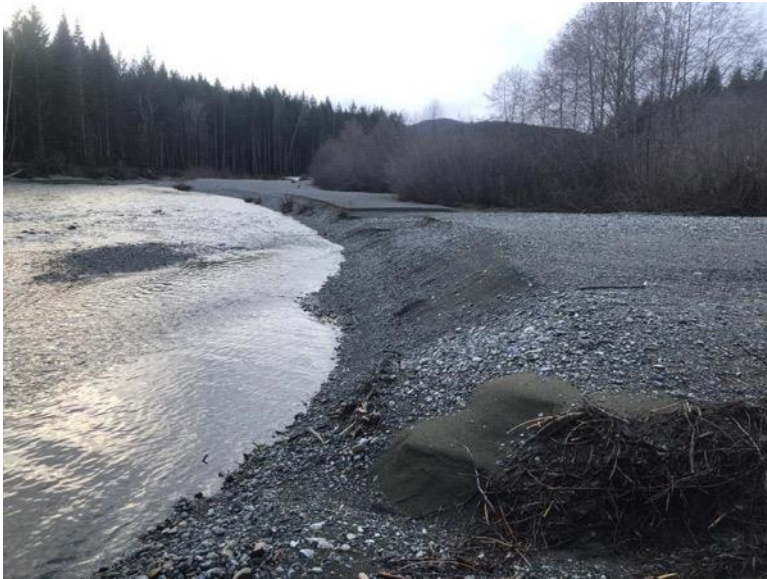
1.) R22 - Riffle 3- gravel bar needs planting

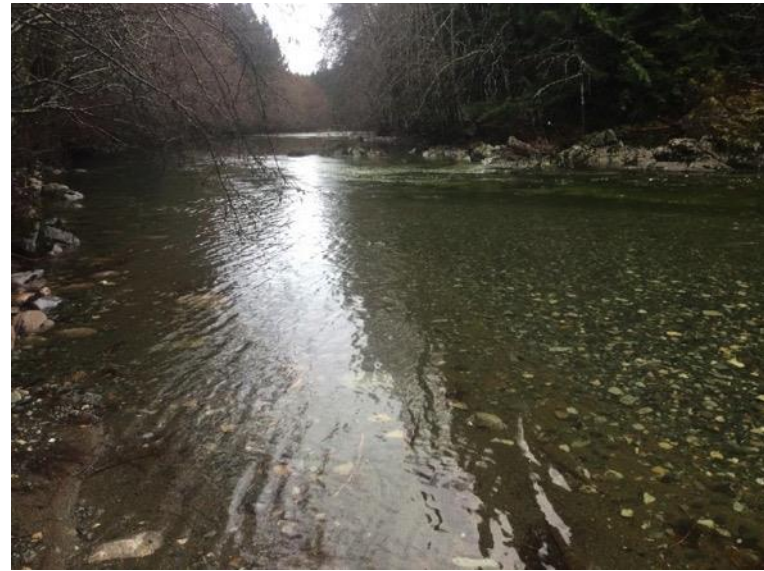
2.) R23 – Pool 1 is the only pool and lacks cover.

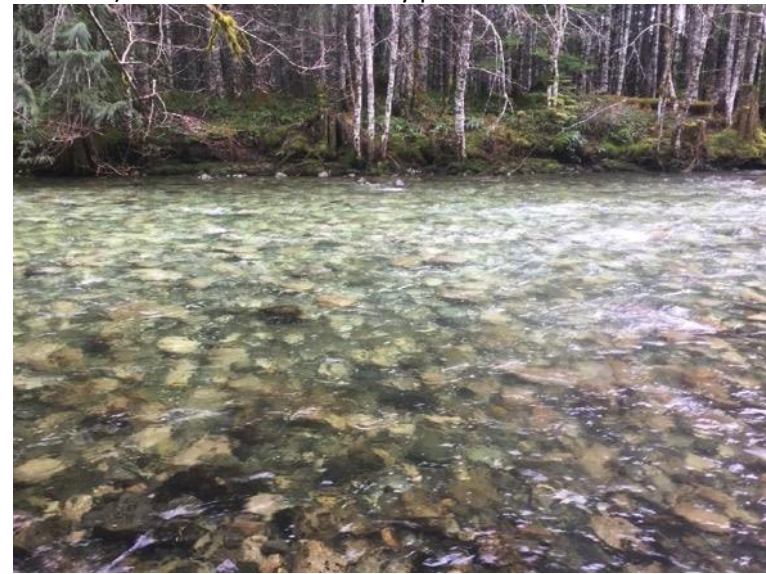
4.) R23- Riffle 2 showing relatively stable banks

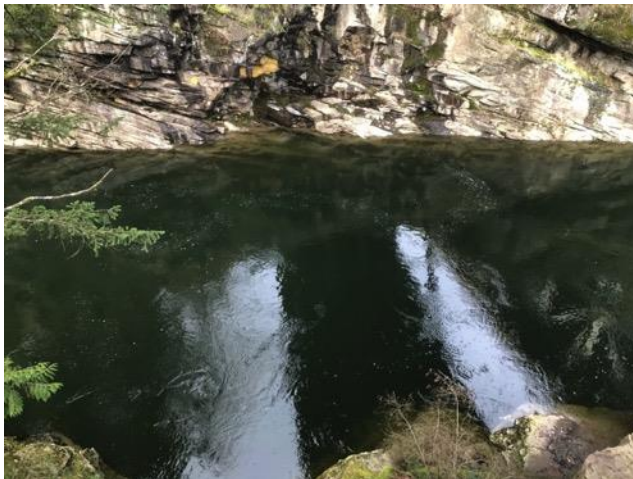
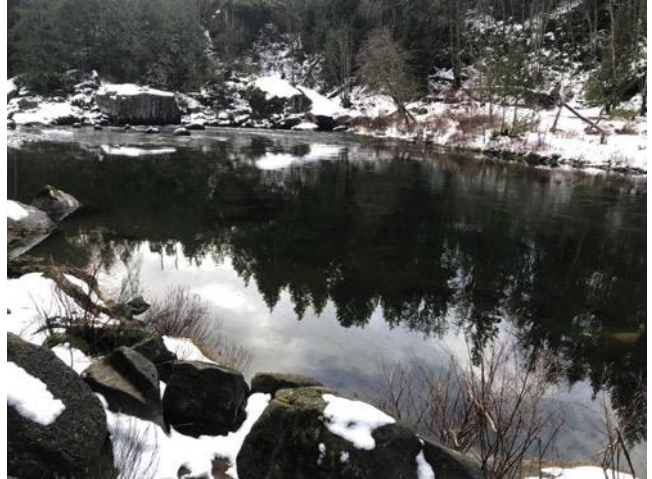
Pool Area scored poor (<40% wetted) throughout the survey except for Reach 4. Pools are made up of residual depth against a crest through scour or dam effects. The deepest pools observed in the survey were formed from bedrock found in canyon areas of Reach 4 and 5 not in the open alluvial areas of the other reaches.

Deep Bedrock controlled Pools in Reach 4 and 5

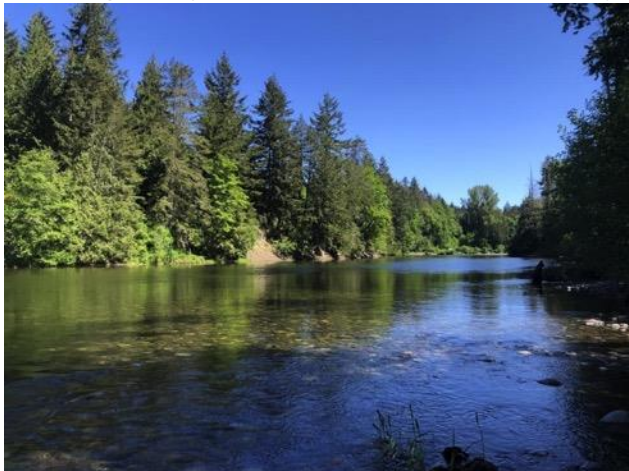
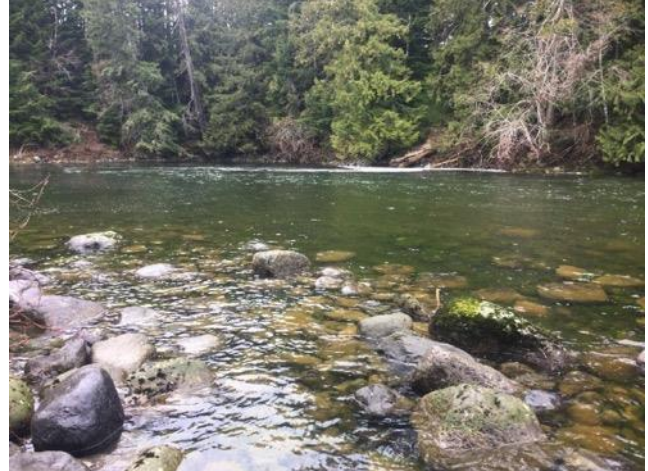
Channel meander and bed scour produced most of the pools in the other reaches. The scour pools were shallow (2-3m deep) and most lacked any permanent device to maintain depth or hold the crest in place (Bedrock, Rooted cutbank, LWD).

Reach 2 shallow gravel scour pool above Morden Trail Reach 13 corner Pool 1 at 180° bend in river.

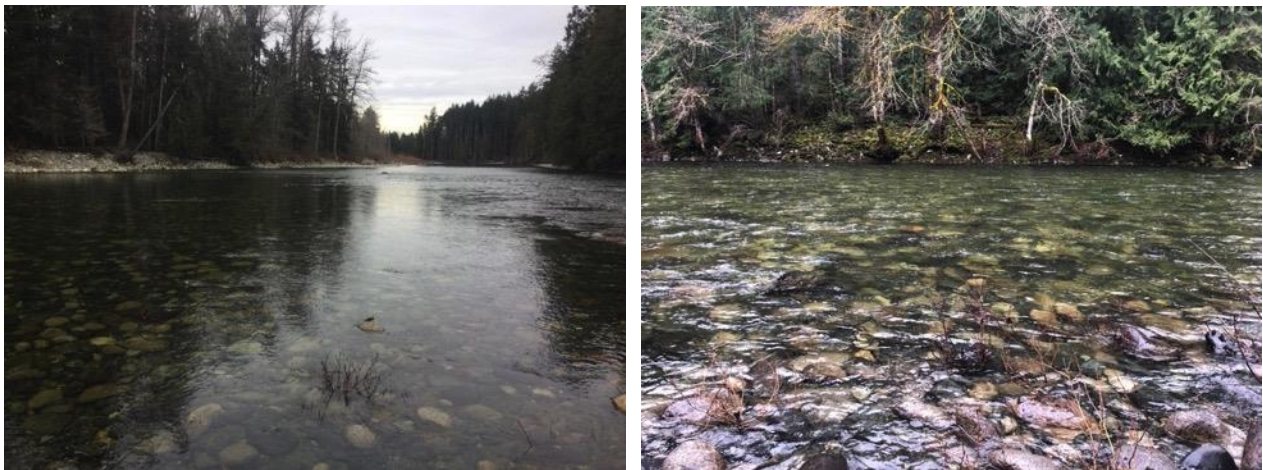
Pool area has been lost to sedimentation. In Reach 2,3 and 22, many pools were filled in by sediment deposition. There are locations in these reaches where the channel sediment deposits are now the same height as the banks forcing flood waters to migrate into the floodplain resulting in more erosion.

Reach 3, Glide too shallow to be a pool. Reach 12 Glide once a riffle before the gravels washed away.

Restoration of pools would require devices to scour or trap and hold substrates. Pools are created by installation of logs, rock groynes or rock crests in the channel. The instream devices have to be able to sustain against such forces as buoyancy, water velocity and debris impacts. The reaches of the Nanaimo River certainly require more and deeper pools but creation/improvements to pools would first require a hydrological assessment by river engineers. Standard biological prescriptions used for smaller/healthier streams are not applicable to the Nanaimo River due to its size and condition. The Nanaimo River appears to be in a state of flux on pool and riffle habitat. The upstream areas are degraded and lack structure to rebuild, while the lower reaches are aggraded with excess gravel. These impacts are in similar locations on the east coast of Vancouver Island in rivers such as the Cowichan, Koksilah and Chemainus. Restoration along these rivers included the removal of sediments and stabilization of banks. These prescriptions first require the river engineering studies of the river.

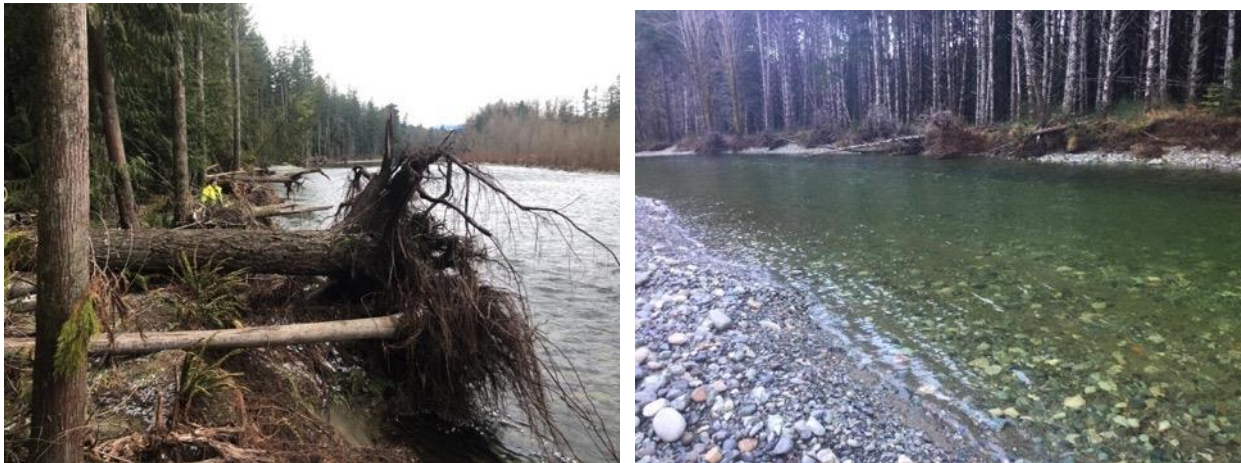
The reaches (R3 & R22) that had the higher counts of LWD, were found in unconfined areas where the eroding banks had dense stands of second growth fir. Unfortunately the LWD recruited from the forest is poorly anchored and passing through with flood events. The mid and upper reaches were less populated with LWD. Reaches with more confined banks of bedrock, boulder and cobble with less meander lack the conditions to trap or hold LWD. High water level/velocity easily cleans the banks of any LWD. Old growth LWD is heavier and longer and would have offered more functional cover but it was not observed anywhere in the river.

LWD is rare, small and poorly anchored throughout the river; observed in Reach 3 & Reach 22

Restoration of LWD was identified as an opportunity in Reach 3 and 22 where there are low eroding treed banks. Stabilizing the second growth felled trees along these wide reaches was ranked medium. The prescriptions for LWD anchoring would involve burying and/or rock ballasting the trees along the banks.

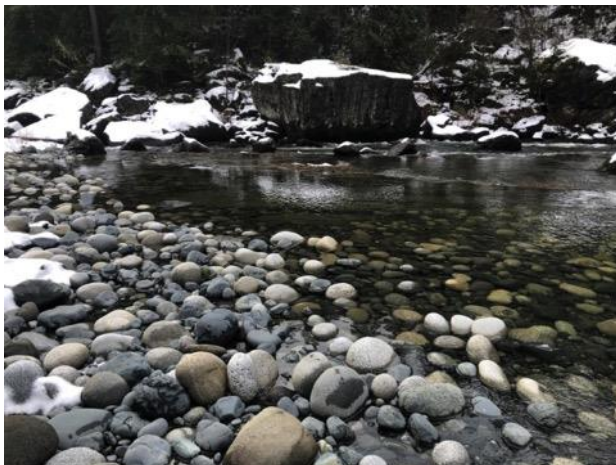
Reach 4 Boulder Riffle in canyon

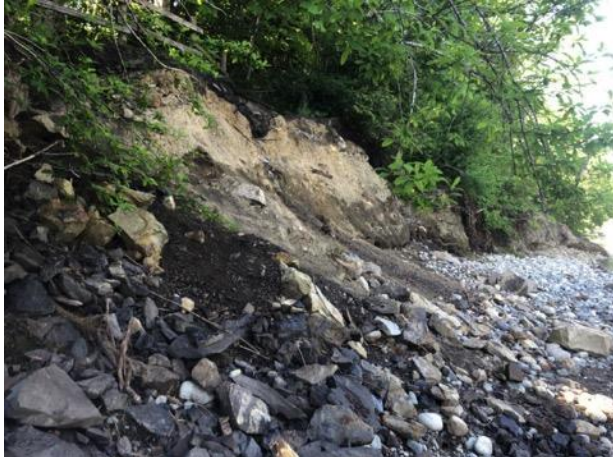
Reaches 2, 3 and 22 had Poor scores for erosion. They had 55%, 33%, and 20% respectively of their reach lengths with bank erosion. These reaches had banks of gravel with inadequate tree root protection. The banks were weak as they were not intertwined with tree roots that bind healthy stream banks offered by old growth trees. Old growth trees were very limited but we observed none that were undermined and failing. Exposed gravel banks and sediment deposits are sources of sediment that affect spawn success and fill in pools. The eroded banks Reaches 2,3 and 22 are considered high priority for restoration. The methods to restore the sites is different in each reach. Reach 2 has trail and agriculture erosion. Reach 3 is losing the Nature Trust Park area to a long eroding bank. Reach 22 has both an eroding bank and a large sediment deposit (as does Reach 18). Erosion can be amended with vegetation planting seedlings and Willow stakes as well as LWD and rock placements.

Reach 2 erosion at RDN trail head

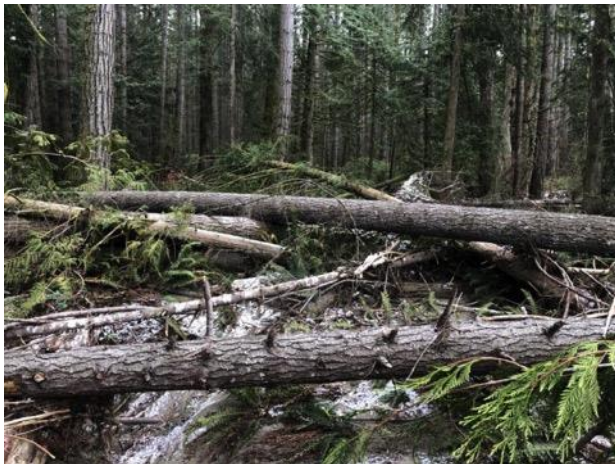
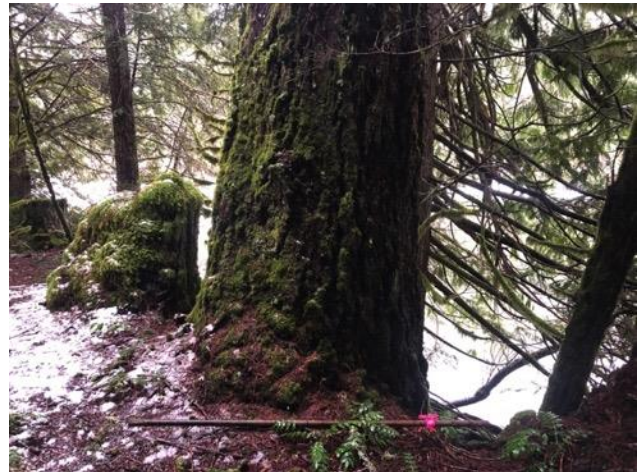
Old growth trees were rarely found in the survey, generally each reach had a few solitary trees or small groups of veterans, they were all Douglas Fir and Red Cedar. These trees were approximately 40 to 55m in height and had diameters of 1.0 to 2.2m. The loss of old growth trees along the riparian area results in bank instability, loss of LWD inputs, reduced canopy closure also losses to wildlife habitat, nutrient supply and cultural use. The old growth tree shortage will take several hundred years to restore. A healthy riparian forest is needed for climate change resilience. Climate change related flood events increase the frequency of flooding. There were flood evacuations of homes in the lower reaches the last two out of three years. Riparian vegetation needs help to be resilient. Riparian restoration, protection and preservation is the most important long term objective we can recommend.

Reach 2- Young trees pushed over by floods Reach 14 - Old Growth (1.8m Douglas Fir) holding on

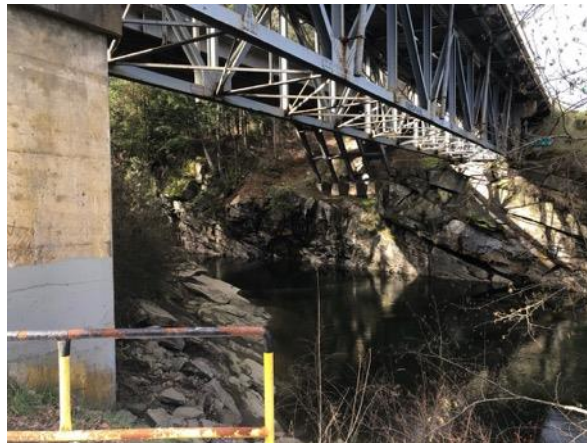
Water Quality – The highway and bridge are potential sources for pollution from runoff and spills. The bridge area catch basins drain straight into the Nanaimo above the pumphouse and hatchery intake. Installation of curtain drains to settling areas is recommended. particularly a concern.

Hwy 1 Bridge drain pipes go direct to pool.
