A Review of Trenchless Watercourse Crossings in Alberta with Respect to Species at Risk

S. Nugent

2011

**Canadian Manuscript Report of
Fisheries and Aquatic Sciences 2947**

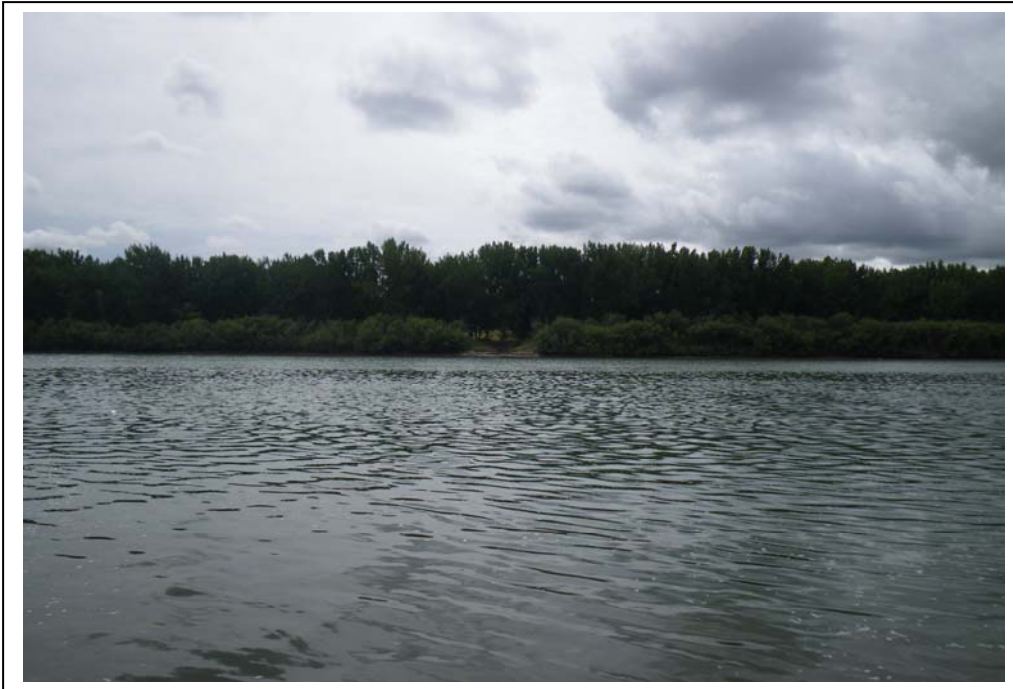
Figure 7: Lake Sturgeon Habitat South Saskatchewan River, Alberta

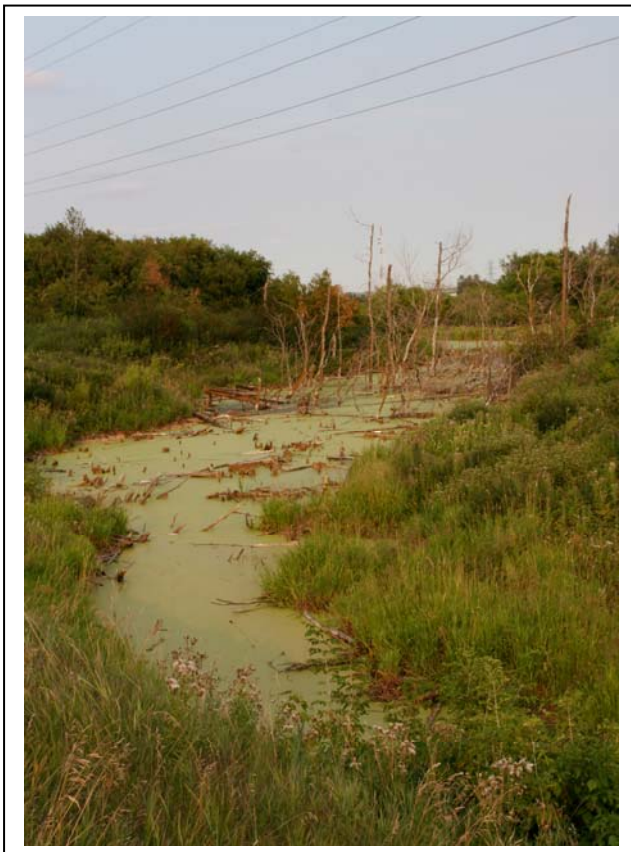
Figure 8: Unsuitable Lake Sturgeon Habitat – Saskatchewan River System Site Excluded from Study

In the habitat occupied by Lake Sturgeon, only eleven potential sites were in our list for monitoring. Of these 11, upon completion of the site assessment, it was determined only 8 sites were suitable Lake Sturgeon habitat due to lack of water depth and little to no significant flow from the river system's main stem in the other three sites. Figure 6 shows the location of the Lake Sturgeon trenchless crossing locations. Figure 7 illustrates a site typically associated with Lake Sturgeon habitat in the South Saskatchewan River. For comparison, Figure 8 shows a site attended during the project, illustrating very poor quality habitat for Lake Sturgeon.

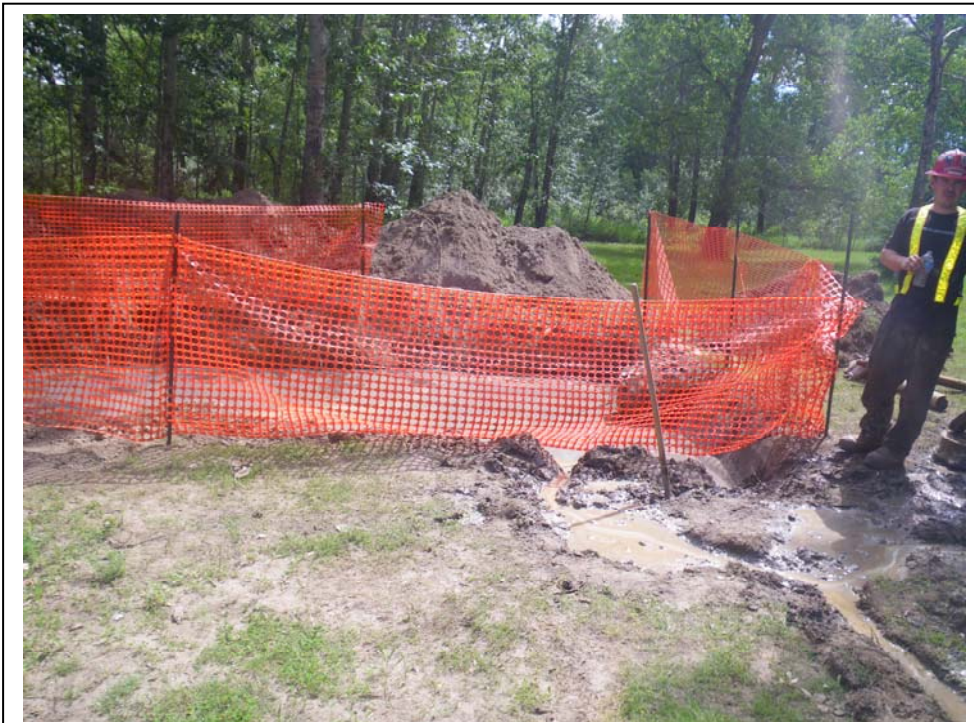
Figure 9: HDD Technique - Bore Hole and Drilling Mud (Red Deer River Alberta, South Saskatchewan River System, July 2010)

An active site on the Red Deer River (South Saskatchewan River system) was observed on July 7, 2010. This pipeline was installed using a high-pressure directional drilling technique (Figure 9). The photo clearly shows the gray liquid (the drilling mud) which can be harmful to fish and fish habitat. However, in this case, the drill was successful and installed far from the edge of the watercourse with no impacts to the river (Figure 10).

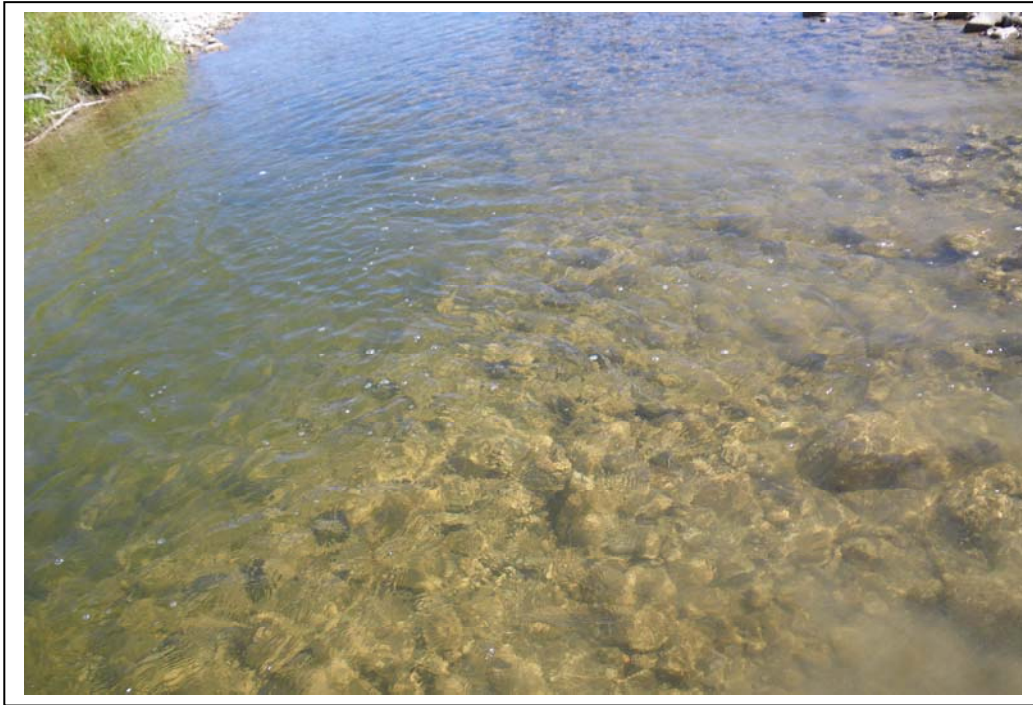
Figure 11: Westslope Cutthroat Trout Habitat (Fish Creek Alberta, Foothills Area, September 2010)

A second active site was attended on September 2, 2010. This was a high-pressure directional drill for a crossing of Fish Creek, in the Foothills area. This is the type of habitat that is typically seen for the Westslope Cutthroat Trout. Figure 11 illustrates the clear water with cobble substrate one would expect in salmonid habitat. Some maintenance work was completed at this site, as an old pipe had shifted and become exposed to the elements (Figure 12). This pipe was removed. Figure 13 shows the upland excavation of the pipeline required as a part of the removal process.

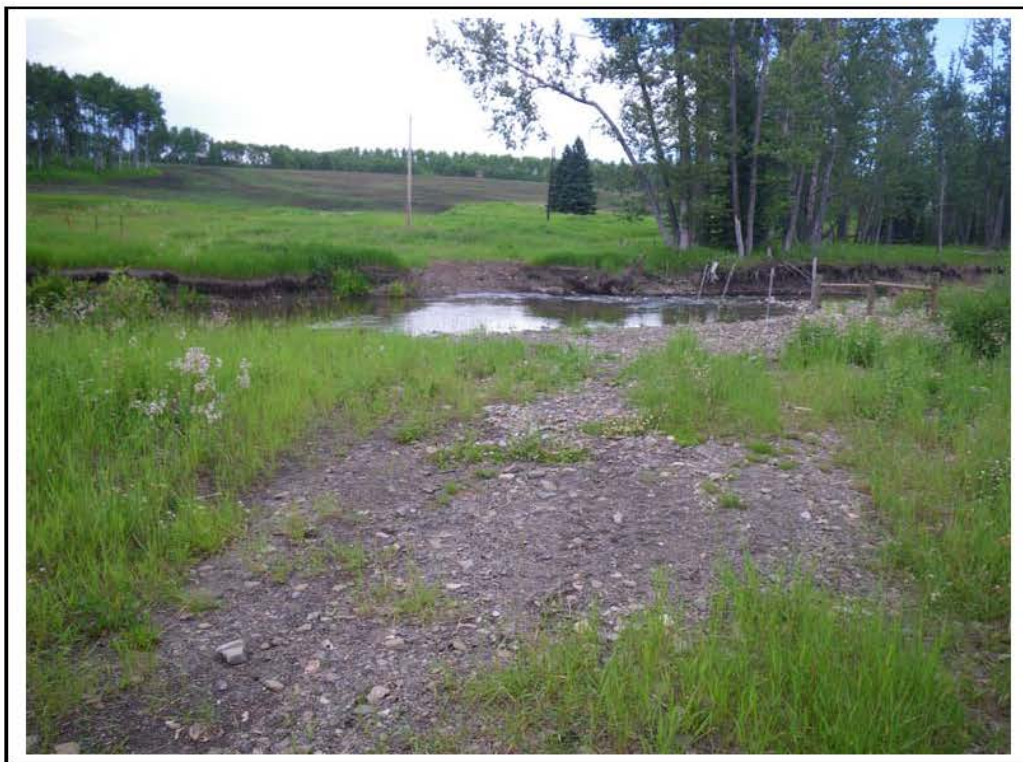
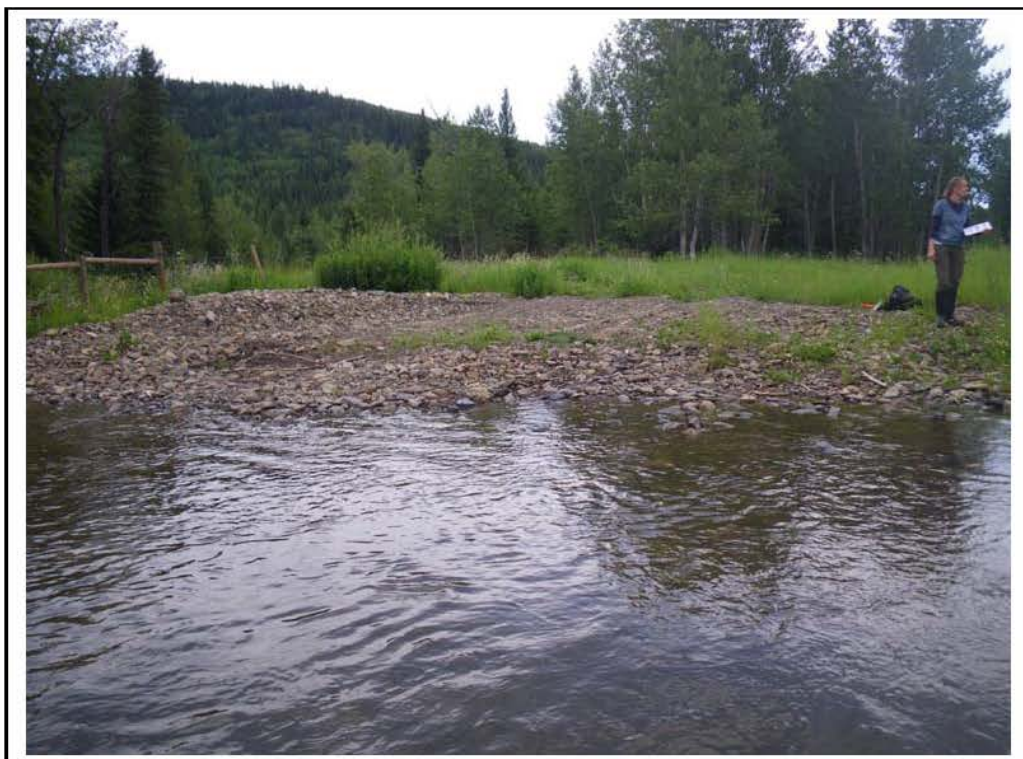
Figure 14: Evidence of Vegetation Removal and Potential Open Trench Crossing in Non-compliance with HDD Trenchless Crossing (Ware Creek Alberta, Foothills area, July 2010)

Within the sample set of 19 sites in the Foothills area, two sites (Ware Creek and Three Point Creek) showed evidence of non-compliance with the OS. These sites showed evidence of vegetation removal and potential of wet crossing/trenching of the creeks. The OS prohibits the use of techniques which could negatively impact the fish and fish habitat, damage the riparian vegetation, and specifies that the crossing is not to be an open cut crossing.

As seen in Figure 14, there is strong evidence of vegetation removal at the crossing site on Ware Creek in the Foothills region. If one were to assume the vegetation removal and creek disturbance visible in the photos were part of the pipeline installation, then this project would be in non-compliance with the requirements of the OS and depending on the extent of the damage/alteration to the fish habitat, could be considered a HADD of fish habitat.

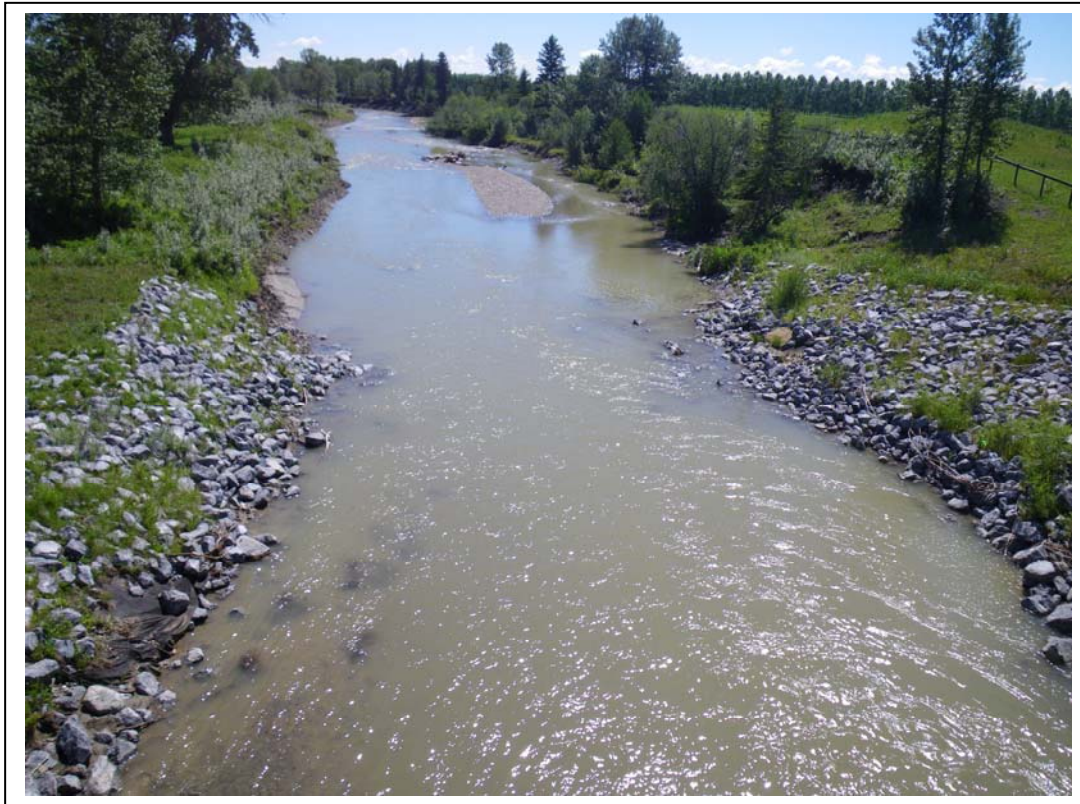
Figure 15: Evidence of Riparian Vegetation Removal and Riprap Placement on Creek Bed (Three Point Creek Alberta, Foothills Area, Downstream From Bridge, July 2010)

Figure 15 shows the second impacted creek, Three Point Creek. In this instance, there is riprap placement on the creek bed and shoreline and evidence of riparian vegetation removal. This site could be in non-compliance with the requirements outlined in the OS if these works are a part of the pipeline installation outlined in the OS notification received by DFO. Depending on the extent of the alteration/damage to the habitat, this project could be considered a HADD of fish habitat.

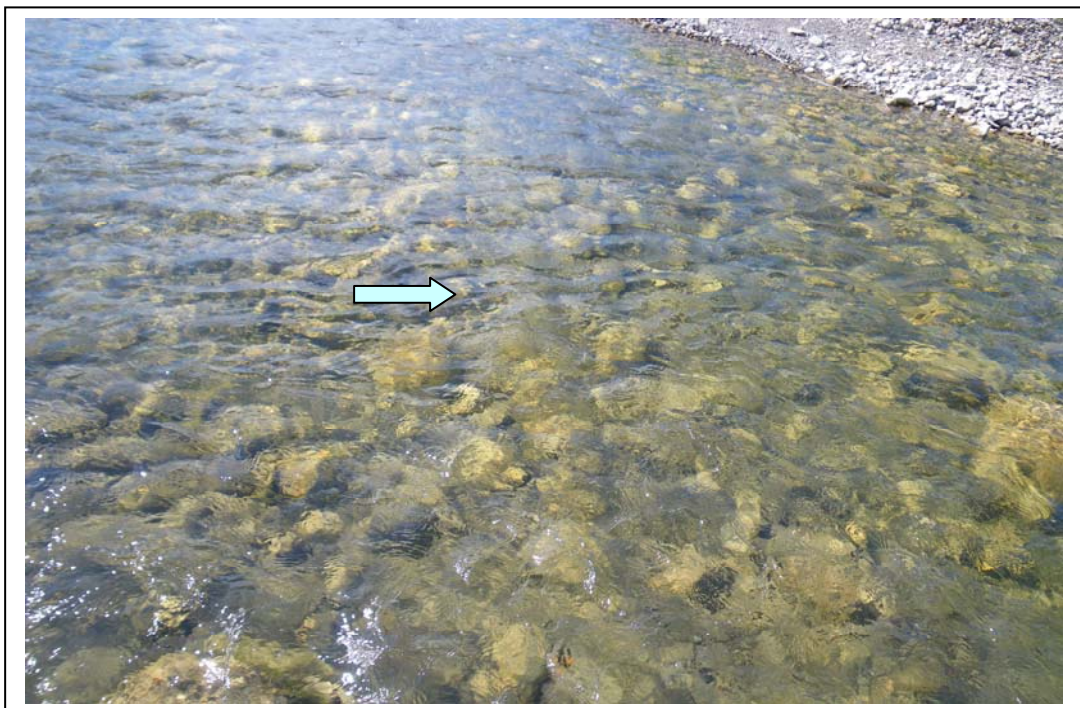
Figure 16: Exposed Pipeline Upstream from Right of Way (Jumping Pound Creek Alberta, July 2010)
Table 4: Summary of Sites with Evidence of Non-compliance or Maintenance Issues

Jumping Pound Creek, also found within the Foothills area, had an HDD installation completed in 2007. Figure 16 shows an exposed pipeline that was located near the vicinity of the right-of-way (ROW) at the watercourse. The significance of maintenance issues with the pipelines is sometimes overlooked and it may be worth considering the effects of these issues on fish and fish habitat. If pipelines such as this were to rupture, considerable damage to the resource may result. Further investigation into these effects should be undertaken to ensure that species that are more sensitive to impacts to their habitat are adequately protected from potential break or rupture of pipeline crossings.

- It may be worthwhile to follow up on the ongoing maintenance and problems associated with underground pipelines. For example, conduct an investigation into the likelihood of pipelines becoming exposed when under a watercourse and, if exposed, review any available statistics on the probability the exposed pipe would rupture. It may be prudent to investigate whether different materials have varying life spans when

exposed to the elements. Given the areas of interest and the presence of sensitive species, the amount of ongoing maintenance and likelihood of failure could in itself prove to be a threat to species at risk and should be investigated further. A review of industry's best management practises for pipeline installation to obtain verification of required pipeline depths is likely a good place to start.
