## PERFORMANCE EVALUATION OF RETROFITTED SOLID MASONRY EXTERIOR WALLS

# PERFORMANCE EVALUATION OF RETROFITTED SOLID MASONRY EXTERIOR WALLS

**FEBRUARY 2005**

Project no.: **RD-0109-A**

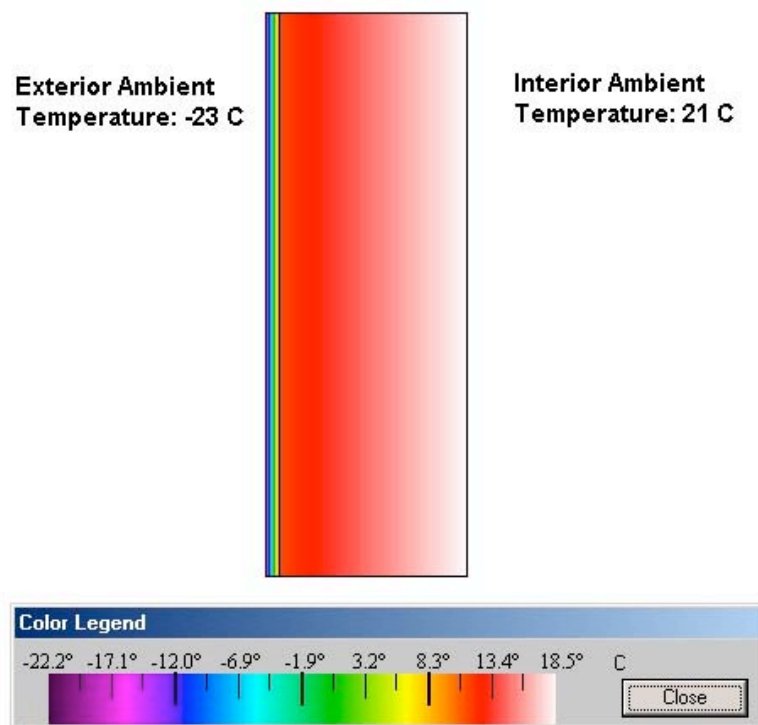
**Figure 2. Masonry wall insulated on exterior surface**

Based upon our model shown in Figure 2, and assuming an outdoor ambient temperature of minus –23 °C and an indoor ambient temperature of 21 °C, the temperature of the brick will vary between 8 °C and 17 °C (refer to Example #1 in Appendix A). Thus, if insulation is installed on the exterior face of the wall as shown in this model, the masonry would be subjected to only a minor variation of the indoor ambient temperature (refer to Figure 2). As a result, any trapped moisture within the brick will never reach the freezing point. Consequently the potential for masonry or mortar joint failure due to the freeze/thaw process has effectively been eliminated.

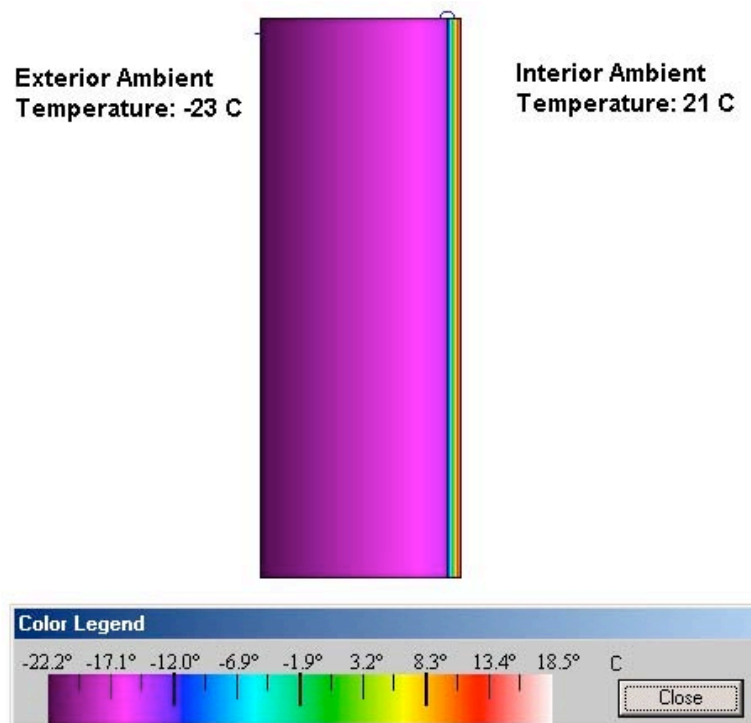
Figure 3. Masonry wall insulated on interior surface

In order to preserve the aesthetic features of the aged masonry walls, builders will generally opt to insulate from the interior. In the third idealized model shown in Figure 3 below, the same composition of masonry and insulation are again placed in series, but now the insulation has been placed along the inside face of the solid masonry wall. Under the same design ambient temperatures, used in the two previous models, the temperature within the masonry will based upon our simulation would vary between minus  $-22^{\circ}\text{C}$  to minus  $-12^{\circ}\text{C}$  (refer to Example 2 in Appendix A) if the insulation is installed on the interior face of the masonry wall. This simulation helps to illustrate that during the heating season, the insulation placed along the inside face of the solid masonry wall acts as a thermal barrier between the heated interior of the building and the exposed exterior masonry. The interior insulated wall is therefore subjected to the colder average temperatures through more of its assembly in comparison to non-insulated or exterior insulated masonry walls.

While the three models above present the differences and thermal effects between non-insulated, exterior insulated, and interior insulated masonry walls, it is important to understand that subjecting the masonry wall to overall cooler temperatures alone is not necessarily detrimental to the longevity of the wall. In fact, the materials properties of “dry” mortar and masonry offer excellent resistance against deterioration in below freezing temperatures.

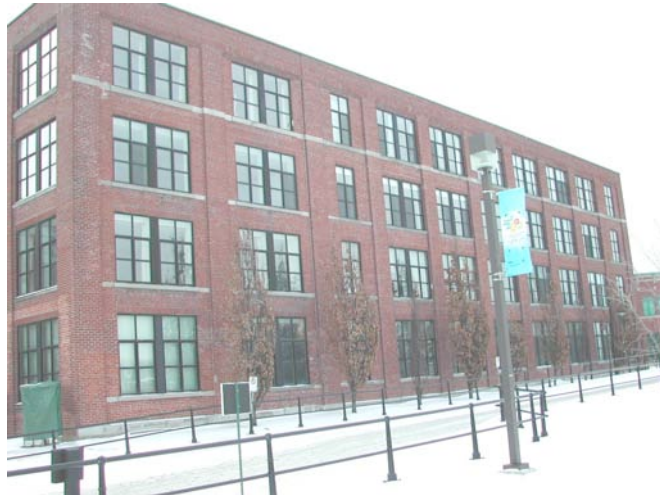
These three 4-storey buildings were built over one hundred years ago. They were originally constructed for industrial purposes and were converted to residential use in 1984. During the retrofit work, polyurethane foam insulation was spray-applied over the interior surface of the solid masonry walls. The assembly was completed with a steel furring frame filled with glass fibre insulation and finished with foil-backed gypsum board sheathing.

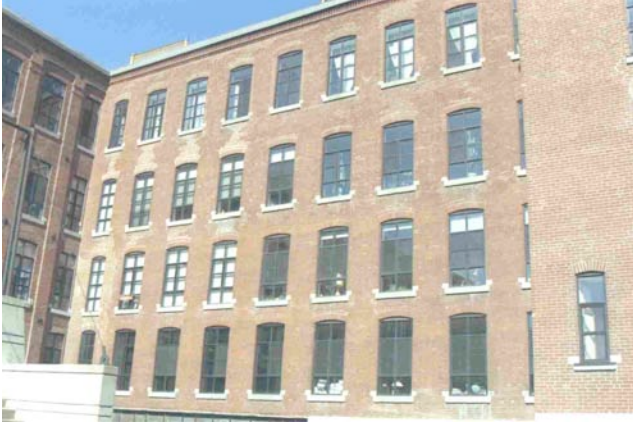
Photograph No. 1

frame (see attached photos below). No problems to the exterior masonry walls were reported to us during our interview with building personnel.

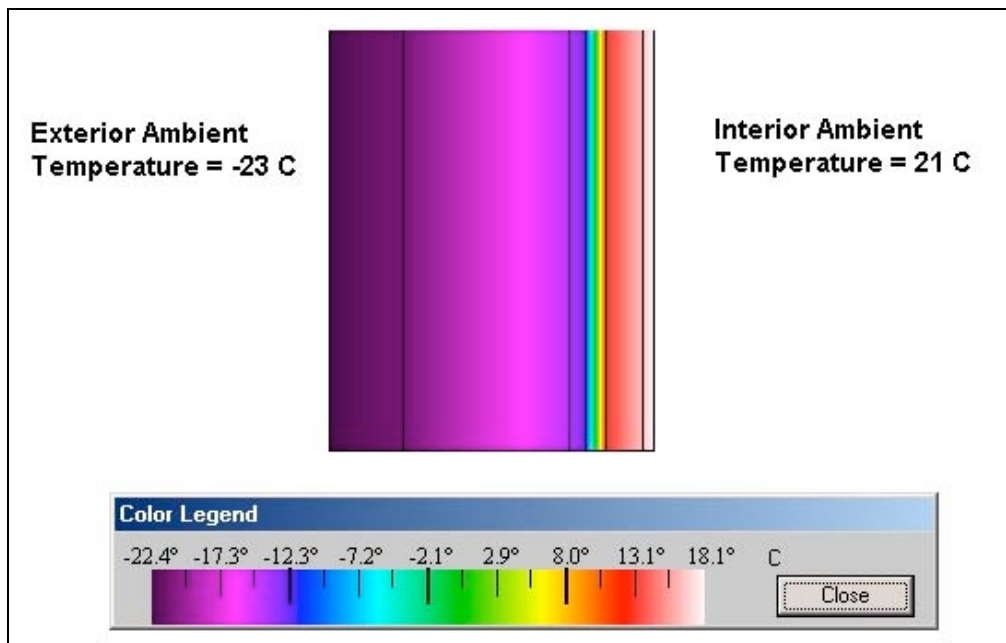
**FIGURE T-2**

The THERM simulation of the retrofit wall assembly below (Figure T-2) also graphically illustrates the temperature of the exterior masonry and terra-cotta blocks to range between minus -12 deg Celsius and minus -23 deg Celsius.

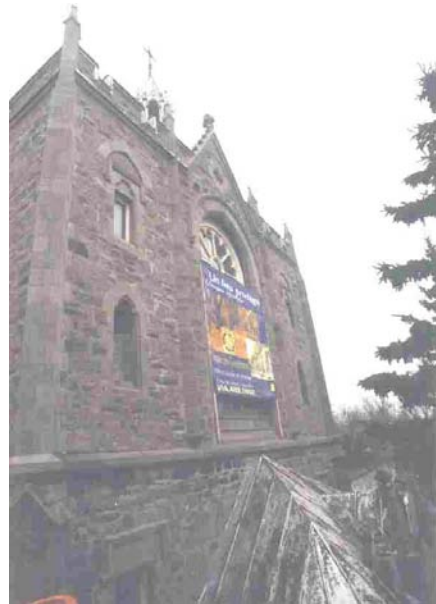
This project consists of the construction of several newer townhouse units, an underground parking lot, and an old monastic residence that was retrofitted into luxury-class condominium units. The latter is a four-storey structure that consists of load-bearing solid stone walls that vary in thickness from 28 to 38 inches. The main structural elements of the building are made of wood and steel. The vertical envelope consists only of the massive masonry walls, as it was desired to preserve the appearance of the masonry on both the interior and exterior wall surfaces. Consequently, there is no insulation and no vapour barrier system in the envelope, though particular care was taken to have a continuous air-barrier at the window-masonry joints. There was also a large section of one wall that was demolished in order to have a curtain wall system installed.

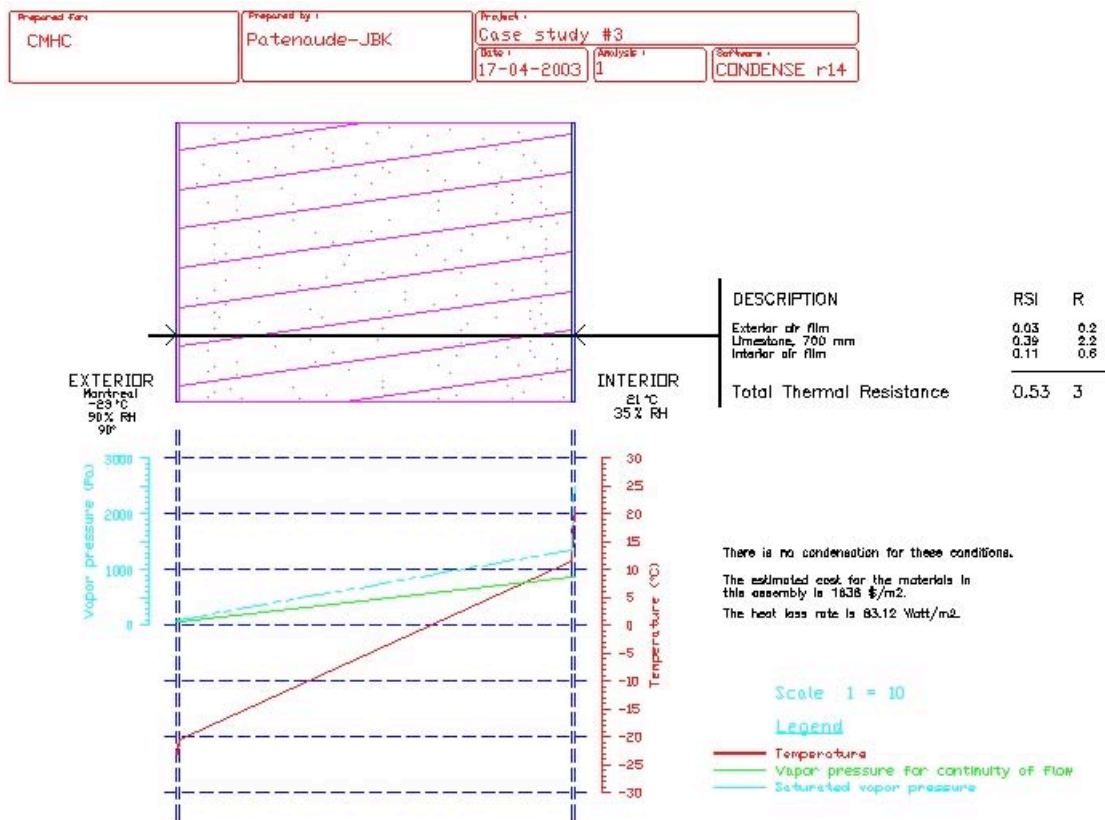
**SIM-3(35)**

The computer modeling with CONDENSE of the existing wall assembly of this building shown below calculated the thermal resistance of the wall to be R3 (RSI 0.53). The average wall temperature was shown to be about minus -5 deg Celsius. No condensation based upon the input conditions for the 700mm thick limestone block walls was noted.

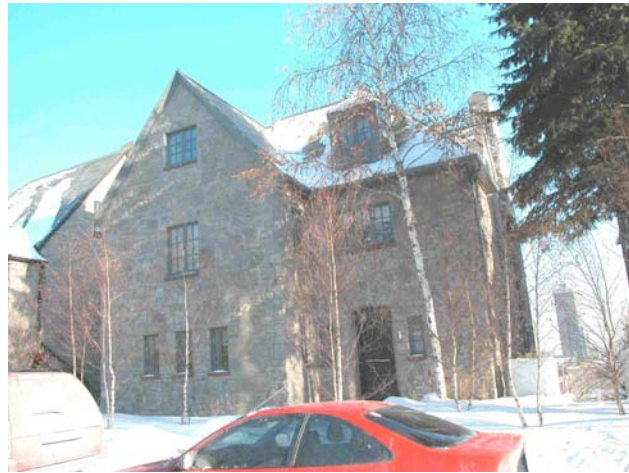
Case study #4 is a single family four-storey home built in the Westmount district of Montréal. The vertical envelope consists of the original solid masonry load-bearing walls and a steel stud partition filled with glass fibre batt insulation. The partition and the masonry are separated by a pressurized and climate controlled air gap that is monitored using a Dynamic Buffer Zone (DBZ) system. During the heating season, dry air is blown into the air gap creating a positive pressure. Since the inner partition was designed to be a continuous air barrier, it is assumed that the dry air eventually exfiltrates through and dries the exterior masonry, and hence reduces the accumulation and entrapment of moisture in the wall system.

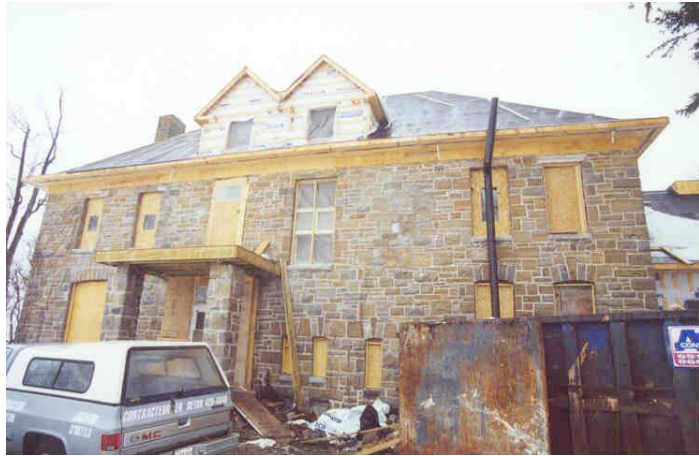
- 18" to 24" limestone blocks;
- 1" polyurethane foam;
- liquid vapour barrier;
- 2" wood stud wall;
- ½" gypsum board

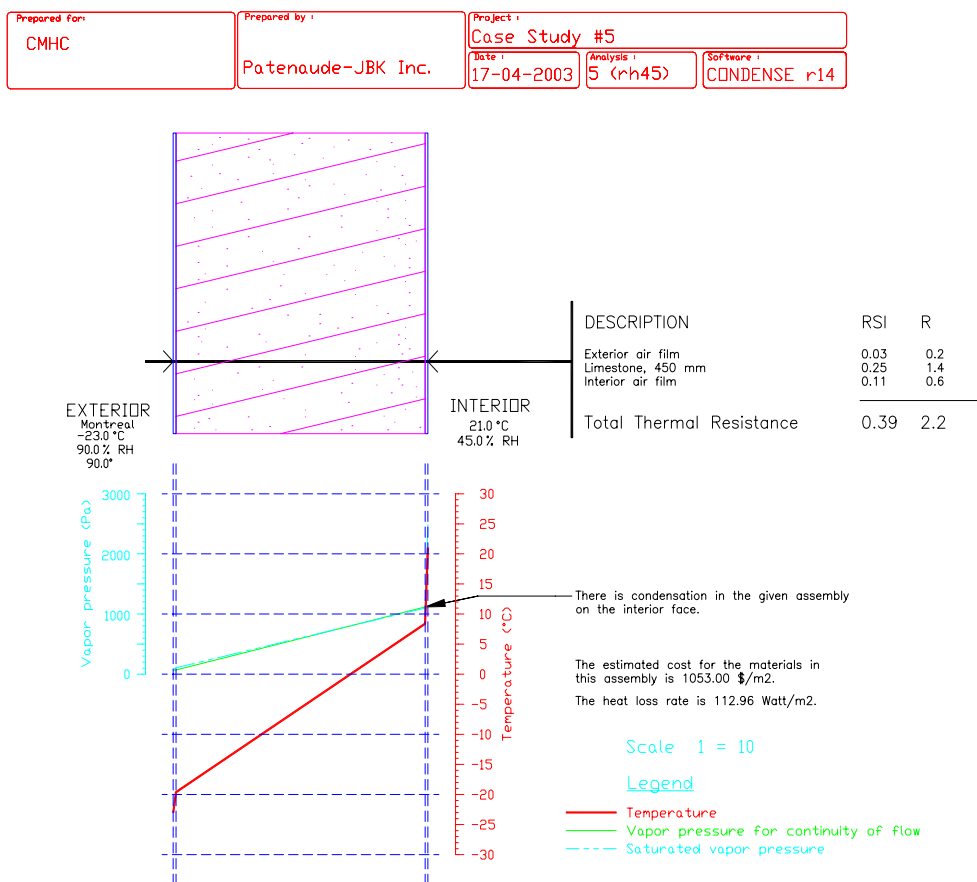
Several models of the same wall assembly were simulated presuming interior relative humidity greater than 35%. Subsequent modeling of the original wall composition (see SIM-5(45) below) showed that condensation would begin to occur along the inside face of the exposed stone wall with an interior relative humidity of 45% or greater.

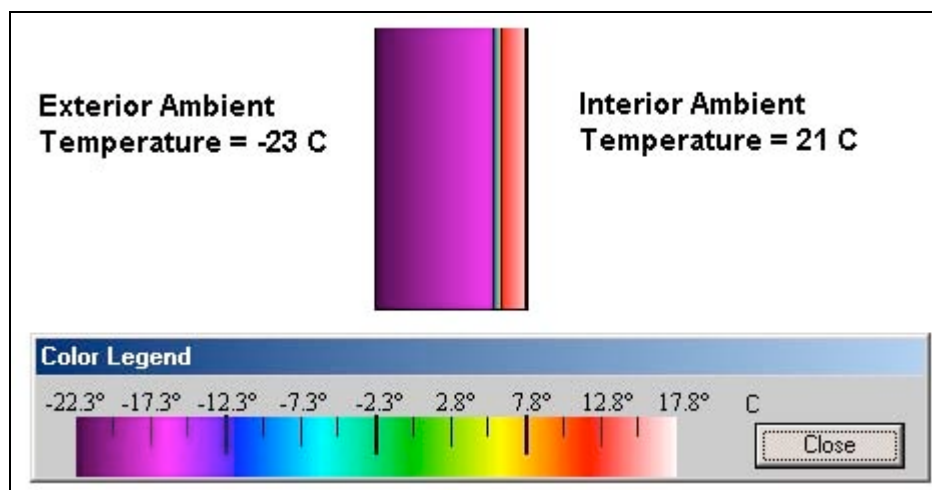
**FIGURE T-5**

The THERM simulation of the retrofit wall assembly below (Figure T-5) graphically illustrates the temperature of the exterior stone walls to range between minus -16 deg Celsius and minus -23 deg Celsius.

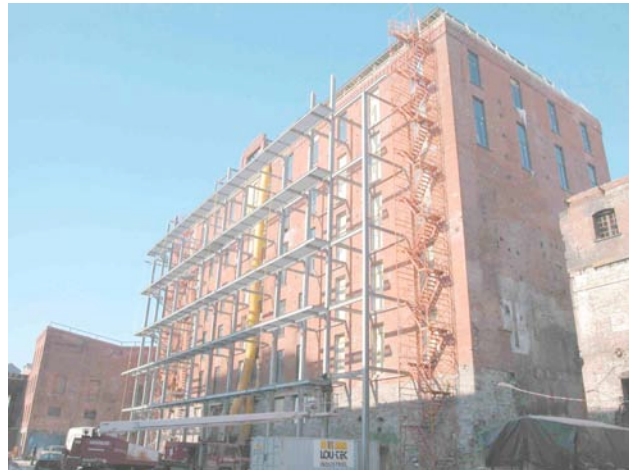
Case Study #6 consists of ten (10) buildings that were constructed between 1854 and 1946. There are about twelve different wall compositions amongst all the buildings. The actual retrofits were dependent upon the composition of the wall (and as of April 2003 not all retrofits had commenced). In general, emphasis was placed on air- and vapour-barriers, with the inclusion of insulation in cases where the window/wall ratio was small. The insulation used was polyurethane foam.

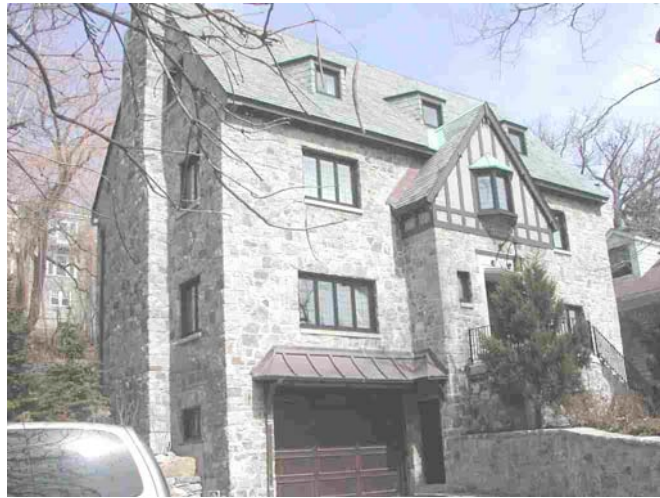
This residence is a 3-storey fieldstone single-family dwelling. Originally insulated with cork panels, the interior walls were stripped down to the masonry and insulated with 1½" polyurethane foam. The assembly was completed with a steel furring frame filled with glass fibre insulation and finished with aluminum-backed gypsum board sheathing.

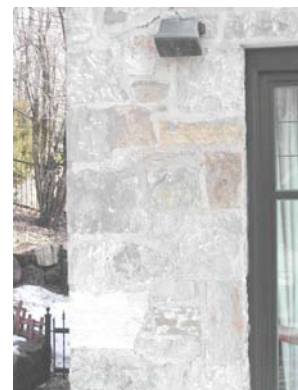
During the site visit the masonry was noted to be in very good condition with little deterioration of the mortar joints. There was no evidence of efflorescence or other outward sign of spalling. Only one relatively minor crack was noted in the masonry, which may or may not be associated with the retrofit (see photo at right). No problems to the exterior masonry walls were reported to us during our interview with the building owner.

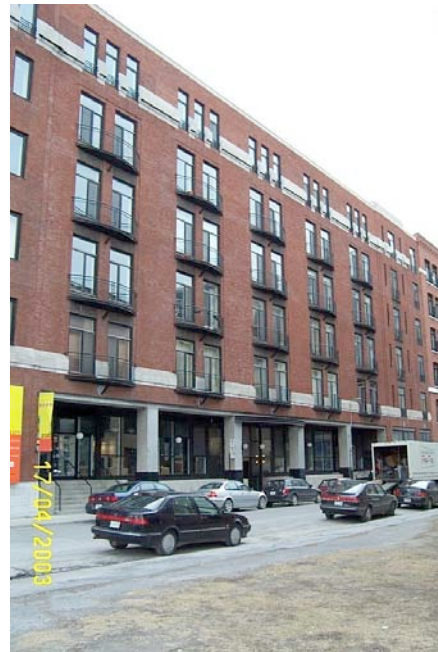
This residential building was retrofitted in 1996 by adding 1½" polyurethane foam to the interior surface of the concrete block walls. The steel furring was built ½" into the foam and is finished with a polyethylene membrane and gypsum board panel. There are some newer sections of wall that were constructed during the retrofit that are not solid masonry, but the majority is as described above.

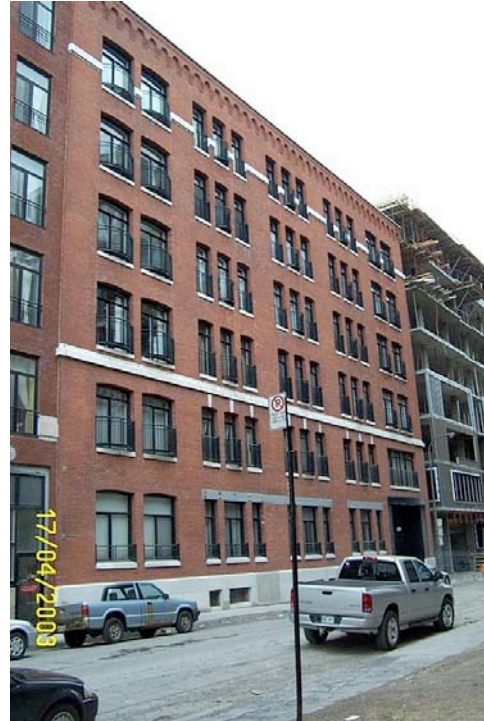
Retrofitted in 1999, this building has some newly constructed brick façades in addition to the solid brick wall described above. The general retrofit approach was to add 1½" polyurethane to the interior surface of the brick, followed by a ½" gypsum board built on steel furring. There is a 3 1/8" air gap between the gypsum and polyurethane due to the steel furring being imbedded ½" into the insulation. The building is used for residential purposes only.

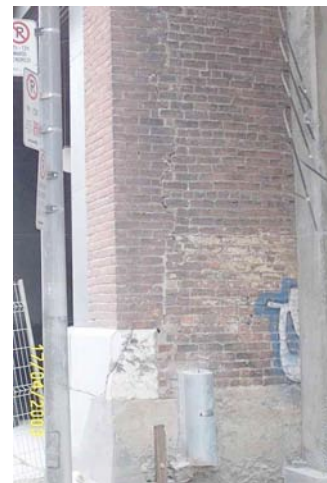
There were some small deficiencies (minor cracks and spalling) observed at the corner of the building where the eastern façade formerly joined with the adjacent building, which was demolished and rebuilt. The photo to the right shows a crack at the corner of the brickwork. These cracks may or may not be related to the insulation retrofit conducted on the building. No problems to the exterior masonry walls were reported to us during our interview with building personnel.

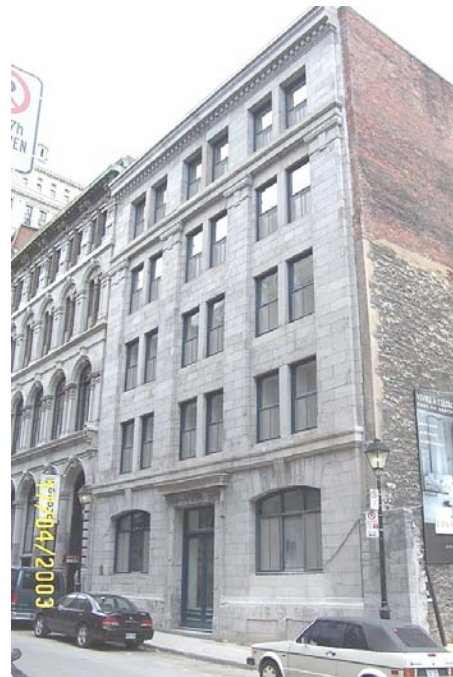
The western façade of the building from this case study consists primarily of fieldstone blocks. Originally it was the only side exposed to the outdoor environment, but the building to the south was demolished, which revealed a second façade constructed of brick. The vertical envelope consists of the existing masonry (fieldstone on the western façade, brick on the southern) insulated with 1½" of polyurethane foam. The interior walls are finished with gypsum board on steel furring.

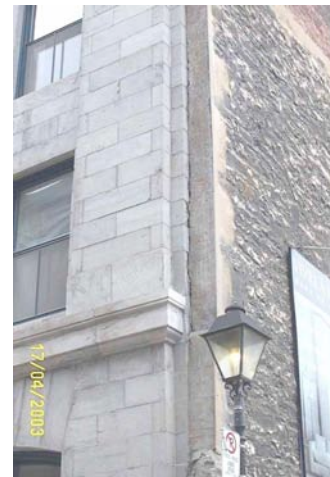
A long crack has formed at the joint of the two masonry walls, where the brick wall of the southern façade meets the fieldstone of the western façade. This cracking is likely the result of differential movement between the two different wall systems. No problems to the exterior masonry walls were reported to us during our interview with building personnel.
