RESEARCH REPORT

PREDICTING TIME TO FOGGING
OF INSULATING GLASS UNITS

Predicting Time to Fogging of Insulating Glass Units

August 26, 2005

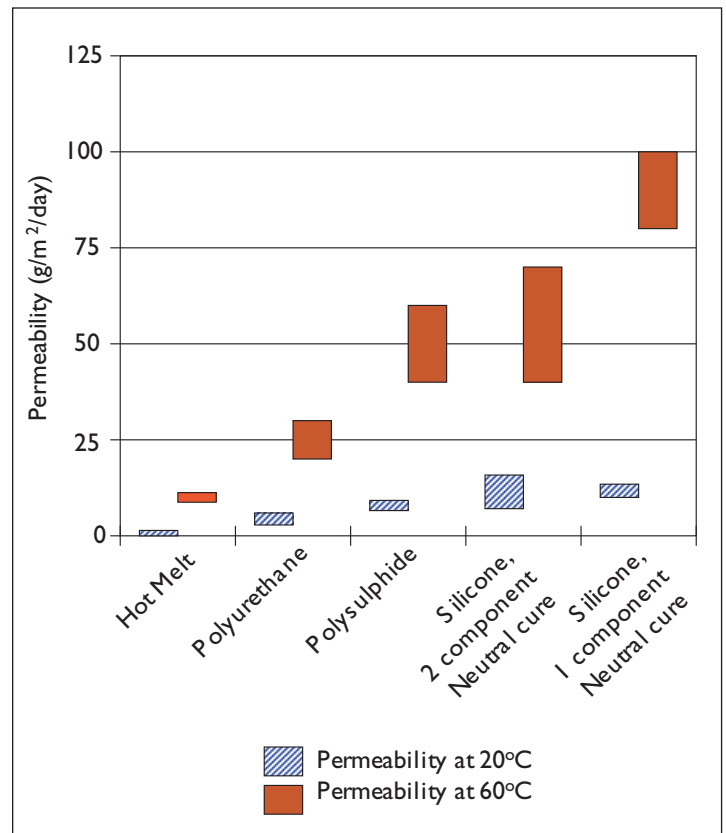
Figure 2: Water vapour transmission rates (permeability) for various insulating glass unit sealants

- **Permeability and cross-section area of the perimeter sealants:** Permeability of insulating glass unit perimeter sealants varies (Figure 2). Polyisobutylene sealants have the highest resistance compared to polysulphide, polyurethane or silicone sealants. The volume of air trapped within an insulating glass unit changes, forcing the glass panes apart or causing them to bend (Figure 3) which causes the perimeter sealants to be stretched or compressed, affecting the path length and area of the sealants and, thus, their permeance.

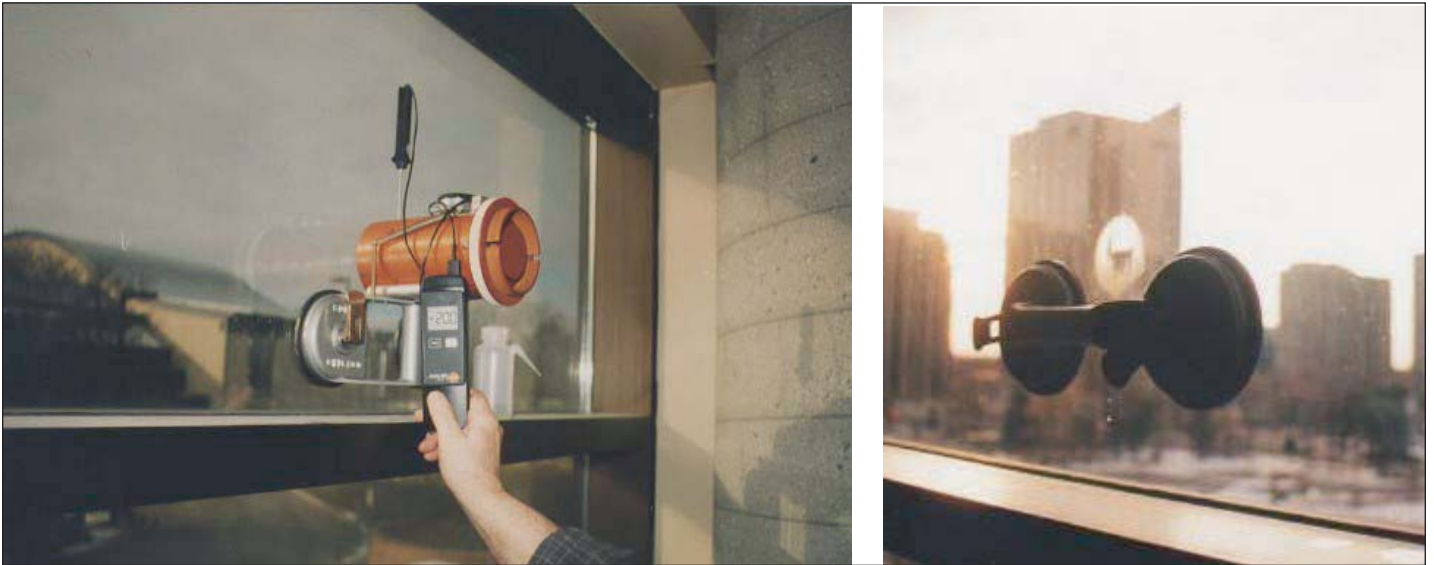
Figure 4: Field dew-point measurement apparatus: (Left) The unit is mounted on an insulating glass unit in contact with the inboard pane of glass. A digital thermometer inserted into the unit measures the temperature of unit in contact with the pane. (Right) The apparatus has been removed (except for the suction cups), revealing a circle of condensation or frost on the cavity-side surface of the pane, directly beneath the chilled contact area of the apparatus.

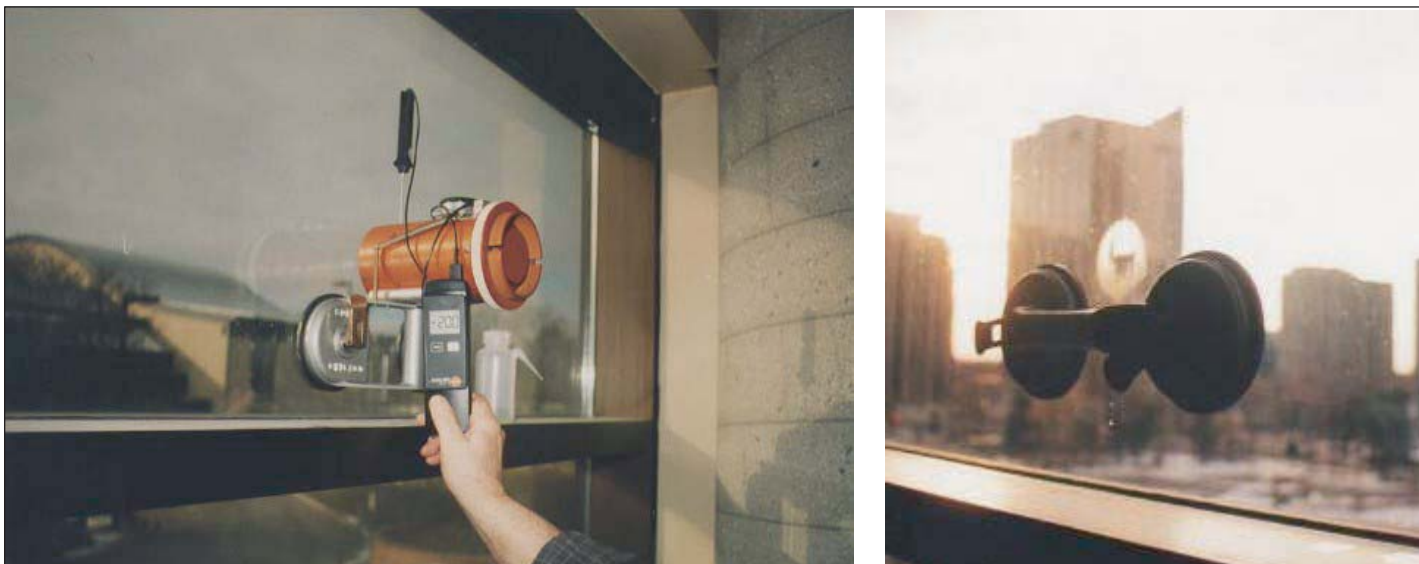
Figure 4 : Appareil de mesure de la température du point de rosée : (À gauche) L'appareil est monté sur un vitrage isolant en contact avec le panneau de verre intérieur. Un thermomètre numérique inséré dans l'appareil mesure la température de celui-ci lorsqu'il est en contact avec le panneau. (À droite) L'appareil a été enlevé (sauf les ventouses), révélant un cercle de condensation ou de givre sur la face du panneau donnant sur le vide, directement sous la surface refroidie par le contact avec l'appareil.

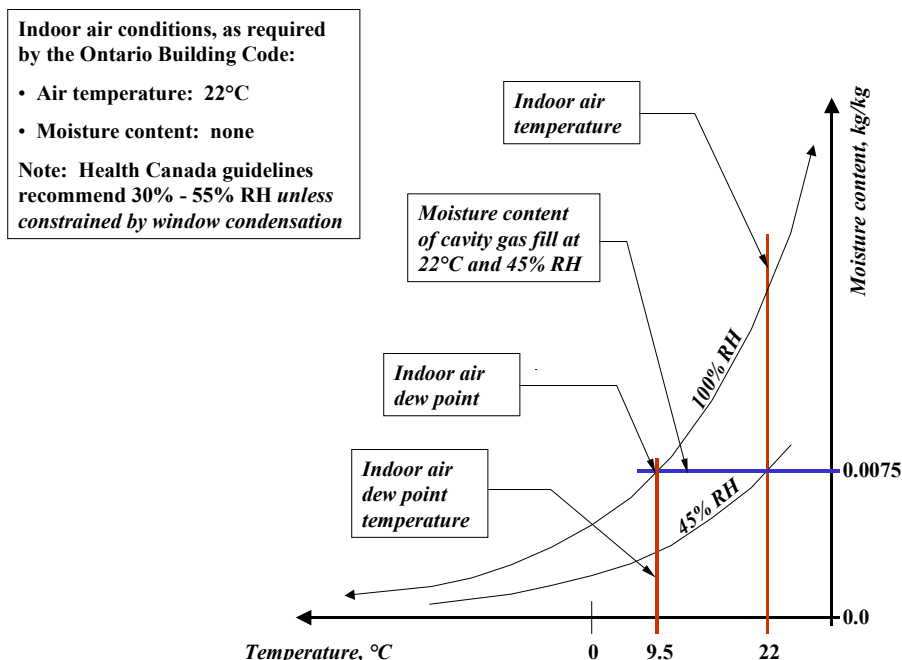
Figure 1: Psychrometric chart showing the dew point temperature of the cavity gas fill within an insulating glass unit. Gas fill is assumed to be plain air, captured at 22°C at 45% RH.

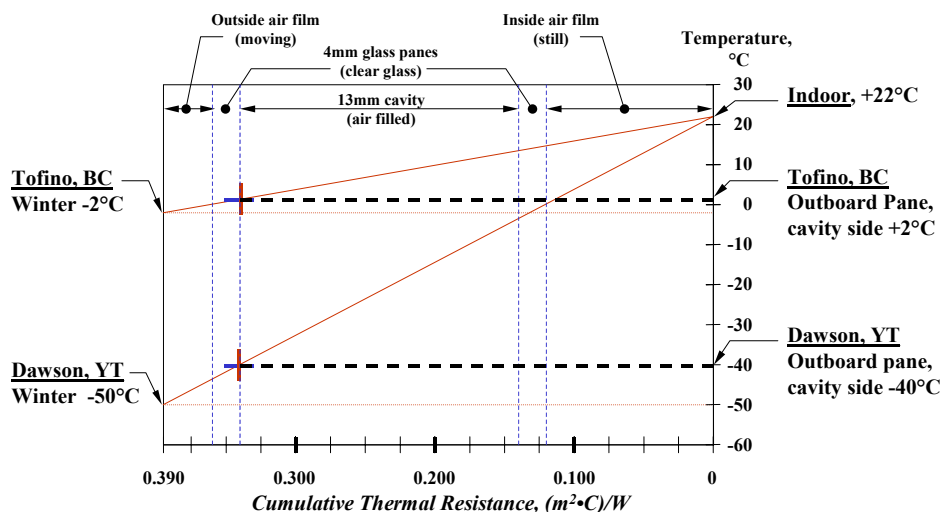
Figure 2. Simple thermal gradient through centre-of-glass region of an insulating glass unit with 4mm glass, 13mm air-filled cavity, exposed to room temperature conditions and the warmest (Tofino, BC) and coldest (Dawson, YT) outdoor January 2 1/2% design temperature in Canada.

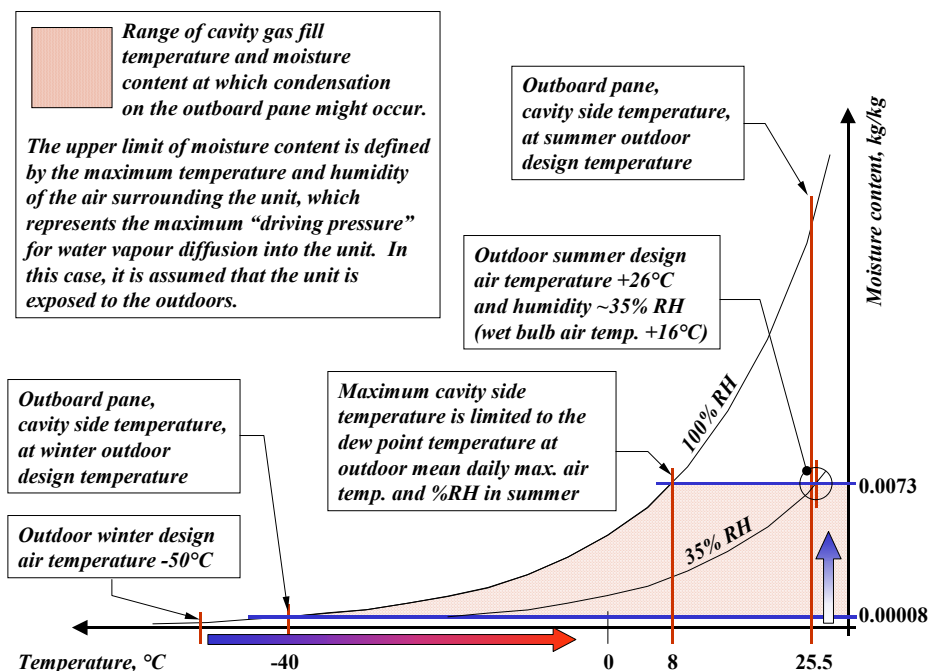
Figure 4: Psychrometric chart showing the moisture content range in which condensation of the cavity gas fill might occur, for an insulating glass unit installed in Dawson, YT. The upper and lower temperatures are defined by the summer and winter design temperatures, and the upper limit of moisture content is defined by the environment to which the perimeter seal of the unit is exposed.

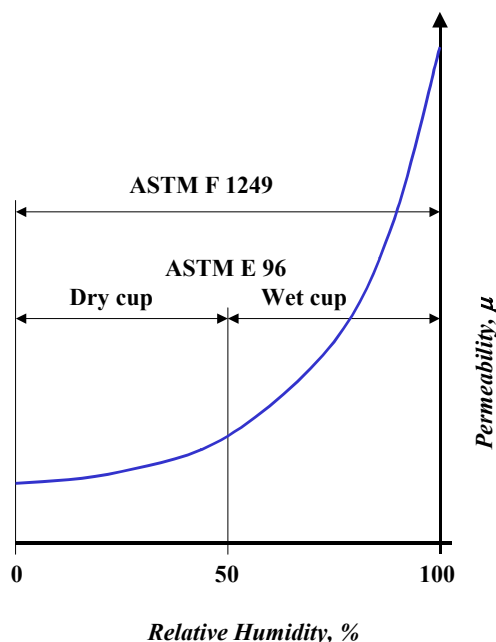
Figure 8: Relationship of permeability to relative humidity of the measurement environment, noted for some materials by comparative measurements made with the “dry cup” and “wet cup” methods of ASTM E 96. The diagram is based figure 5.10 from Hutcheon and Handegord, 1983 [21]. The range of relative humidity between the cup and sensor chamber for ASTM F 1249 is added, for reference.

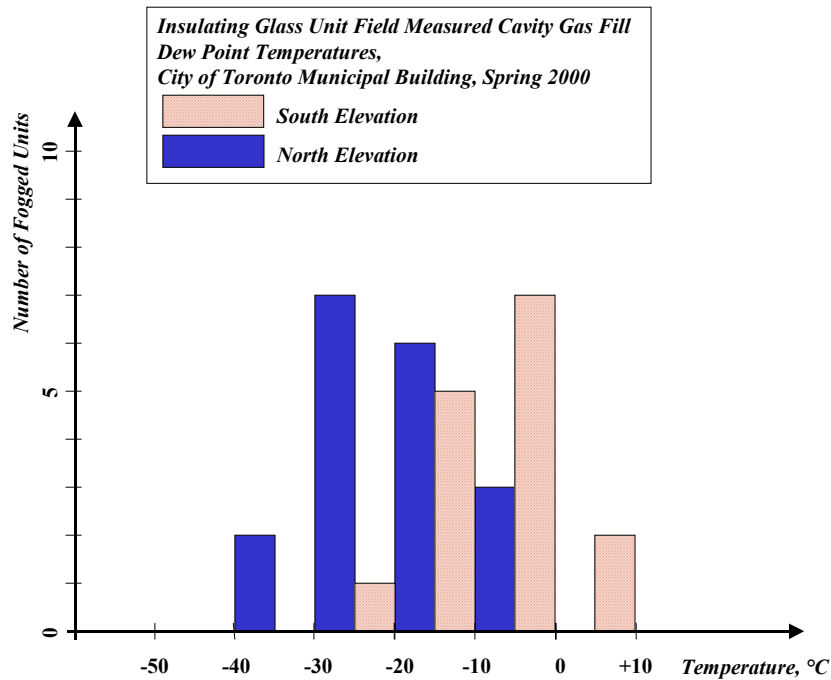
Figure 11: Field dew point measurements of the cavity gas fill of insulating glass units in a municipal building in Toronto, Ontario. The units were installed in identical curtain walls, in the south elevation and north elevation of the building. The curtain walls were exposed to the same atrium space within the building. Cavity gas fill temperatures were distinctly warmer in units in the south elevation, indicating a shorter time to fogging.

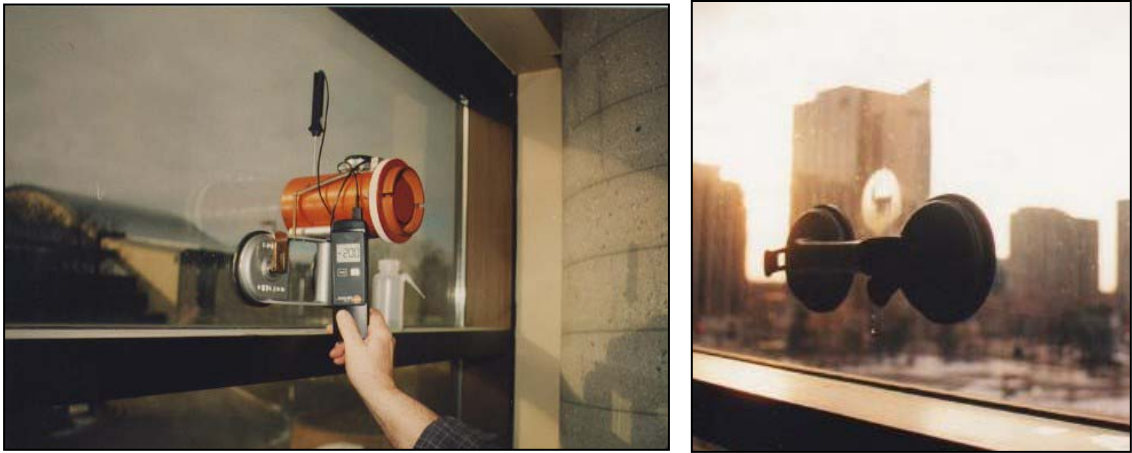
Figures 18 and 19 Field dew point measurement apparatus, as described in ASTM E 576. In the left photo, the unit is mounted on an insulating glass unit, in contact with the inboard pane of glass. A digital thermometer inserted into the unit measures the temperature of unit in contact with the pane. In the right photo, the apparatus has been removed (except for the suction cups), revealing a circle of condensation or frost on the cavity-side surface of the pane, directly beneath the chilled contact area of the apparatus. The temperature at which condensation or frost is first observed is recorded as the dew point temperature of the cavity gas fill.

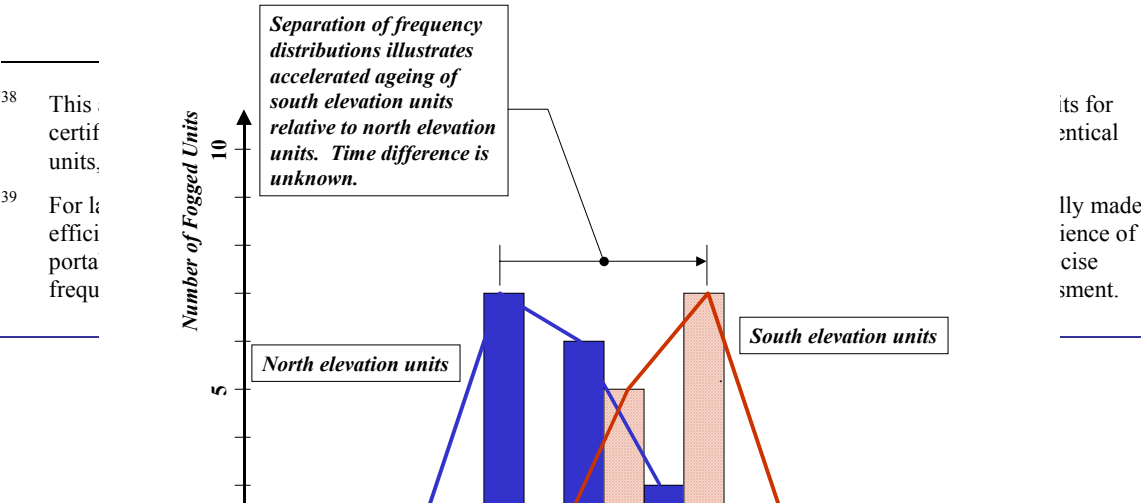
Figure 20: Frequency distributions of field measured dew point temperatures, repeated from Figure 11. Single lines representing the maximum value in each “bin” have been added, for later use.

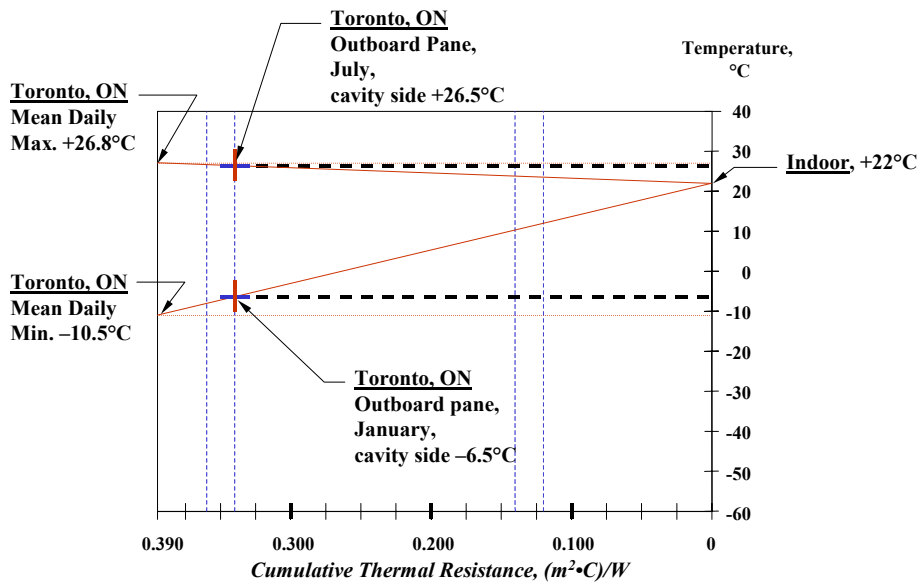
Figure 21: Simple thermal gradient for “normal” mean daily minimum and maximum temperatures for Toronto, Ontario. Mean daily maximum and minimum outdoor temperatures are used instead of design temperatures, to provide a more realistic range of temperatures in which fogging is likely to occur and be noticed by building occupants.

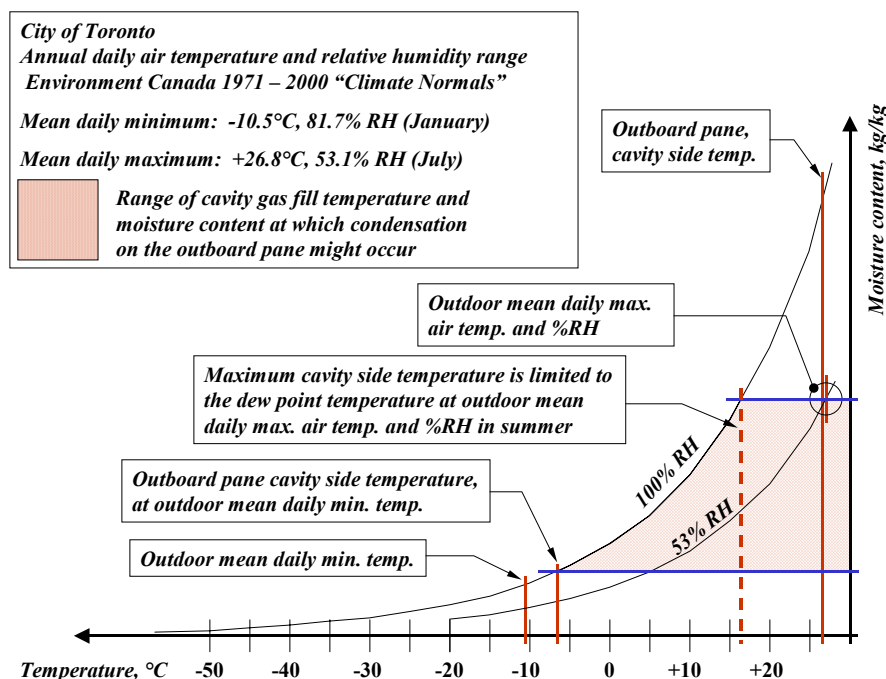
Figure 22: Psychrometric chart showing the range of outboard pane cavity side temperatures determined by the simple thermal gradient in Figure 18.

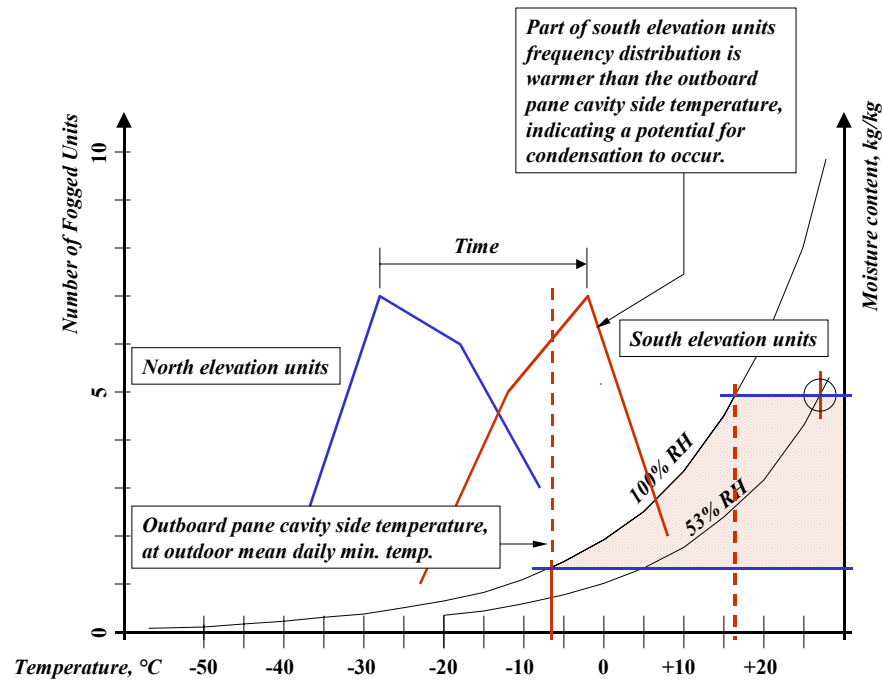
Figure 23. Frequency distributions of field measured dew point temperatures in the municipal building in Toronto, Ontario plotted together with the psychrometric chart from the previous figure. The frequency distribution for the units in the north elevation has moved into the range of cavity-side temperatures that can be expected to occur under “normal” weather conditions, indicating a potential for fogging. The frequency distribution for the north elevation units is still colder than the outboard pane cavity side temperatures, so the potential for fogging is less.

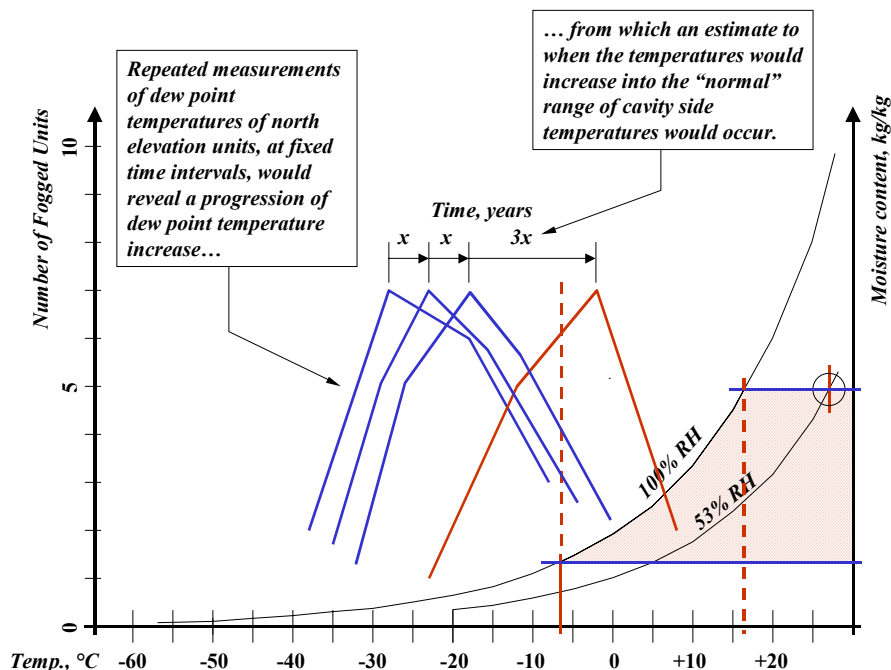
Figure 24: Repeated measurements of dew point temperature of the north elevation units at fixed intervals should reveal a progression of the frequency distribution of dew point temperatures, increasing in temperature with time. The time / temperature rise change between early measurements could be used to predict when the dew point temperatures would increase into the range of outboard pane, cavity-side temperatures that could be expected to occur, based on outdoor temperatures.

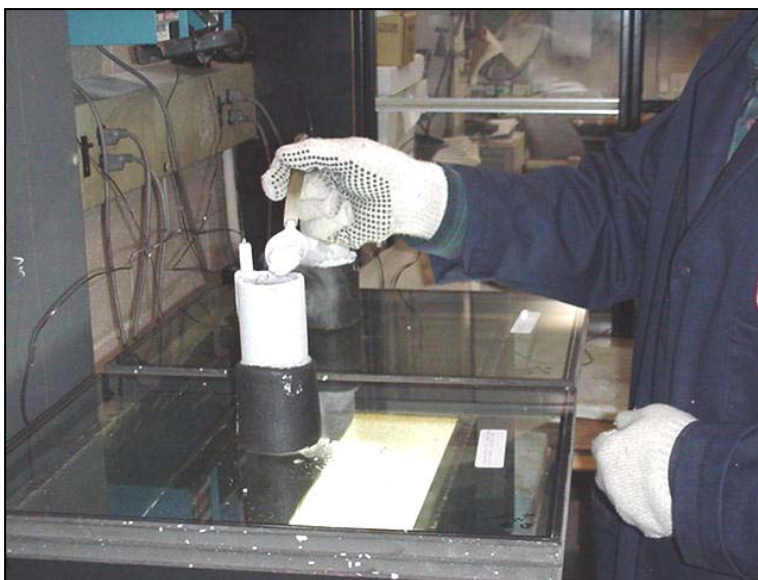
Figure 25: Dew point test apparatus used by the Insulating Glass Laboratory at Bodycote Materials Testing Canada Inc. Solidified carbon dioxide (“dry ice”) is being added to the metal cylinder containing ethyl alcohol. The bottom of the cylinder (sheathed in foam rubber at the sides for handling) is in contact with the upper glass pane of the insulating glass unit, to provide local cooling. If the glass is cooled below the dew point temperature of the cavity gas fill, condensation will occur on the cavity side, similar to shown in Figure 19. File photo courtesy of Bodycote Materials Testing Canada Inc.

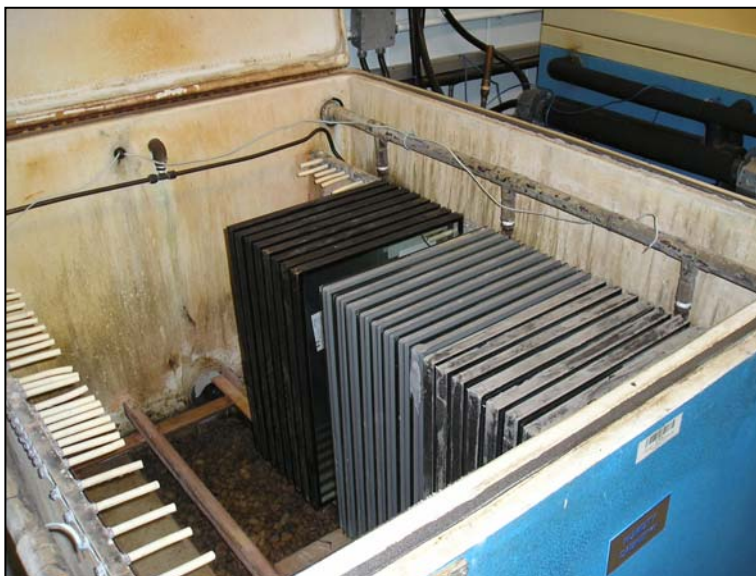
Figure 26: CGSB-12.8 High Humidity Chamber in the Insulating Glass Laboratory at Bodycote Materials Testing Canada Inc. Insulating glass units are placed on a narrow end, held in place and separated by the “teeth” at the sides. The units are held off the bottom so that they do not sit in water. A water spray maintains 100% relative humidity in the cabinet. The water temperature is cycled between $22 \pm 3^{\circ}\text{C}$ (lab conditions) to $55 \pm 3^{\circ}\text{C}$, inducing a change in the cavity gas fill volume. High temperature increases the permeability of the sealants, high humidity increases the rate of water vapour diffusion through the sealants, and changes in cavity gas fill volume causes mechanical stress to the sealants (when the units are sealed). File photo courtesy of Bodycote Materials Testing Canada Inc.

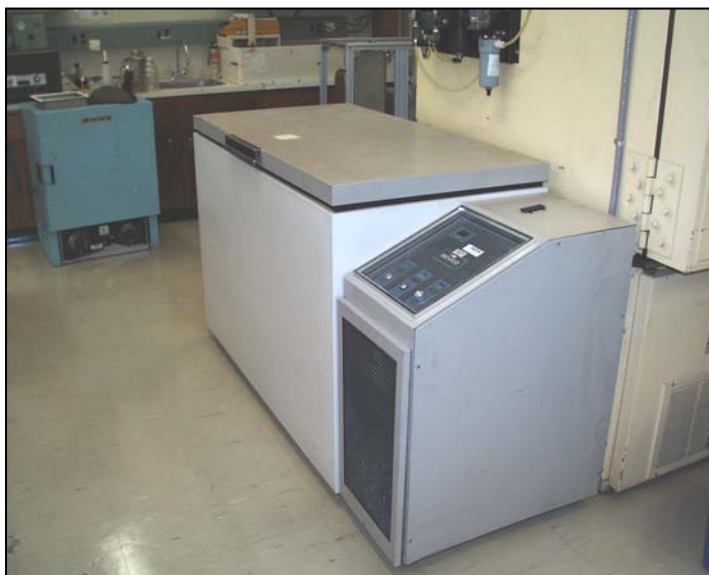
Figure 27: Deep freeze unit at Bodycote Materials Testing Canada Inc.
This chest freezer is capable of attaining temperatures of -60°C
and was used to provide simulated outdoor exposure.

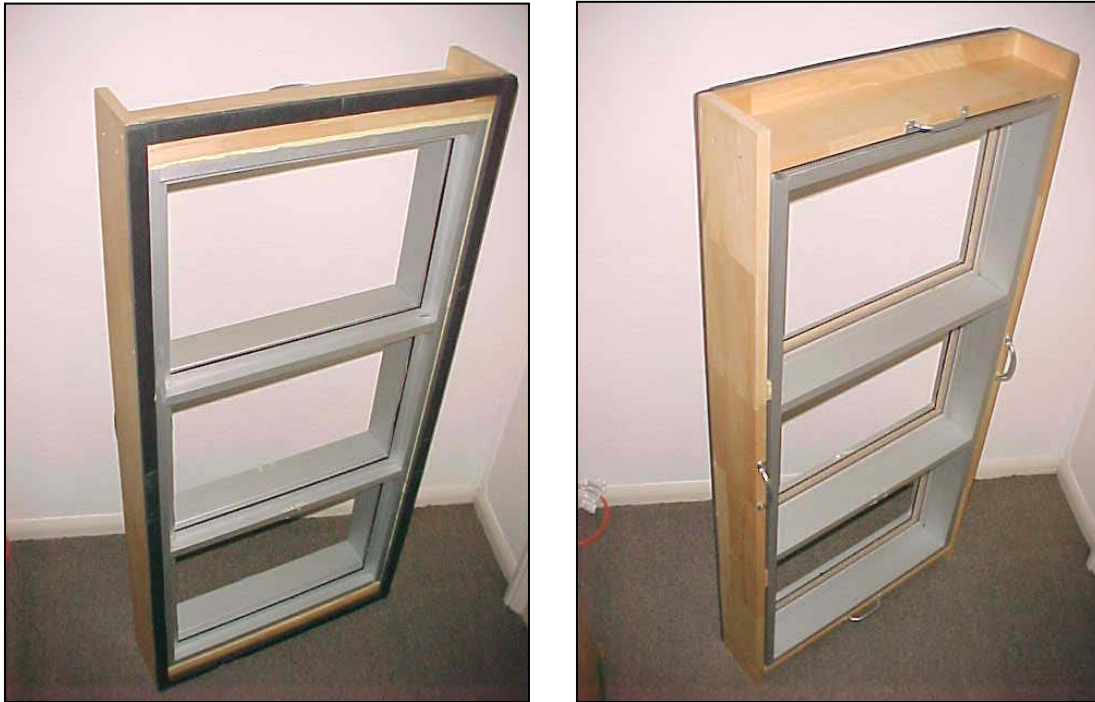
Figures 28, and 29: Outdoor exposure frame. At upper left, the exterior face exposed to the freezer chest, at right the room-side face. At upper right the interior face exposed to room conditions. The window frame was mounted to a wood buck to fit the freezer chest opening. Gaps between the frame and the wood buck, and the wood buck and the freezer were sealed to separate the cold environment within the chamber from the warmer laboratory environment.

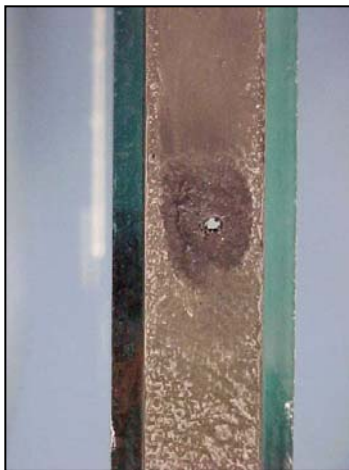
Figure 35: Typical breach opening reamed by 1.59mm (1 1/6 in.) drill bit. The interior of the cavity can be seen clearly through the opening.
