Effect of Mesh and Bale Orientation on the Strength of Straw Bale Walls

EFFECT OF MESH AND BALE ORIENTATION ON THE STRENGTH OF STRAW BALE WALLS

FINAL REPORT

P.I. Colin MacDougall, Department of Civil Engineering, Queen's University
Co-Investigators: Chris Magwood, Steve Vardy

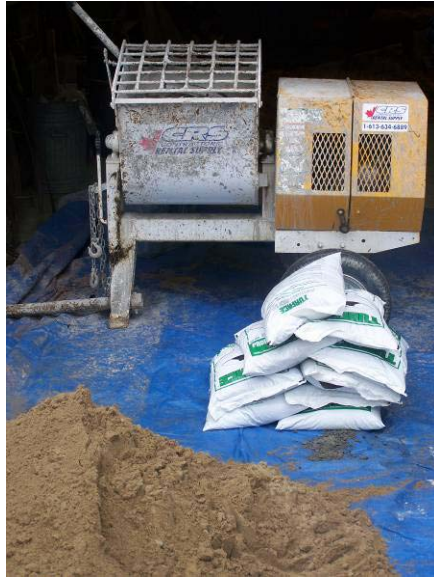
Figure 1 – Batching of materials prior to mixing plaster in mortar mixer.

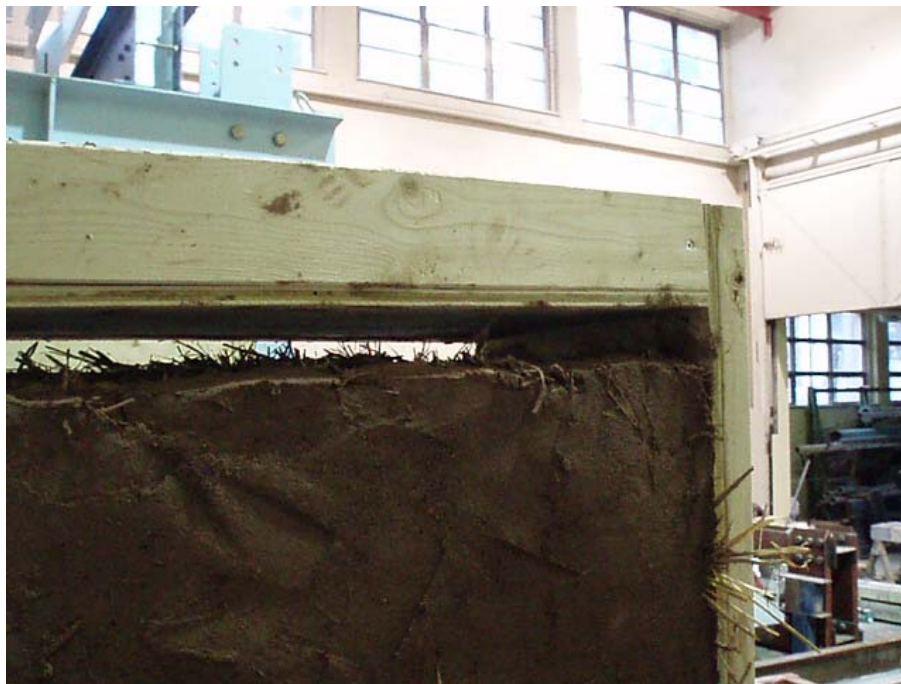
Figure 11 – Slumping of clay plaster wall.

The plaster was then allowed to stand and cure in the laboratory. The air in the lab is generally kept constant at 20 °C. The cement plaster began to cure within a few hours. The clay plaster, however, could take several days to begin to dry and achieve strength. As a result, it was observed that the clay walls tended to slump by 50 to 75 mm below the

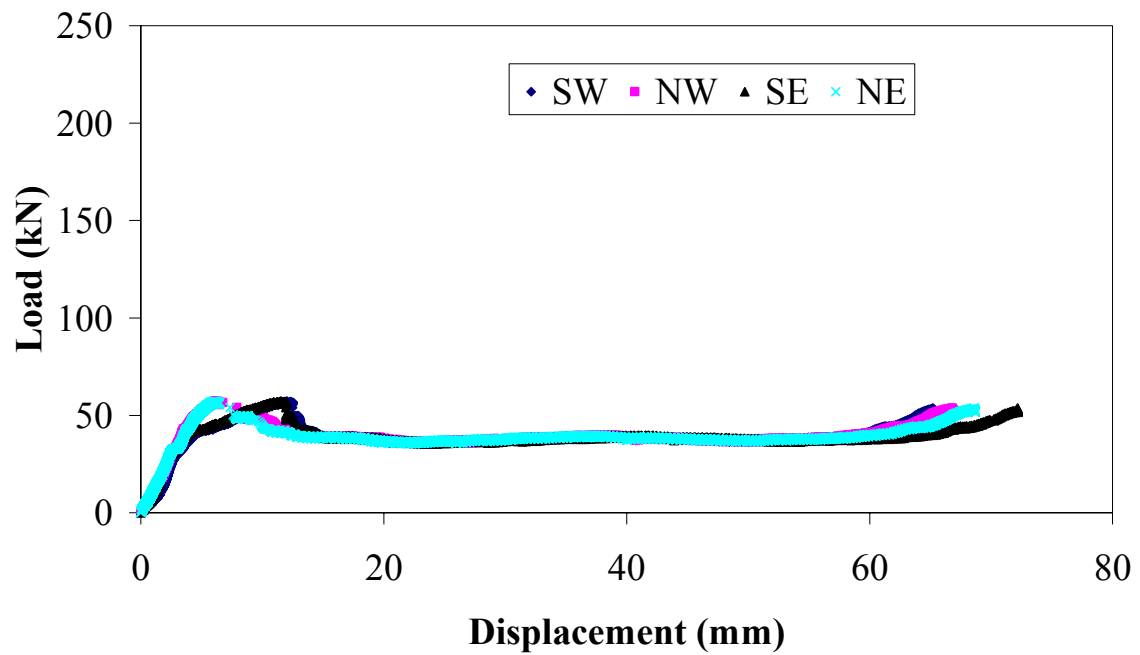
Figure 15 – Load versus vertical displacement for Wall 4 (clay plaster, bales flat).

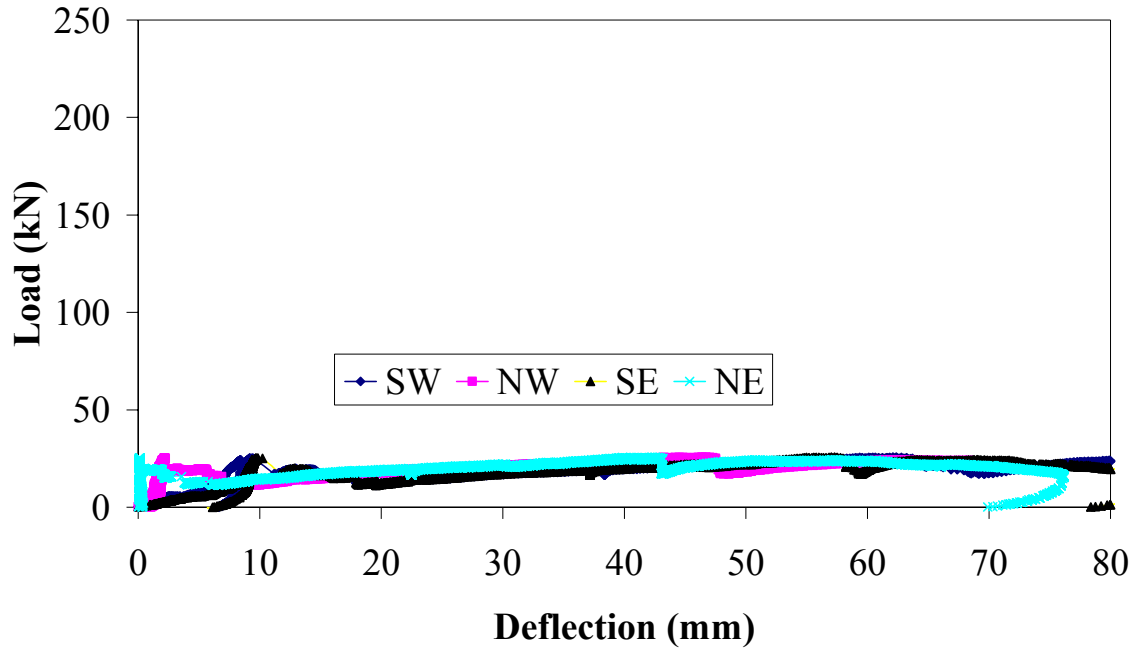
Figure 16 – Load versus vertical displacement for Wall 2 (clay plaster, bales on-edge).

For the most part, fairly uniform vertical loading was observed. Therefore, it is reasonable to average the values of the vertical LVDTs. Two exceptions are shown in Figure 16 and 17. In the case of Wall 2, shown in Figure 16, it can be seen that the SE and SW LVDTs were not properly secured and underwent slippage at about 5 kN. Therefore, these LVDT measurements were not included in the average vertical deflection plot that will be presented subsequently. In the case of Wall 5, it can be seen that as the loading was increased beyond 150 kN, the deflections appear to reverse and decrease. This is because the steel load plate began to bend, as shown in Figure 18, causing the ends to lift off the wall. The LVDT measurements were only included up to 150 kN in the average vertical deflection plot that will be presented subsequently.

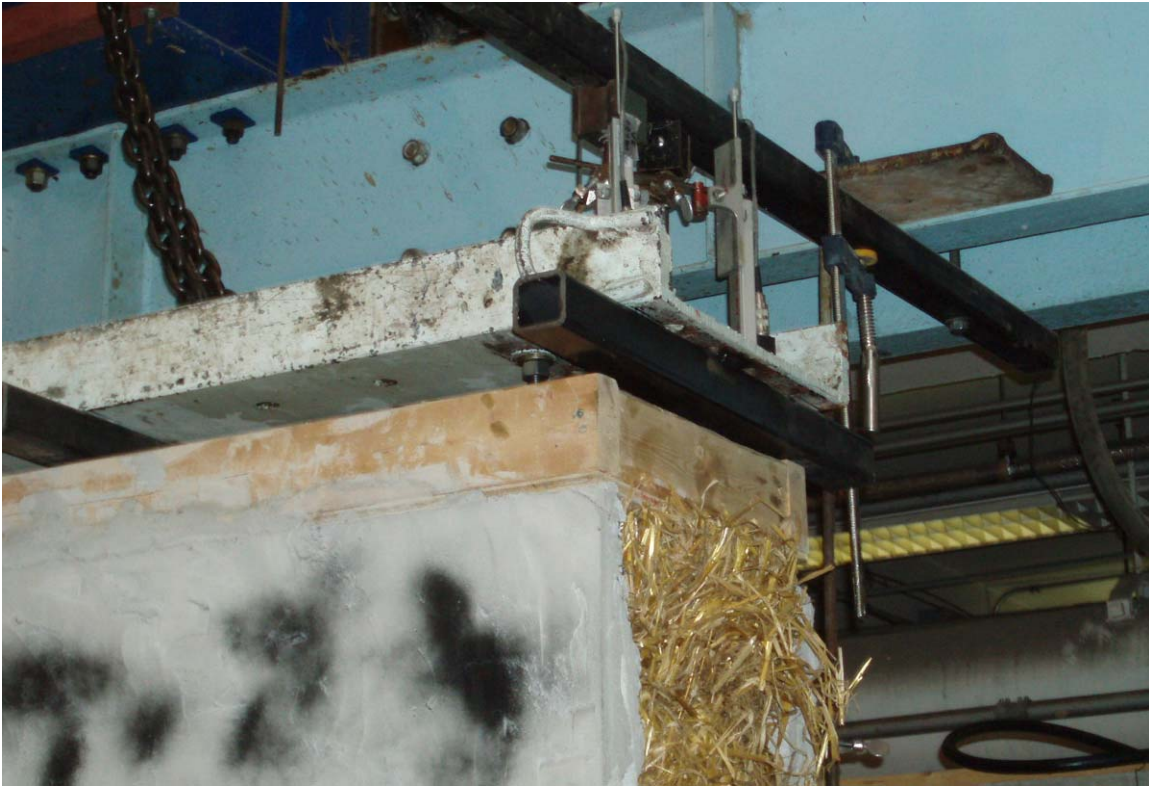
Figure 18 – Steel beam bending and lifting off timber top plate during loading of Wall 5.

An exception was Wall 5 (Figure 53). In this case, failure was initiated as the steel top plate underwent bending due to insufficient stiffness. This causes a concentration of load at the center of the timber top plate, causing it to fail by crushing and splitting. In turn, there was localized crushing of the cement plaster adjacent the timber top plate.

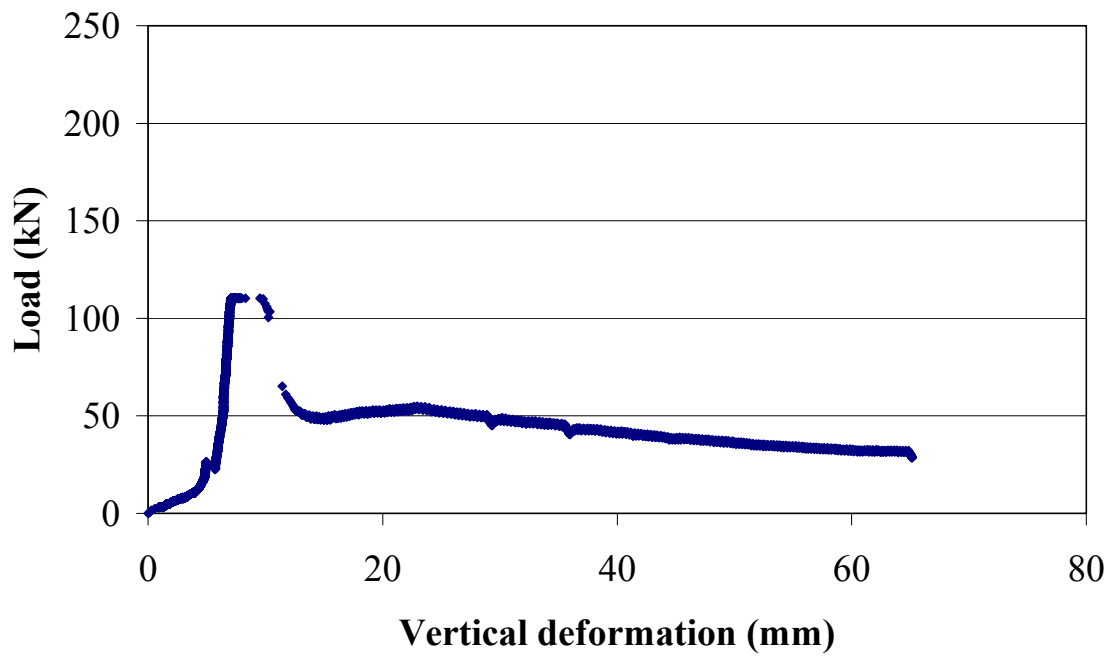
Figure 19 – Load versus average vertical displacement for Wall 1 (cement plaster, bales on-edge).

Figures 19 to 28 show the load versus average vertical deflection for all ten walls tested. It should be noted that in Figure 19 (Wall 1) the maximum capacity of the load cell was reached at 115 kN, causing the plateau observed for this test. The ultimate load for this test was therefore not captured. In subsequent discussion, the ultimate load for this test will be taken as 115 kN. Also note that in Figure 20 (Wall 2), the load was increased to 25 kN, at which point the wall was unloaded and then reloaded.

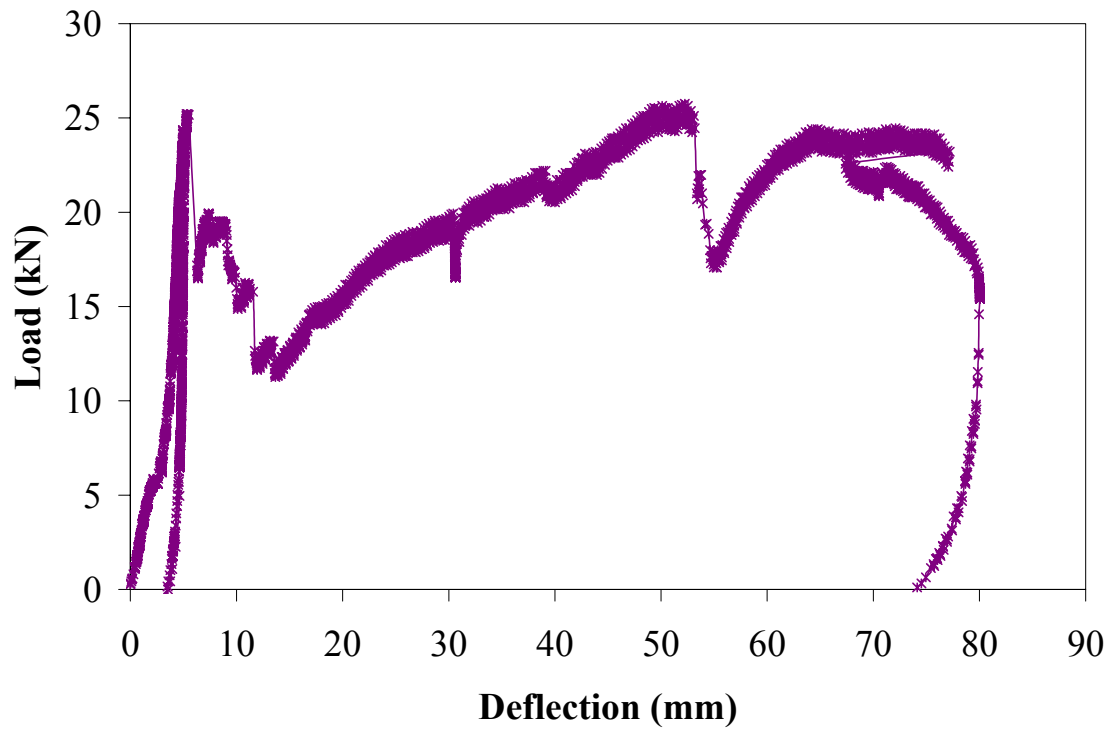
Figure 20 – Load versus average vertical displacement for Wall 2 (clay plaster, bales on-edge).

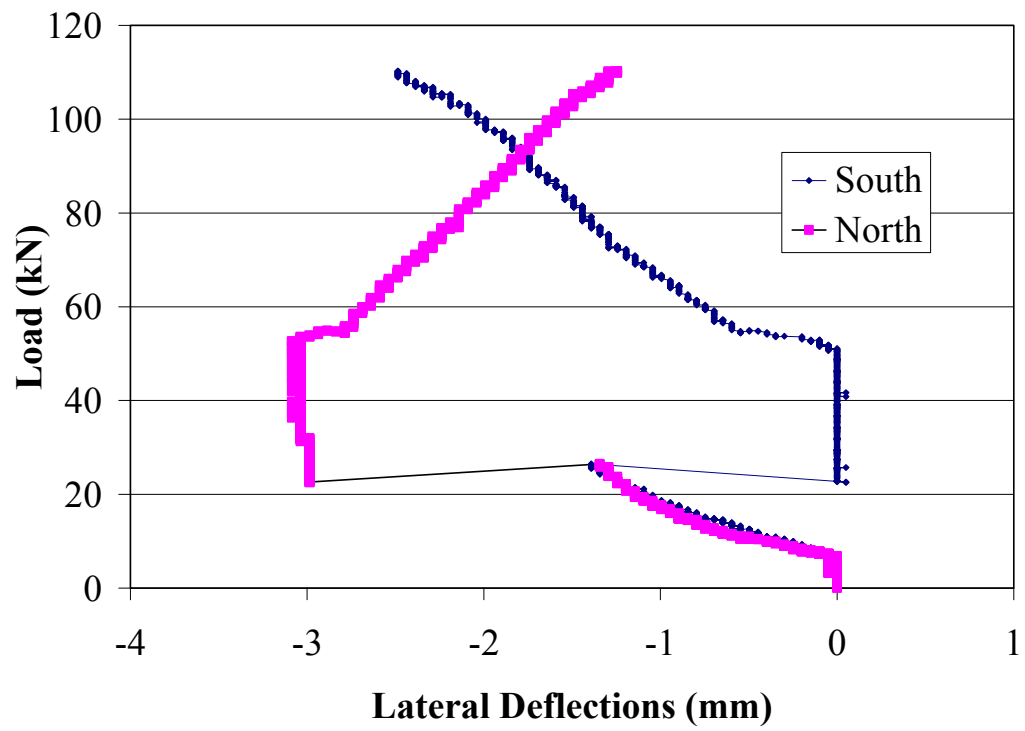
Figure 29 – Lateral deflections at the top of Wall 1 (cement plaster, bales on-edge).

Lateral deflections were measured by LVDTs at the top and mid-height of each wall. The lateral deflections at the top of the walls are given in Figures 29 to 38. In Figure 29 (Wall 1), there is evidence that the LVDTs underwent slippage at about 25 kN of loading. Therefore, these results will not be considered in the remaining discussion. For the remaining walls, there are two typical behaviours observed. For Walls 3, 4, 7, and 10 the lateral deflections at the top of the wall remain zero (or very close to zero) until the ultimate load is reached. At this point, the lateral deflections increase rapidly. For Walls 2, 5, 6, 8, and 9 the deflections increase as the load increases. This indicates that these walls are not perfectly straight, causing the wall to bend and deflect laterally as load is applied. In addition, for Walls 2, 5, 8, and 9 the deflections at the North and South ends of the walls are not equal as the load increases. This indicates that the top of these walls is also twisting as load is being applied.

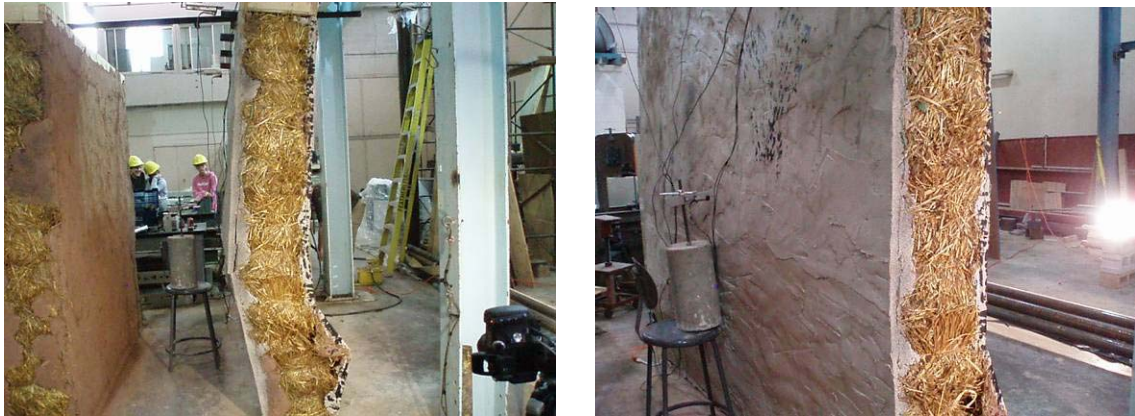
Figure 49 – Failure of Wall 1 (cement plaster, bales on-edge): (a) Side view; (b) Isometric view.

Walls 1, 2, 6, and 8, which had bales stacked on-edge, generally failed by bending laterally and buckling. In the case of Wall 1 (Figure 49(a)), this was accompanied by debonding of the plaster from the straw.

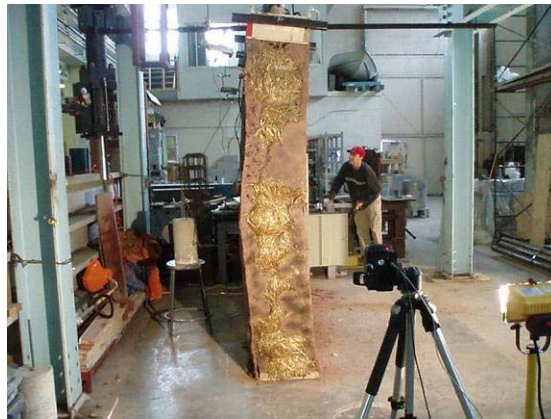
Figure 50 – Failure of Wall 2 (clay plaster, bales on-edge).

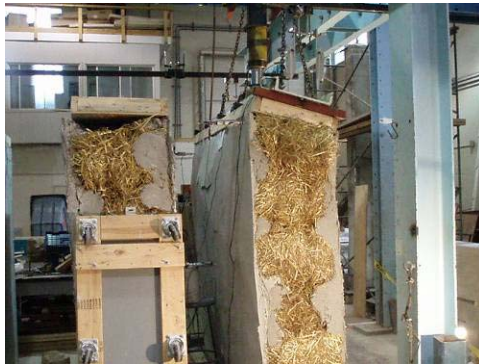
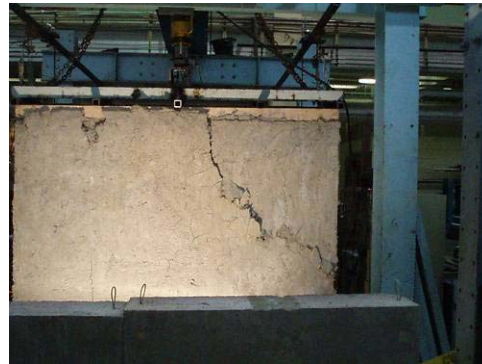
Figure 51 – Failure of Wall 3 (clay/cement plaster, bales flat): (a) Side view; (b) Front view.

Walls 3, 4, 5, 7, 9, and 10 had bales stacked flat and generally failed by vertical crushing and accompanied by much less lateral bending.

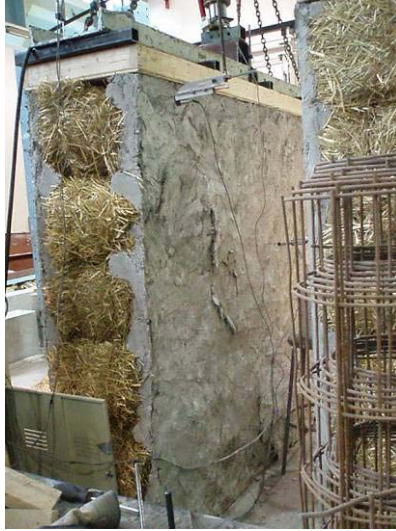
Figure 52 - Failure of Wall 4 (clay plaster, bales flat).

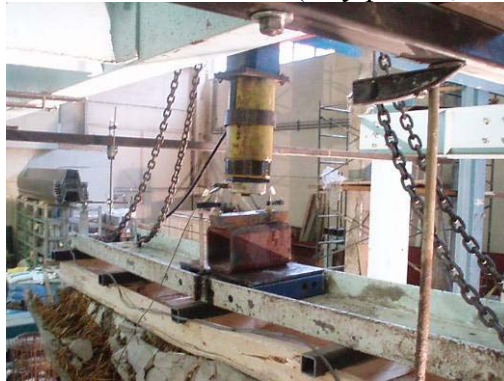
Figure 53 – Failure of Wall 5 (cement plaster, bales flat).

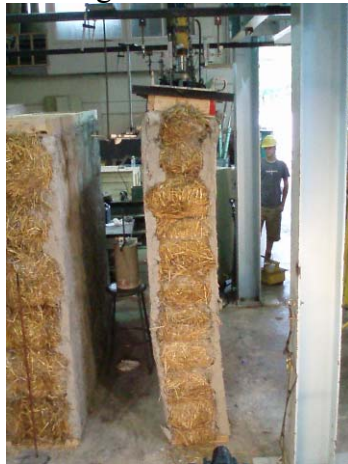
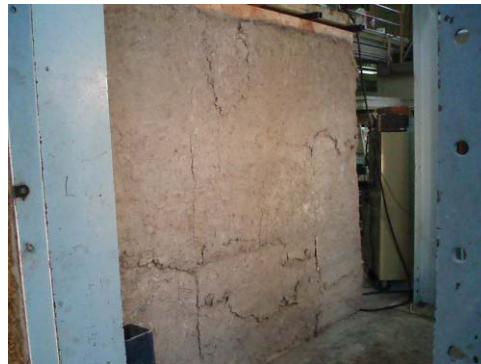
Figure 54 – Failure of Wall 6 (clay plaster, bales on-edge): (a) Side view; (b) Isometric view.

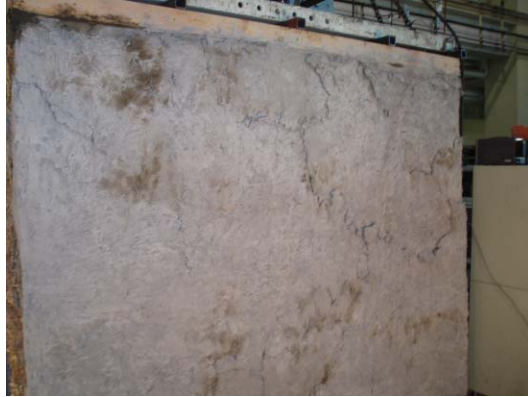
Figure 55 – Failure of Wall 7 (clay plaster, bales flat).

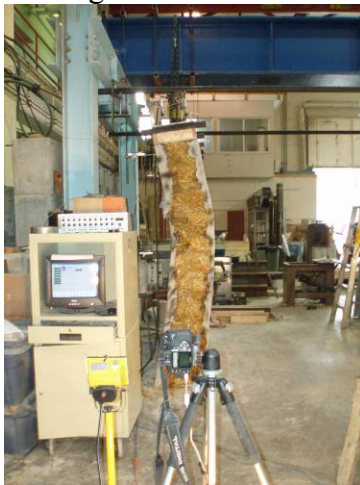
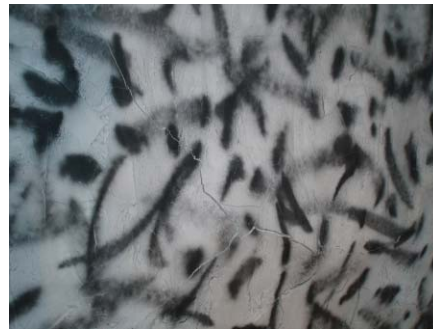
Figure 56 – Failure of Wall 8 (cement plaster, bales on-edge): (a) Side view; (b) Close-up of cracking.

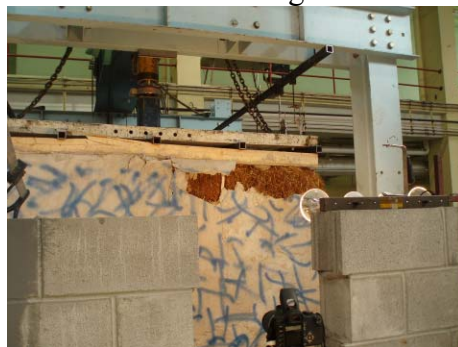
Figure 57 – Failure of Wall 9 (cement plaster, bales flat).
