Cement Skin EPS Core Building System:
Proof of Concept Testing:
Preliminary Structural Evaluation

Proof of Concept Testing
Cement Skin- EPS Core Building System
- Preliminary Structural Evaluation

Final Report

November 2001

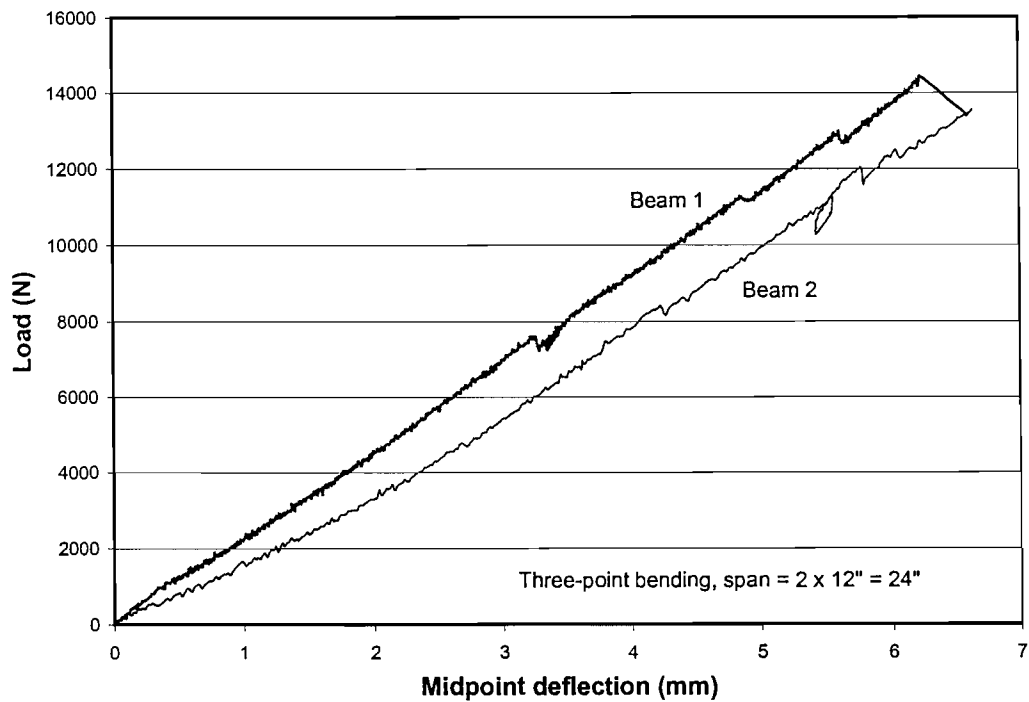
Fig. 2: Three-point bending tests of sandwich beams with skin perpendicular to base

Two composite beams (305 mm x 355 mm x 1219 mm) were fabricated for in-plane shear tests to determine the shear resistance of the sandwich beam. They were tested in a 3-point bending set-up with a short span of 609 mm and a vertical cement skin (perpendicular to the base) to examine the shear capacity. The set-up is shown in Photo 10. The load-deflection curves are presented in Fig. 2, and the failure of the beam is shown in photo 11. Obviously, it was a typical flexural failure. The maximum load obtained was close to the theoretical failure load in flexion, indicating that the response of the sandwich beam was similar to that of the 50 mm (2") cement skin alone in bending. The contribution of the core was almost negligible. It was also found that the beam specimen, either 3-point simply supported beam or cantilever beam, is not a suitable specimen to test for the shear strength. Shear failure is not possible with beam specimens. Therefore, the initially proposed cyclic shear tests on the cantilever beams did not appear to be meaningful. Instead, cyclic shear tests on the full-scale wall up to seismic design load seemed more useful in house design. It was therefore decided the cyclic loading on full-scale wall test be added to investigate the seismic response.

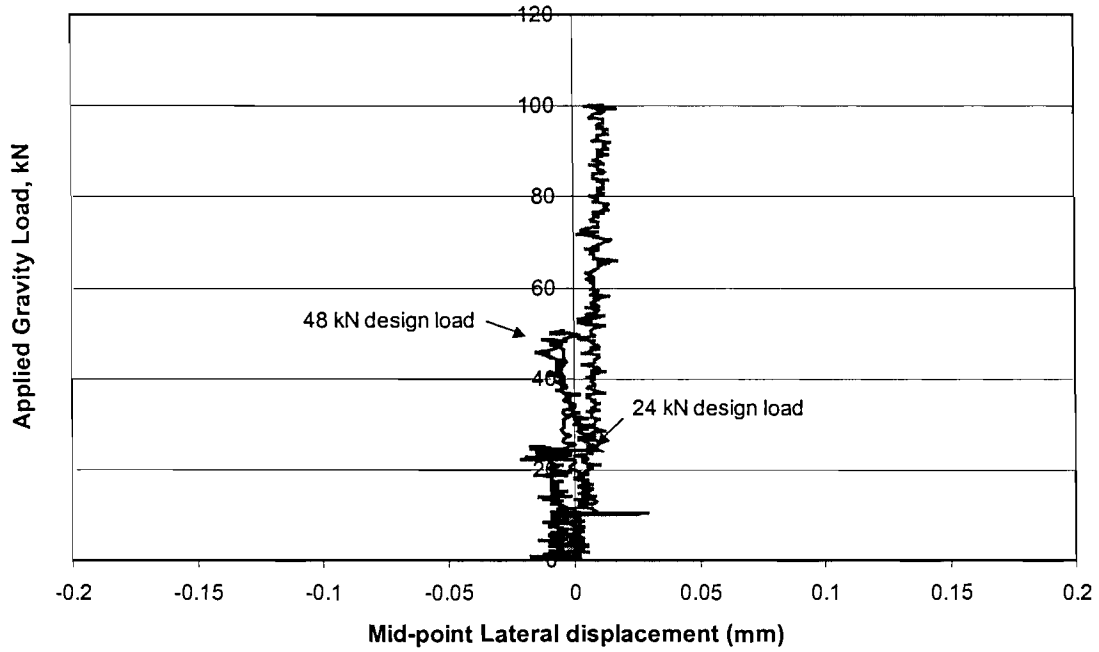
Fig. 6: Gravity load tests up to 100 kN

- (1) Gravity load tests. Fig. 6 shows the first gravity load tests with load gradually added to 24 kN, 48 kN and 100 kN (at least twice the design load). LVDT 18 was used to record the midpoint displacement. The lateral displacement was nearly zero and no damage was observed anywhere.

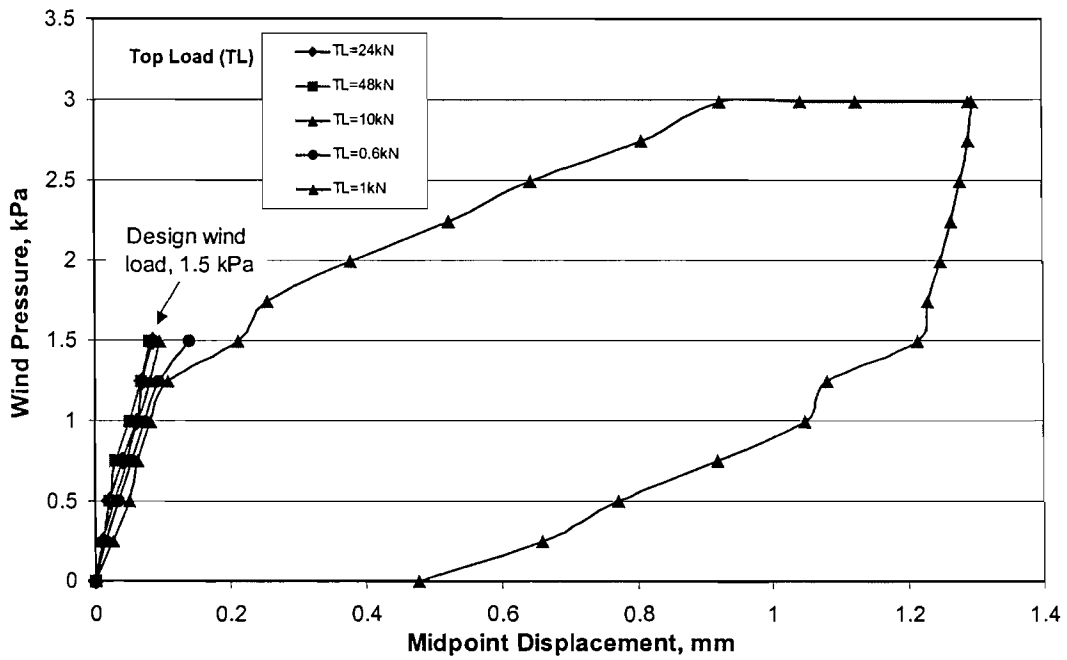
Fig. 7: Wind load tests up to 3 kPa (62 psf)

- (2) Wind load tests. Fig. 7 shows wind load tests at design load (1.5 kPa) and doubled design load (3 kPa) with various top loads (TL) as dead load while wind pressure was applied. Midpoint displacement was measured by LVDT 18. It seemed that the lateral displacement was slightly increased as the top load decreased. No damage was observed.

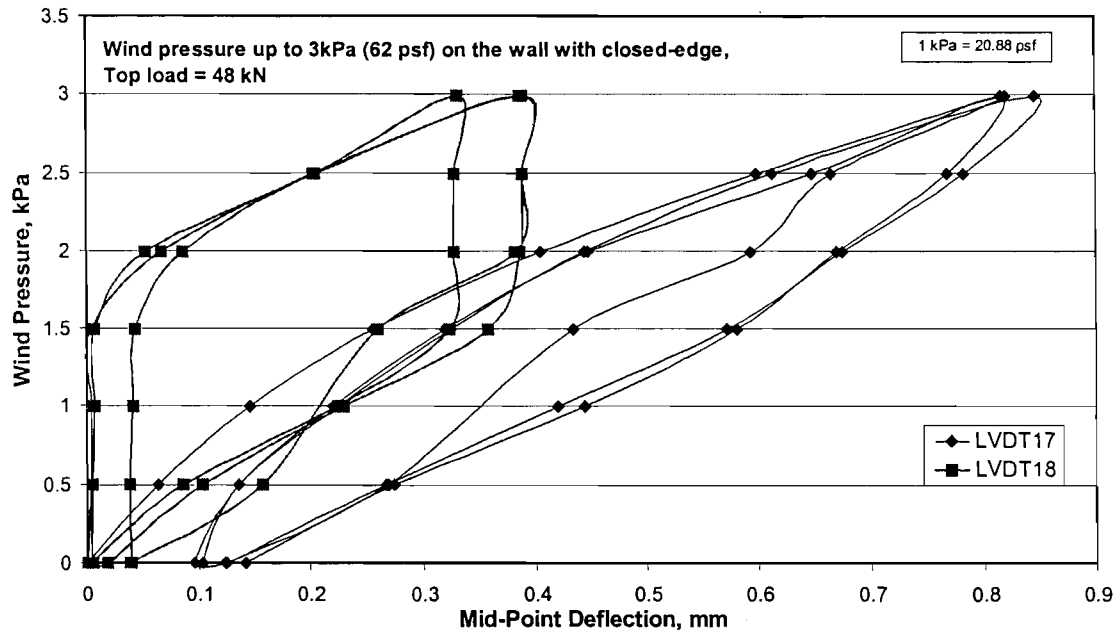
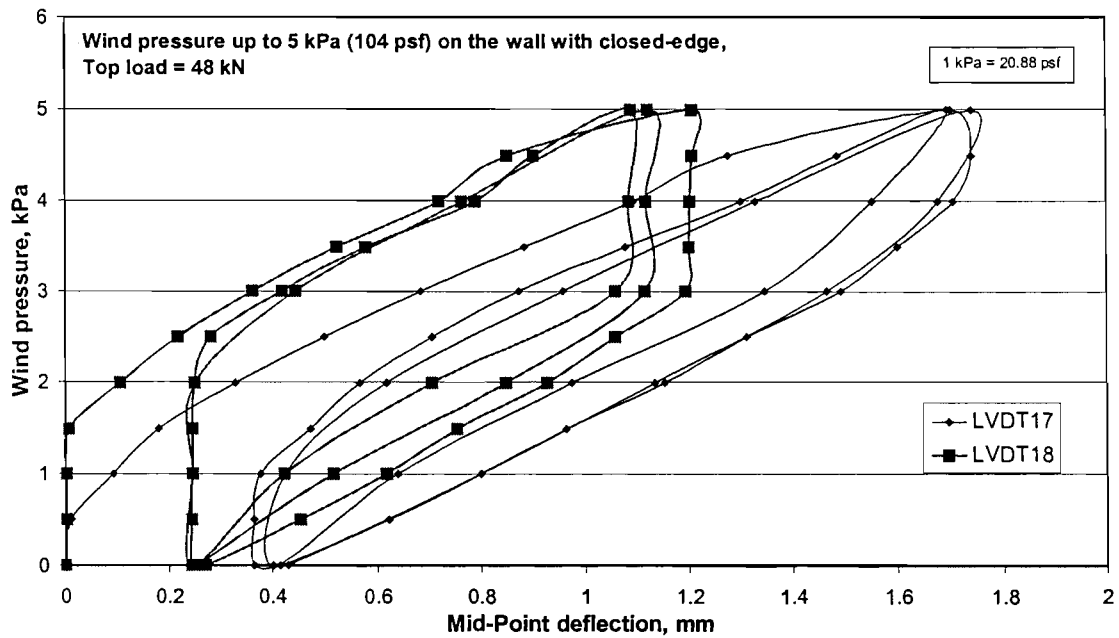
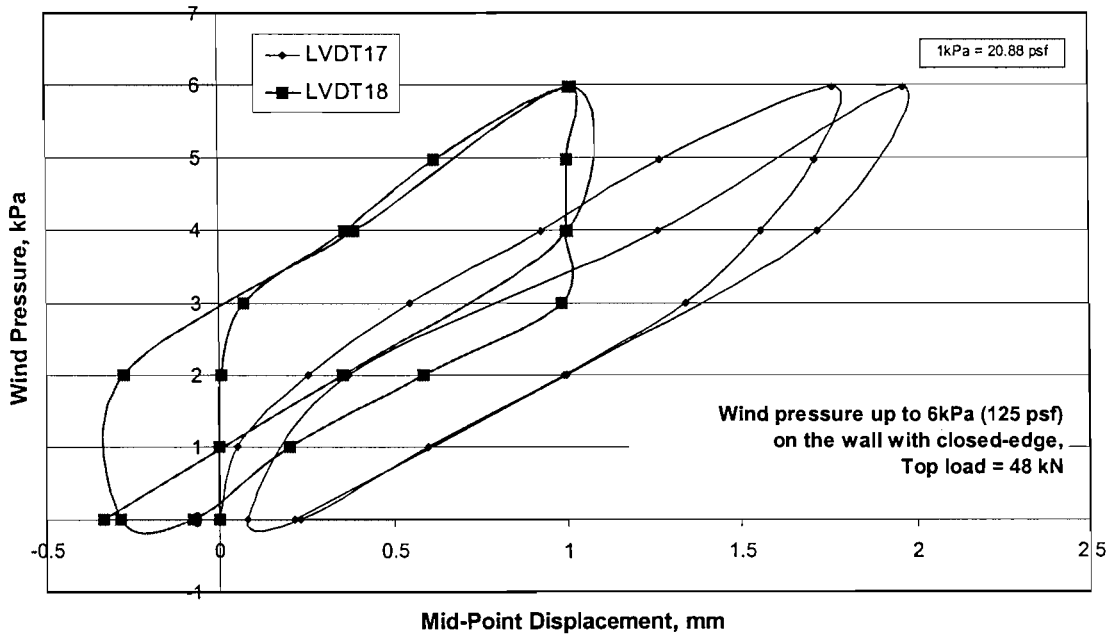
Fig. 8: Cyclic wind load tests up to 3 kPa (62 psf)

Fig. 9: Cyclic wind load tests up to 5 kPa (104 psf)

Fig. 10: Cyclic wind load tests up to 6 kPa (125 psf)

- (3) Cyclic wind load tests. Figs. 8, 9 and 10 show the response of wall to the cyclically added wind pressure up to 3 kPa (twice design load), 5 kPa (4 times design load) and 6 kPa (5 times design load). A 48 kN dead load was kept on the top. Both LVDT 17 and 18 were used to detect displacement. The back side (LVDT 17) moved more than the front side (LVDT 18), suggesting that the two skins did not move by the same amount. No crack was noticed.

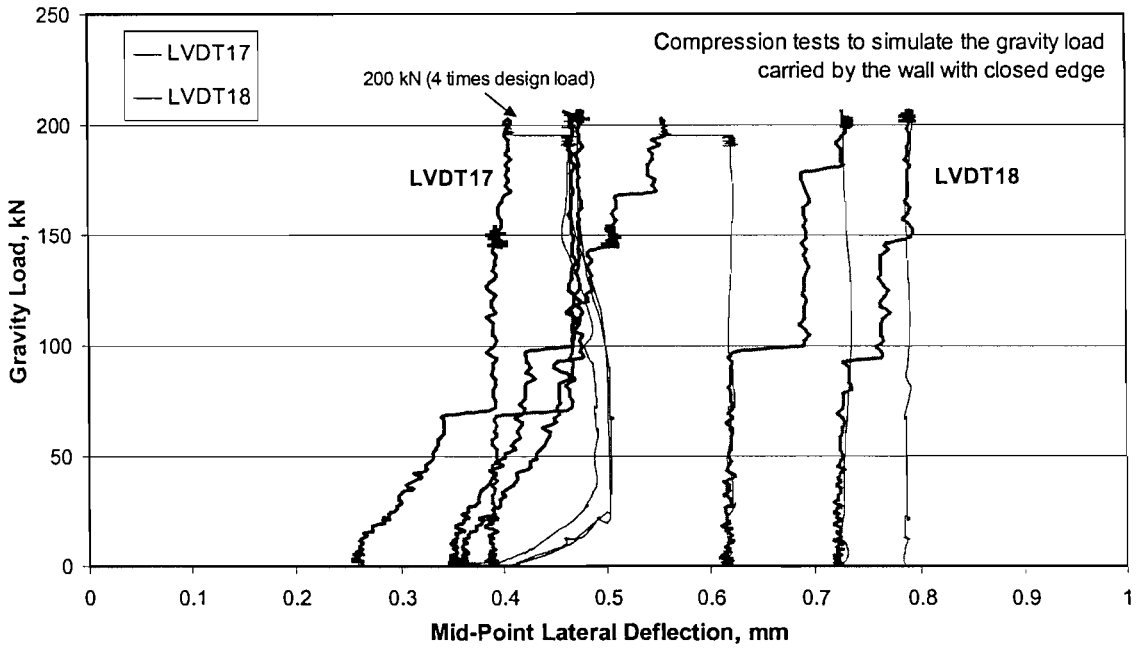
Fig. 11: Cyclic gravity load tests up to 200 kN (close edge)

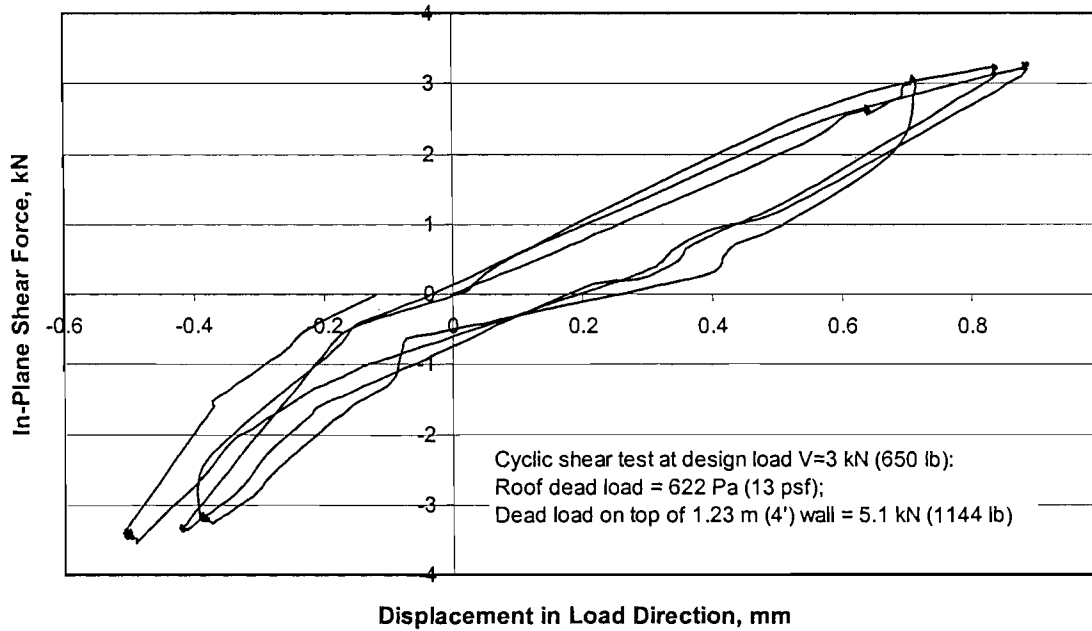
Fig. 12: Cyclic in-plane shear tests up to 3 kN (650lb)

Fig. 13: Cyclic in-plane shear tests up to 12 kN (2600lb)

- (5) Cyclic shear tests. Figs. 12 and 13 show the response to the cyclic shear load up to 2.9 kN (design load) and 11.6 kN (4 times design load), respectively. The tests were to simulate the seismic action on the house. The roof dead load of 5.1 kN was applied as constant top load. No damage was observed.

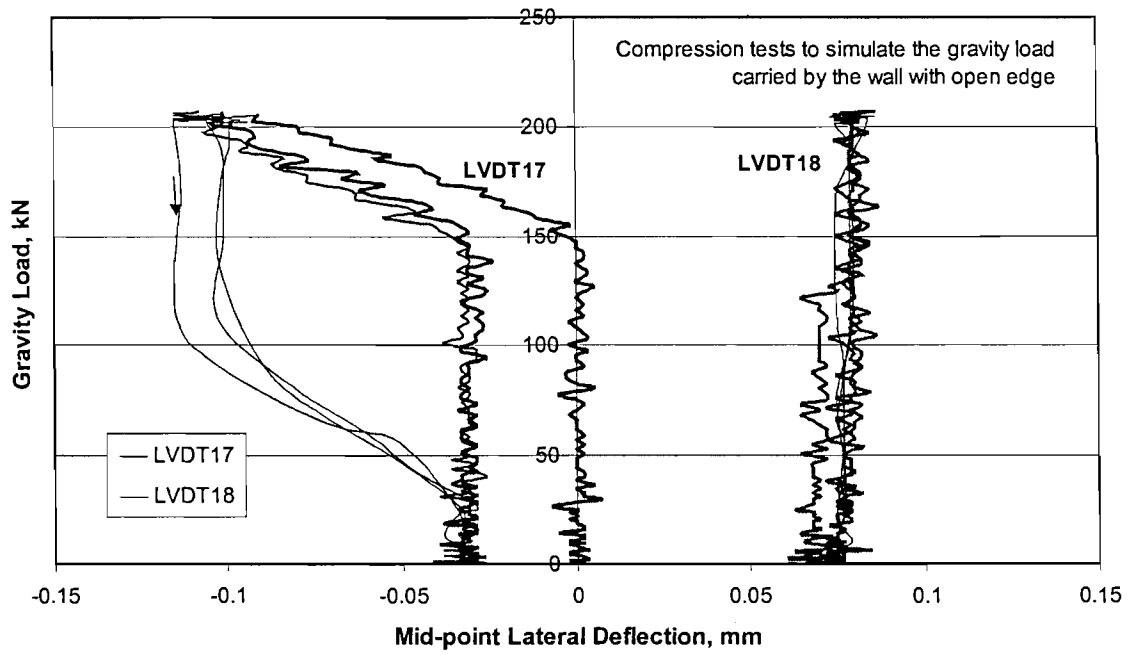
Fig. 14: Cyclic gravity load tests up to 200 kN (open edge)

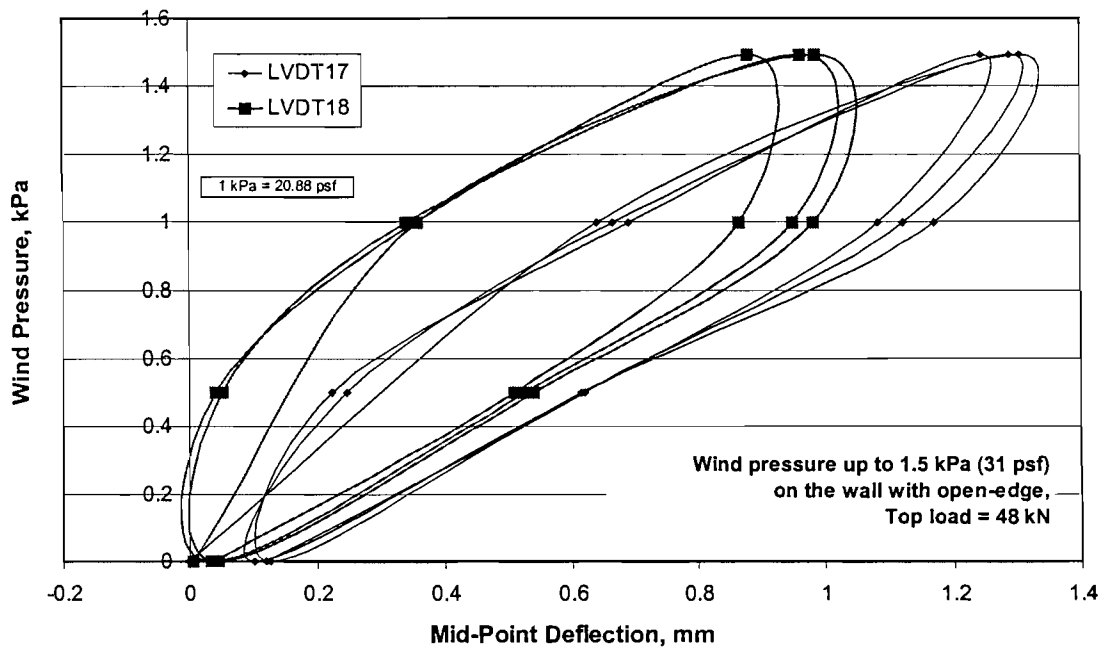
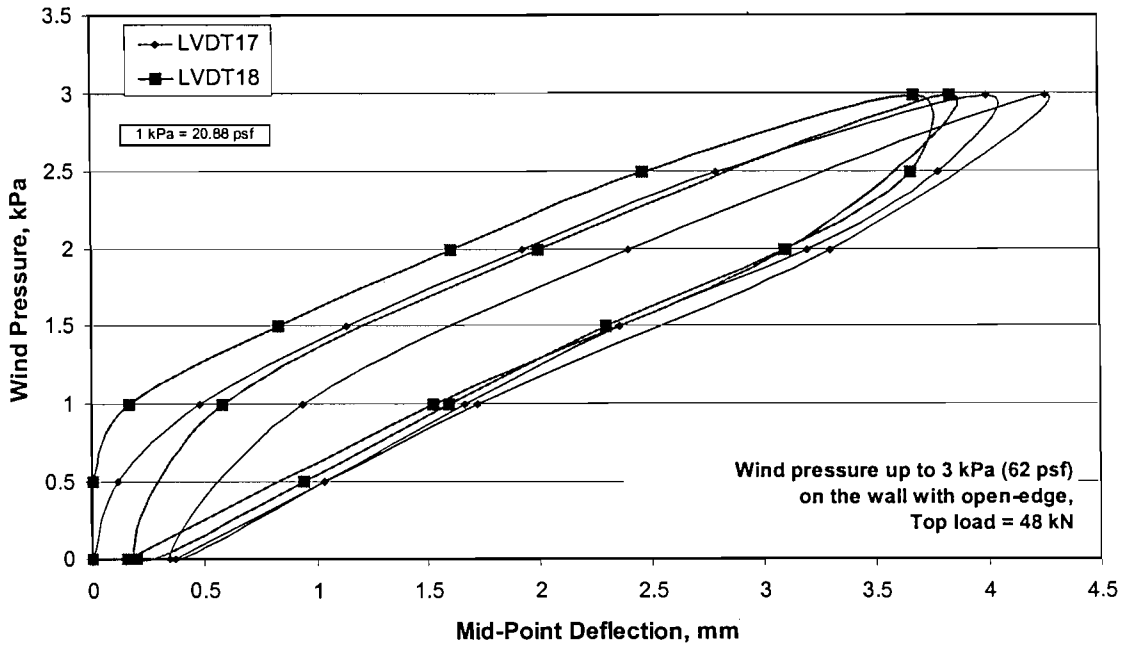
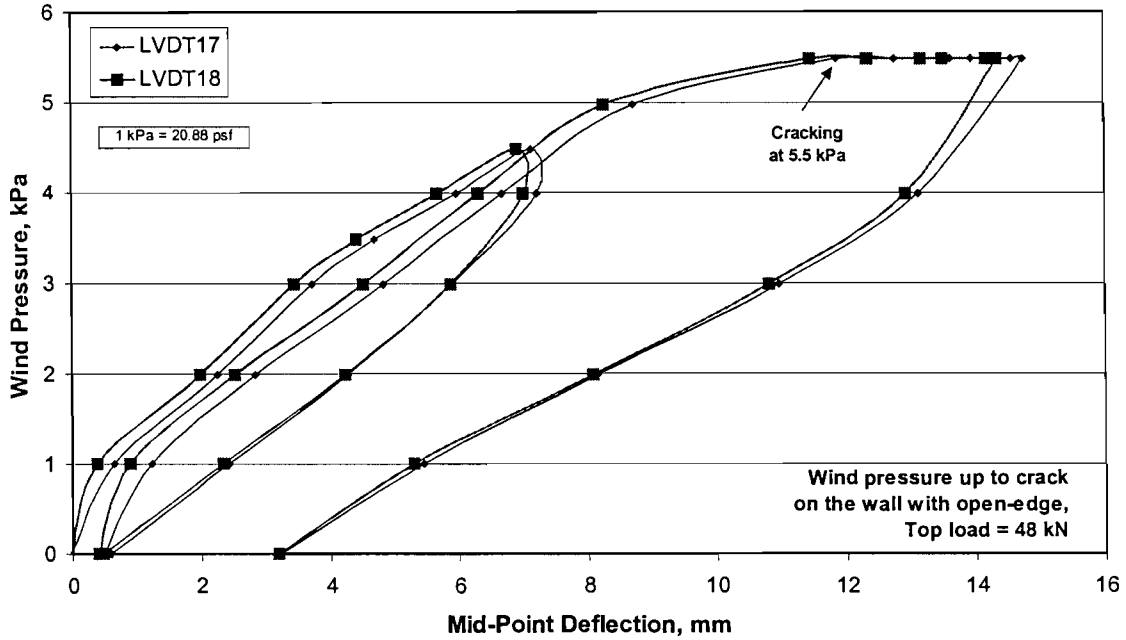
Fig. 15: Cyclic wind load tests up to 1.5 kPa (31 psf) – open edge

Fig. 16: Cyclic wind load tests up to 3 kPa (62 psf) – open edge

Fig. 17: Cyclic wind load tests up to cracking – open edge

- (2) Cyclic wind load tests. Figs. 15, 16 and 17 show the wind load test results up to 1.5 kPa, 3 kPa and 5.5 kPa. At 5.5 kPa, the first transverse crack was initiated on the front surface with significant lateral displacement. The gap between the air bag and the wall was apparent (Photo 23). With open edge, the wall underwent much more lateral displacements. It was approximately 10 times more at wind pressure of 1.5 kPa, 10 times more of 3 kPa and 11 times more of 6 kPa. The differences between the two LVDTs were getting smaller when more displacements were measured. The crack pattern is displayed in Photo 24.

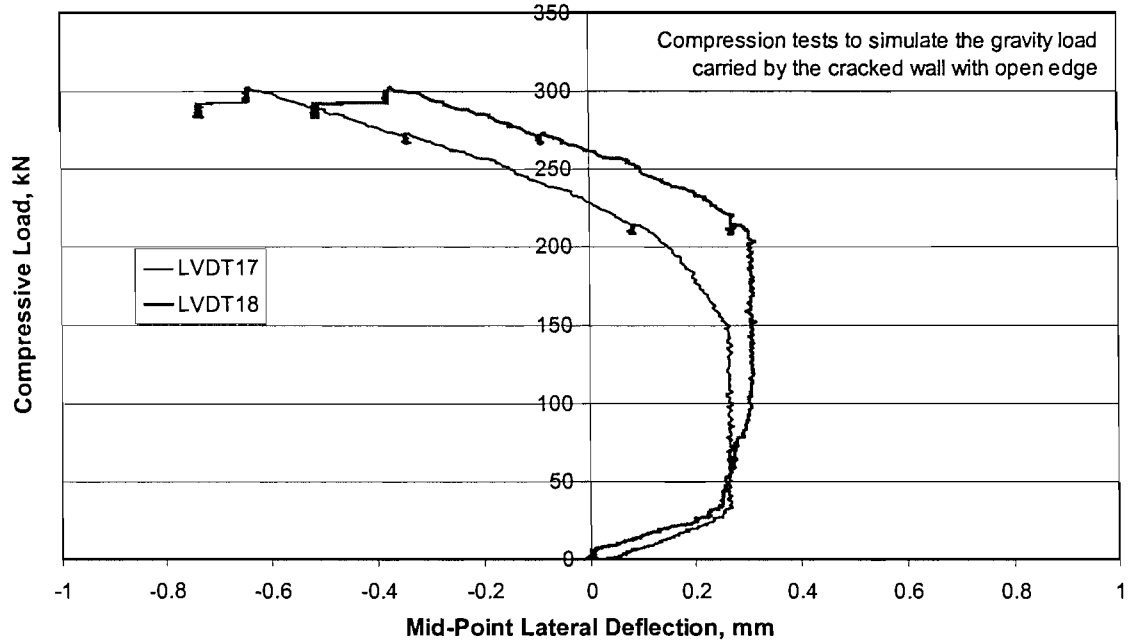
Fig. 18: Compression tests on the cracked wall up to 300 kN – open edge

Fig. 19: Failure test of the cracked wall up to buckling –open edge

- (3) Tests on cracked wall. Compressive tests were conducted to examine the vertical load carrying capacity of the cracked wall. The wall was loaded up to 300 kN, unloaded to zero (Fig. 18), and then loaded again to failure (Fig. 19). Significant lateral displacement was observed. For failure tests, the air bag was removed and LVDT 17 was placed on the back side. The two LVDTs exhibited almost identical values. Buckling was typical failure mode (Photo 25) and second transverse crack was observed (Photo 26). This multiple cracking was clearly attributed to the continuous mesh reinforcement. The test was stopped when the maximum displacement reached 38 mm.

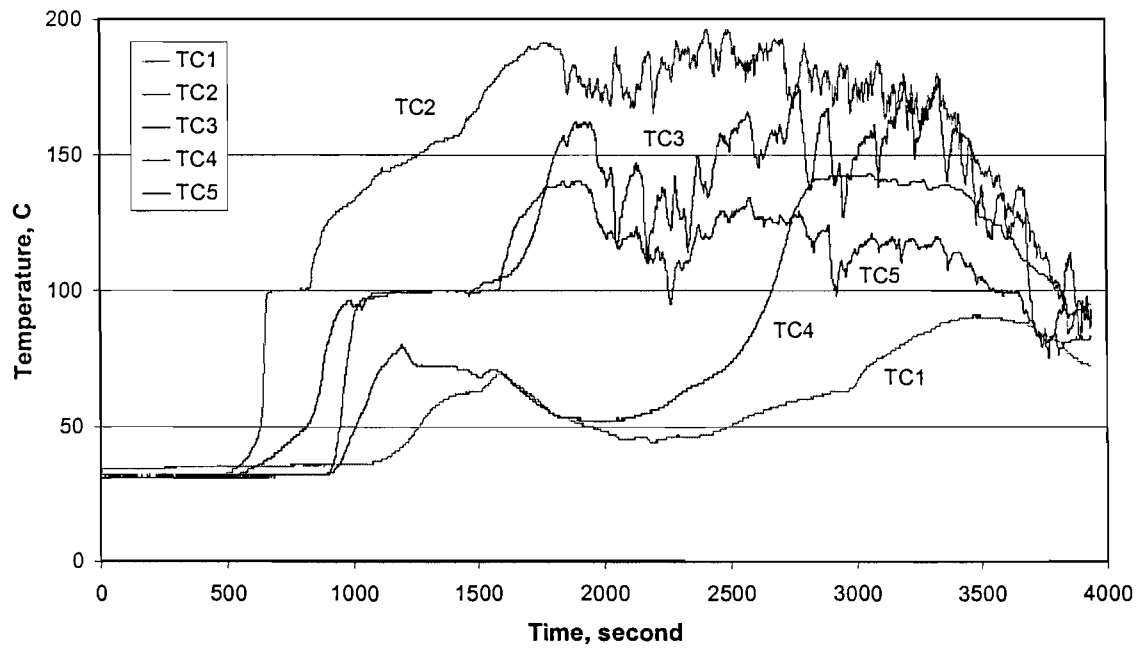
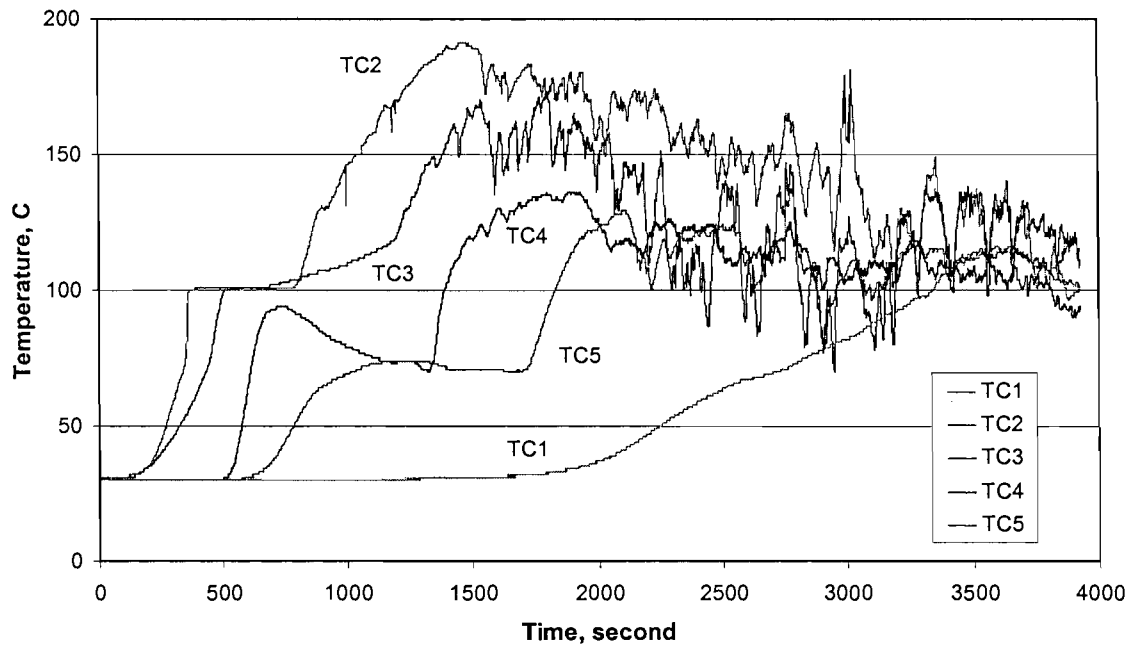
Fig. 23: Temperature distributions in column 1 during blow torch test

Fig. 24: Temperature distributions in column 2 during blow torch test (Dead load on top = 5.3 kN (1200 lb))

Fig. 25: Temperature distributions in Column 3 with TC 1 inside cement skin

During the 1-hour blow torch test with 5.3 kN (1200 lb) weights on top, column 2 stood still even after the core was burnt, the cement skin popped out and a transverse crack initiated. Column 3 was tested with TC1 directly exposed to the fire (Fig. 22) through a small hole on the front skin. The temperature limit for the type T thermal couple was 400 C. When the temperature exceeded 400 C, the reading became zero (Fig. 25). Obviously, at the tip of the flame, the temperature was higher than 400 C. The temperature detected by TC2 right behind the skin and the TC1 was also higher than that measured in Columns 1 and 2, suggesting that the little hole generated a path for the heat.

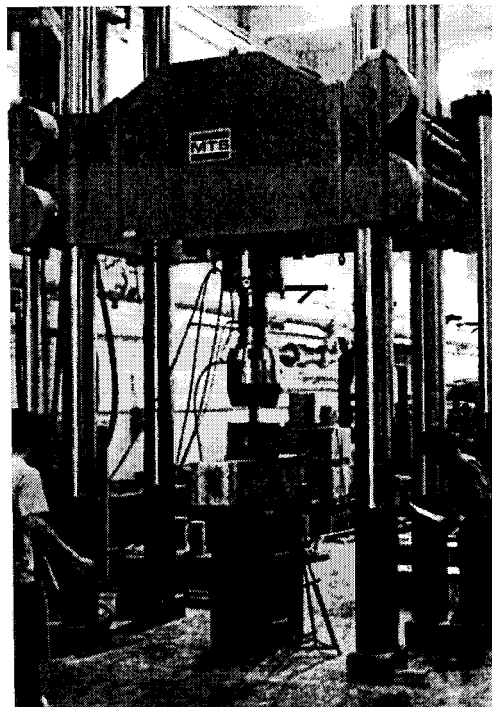
Photo 12: Overview of MTS machine and full-scale wall test site

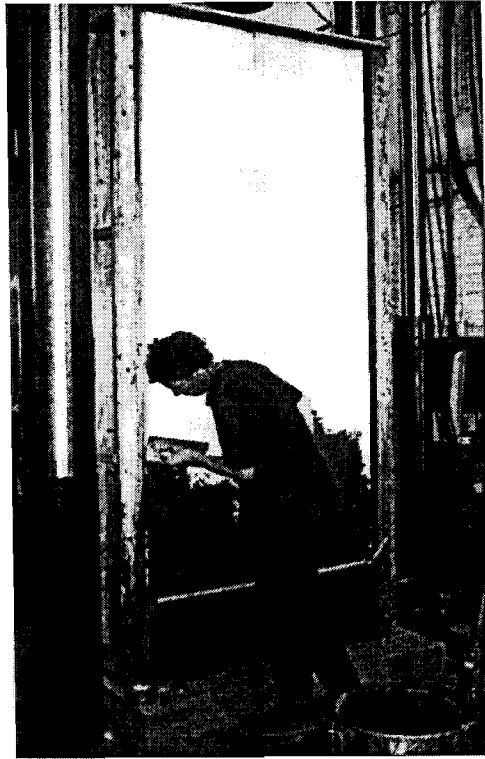
Photo 15: Application of first coat of cement on EPS core

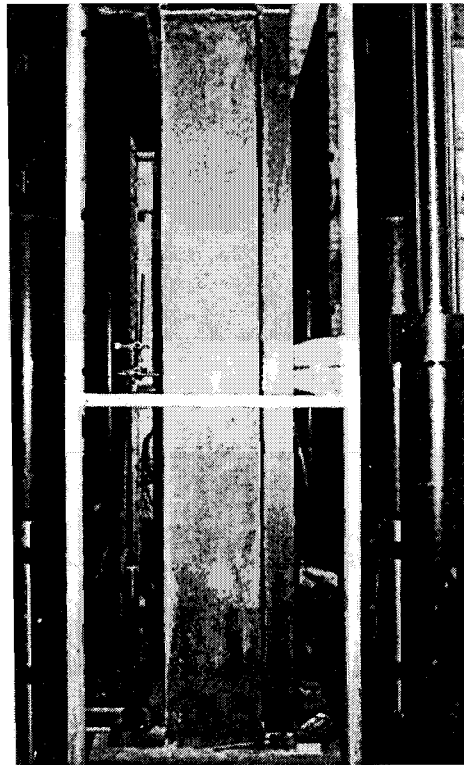
Photo 18: Installed air bag to apply the wind pressure on closed edge wall

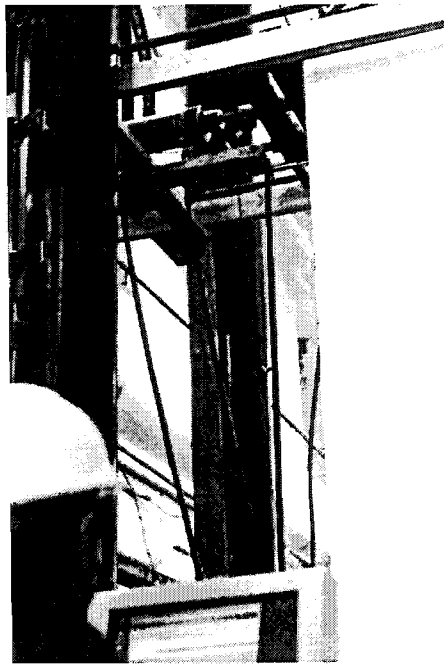
Photo 20: Setup for cyclic shear tests (right side view)

Photo 21: Setup for cyclic shear tests (left side view)

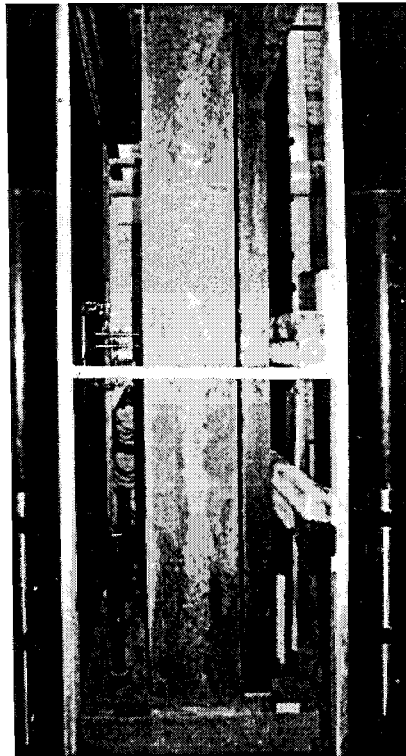
Photo 23: Opening of the gap between the wall and the inflated air bag

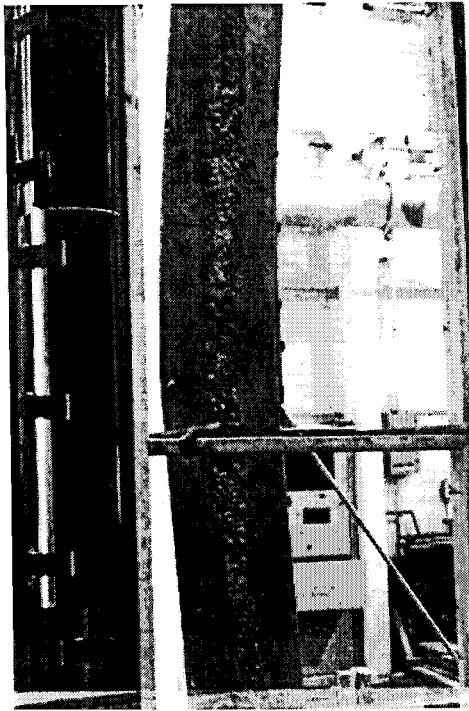
Photo 25: Buckling of the wall at a compressive load of 500 kN

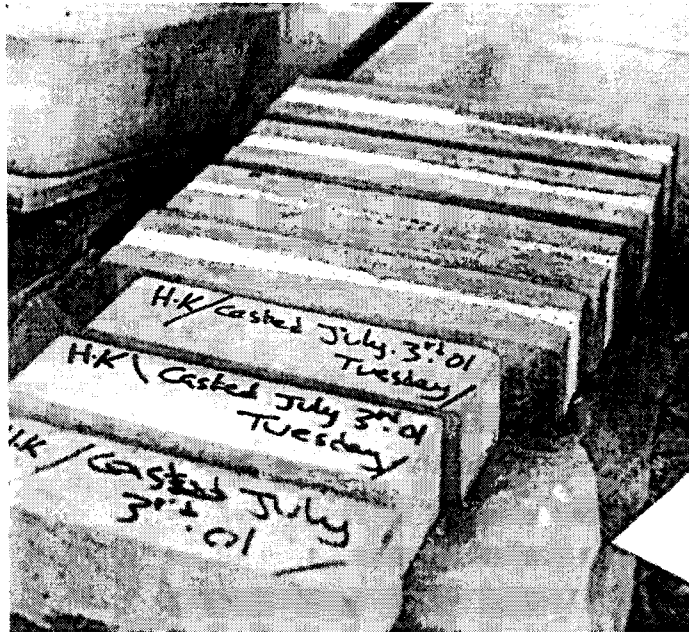
Photo 27: Samples for freeze-thaw tests
