# **MONITORED PERFORMANCE OF AN INSULATING CONCRETE FORM MULTI-UNIT RESIDENTIAL BUILDING**

## **FINAL REPORT**

**Prepared for  
Duncan Hill - Canada Mortgage and Housing Corporation (CMHC)  
Ross Monsour – Ready Mix Concrete Association of Ontario  
Premier Project Consultants and Jamesway Construction Corporation**

**Enermodal Engineering Limited  
650 Riverbend Drive  
Kitchener, ON N2K 3S2  
tel: 519-743-8777  
fax: 519-743-8778  
e-mail: [office@enermodal.com](mailto:office@enermodal.com)  
web site: [www.enermodal.com](http://www.enermodal.com)**

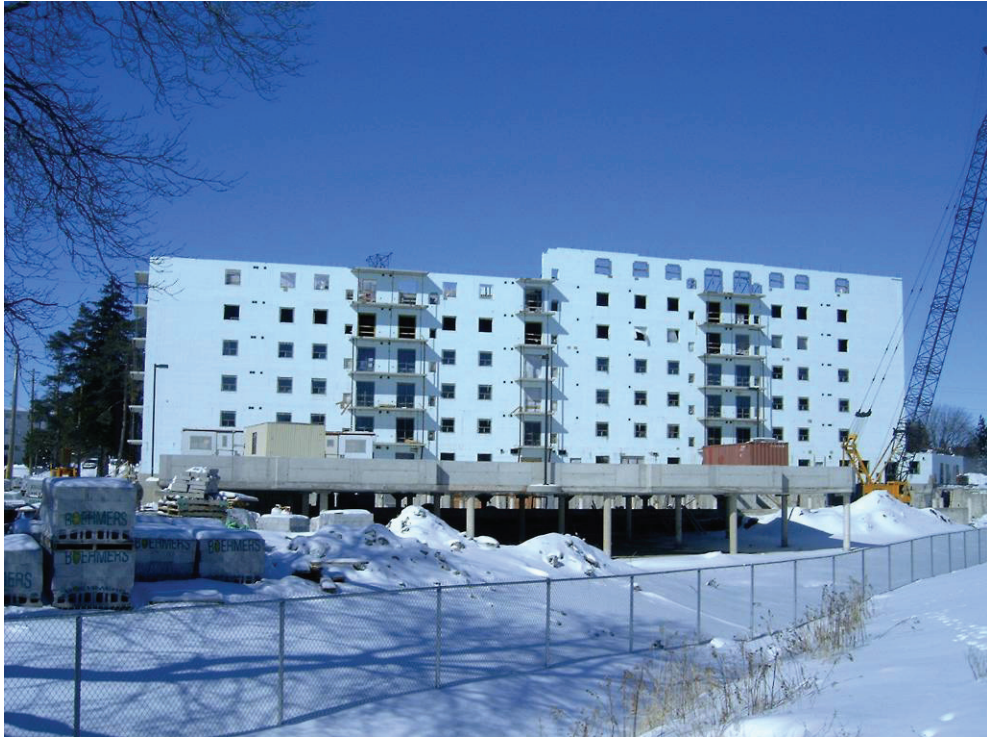
**Figure 1: ICF walls being constructed at Cedar Creek apartments.**

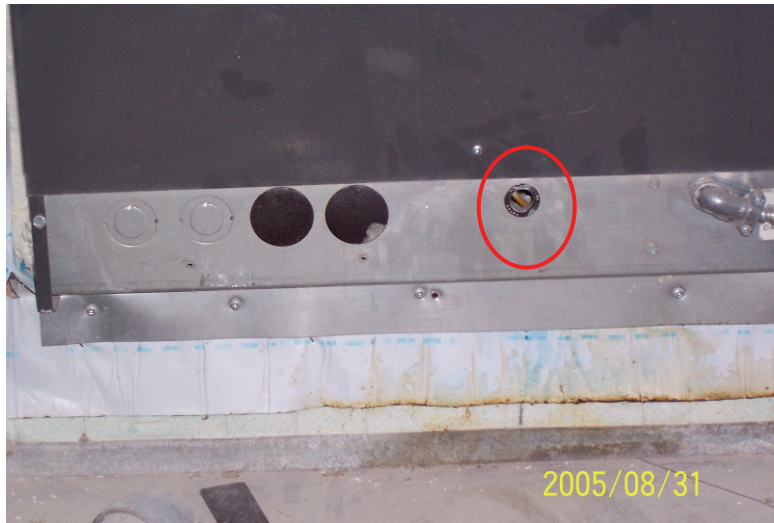
**Figure 10: Uncovered knock-out in the condenser cabinet.**

<b>Location</b>	<b>Leakage Appraisal</b>	<b>Suites Affected</b>	<b>Comment</b>
Through-the-wall condenser			
3/4" dia. hole at base of unit (See Figure 1 below)	Large	All	Could be sealed with a plastic insert
Opening for refrigerant line leading to cooling coil (See Figure 2 below)	Large	All	Could still be caulked and sealed
Gap between the condenser and the wall opening	Medium	Few	All building caulking should be checked
Sliding patio door (See Figure 3 below)	Medium	All	Consider doors with better weather seals in future
Window and door RFO	Small	Few	All building caulking should be checked
Sliding windows	Small	Few	
Range hood, bath fan	Small	Few	
Front vestibule pot lights (See Figure 4 below)	Large	Three	Could seal the vestibule ceiling space to prevent air movement between the inside and outside of the vestibule.
Sprinkler riser in garbage room (See Figure 5 below)	Large	One	Seal around riser

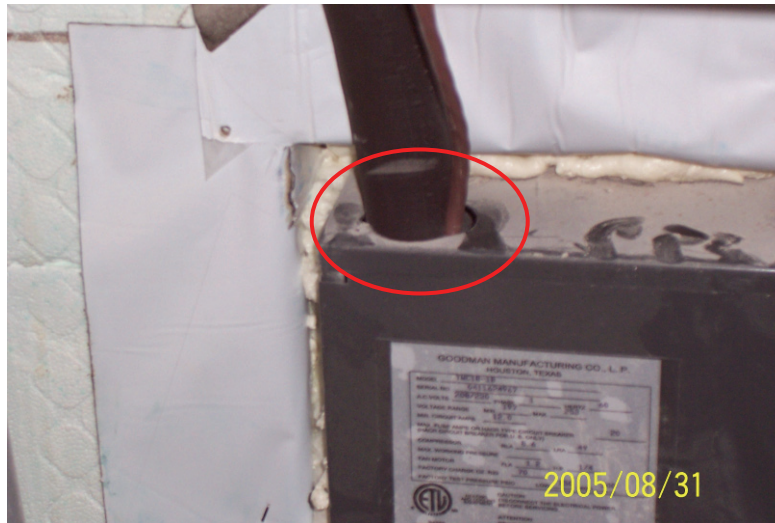
**Figure 11: Unsealed opening for condenser refrigerant line.**

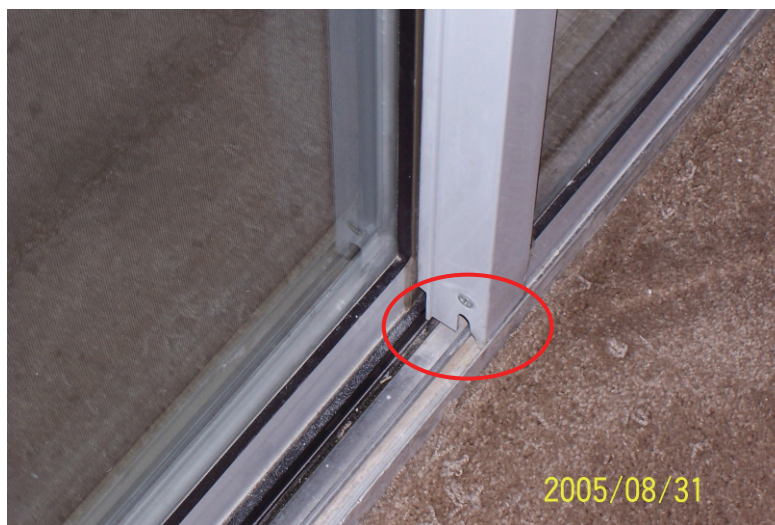
**Figure 12: Poor seal along the bottom (and top) of the sliding doors.**

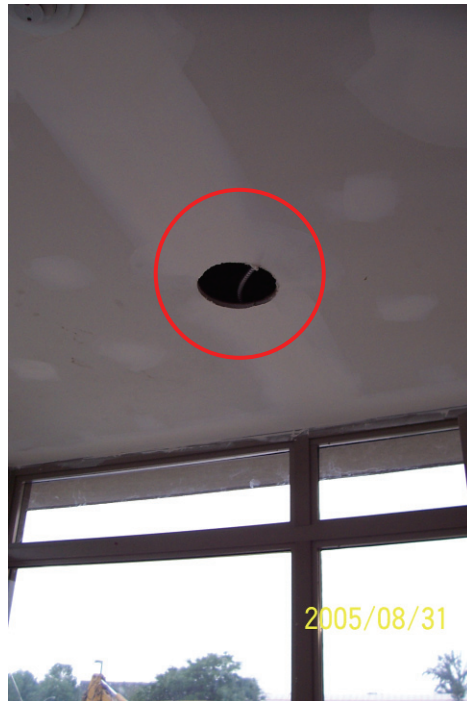
**Figure 13: Pot light in the vestibule provides pathway to outside.**

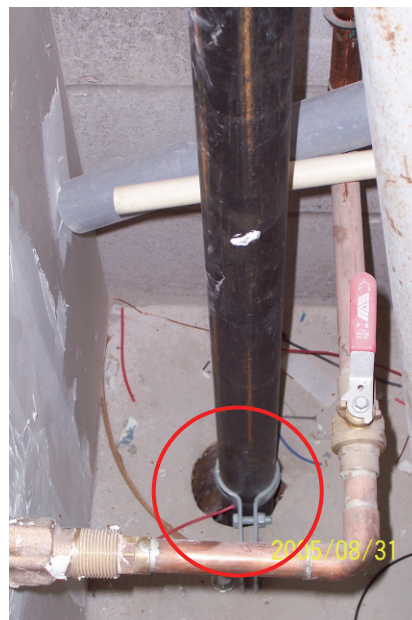
**Figure 14: Missing seal around sprinkler riser in garbage room allows unwanted floor-to-floor air movement.**

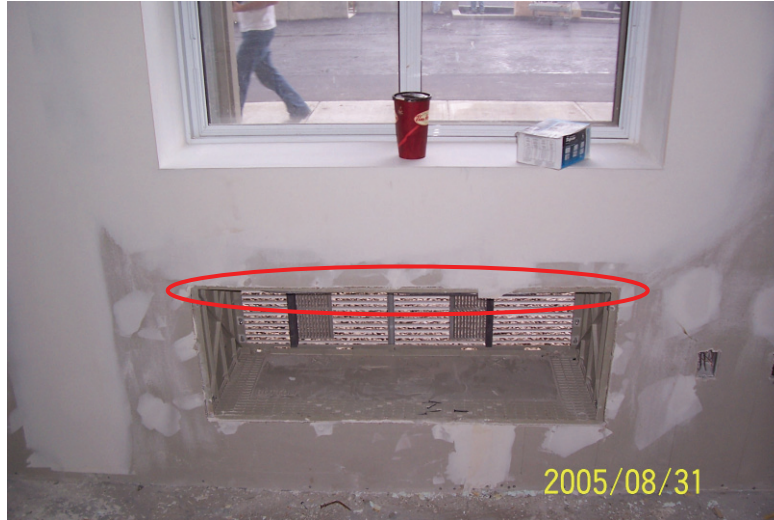
**Figure 15: Unsealed front office AC sleeve.**

Front office AC sleeve (See Figure 6 below)	Large	One	Caulk around the sleeve.
Light switch next to double exterior doors in garbage room	Small	One	
Around duct work penetrating exterior wall in SE corner of garbage room	Small	Two	All building caulking should be checked

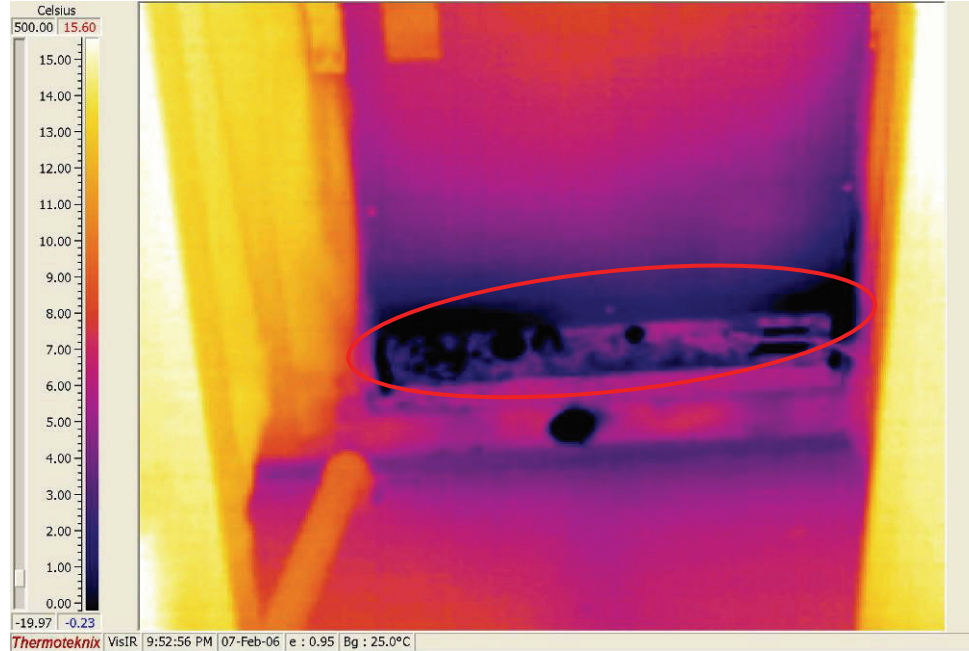
surface of the cabinet varies from 10°C down to 0°C at the bottom (the very dark areas). This shows that the condenser unit is a significant thermal bridge. Unnecessary and unused penetrations through the condenser cabinet could be sealed and insulated.

**Figure 16: Suite 110 condenser unit.**

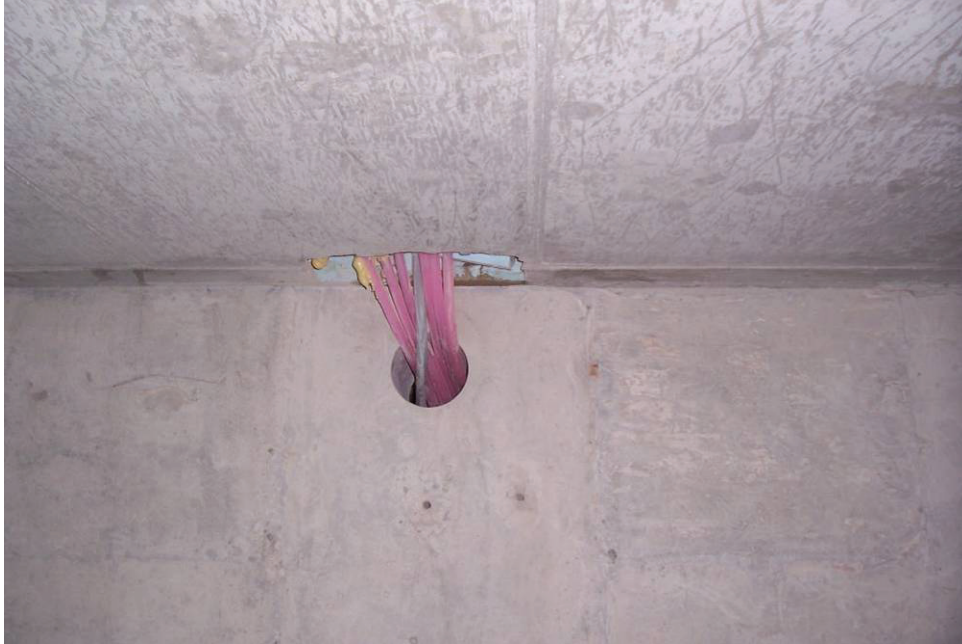
Thermographic scans of the parking garage indicated that the surface temperature was relatively consistent over the entire envelope. Figure 31, below, shows some electrical cables passing through a hole in the concrete wall (separating the conditioned parking area from the unconditioned parking area) without any sealing. All unsealed openings allow unwanted air infiltration and a direct connection between the conditioned building interior and the exterior environment.

**Figure 31: Unsealed opening for electrical cables.**
