## Drainage and Retention of Water by Cladding Systems

### Part 4 – Drainage Testing of Vinyl Siding Test Walls

Donald M. Onysko and Constance Thivierge

30 March, 2007

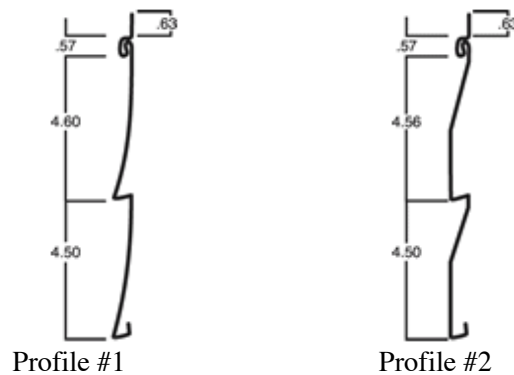
**Figure 1** Cross section of Profiles #1 and #2

and Profile #2 was a double 4.5 inches dutchlap siding (brownstone colour). The specifications for both profiles and for the starter strip used are presented in Appendix I. One specimen was fabricated using Profile #1 siding and two walls were built using Profile #2 siding. These profiles are shown in Figure 1.

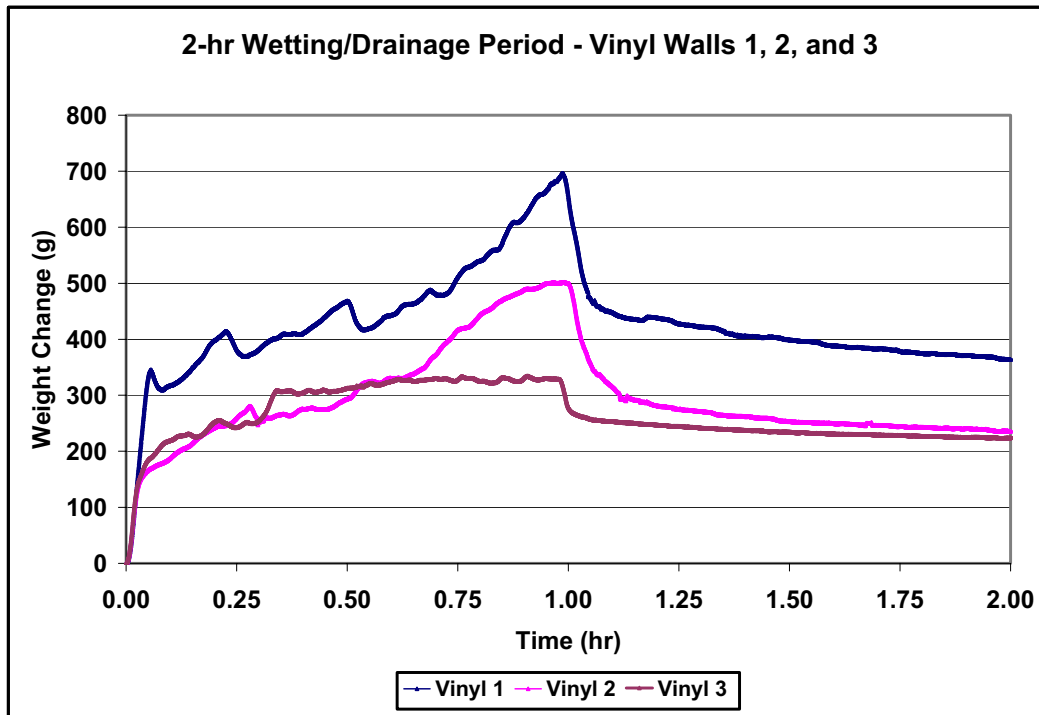
**Figure 2** Summary weight change plots for 3 vinyl siding walls

The weight change plots were combined to allow the results for all three walls to be compared. That information is provided in two figures. Figure 2 shows the results for the 2-hr test, and Figure 3 shows the combined results for the 2-hr and 48-hr test period. In both cases, zero time represents the start of wetting of each wall in turn.

The three plots in Figure 2 are instructive in revealing how water was retained during wetting. This opinion is based on observations during the tests and the shape of the resulting plots. Wall 1 experienced the most retention and leakage, leakage that involved wetting of the wood framing, and hence storage. The sharp increase in weight to the end of the wetting phase of the curve implies that more water would have been retained if the wetting had been allowed to continue. To a lesser degree, this also happened for Wall 2 which had a different profile. The retention at this stage seems largely dependent on the degree of failure to hold water within the siding space to be drained through the holes provided. Wall 3 on the other hand which experienced little extraneous leakage reached a near plateau of retention in 20 minutes, so the head of water attained remained sufficient to expel the water as rapidly as it was supplied to the wall. Due to the extraneous leakage, it is not possible to compare the ability of the two types of profiles to shed water that may enter a defect as was being simulated here.

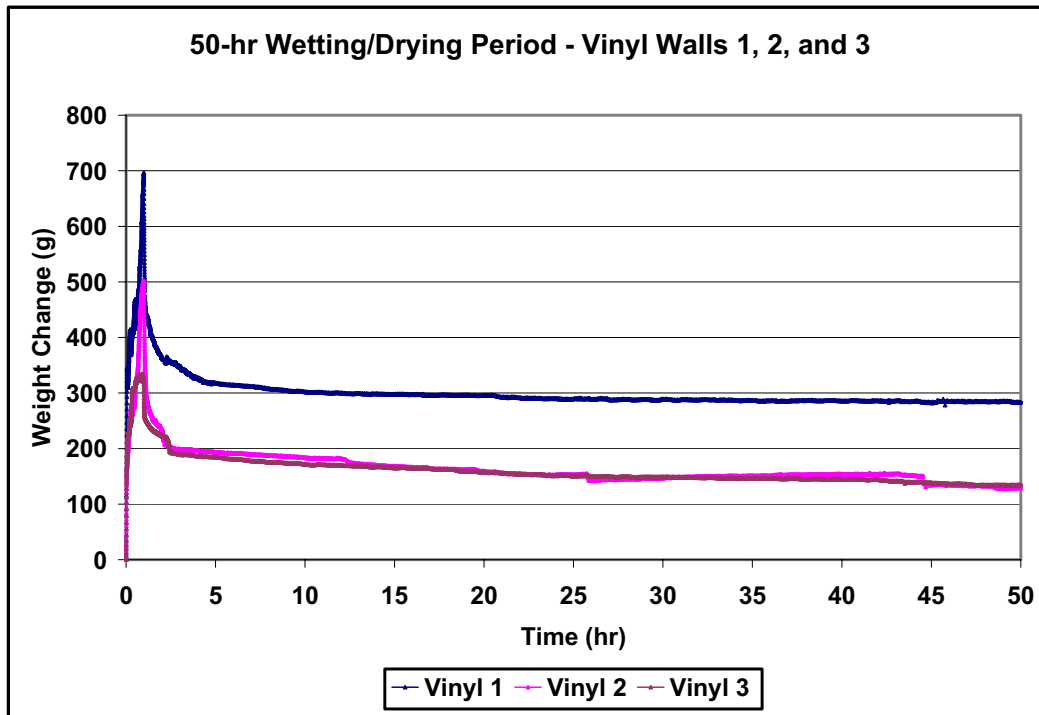
**Figure 3** Weight change for the entire 2-hr plus 48-hr time period

In Figure 3, the wetting and drying results are presented over the full 50 hours of wetting/drainage/drying. Walls 2 and 3 which experienced less storage by wetting of the wood framing than Wall 1 dried almost identically. The drying rates for Wall 1, 2, and 3 (obtained by regression of the drying curves to the end of the period for each wall) were 0.38, 0.91, and 0.86 g/hr respectively between the 10-hr and 50-hr points on the plot. The total retention at that time was about 130 g for each wall. The free water retained in the joint profile was still sufficient to partially spill out when the walls were dismounted and turned over on their faces for measurement of moisture changes using the capacitance meter. By doing so, rewetting of the WRB may have occurred to allow the contour maps shown in Appendix V to show a larger extent of wetting than actually occurred when these walls stood in place.

The drying curves shown in Figure 3 and those in Appendix III show a reasonably linear pattern during the drying phase. Examining the variations in environmental conditions over that entire period presented in Appendix V would lead one to expect some cycling in the Figure 2 plots. However, there was no correspondence. The vinyl cladding was not susceptible to those minor changes. The fact that no effect was measured implies that the exposed wood framing and OSB were not readily susceptible either. Therefore, changes noted during tests on EIFS walls suggest that those changes were largely attributable to pickup of moisture by the EIFS portion of the walls tested and not by the wood framing.

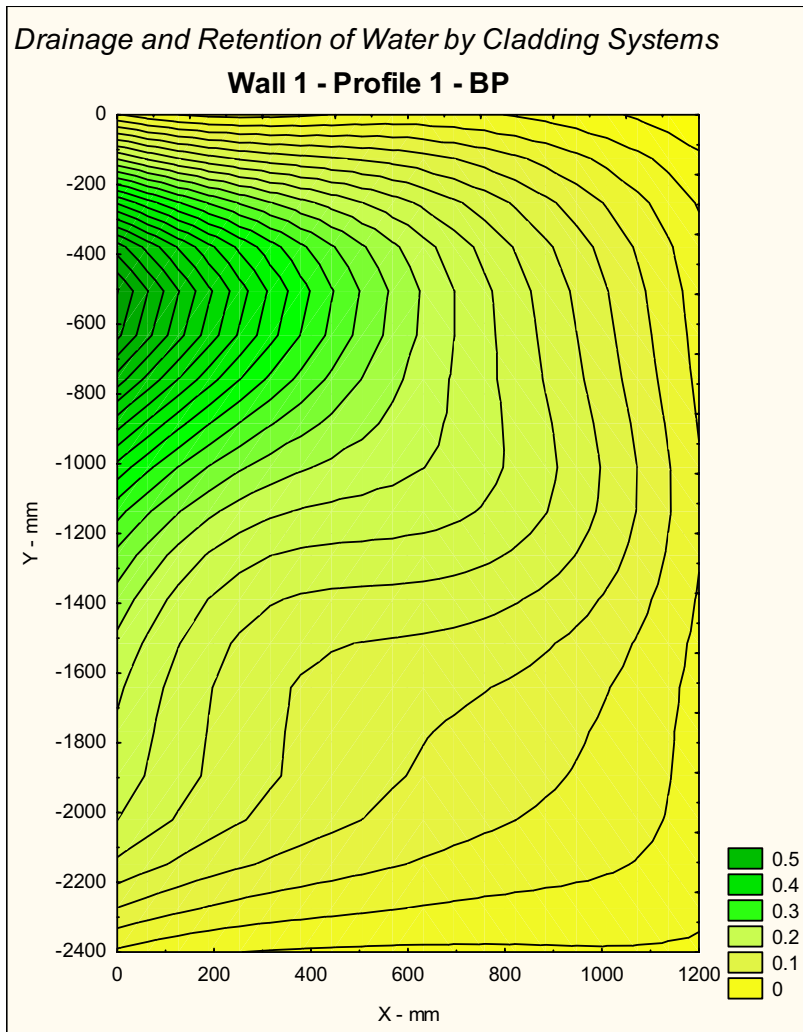
**Figure 4** *Moisture map for Wall 1 showing where there was a higher concentration of moisture retained at the conclusion of the 50 hr drying period*

The moisture mapping figures provided in Appendix IV show areas of the wall that, when viewed face on, show portions of the wall having higher moisture content changes that correspond with regions where we observed leakage. For purposes of this discussion the plot for Wall 1 is repeated below.

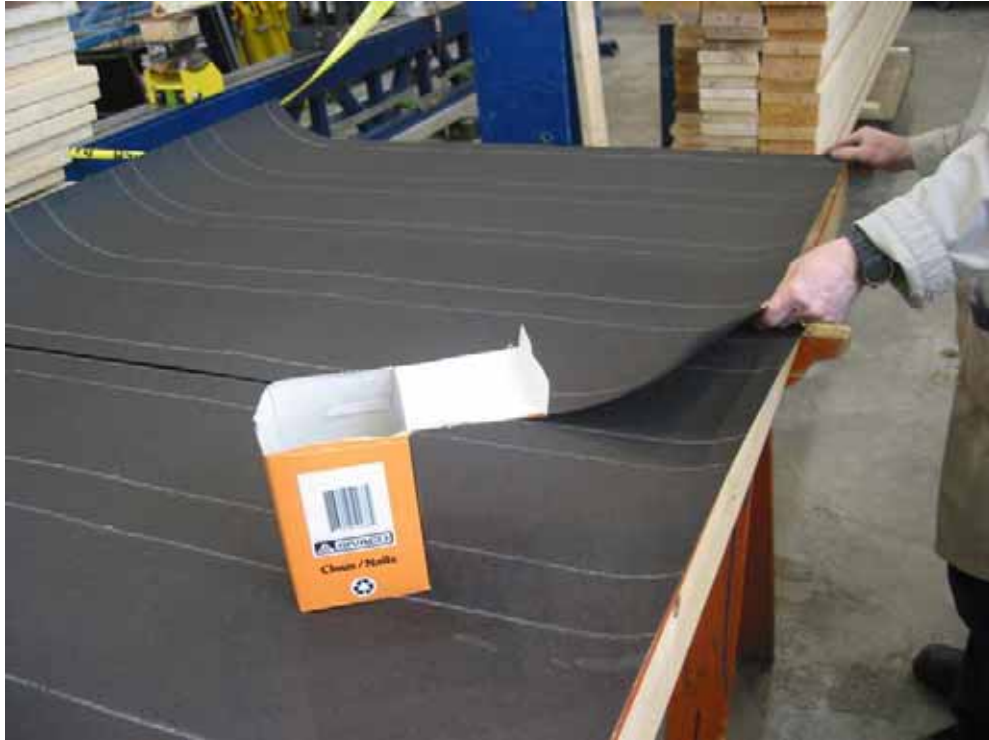
**Figure I -1 Installation of WRB**

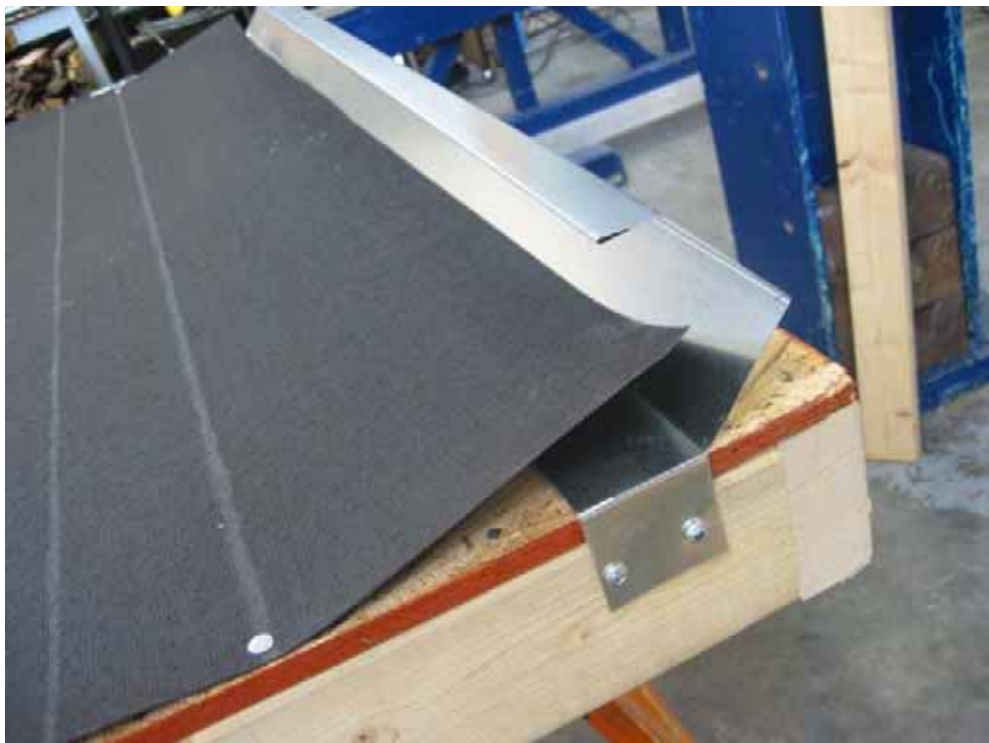
**Figure I-2 WRB overlapping the gutter installation**

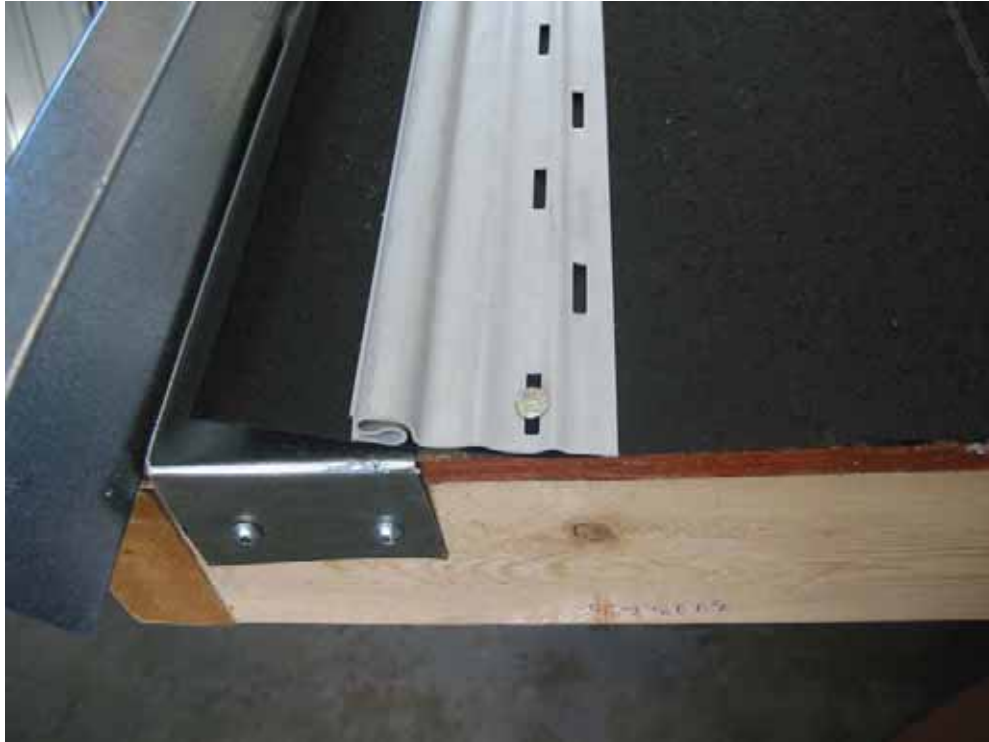
**Figure I-3 Installation of starter strip**

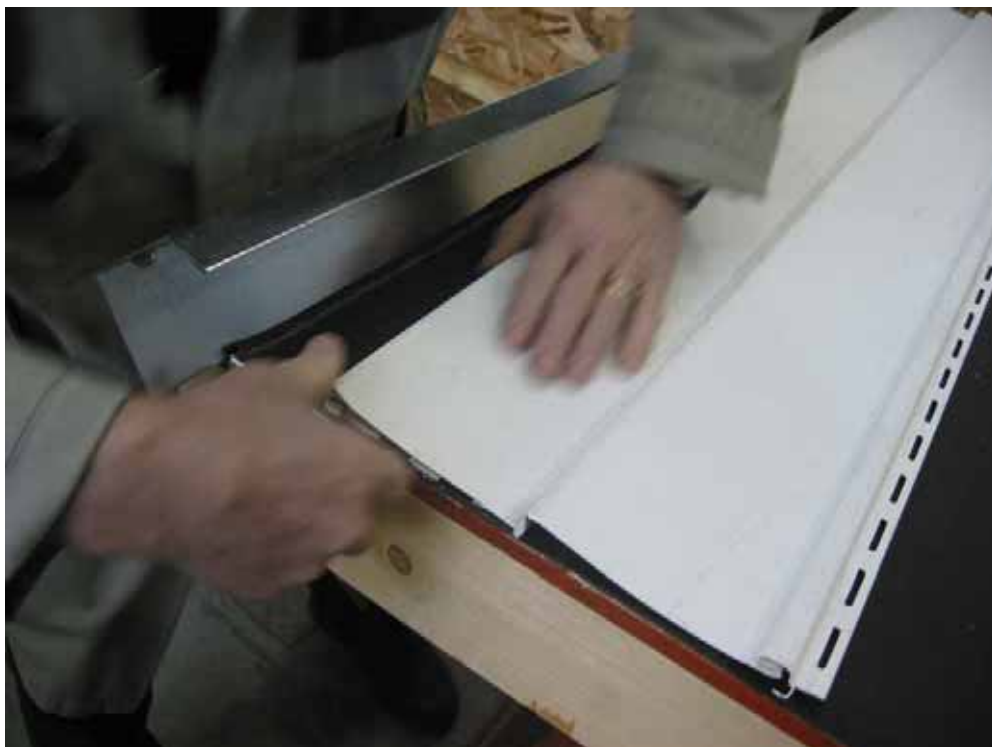
**Figure I-4 Installation of first course of siding (Profile #1) by clipping it to the starter strip.**

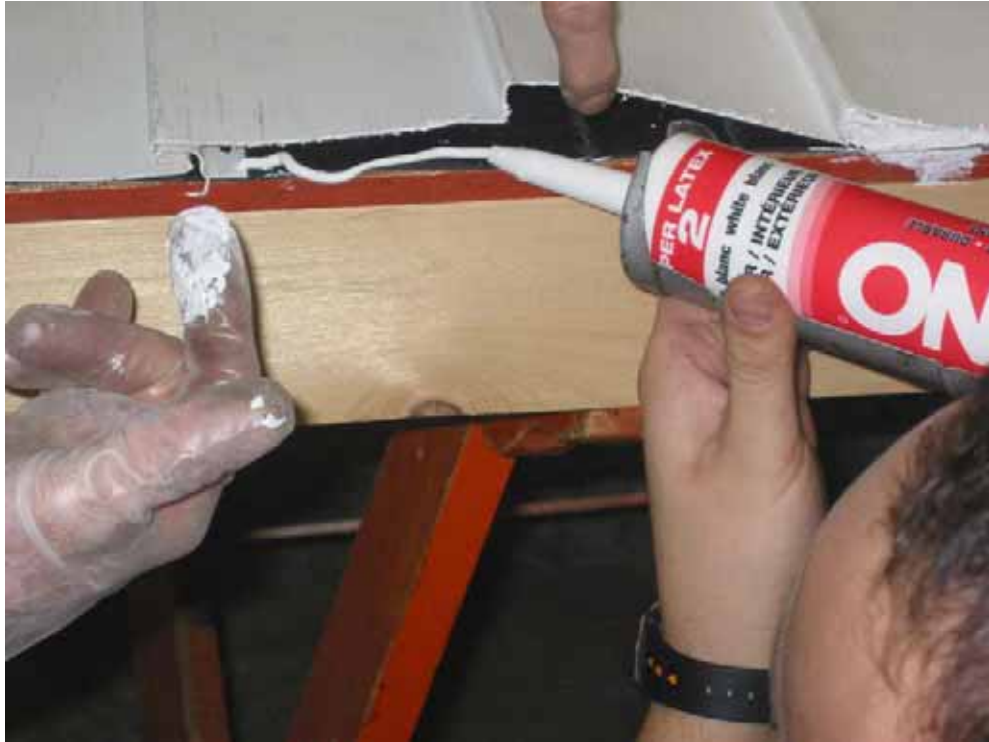
**Figure I-5 Sealing the ends of the vinyl siding by means of caulking**

*Application of Mono super latex sealant on both ends of each course of vinyl siding:* The sealant was used to block the ends of each course of siding to prevent lateral flow of water out of the test walls. It was expected that this sealant would bond to both the WRB and the vinyl siding to prevent leakage.

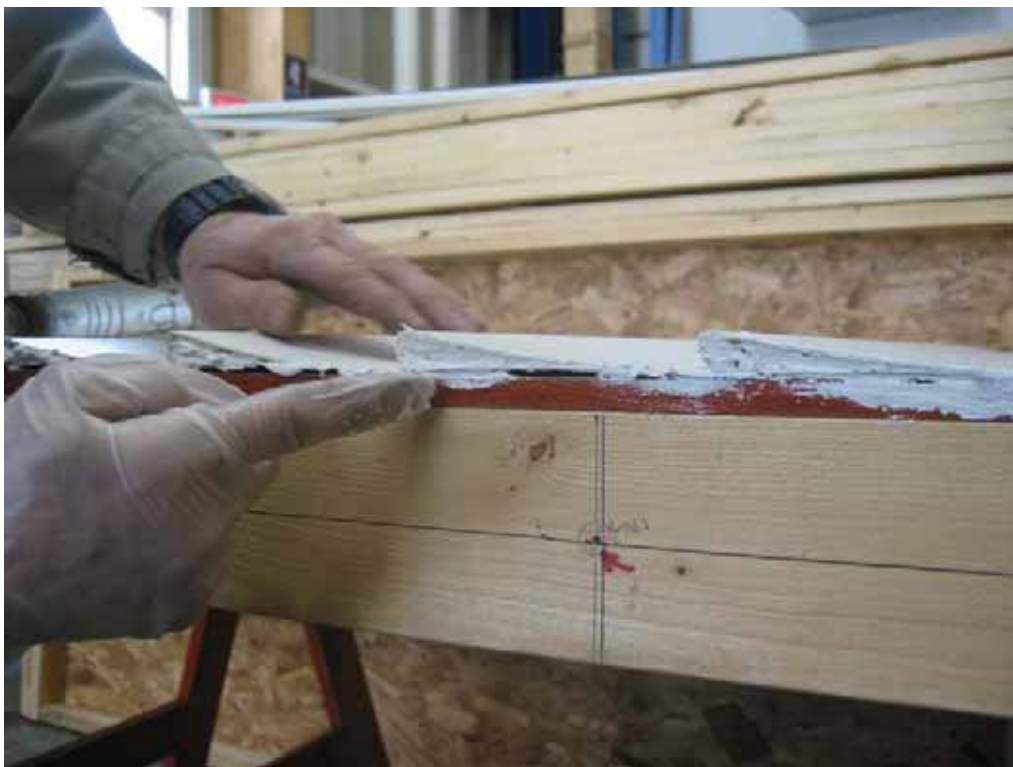
**Figure I-6 Touching up sealing the ends of the vinyl siding using caulking**

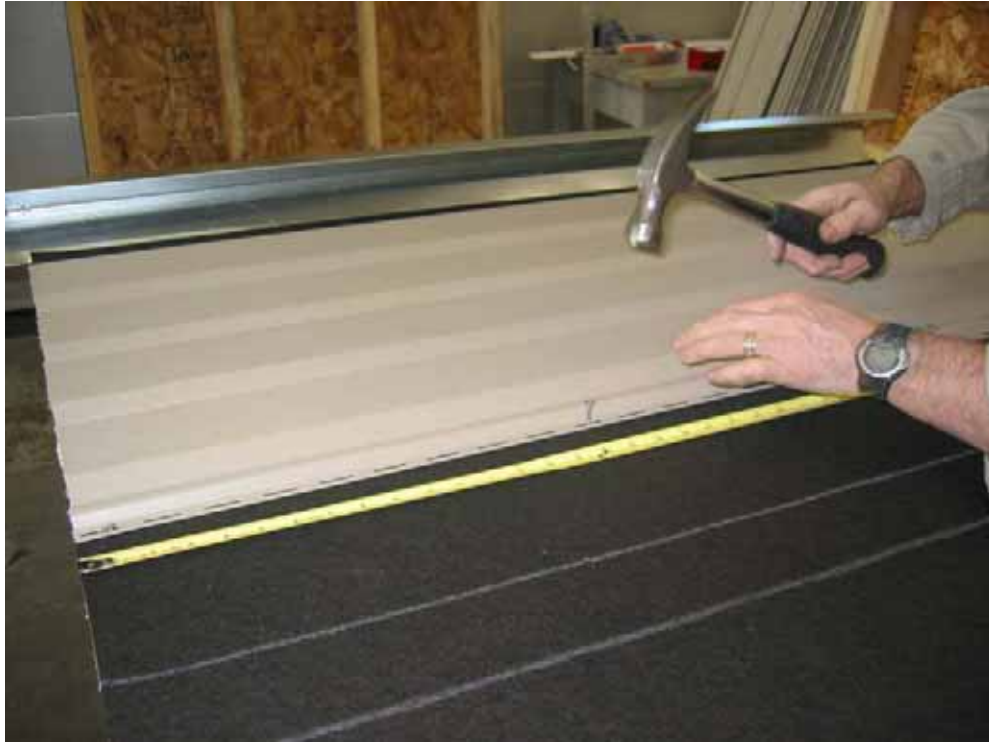
**Figure I-7 Normal progression installing vinyl siding from the bottom of the wall up, Profile #2**

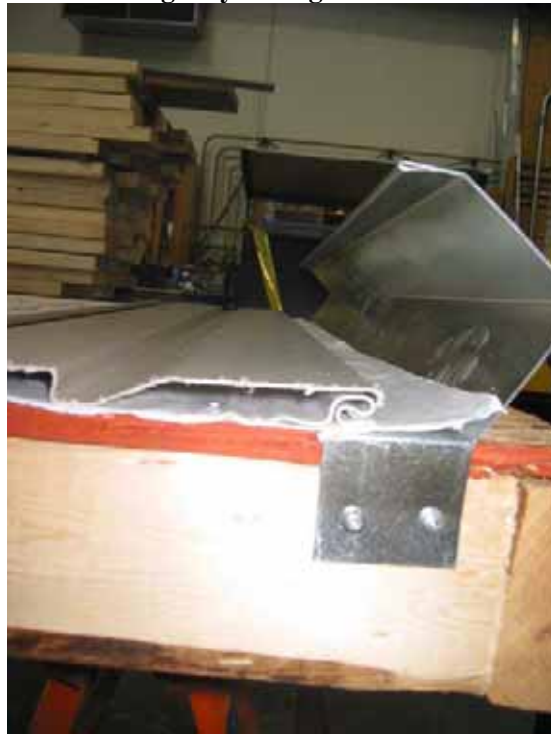
**Figure I-8 Profile #2 at connection to starter strip**

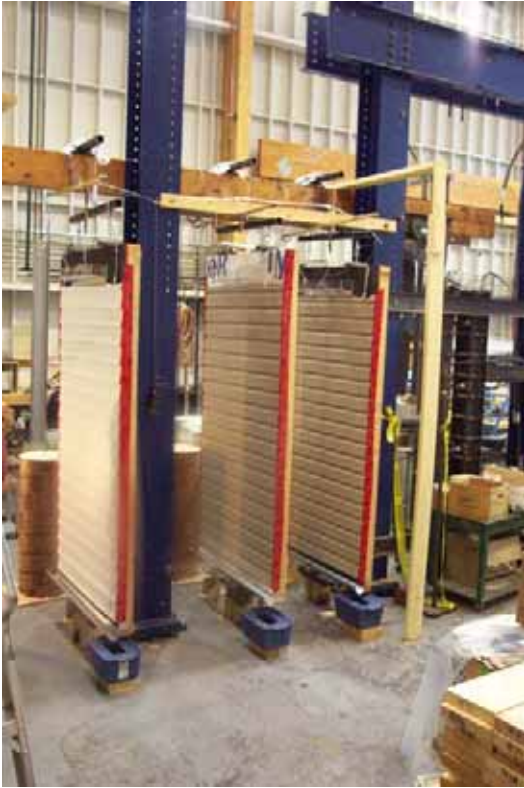
**Figure II-1 View of overall test set-up Walls 1-3, left to right.**

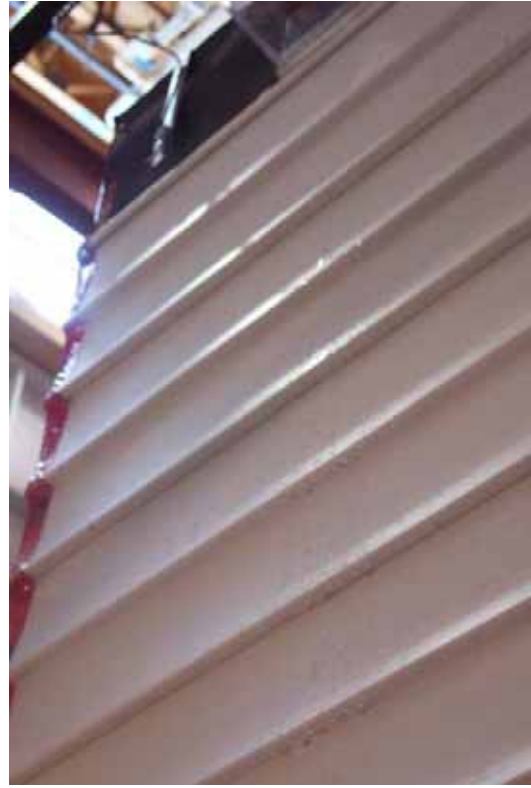
**Figure II-2 Wall 1 undergoing test with rivulets cascading down surface of wall from the top.**

During the wetting phase of Wall 1 (which involved Profile #1 and building paper) water entering the first course of siding immediately started draining out of the small drainage holes provided by the vinyl siding profile for this purpose. Some head of water developed there and this was sufficient for some water to leak out through the imperfectly sealed edges. Some of this water was not caught by the gutter and ended up on the floor. Most of the water drained out of the wall by passing through two or three drainage holes

located in the first course of siding. The shape of the vinyl profile simulated bevelled wood siding. The momentum of the water leaking out of these holes and flowing down this slope caused some of the water to escape from contact with the wall. This drainage wetted the floor in front of the wall for a distance of about 0.4 m.

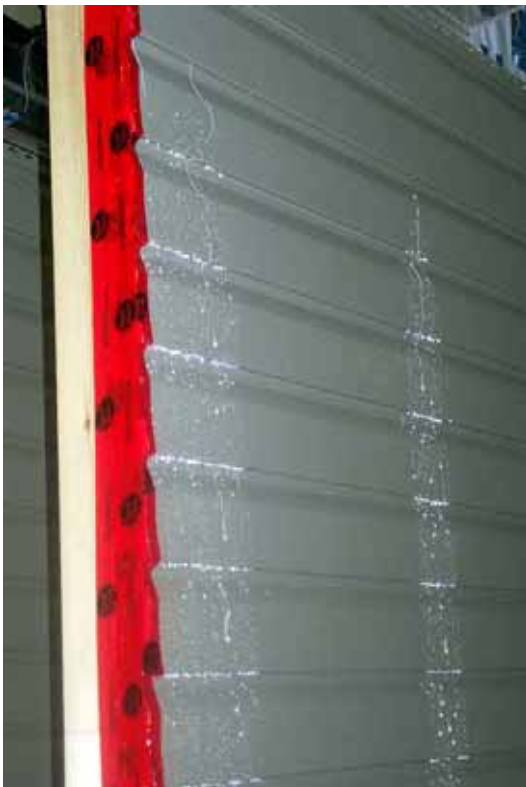
**Figure II-3 Wall 2 showing water cascading from top siding course and from leak at side.**

Walls 2 and 3 (utilizing vinyl siding having Profile #2 with SPBO and building paper WRB membranes) demonstrated similar, though not as extensive, moisture loss by side leakage as Wall 1. The profile of this siding simulated a different type of wood siding having significant portions of the siding face parallel to the back plane of the wall. Water draining from these drainage holes did not build up sufficient momentum to escape from the wall face, but was retained close to that surface and permitted it to drain down for collection by the gutter. Photos of the walls undergoing test are shown in Appendix II.

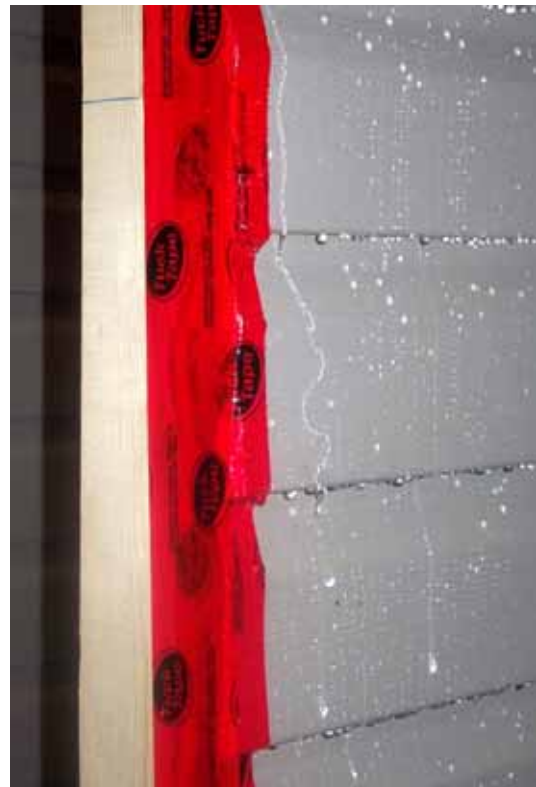
**Figure II-4 Wall 2 showing close-up of cascading water rivulets.**

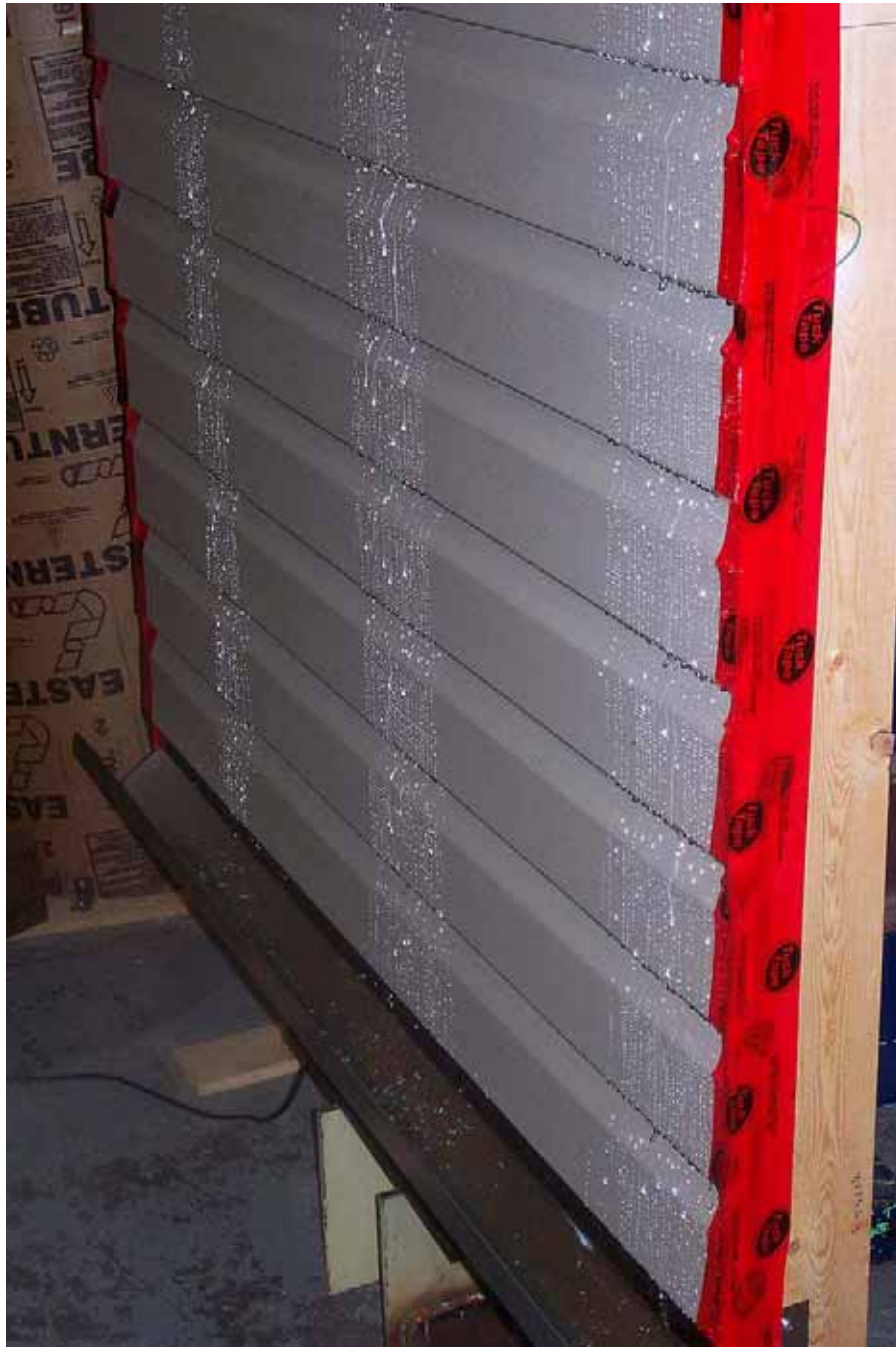
**Figure II-5 Wall 3 showing water cascading from drainage holes provided in the siding profile at the top course. Note the drainage is largely held along the siding surface by the design of the profile.**

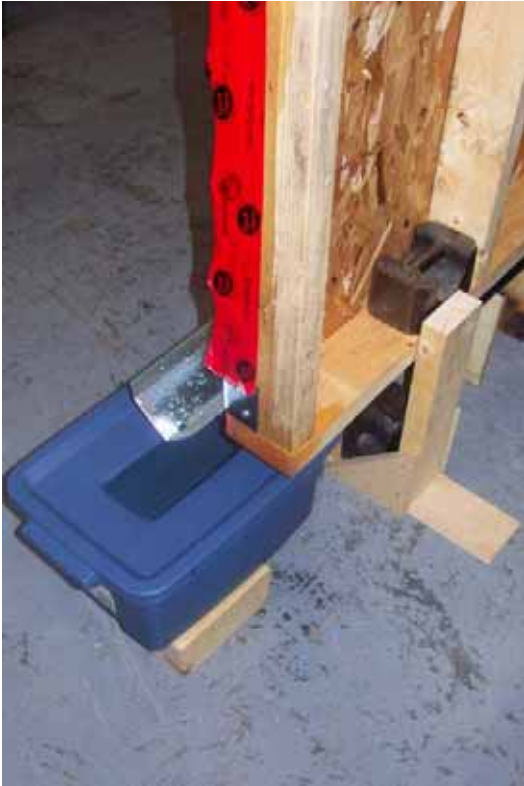
**Figure II-6 Wetting of framing, Wall 1**

Water escaping from both edges, near the top of the wall, drained down and wetted some of the wood framing that was not protected by the WRB. This wetting was found at the junction of the edge studs and the sill plate (on both sides of the specimen). Water may also have found its way behind the edges of WRB and be absorbed by the OSB.

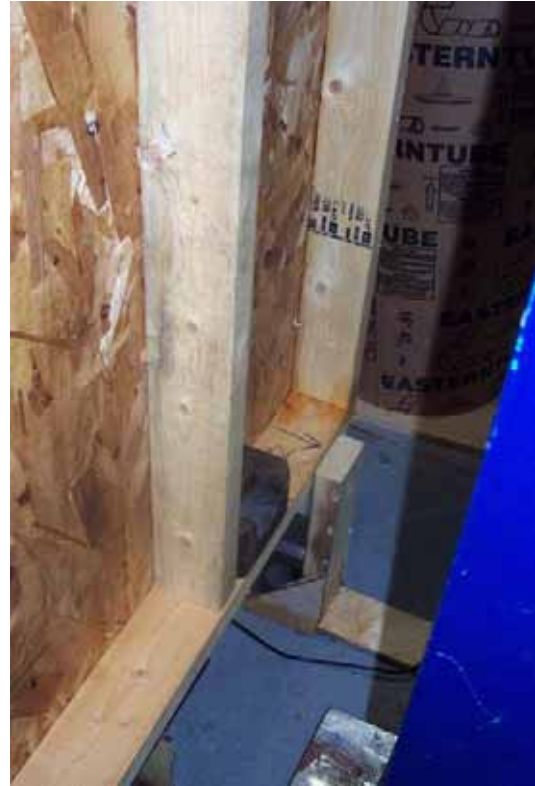
**Figure II-7 Wetting of framing, Wall 2**

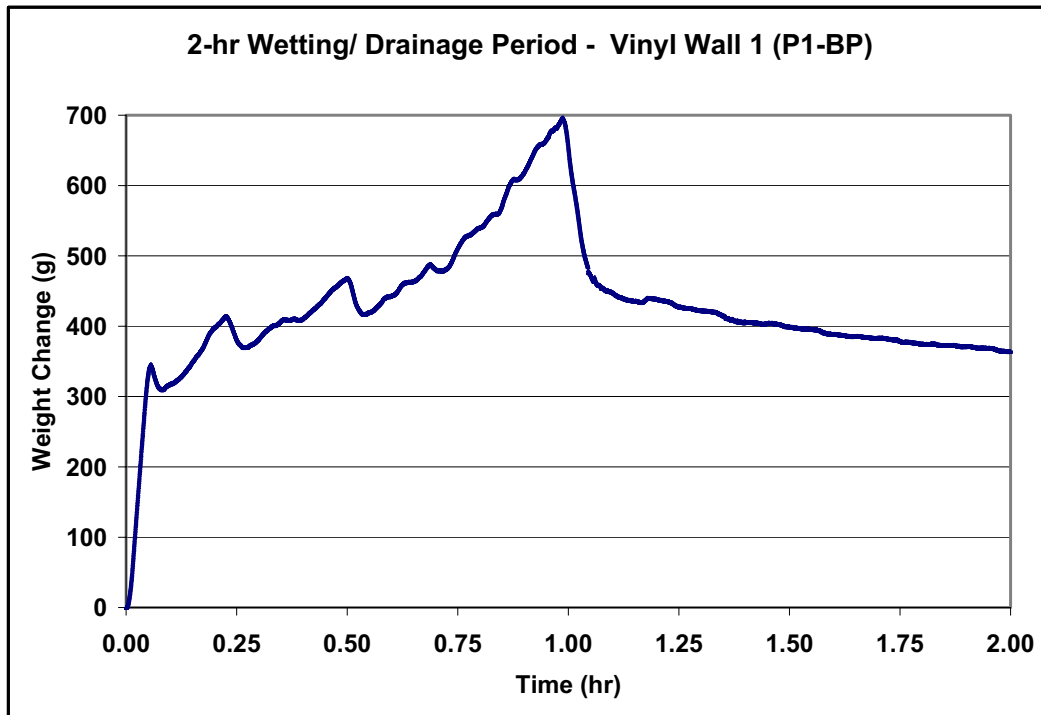
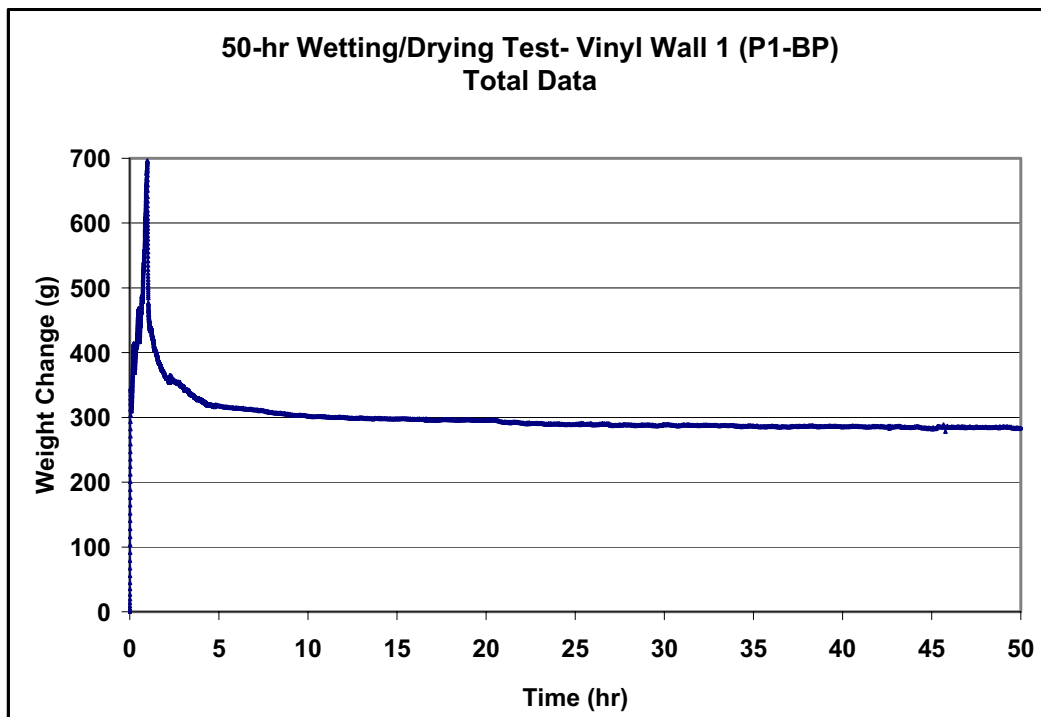
**Figure II-1** Drainage test on Wall 1 (P1-BP) showing the first 2-hr wetting/drainage period (top) and the total monitoring period of 50 hours, including the drying period (bottom).

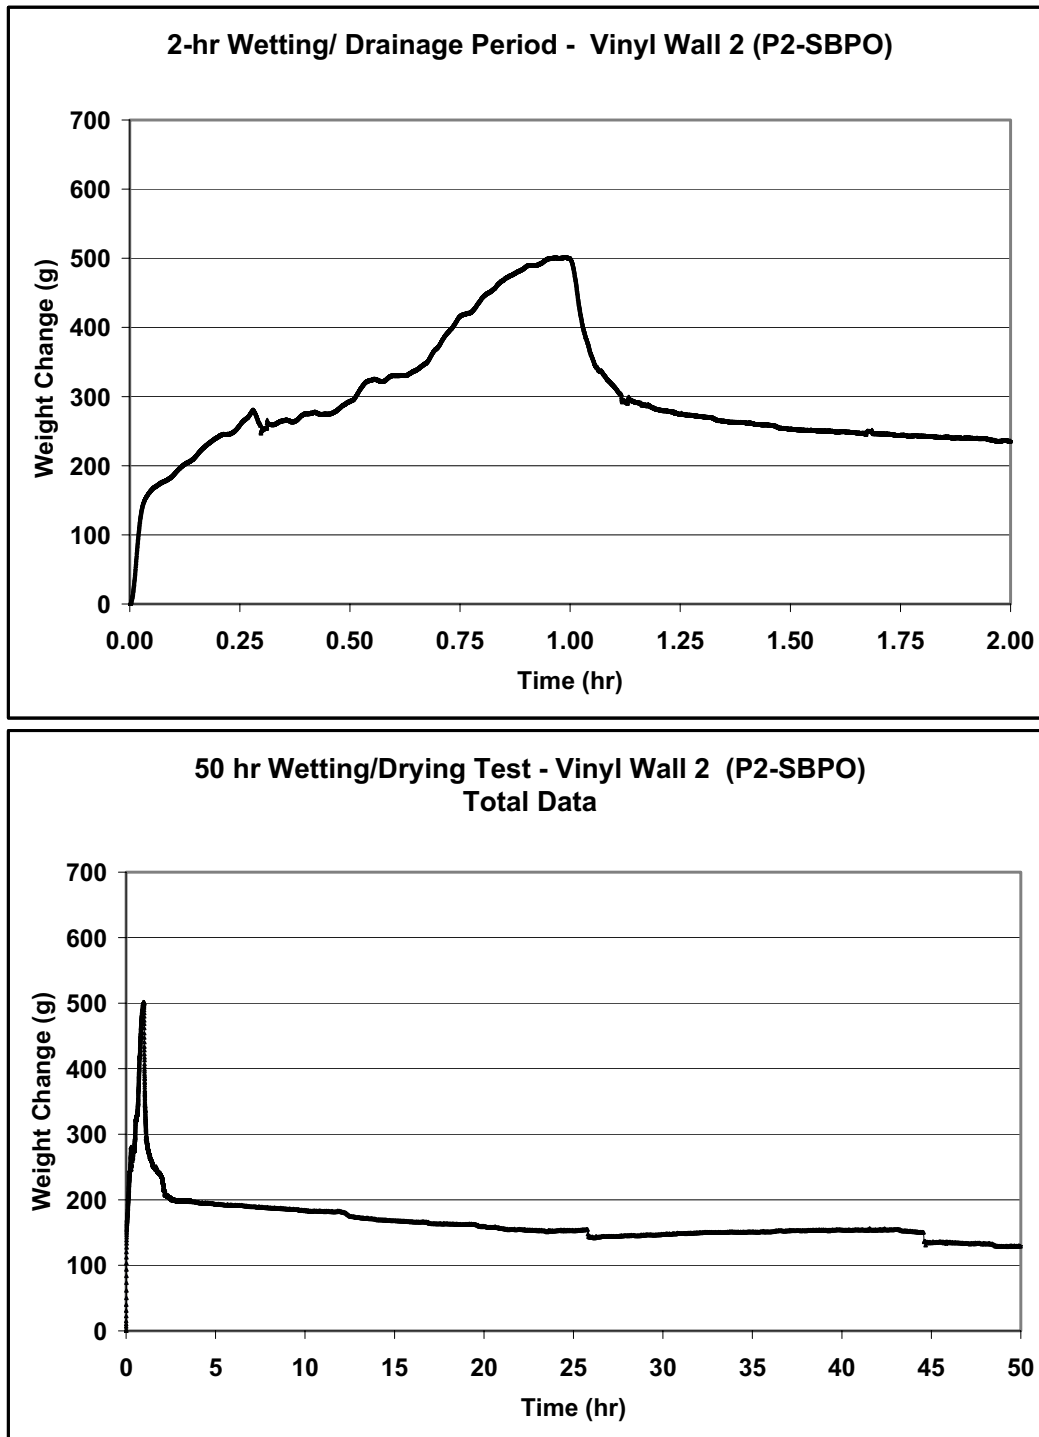
**Figure II-2** Drainage test on Wall 2 (P2-SBPO) showing the first 2-hr wetting/drainage period (top) and the total monitoring period of 50 hours, including the drying period (bottom).

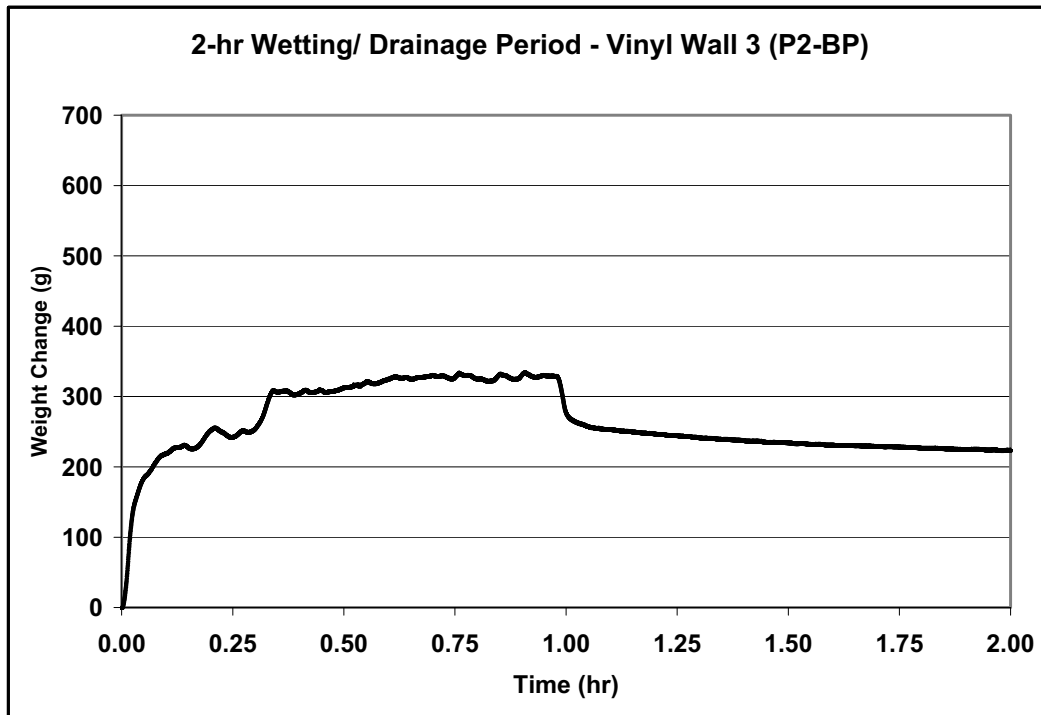
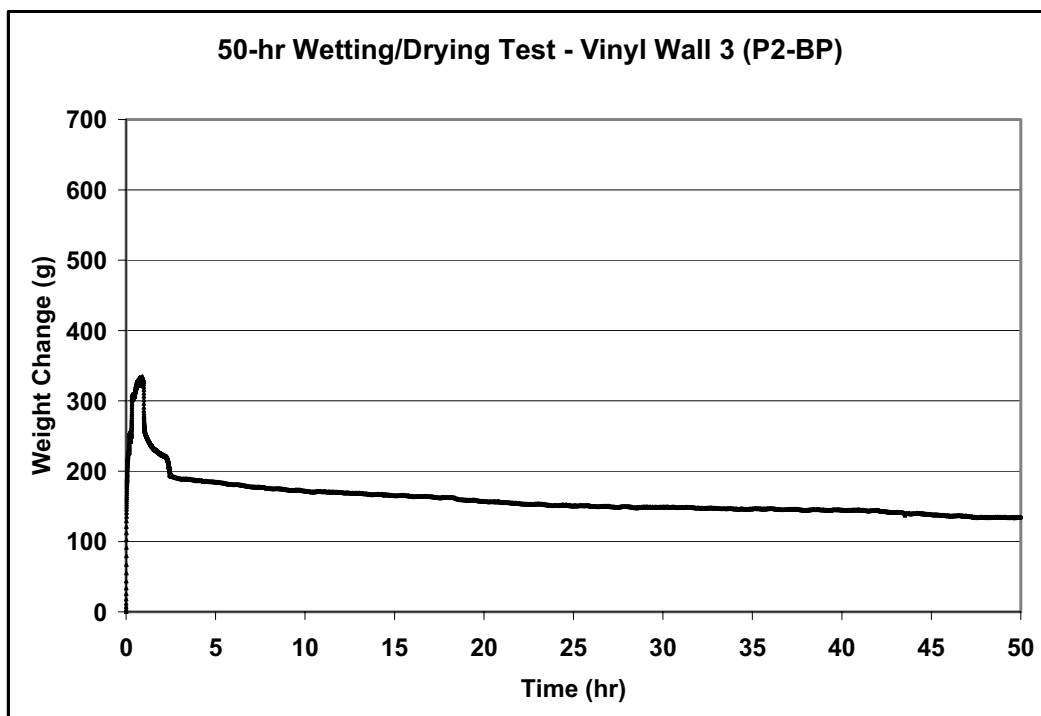
**Figure II-3** Drainage test on Wall 3 (P2-BP) showing the first 2-hr wetting/drainage period (top) and the total monitoring period of 50 hours, including the drying period (bottom).

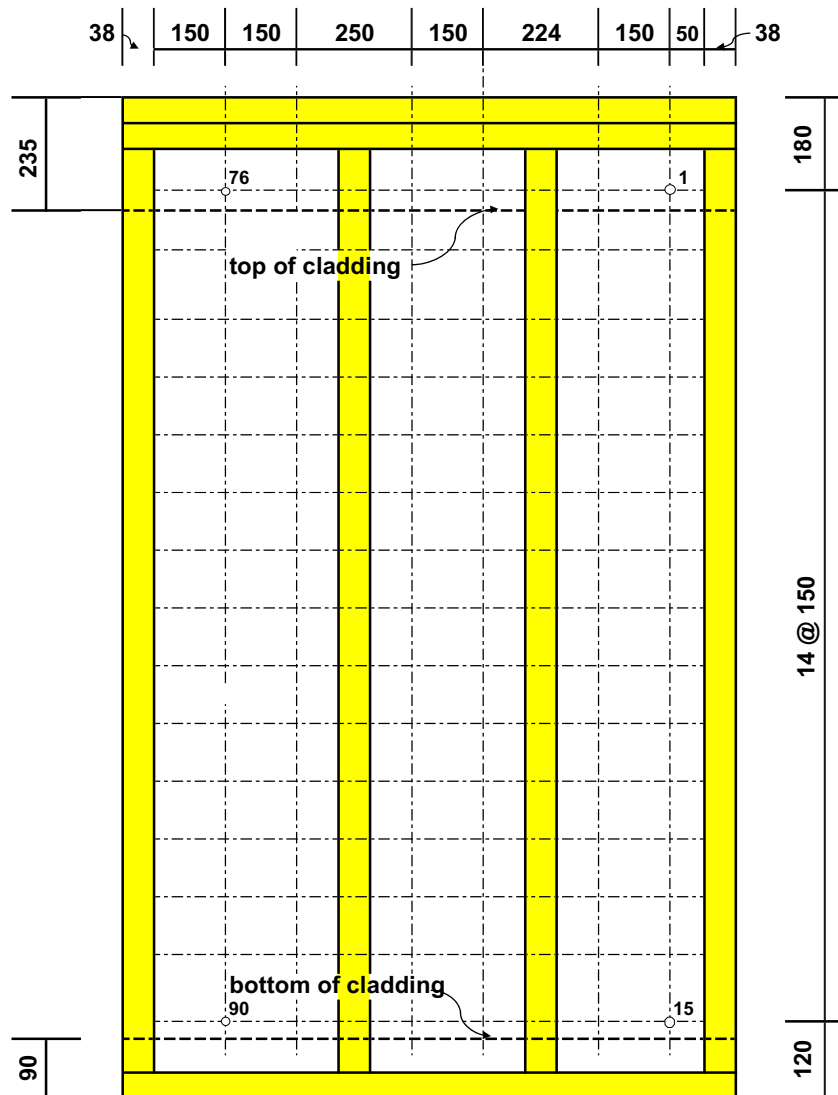
The figure below provides the dimensions used for establishing the grid for measurement and plotting.

The actual size of the wall panels was 4 x 8 feet (1219 x 2438 mm). For the purpose of moisture mapping, it will be convenient to display the moisture for a 1200 x 2400 wall, with positioning of the cladding as built and defined in the individual test reports. The accuracy of placement of the capacitance moisture meter was not likely better than 2 mm and the grid line positions have been rounded to account for the slightly smaller SI wall compared with the actual wall size. Moisture difference readings for the top and bottom wall boundary have been assumed to be zero. The usefulness of the contour plots lies in their relative depiction of moisture concentration rather than the absolute numerical measure that the readings imply.

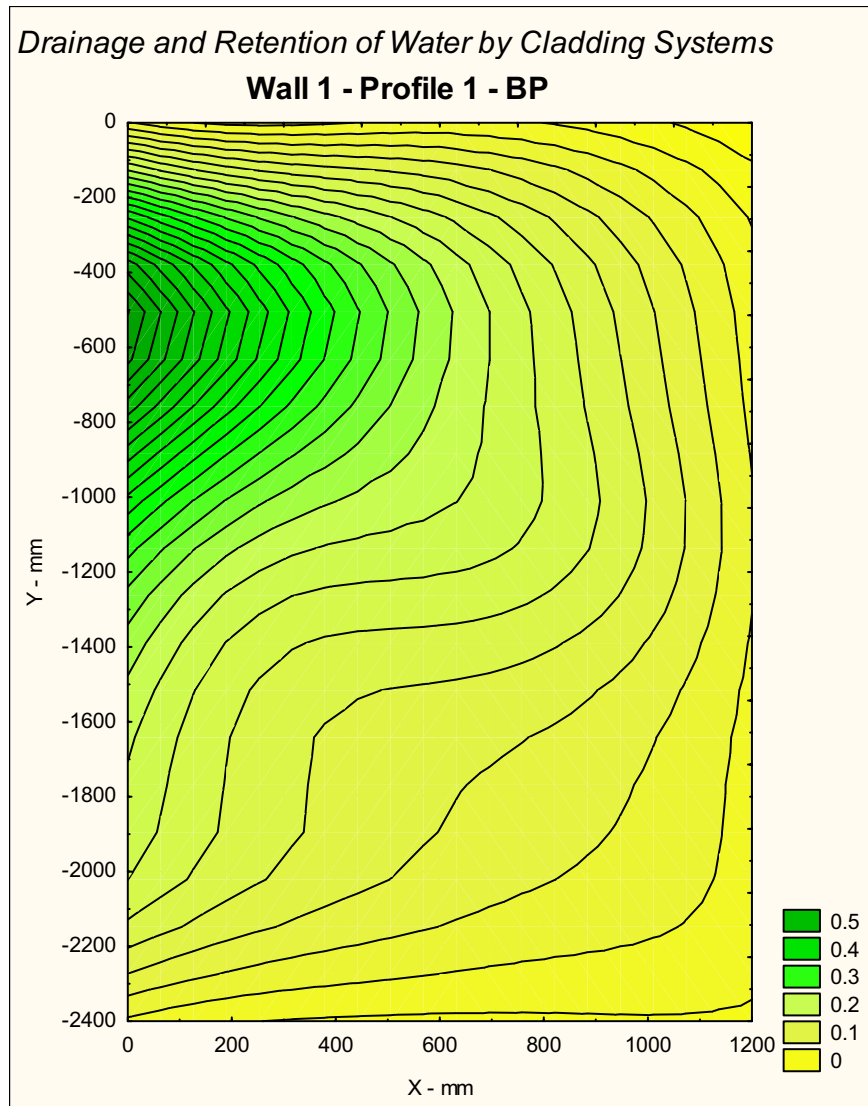
**Figure IV-1 Moisture Contours for Vinyl Siding Wall 1 (Profile #1 with Building Paper)**

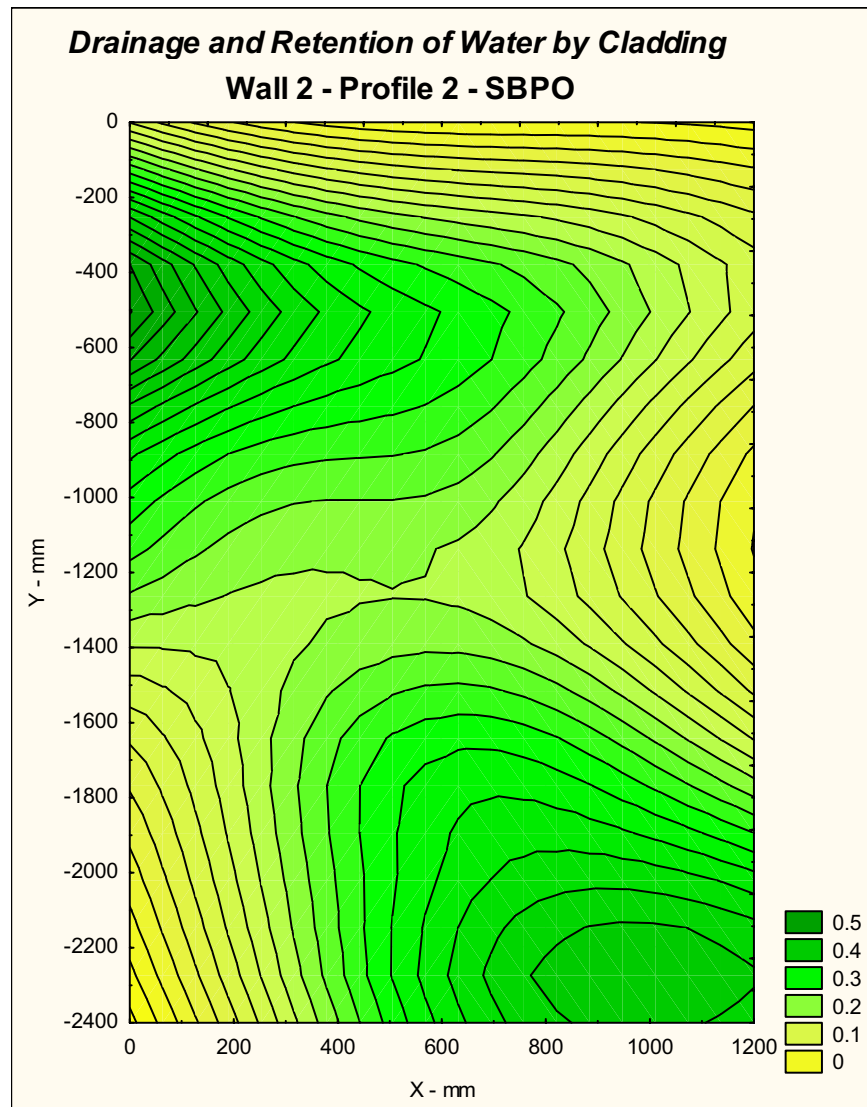
**Figure IV-2 Moisture Contours for Vinyl Siding Wall 2 (Profile #2 having SBPO WRB)**

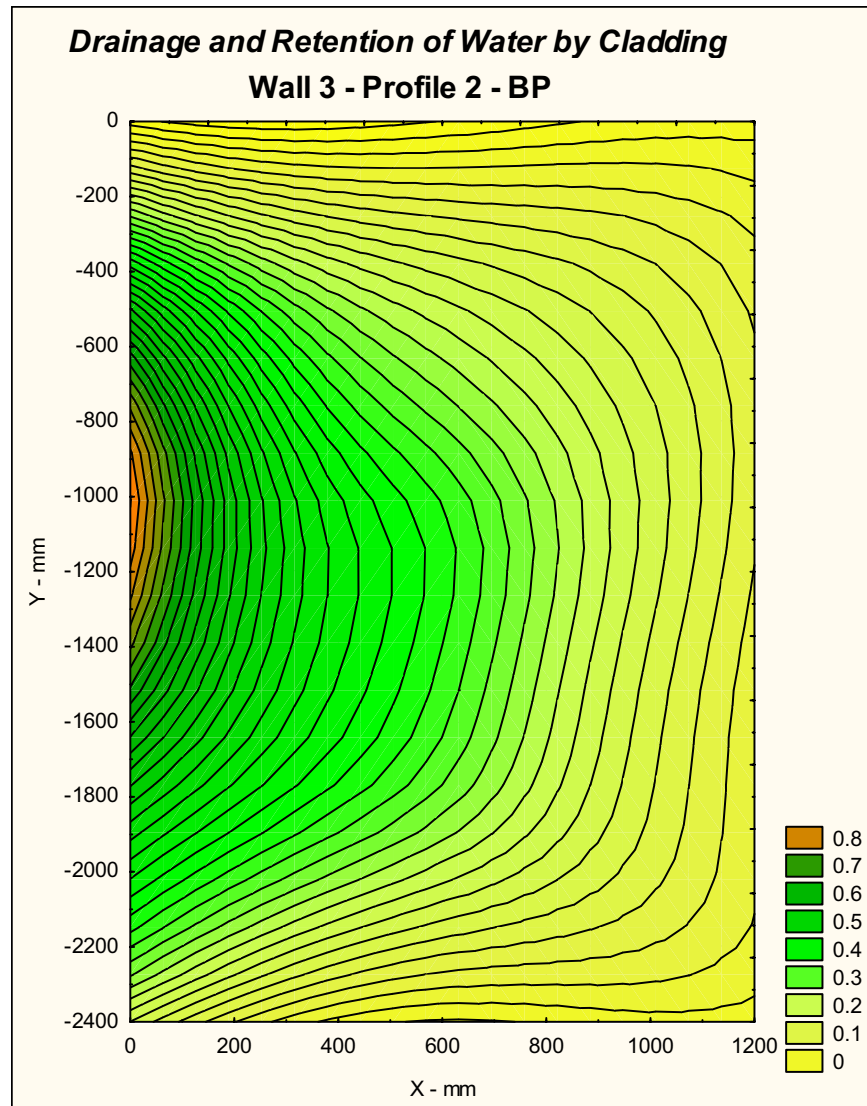
**Figure IV-3 Moisture Contours for Vinyl Siding Wall 3 (Profile #2 having Building Paper)**
