## Drainage and Retention of Water by Cladding Systems

### Part 4 – Drainage Testing of Vinyl Siding Test Walls

Donald M. Onysko and Constance Thivierge

30 March, 2007

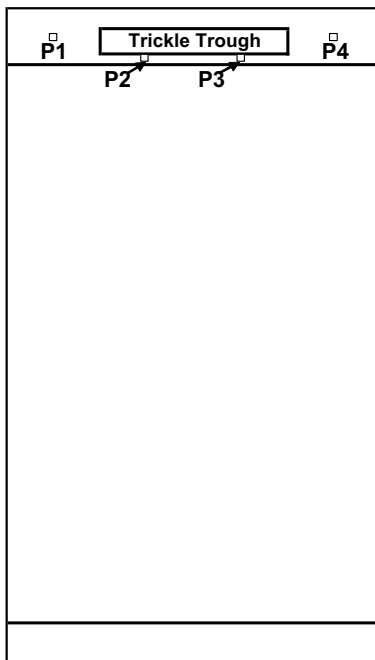
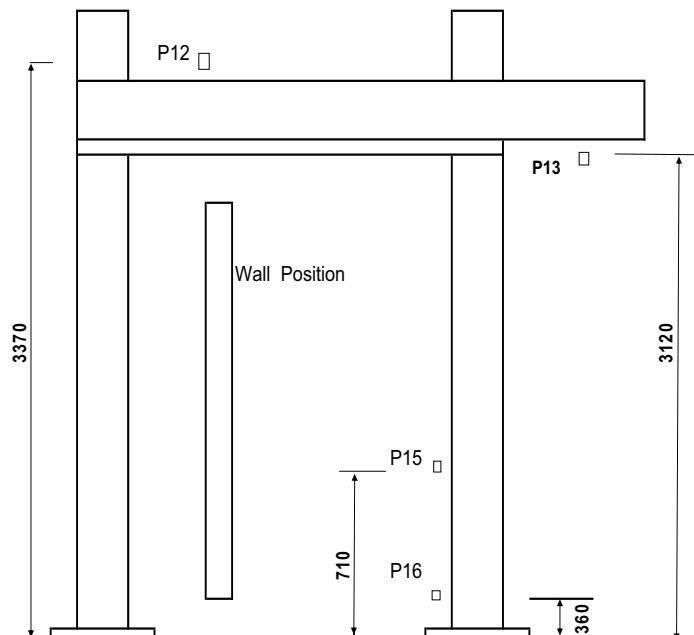
As a reminder as to the location of all sensor locations, the following two figures are repeated from an earlier report in the series (Part 2) on testing methodology. P1 to P4 are attached just above the top of the drainage cavity. P12 and P13 are just above and just below the laminated beam supporting the three test walls, P15 is at table top level, and P16 is located near the column shown at gutter height.

Four RH and temperature sensors were installed at the top part of each wall specimen to monitor the conditions of air exiting the top of the drainage cavity. These were spaced uniformly across the top of each wall. Two of these sensors were positioned below the trickle trough and the other two were at about the same level but symmetrically placed away from both sides of the trough. All sensors were placed at about 25-25 mm (1-2 inches) from the top of the cladding. The aim was to compare these measurements with the ambient conditions in the lab. To monitor these conditions, four additional monitoring stations were installed. Two stations were positioned above the test frame, one station was on top of a table in the vicinity where the instrumentation was located and one station was close to the floor at the height of the bottom of the cladding. These results are shown plotted in Appendix V together with a description of the sensor locations.

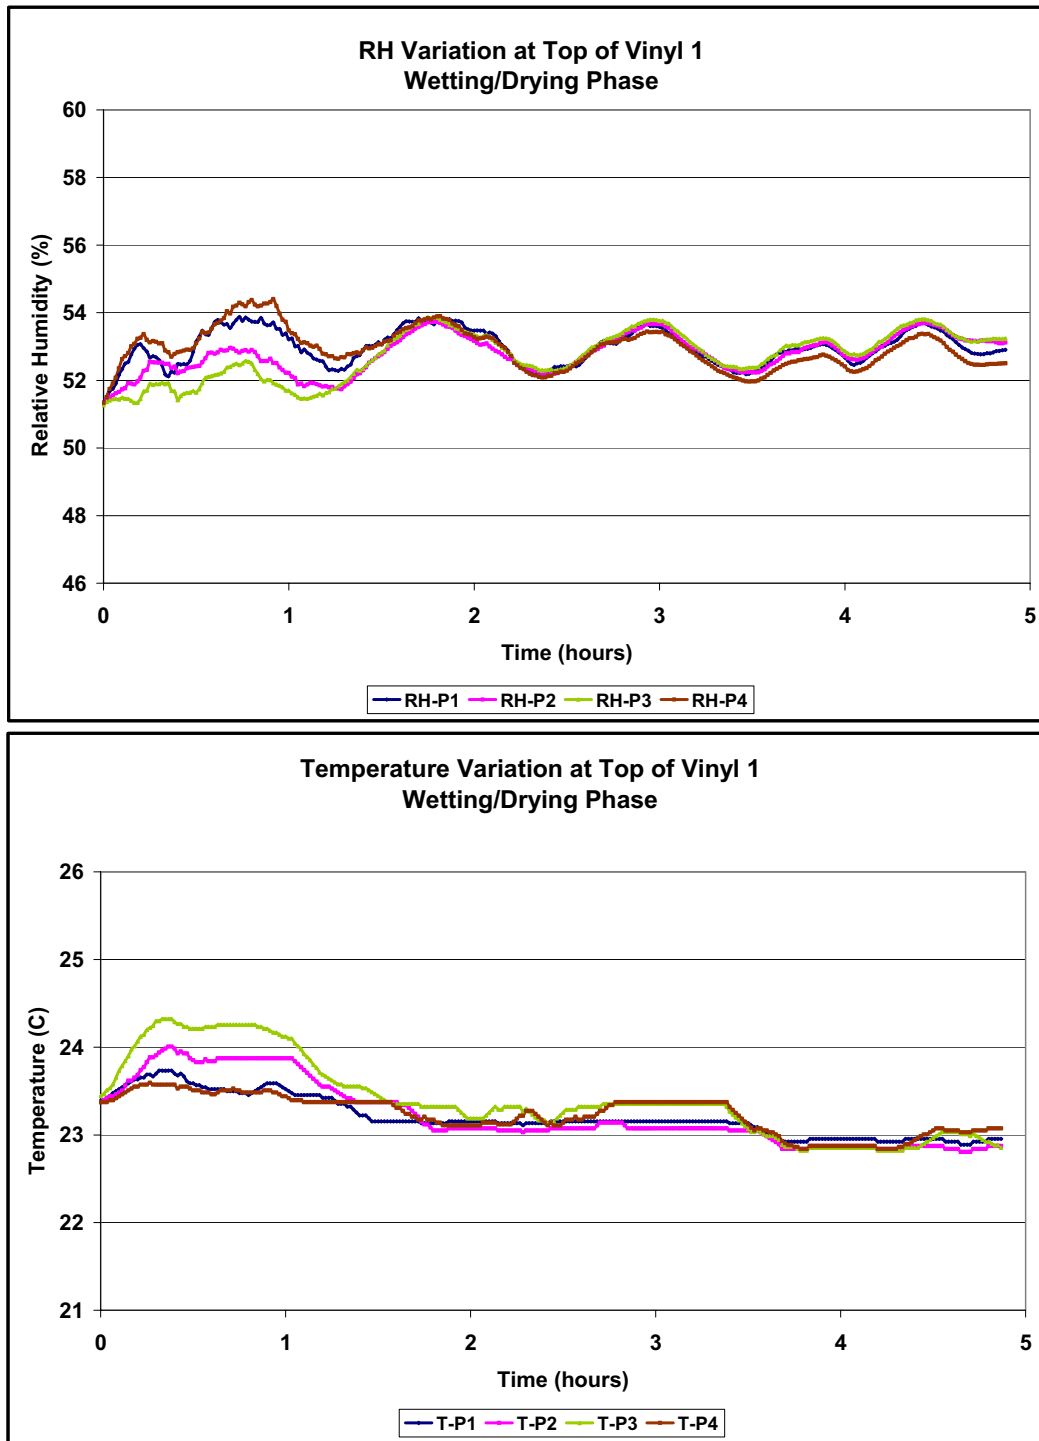
**Figure V-1** Relative humidity and temperature monitoring at the top of the drainage cavity during the wetting/drainage testing for Vinyl Wall 1 (Profile #1 and Building Paper).

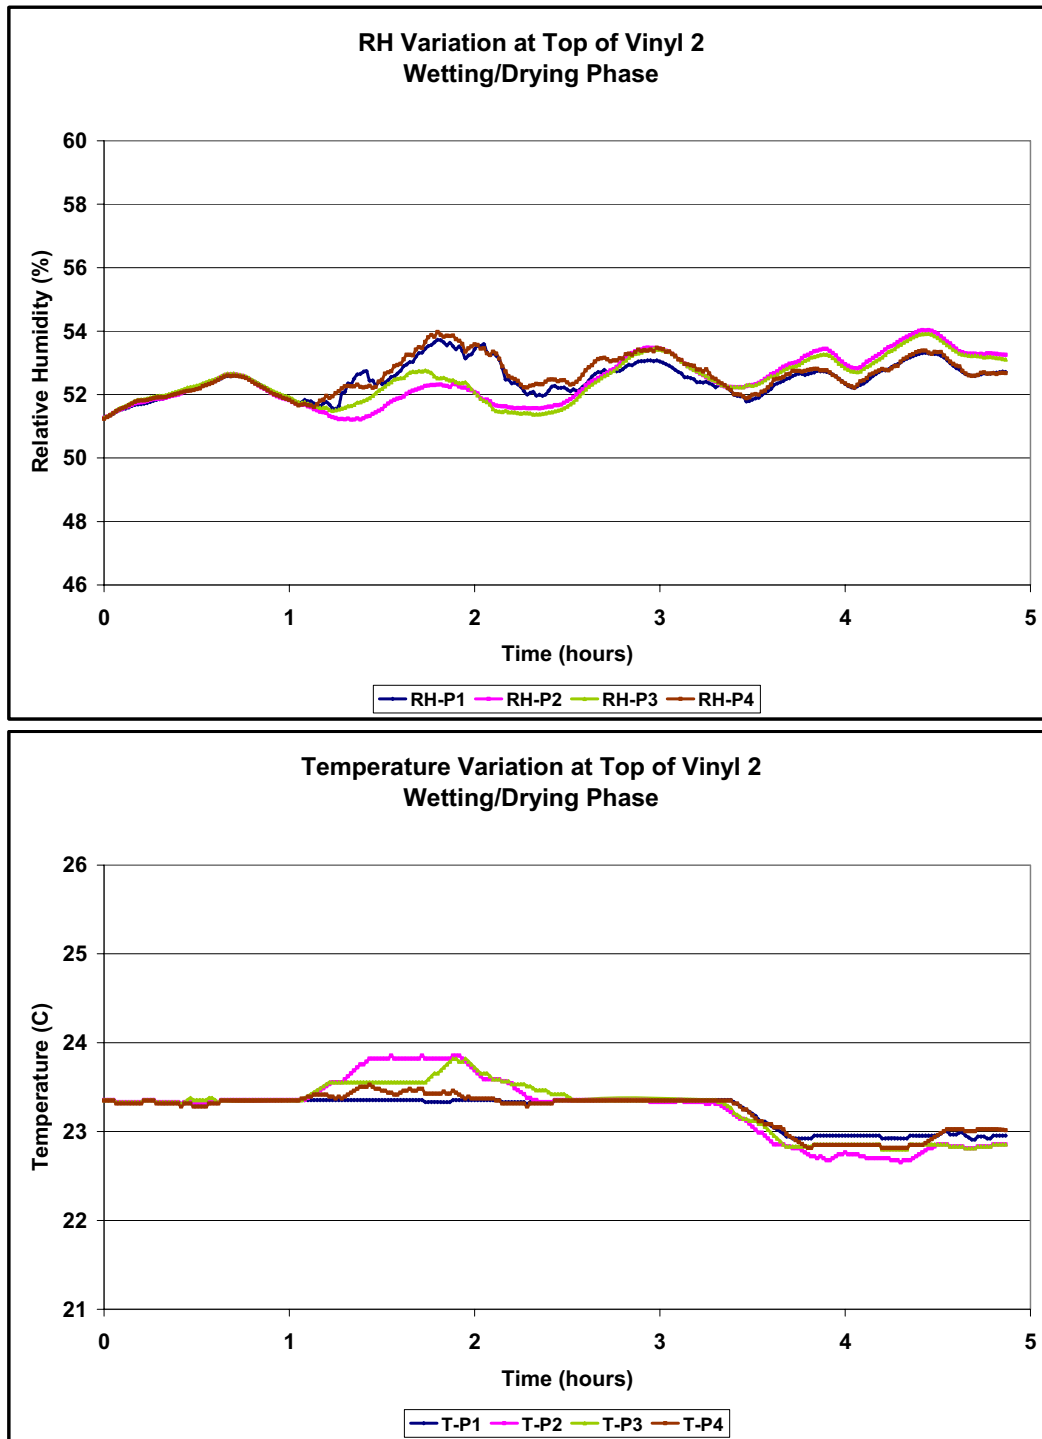
**Figure V-2** Relative humidity and temperature monitoring at the top of the drainage cavity during the wetting/drainage testing for Vinyl Wall 2 (Profile #2 and SBPO).

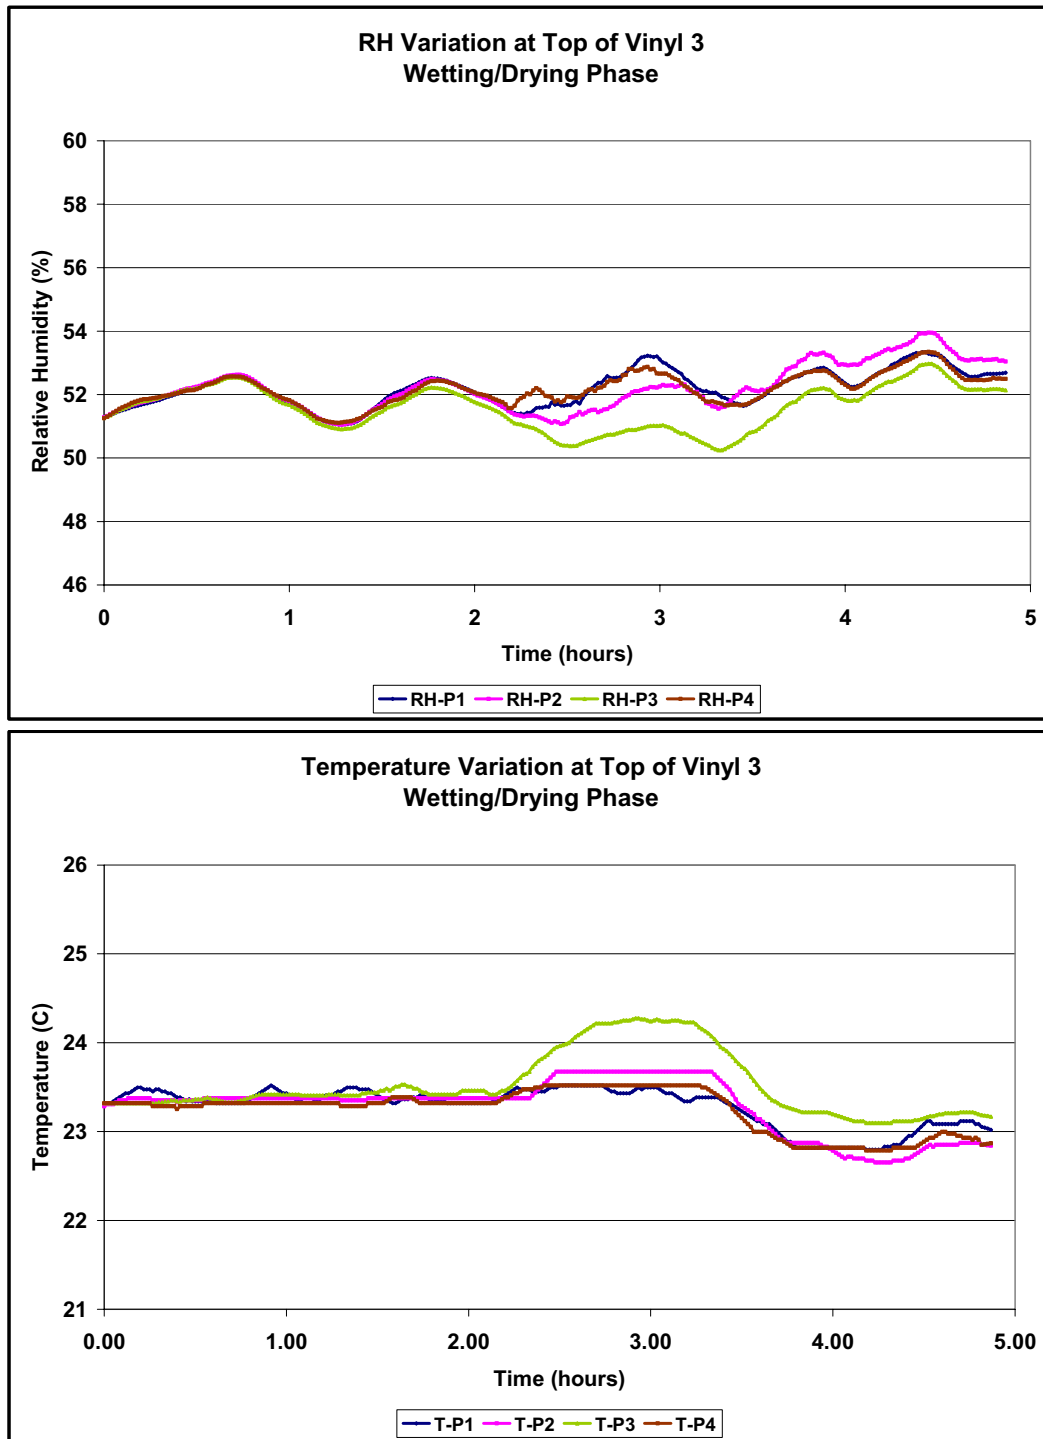
**Figure V-3** Relative humidity and temperature monitoring at the top of the drainage cavity during the wetting/drainage testing for Vinyl Wall 3 (Profile #2 and Building Paper).

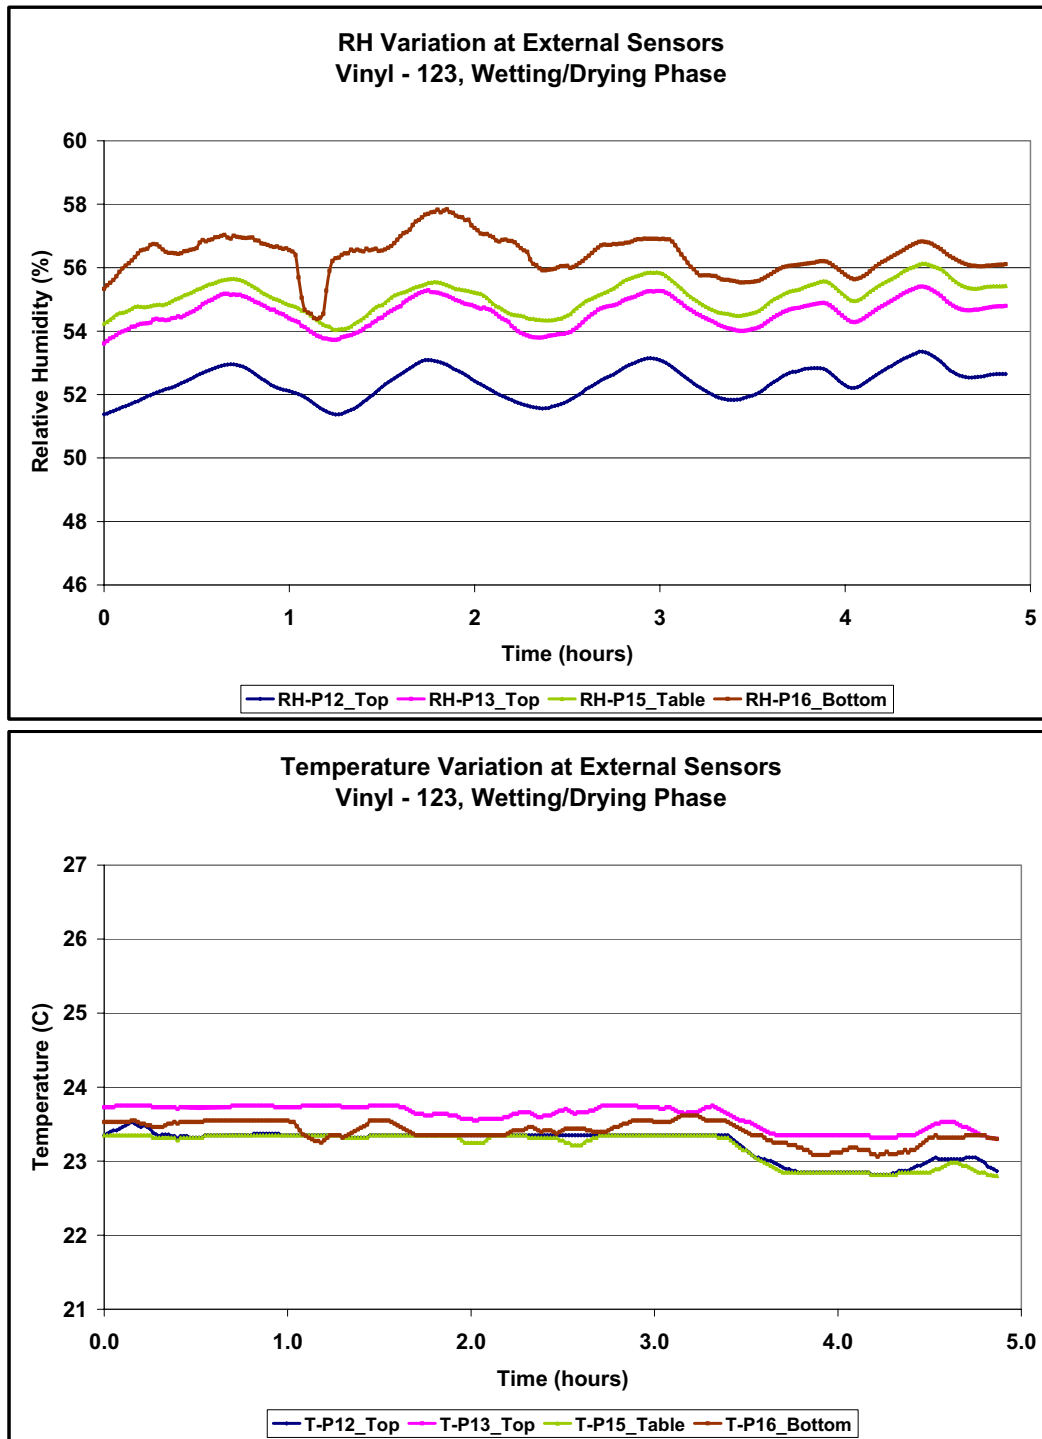
**Figure V-4** Relative humidity and temperature monitoring of ambient conditions at different elevations around the test area during the wetting/drainage testing of Vinyl Walls 1, 2, and 3.

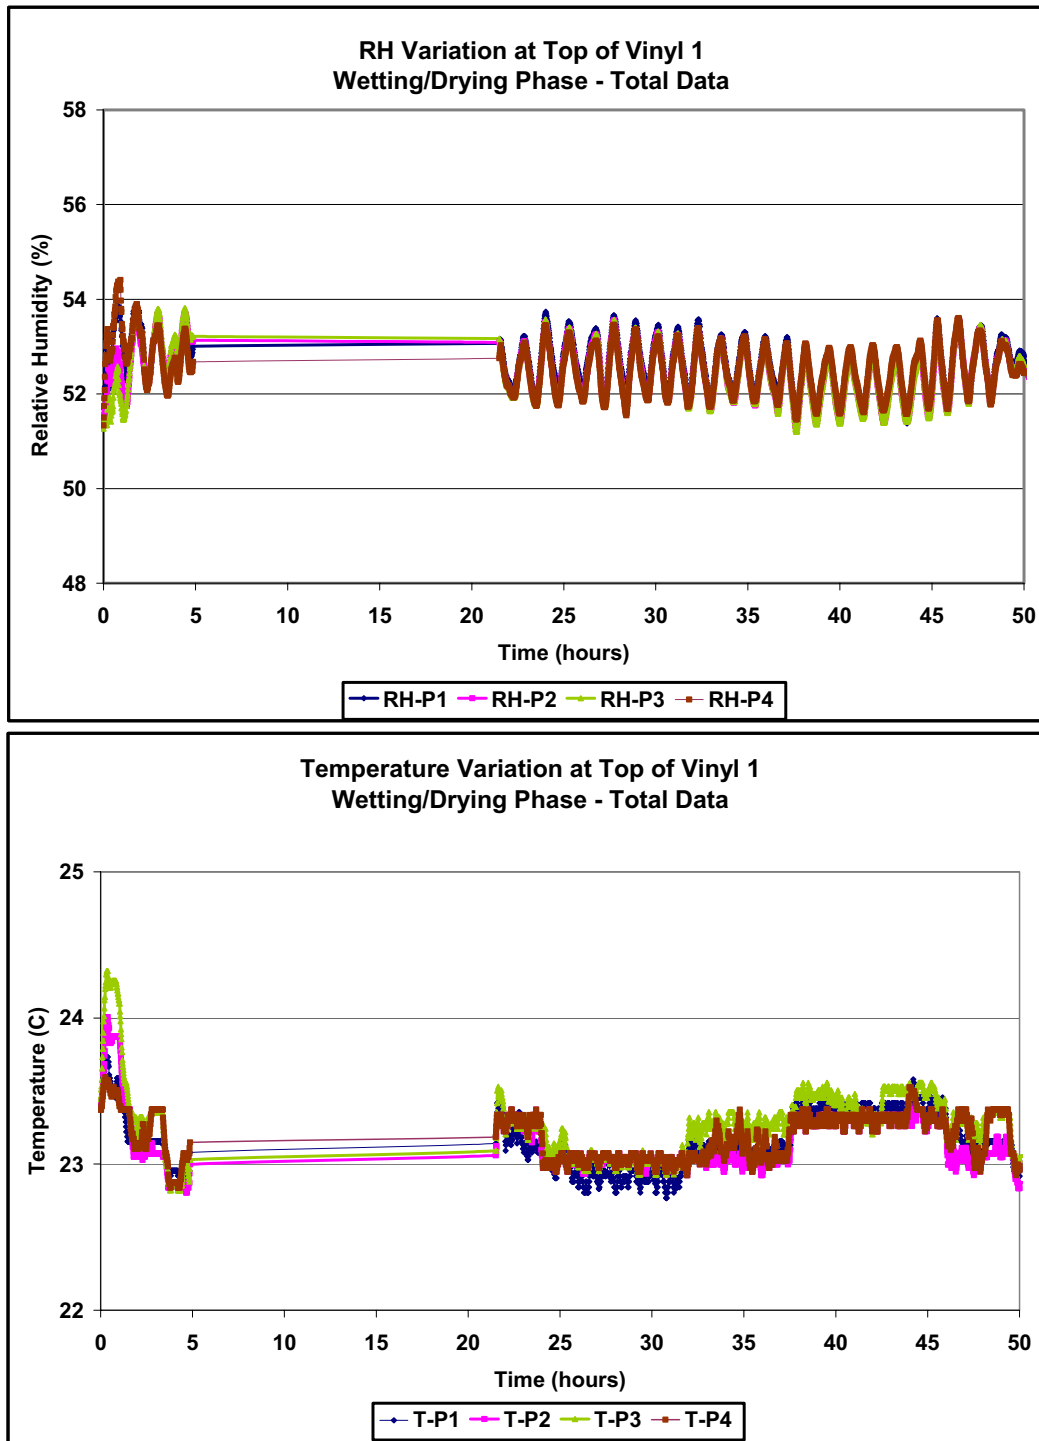
**Figure V-5** Relative humidity and temperature monitoring at the top of the drainage cavity over the whole test period including a 2-day drying period for Vinyl Wall 1 (Profile #1 and Building Paper). The data acquisition system was turned off by error for a period after the initial wetting/drainage testing was completed on the three vinyl siding walls being tested.

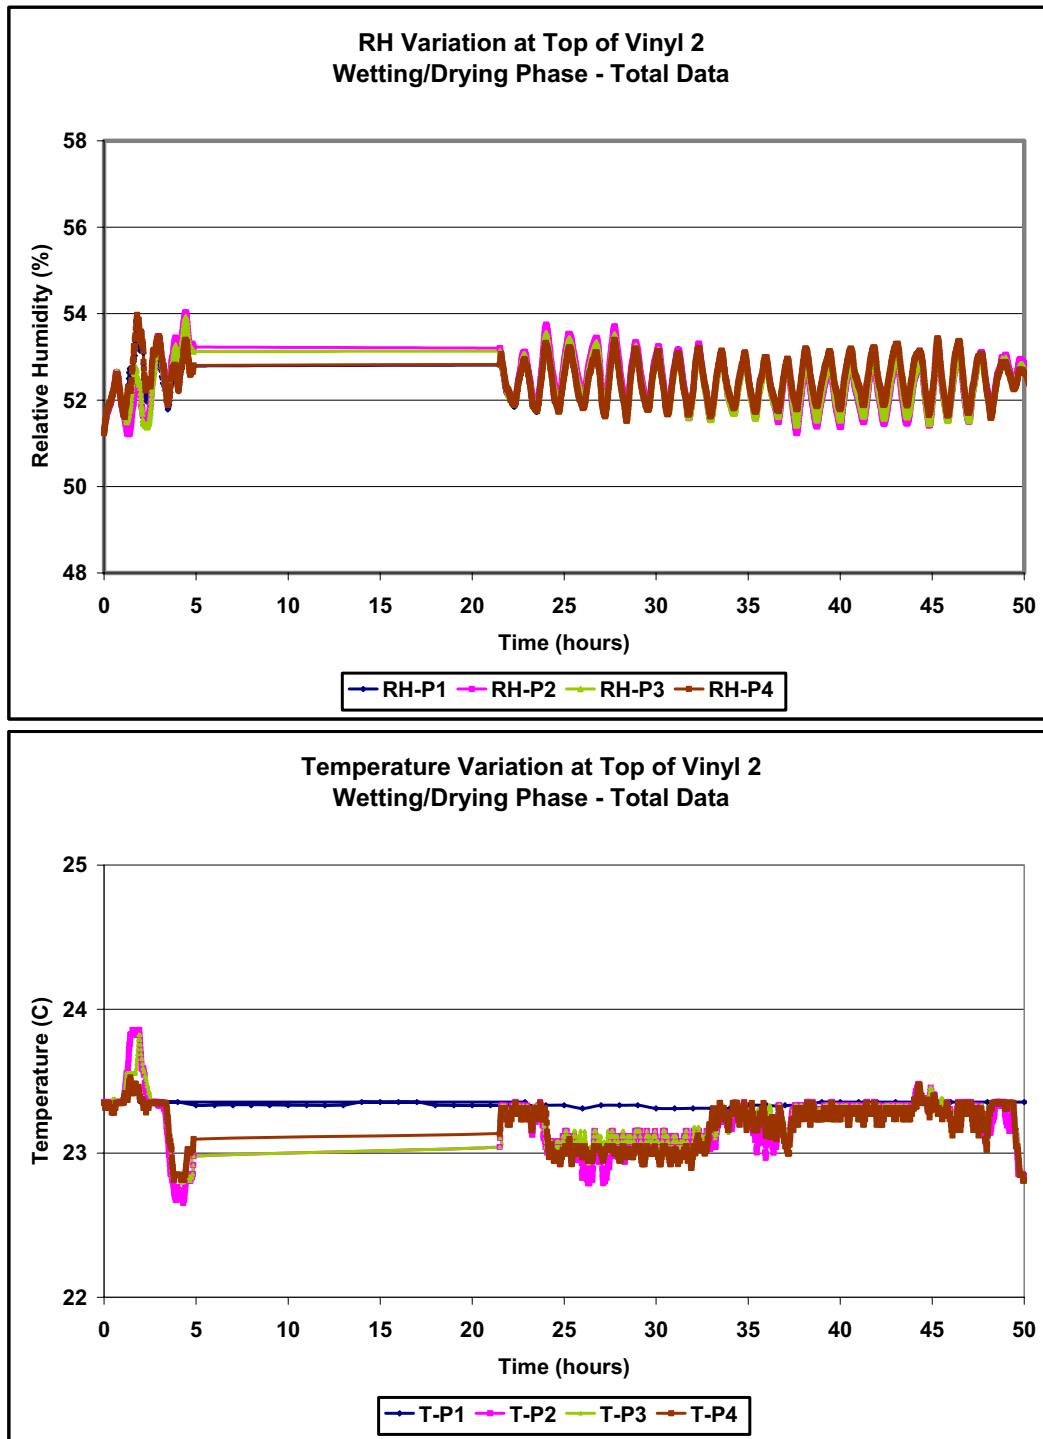
**Figure V-6** Relative humidity and temperature monitoring at the top of the drainage cavity over the whole test period including a 2-day drying period for Vinyl Wall 2 (Profile #2 and SBPO).

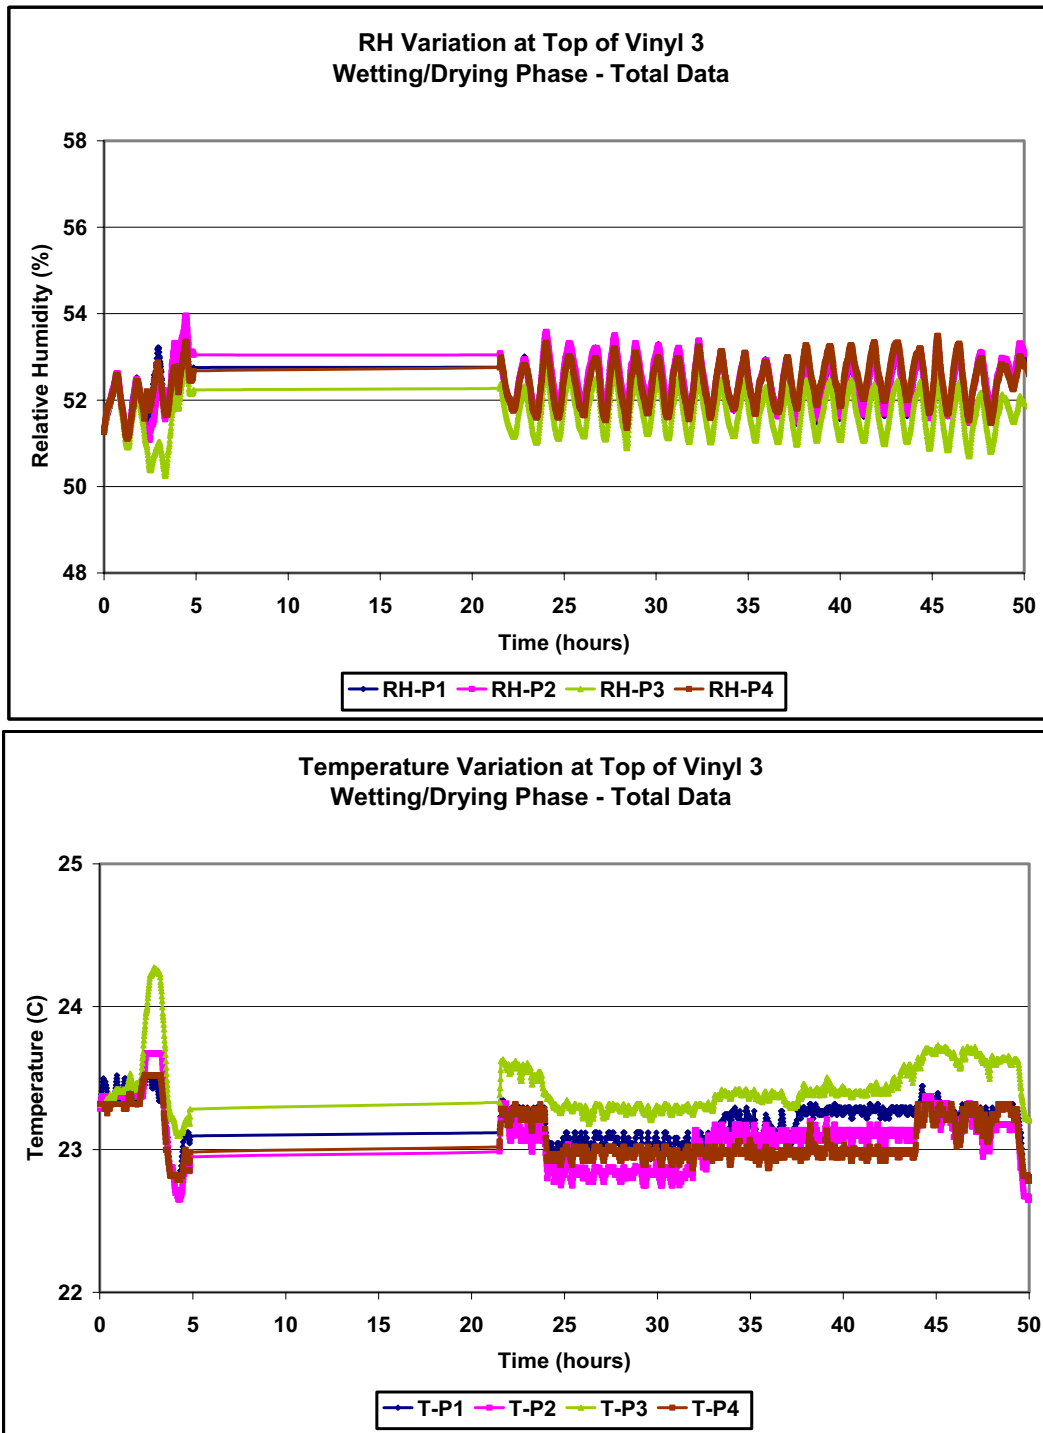
**Figure V-7** Relative humidity and temperature monitoring at the top of the drainage cavity over the whole test period including a 2-day drying period for Vinyl Wall 3 (Profile #2 and Building Paper).

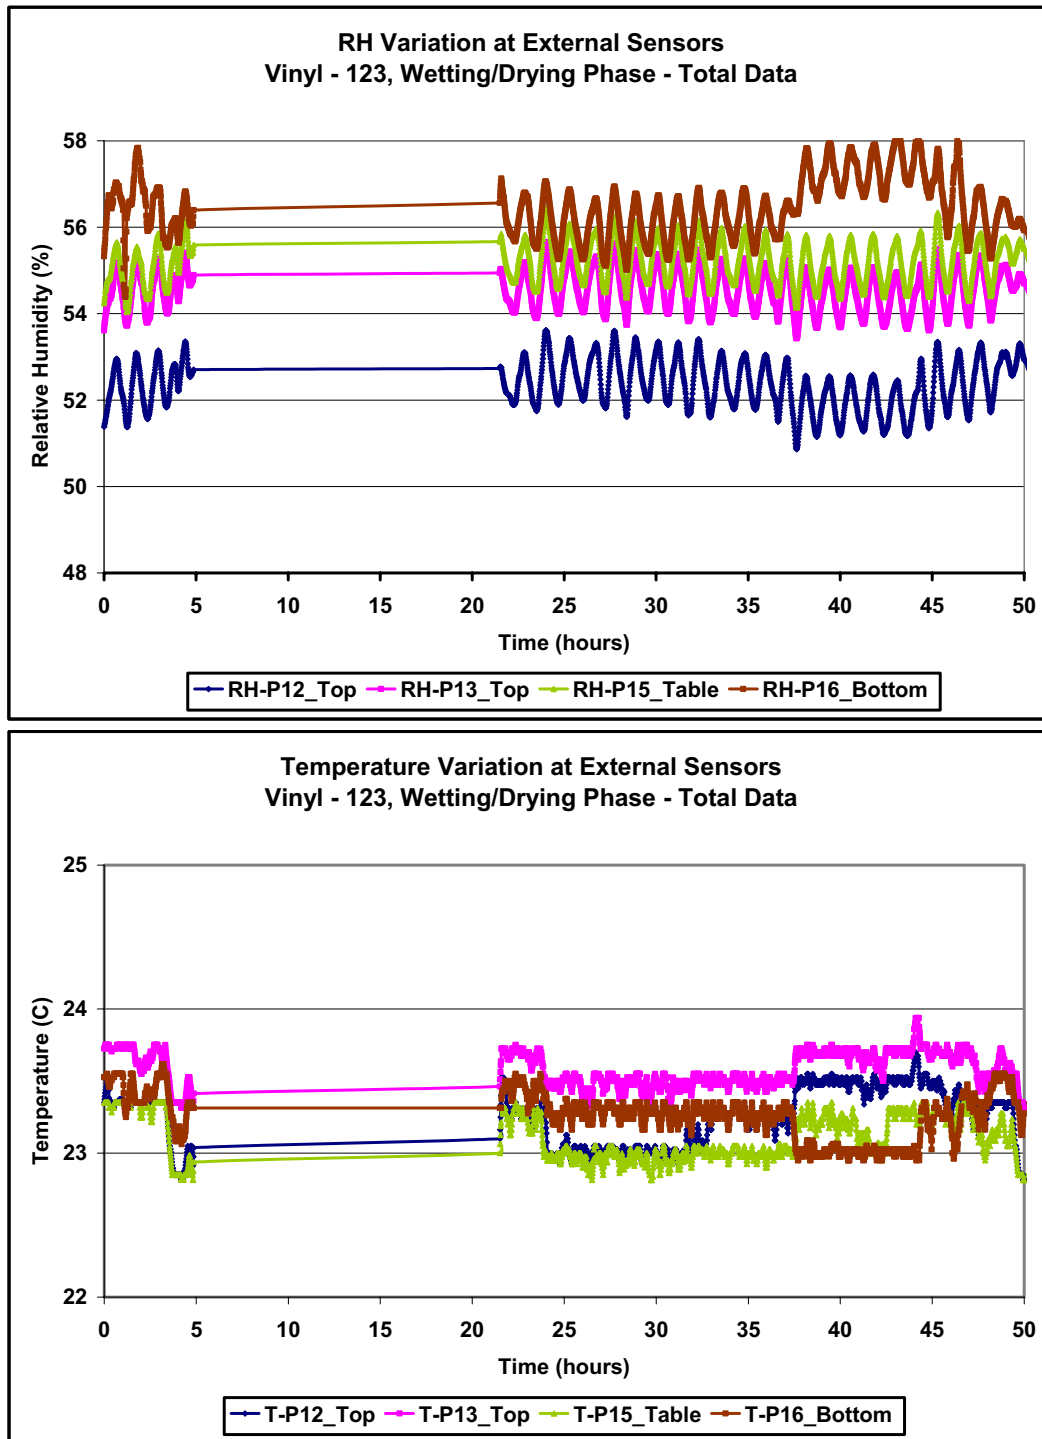
**Figure V-4** Relative humidity and temperature monitoring of ambient conditions at different elevations around the test area during the wetting/drainage testing of Vinyl Walls 1, 2, and 3.
