Field Investigations of Indoor Environment and Energy Usage in Mid-Rise Residential Buildings

FIELD INVESTIGATIONS OF INDOOR ENVIRONMENT AND ENERGY USAGE IN MID-RISE RESIDENTIAL BUILDINGS

Scanada Consultants Limited
436 MacLaren Street
Ottawa, Ontario K2P 0M8

Draft: August 1996
Final: August 1997

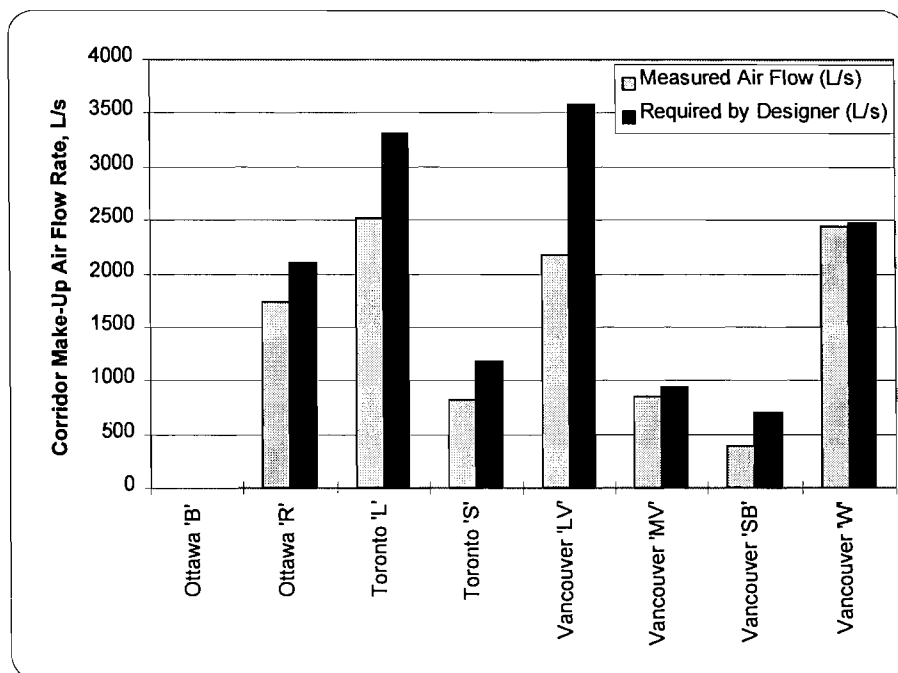
Figure 3-2: Performance of corridor make-up air system in mid-rise buildings.

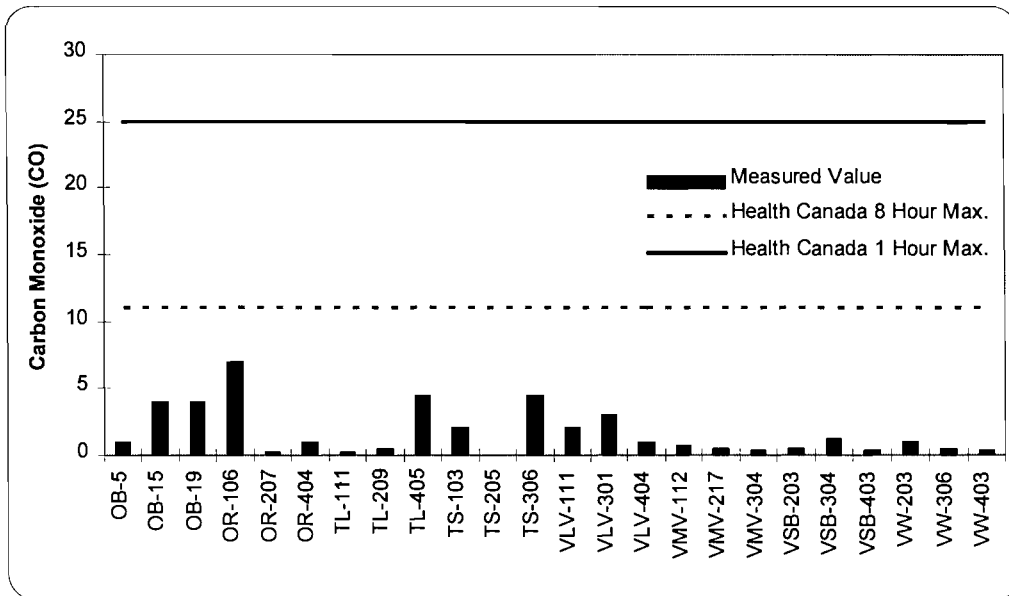
The measured readings were compared with the Health Canada guidelines. The guidelines suggests a permissible exposure limit of 25 ppm for one hour period and average 11 ppm over 8 hour period. In all buildings, the maximum value of CO levels ranged from negligible to about 7 ppm.

Figure 3-8: Maximum levels of carbon monoxide readings measured in test units.
