Understanding Vapour Permeance and Condensation in Wall Assemblies : Volume 1: Main Report

UNDERSTANDING VAPOUR PERMEANCE AND CONDENSATION IN WALL ASSEMBLIES

for Canada Mortgage and Housing Corporation

> Halsall Associates Ltd. and University of Waterloo

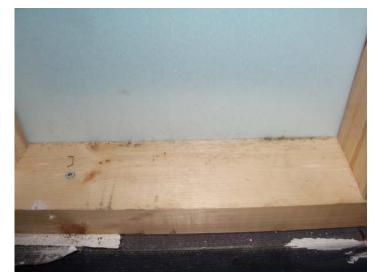
Photo 4.1: XPS South wall. Possible mold at outboard side of sill plate.

The XPS south wall exhibited no evidence of mold or damage on the back (exterior) face of the drywall. There was no evidence of moisture accumulation or damage in the fiberglass batt and no evidence of moisture damage on the back of the sheathing (See Photo 4.1).

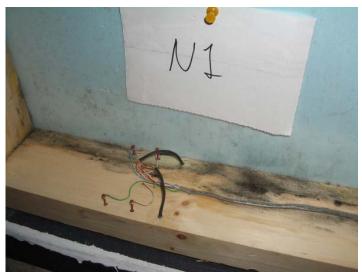
Photo 4.2: XPS Wall North - Mold growth at outboard side of sill plate

There was mold and significant evidence of condensation on the outboard side of the wood framing (See Photo 4.2) in the XPS North wall. Some water damage was seen on the back of the drywall, at the bottom plate. There was also evidence of moisture accumulation or staining in the fiberglass batts.

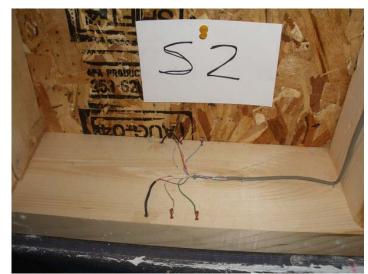
Photo 4.3: No Poly Wall South. No discernable damage or staining visible.

There was no damage or evidence of mold on the back (exterior) face of the drywall in the No Poly South Wall. There was also no evidence of moisture accumulation or damage in the fiberglass batts or framing (see Photo 4.3).

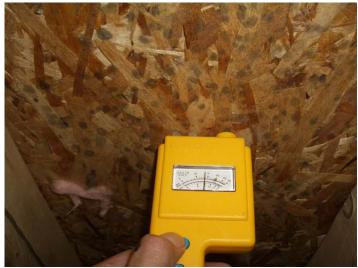
Photo 4.4: No Poly Wall North. Close-up of sheathing showing mold growth.

There was mold and significant evidence of condensation on the outboard side of the wood framing and on the sheathing in the No Poly North wall (See Photo 4.4). There was also noticeable grain/flake raising or thickness swelling of the OSB; a straightedge held against the sheathing revealed daylight. There was also evidence of moisture accumulation or damage in the fiberglass batts. No water damage was observed on the back of the drywall.

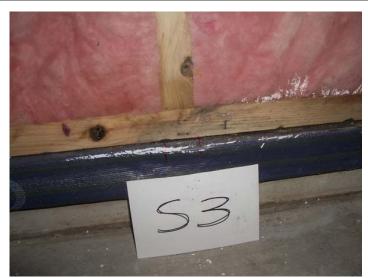
Photo 4.5: Poly Wall South. Mold visible at inboard side of bottom plate, also some visible condensation on the polyethylene

There was significant evidence of condensation and very high moisture contents on the inboard side of the wood framing on the South Poly Wall. Mold damage was visible on the inboard side of much of the framing, especially at the bottom plate, with some visible condensation on the polyethylene (See Photo 4.5). There was no damage or evidence of mold on the back (exterior) face of the drywall.

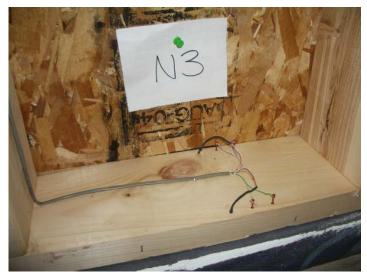
Photo 4.6: Poly Wall North. No evidence of condensation or mold growth

Sheathing and framing showed no mold or moisture damage evidence in the North Poly Wall (See Photo 4.6). There was minimal evidence of moisture accumulation or damage in the fiberglass batts and no water damage was seen on the back of the drywall.

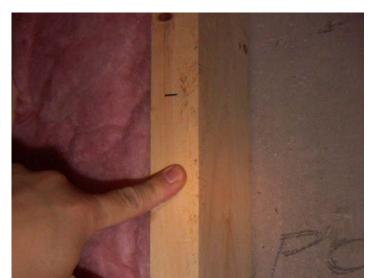
Photo 4.7: Poly Wall. Brown staining at inboard side of stud.

There was some staining at the inboard side of the Poly Wall (See Photo 4.7). There was no evidence of moisture damage to the fiberglass insulation. There was no visible condensation on the polyethylene vapour barrier and no moisture damage on the drywall.

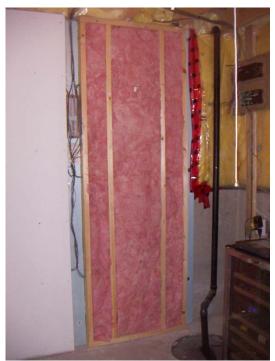
Photo 4.8: No Poly Wall - No evidence of moisture damage.

There was no evidence of moisture damage on the drywall, framing, or in the fiberglass insulation in the No Poly Wall (See Photo 4.8).

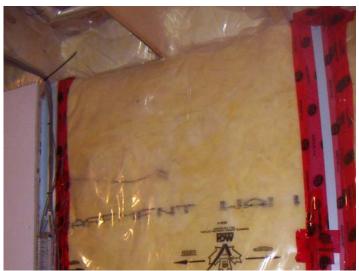
Photo 4.9: Roll Blanket Wall - Discoloration of upper batt (evidence of moisture).

Evidence of moisture accumulation (discolouration) was seen in the upper batt in the Roll Blanket Wall (See Photo 4.9). This wall was not disassembled, due to the disturbance that would result to the wall, and the lack of framing members to measure with a moisture meter.
