Nature's Revenue Streams: Assessment of Stormwater Treatment via Engineered Ecology<sup>TM</sup> Treatment Systems and Stream Restoration

December 2008

Final Report

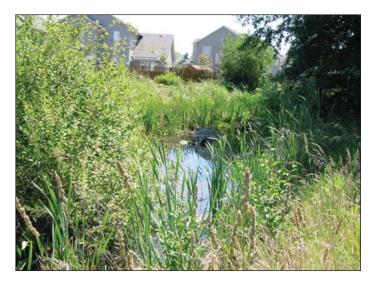
Figure I View of wetland between Willowbrook and Glanford 2003

- Nutrients: Total nitrogen was reduced by 38.6%, and a small amount of ortho-P was exported.
- Total dissolved solids: Chloride concentration, TDS, and specific conductance decreased on average, but only slightly.

- *Total suspended solids*: Average TSS and turbidity removal rates were 28% and 42.7%, respectively.
- *Temperature*: Temperature decreased from inlet to outlet by 1° C on average, likely owing to plant evapotranspiration.
- Metals: Arsenic, chromium, lead, mercury, tin and zinc were all lower at the outlet than at the inlet, with few exceptions. Average reduction of sodium and zinc was 4.1 % and 24.9%, respectively.
- Sediment Chemistry: Sediment samples were inconsistent, although wetland sediments at the outlet were lower on average in arsenic, iron, mercury, sodium, lead and tin.
- Bacteriology: Fecal coliforms reached 1,200 CFU/100 mL at the inlet on June 11, 2007, at which time there were 144 CFU/100mL Enterococcus.

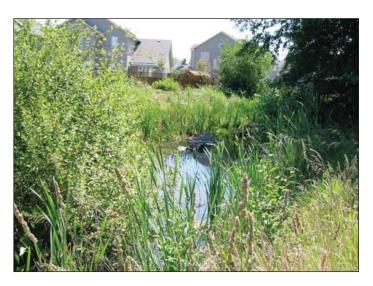
Figure I Vue de terres humides entre Willowbrook et Glanford en 2003

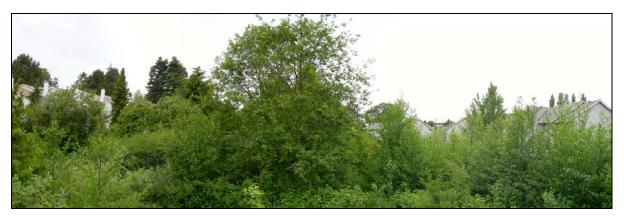
Figure 4. The Willowbrook subdivision and wetland complex six years after construction.

The most complex site was Willowbrook subdivision, an in-fill residential development on former agricultural land (Figure 3). A cow pasture, surrounded by development on three sides, with a major arterial road on the fourth side, was redeveloped to accommodate 35 homes. A part of this development, Swan Creek, which had previously been ditched and relocated along one edge of the pasture, was reconstructed complete with a small floodplain and in-stream channel complexity to improve aquatic habitat (Figure 4 - Figure 6). Wetlands were developed along the east side of the stream to attenuate stormwater from the development and to capture pollutants before they reached Swan Creek. A second linear wetland was constructed to the north of the development, along a sewer right-of-way, to provide treatment for stormwater coming from a neighbouring development as well as a portion of the Willowbrook development.

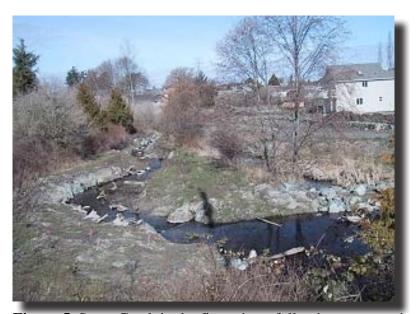
**Figure 5.** Swan Creek in the first winter following construction. The realigned channel and new pond are at the left, the old channel (ditch) remains on the right.

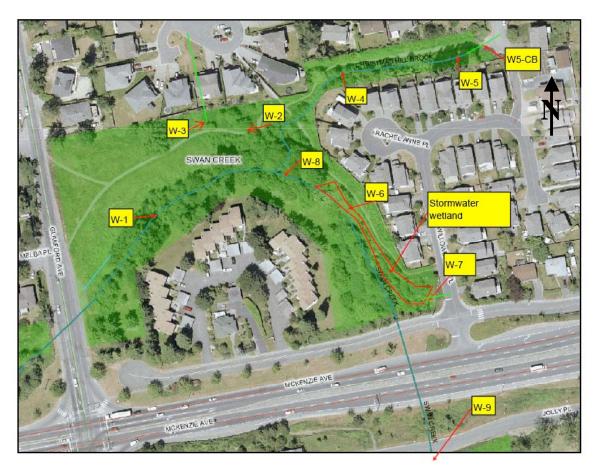
Figure 7. Willowbrook and Glanford Station sample sites. Swan Creek flows from the south to the north and then curves west and southwest toward the Colquitz River.

Sample sites were located upstream of the Willowbrook subdivision (W9) at the inlet to the main wetland (W7) and the outlet of the main wetland (W6) in Swan Creek below the main wetland outlet (W8), at the inlet to the chain of wetlands (W5), at the outlet of the linear wetland (W4), at the inlet to Glanford pond (W3) at the outlet from Glanford pond (W2) and in Swan Creek downstream of the wetlands (W1) (Figure 7).

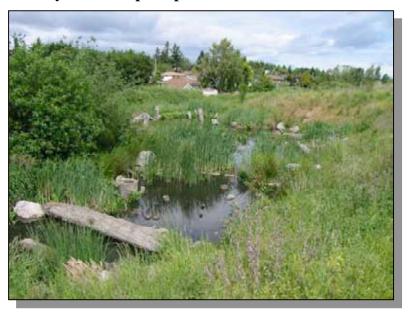
Figure 9. Baxter Pond May 2006.

In the early 1990's, Baxter Pond was developed as a dry detention pond to take runoff from the adjacent Pat Bay Highway. This design was not particularly effective because the plants would die off each year when the pond dried out (Figure 8). In 2001 Baxter Pond was redesigned as a wetland pond, with open water in the deepest portions, to treat stormwater from the newly developing Rogers Farm Subdivision on the slopes above the pond and to provide wetland habitat. The area where Baxter Pond was located was previously a wetland that had been filled in as part of the construction of the Pat Bay Highway and this project sought to restore a portion of that habitat. This wetland complex also receives stormwater run-off directly from the Pat Bay Highway and Pacific Christian School. Baxter Pond discharges into Gabo Creek which is a tributary of the Colquitz River.

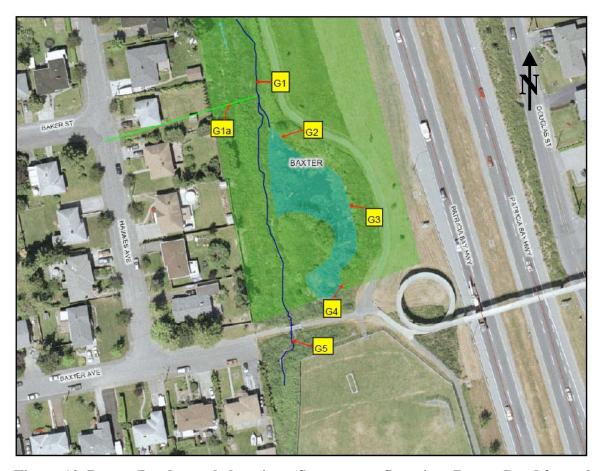
Figure 10. Baxter Pond sample locations. Stormwater flows into Baxter Pond from the right and then north through the pond into Gabo Creek which also flows north.

Sample sites were located upstream of Baxter Pond on Gabo Creek (G5), at the inlet to Baxter Pond (G4), mid-way along Baxter Pond (G3), at the outlet of the pond (G2), and downstream of the pond on Gabo Creek (G1). Partway through the study an additional stormwater outlet was located (previously dry) which drained the Hawkes Avenue area (G1a) (Figure 10).

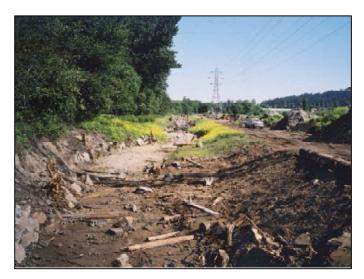
Figure 11. Blenkinsop ditch (top) and Galeys' field (middle) prior to the realignment and restoration of Blenkinsop Creek. (Bottom) the realignment during construction.

Blenkinsop Creek drains out of Blenkinsop Lake which receives agricultural and urban runoff from the Blenkinsop Valley. The lake used to extend almost a kilometer further south than it presently does. In the early 1900's a channel was blasted to drain the lake and create land for a subdivision. This process was interrupted by the First World War, and the land was turned into farmland to take advantage of the rich soils laid down in the lake. "Blenkinsop Creek" was thus connected to Cumberland Brook and what is now known as "Big Barn Creek," both of which have also been ditched as a result of farming practices over time (Figure 11 top). Blenkinsop Creek flows south almost two and a half kilometers into Swan Lake.

The intent of the Blenkinsop Creek restoration project was to rebuild approximately 650m of Blenkinsop Creek into a stream (Figure 11 middle and bottom), recreate aquatic habitat and bird habitat, attenuate flood flows and reduce the soil erosion and nutrient input from a neighbouring farm. Because these lands were once a lake bed, the soils are very rich in organics and nutrients, which contributes to eutrophication in Swan Lake.

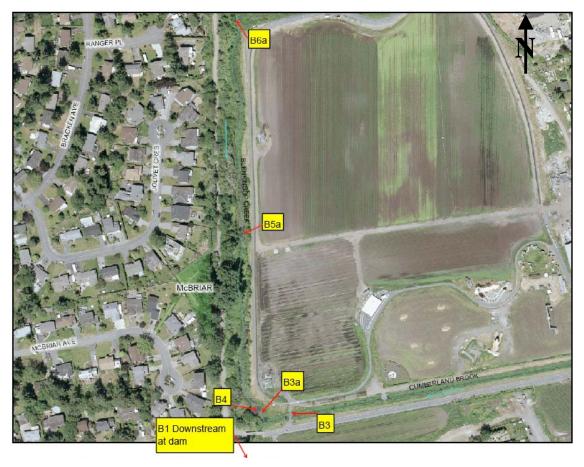
Figure 12. Blenkinsop Creek sample locations. Blenkinsop Creek flows south from Blenkinsop Lake toward Swan Lake. Cumberland Brook flows from east to west, into Blenkinsop Creek.

Unlike the other sites in this study, limited historical sampling data were available for Blenkinsop Creek. Sites in this study followed the old locations as closely as possible, given the realignment of the channel. Sites were located near the outlet of Blenkinsop Lake, downstream of the weir and upstream of Galeys' field (B6a), midway along Galeys' field (B5a), at the south end of the field, upstream of the confluence with Cumberland Brook (B4), at the discharge of the tile drain from Galeys' field (B3a) and downstream on Blenkinsop Creek at Cumberland Dam (B4) (Figure 12).

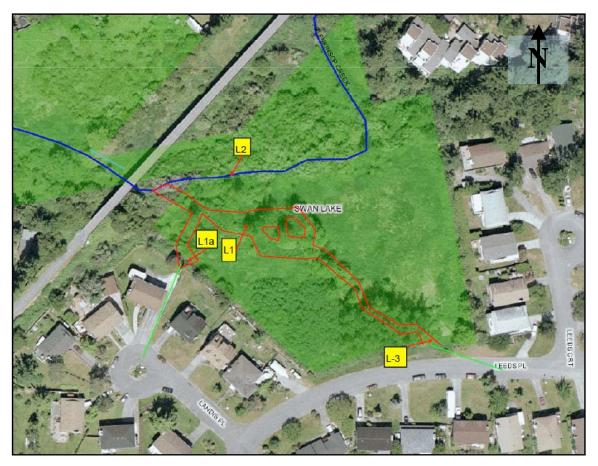
Figure 13. Leeds Creek sample site locations. Leeds Creek begins in a culvert at the lower right and flows northwest toward Blenkinsop Creek which is flowing south and then east towards Swan Lake.

Sample sites were located at inlet to Leeds Creek (L3) (a culvert), approximately 100 m downstream on Leeds Creek, upstream of the confluence with Blenkinsop Creek (L1) and on Blenkinsop Creek upstream of its confluence with Leeds Creek (L2) (Figure 13). During the course of sampling, another storm outlet was located downstream of site L1 and was designated L1a.

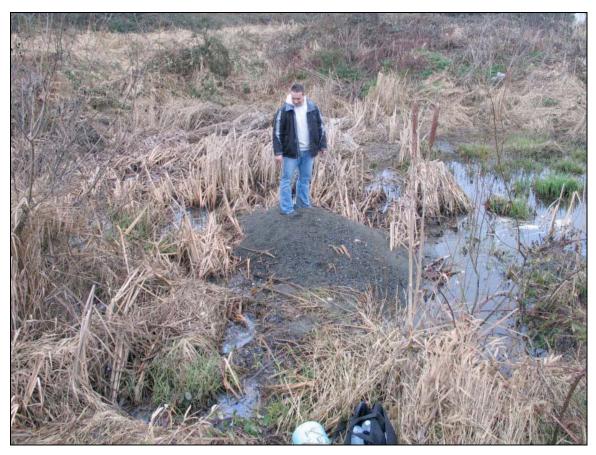
Figure 43. Sediment deposited in Baxter Pond just beyond the stormwater inlet. Material was washed off the Pat Bay Highway following a winter snowstorm.
