Cost-Effective Concrete Repair: Research, Investigation, Analysis, and Implementation

COST-EFFECTIVE CONCRETE REPAIR

Research,
Investigation,
Analysis, and
Implementation

Morrison Hershfield Limited*
4 Lansing Square
North York Ontario M2J 1T1
(416) 499-3110

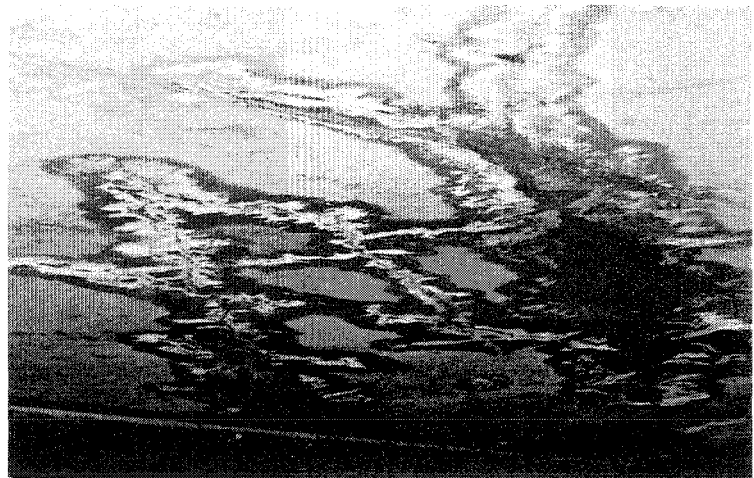
Figure 1-3 Leaching and Efflorescence

The leaching at cracks and holes may be intermittent, perhaps seasonal, with fluctuating ground water or exposure conditions. Thus, the surface of the crack or hole may not always appear wet but, it will frequently exhibit a stain and encrusted salts or efflorescence.

There are no standard tests applicable to leaching or efflorescence in concrete and it is generally not of significant structural concern; however, over time, the leaching results in a loss of lime in the paste and leads to a slow deterioration of the concrete with possible loss of structural integrity. The loss of free lime in the hardened concrete may also decrease the pH of the concrete as the alkalinity produced by the free lime is lost. This can result in localized corrosion of the embedded metals.

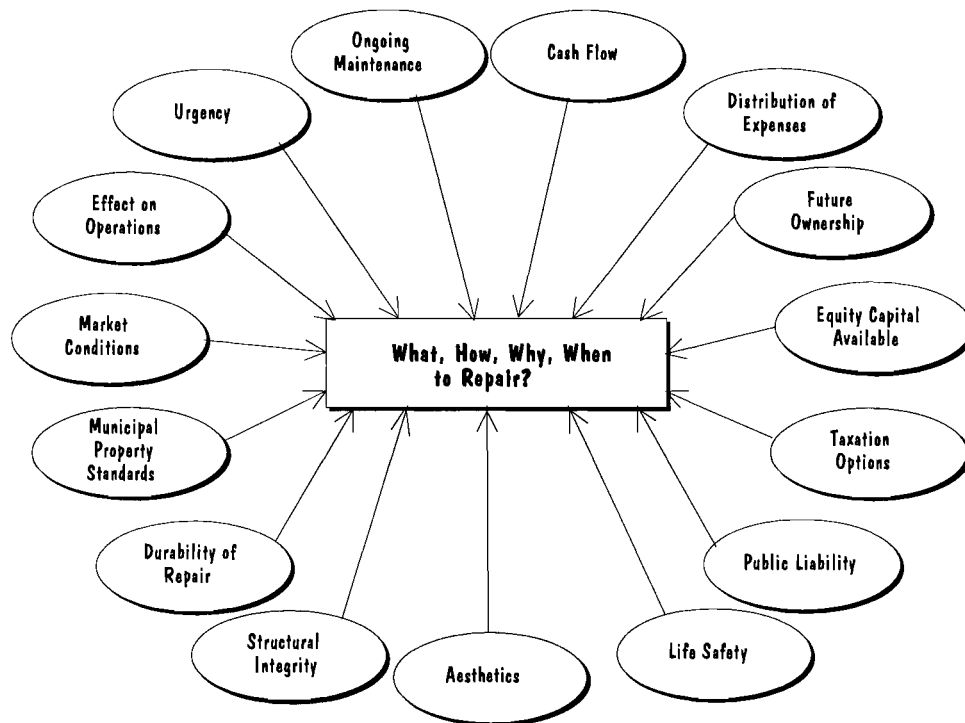
Figure 3-1 - Owner's Concerns

What to repair, how to repair it, when the repairs should be done, and why the repairs should be done are questions that must be addressed before performing any work. Figure 3-1 depicts many of the considerations that may weigh in the decision to do repair work. Some are more applicable to privately owned buildings, some to co-operative housing or condominiums and some to public non-profit housing. Each building owner or property manager responsible for the sound condition of the facilities should fully examine the various opportunities and constraints appropriate to their property.

At some time, between points B and C on Figure 3-4, the owner must take action to correct the deterioration. That point would be the threshold, beyond which, the concrete no longer meets the owner's minimum desired level of performance. Factors that determine the minimum desirable level of performance vary among owners, but can usually be ascribed to elements of the owner's concerns shown in Figure 3-1.

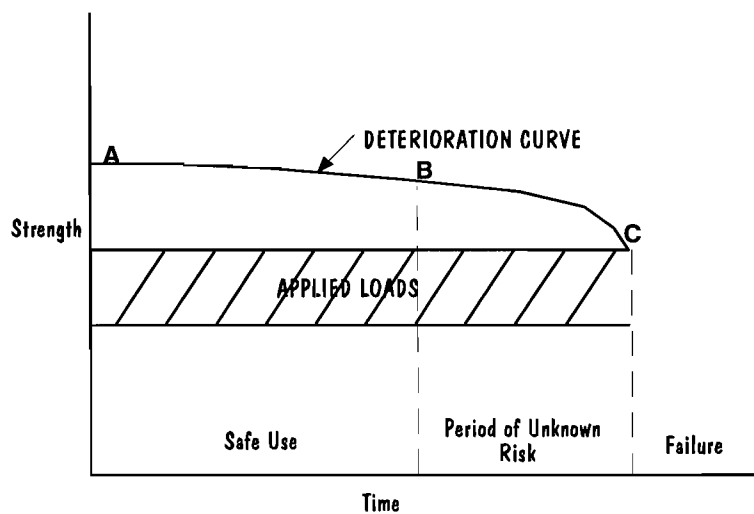
Figure 3-4 Reduction in Resistance to Deterioration over Time

Initially, the loss of structural strength is of little concern since there is a large margin of safety between what loads the structure can resist and those that it experiences. Later, as deterioration progresses, the risk of structural inadequacy increases and, finally, the structural element could fail. Of concern to owners as the deterioration progresses, is not only the risk of failure, but, that the rate of deterioration is very likely increasing as time passes.

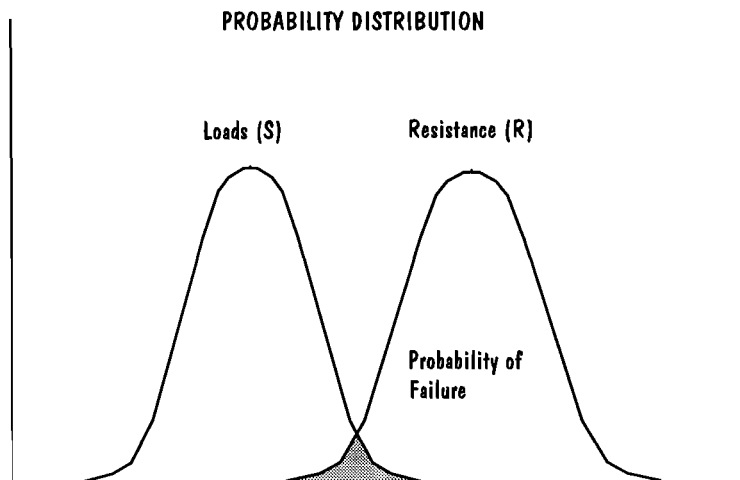
Figure F-1: Probability Distribution of Loads and Resistance

The following simplified rationale is provided for owners and managers without an engineering background so that they might understand why failures, though rare, have occurred. The applied loads (S) and the actual resistance of the structure (R) for a group or population of structures or structural elements can each be represented by a probability distribution (Figure F-1). A particular structure will have a particular resistance to a certain combination of loads. If R remains greater than S, the structure is safe. Since, as a result of the variables in design and construction, some structures have greater resistance to the applied loads, those structures will have a greater margin of safety. This increased margin of safety can have a two-fold effect. Firstly, there is likely greater resistance to deterioration imparted to the concrete structure by such qualities as higher strength, better air entrainment, better drainage, and construction closer to design dimensions and tolerances. For instance, a slab that is thicker and of better quality concrete will be less affected structurally by freeze-thaw damage than a thinner slab of lesser quality concrete.

There is, of course, a cost associated with providing increased margins of safety and so it behooves designers, standards writers and code writers to provide a reasonable margin of safety at a reasonable cost. There is also a probability that the Resistance R may be less than Load S . This is depicted by the shaded area under the two probability distribution curves where the curves cross representing the chance of failure. The spread between the average resistance R and average load S can be used to describe the margin of safety.
