## Field Survey of Heat Recovery Ventilation Systems Final Report

# ***Field Survey of Heat Recovery Ventilation Systems***

Final Report

Date:  
**December 1998**

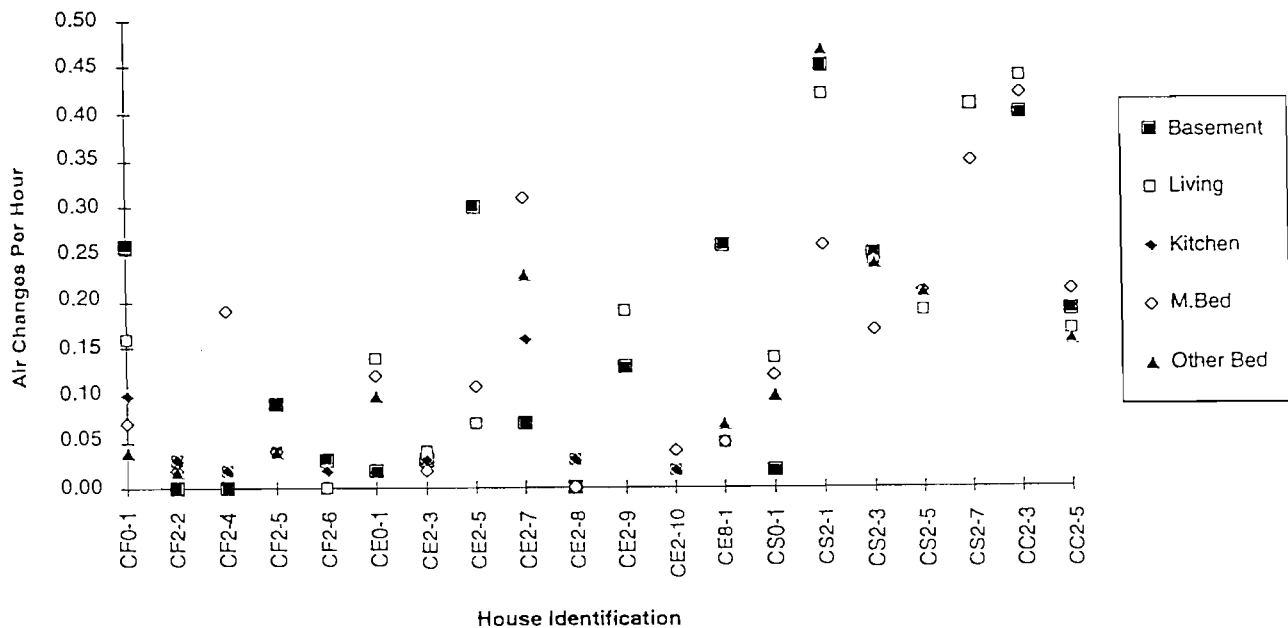
The apparent natural AC/H rates were measured with the HRV off, doors open, and furnace circulation fans running where applicable. For these tests, the outside ports of the HRV were not sealed and, hence, some induced air change could be expected for the HRVs connected to the furnace return air plenum. Figure 8.1 shows the results of this testing in five standardized locations within each home.

**Figure 8.1: Apparent Natural AC/H Rates**

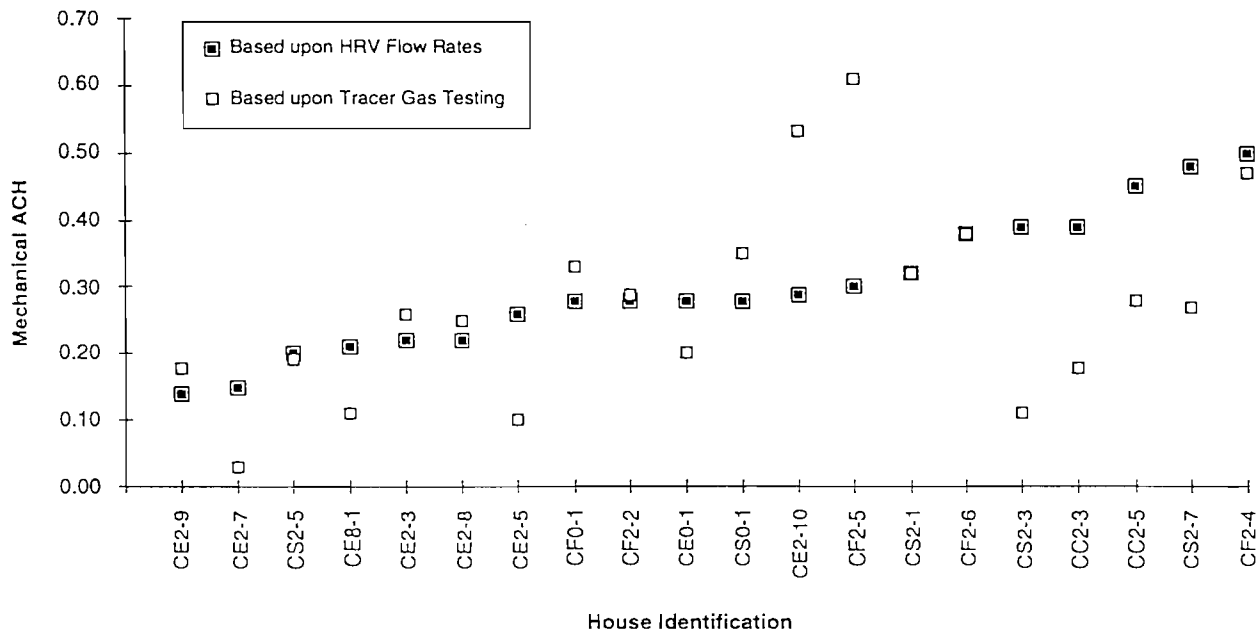
The houses in the following chart were sorted from lowest to highest HRV predicted whole house AC/H rates to make the chart easier to review.

**Figure 8.8 Comparison of Whole House Mechanical AC/H Rate Results**

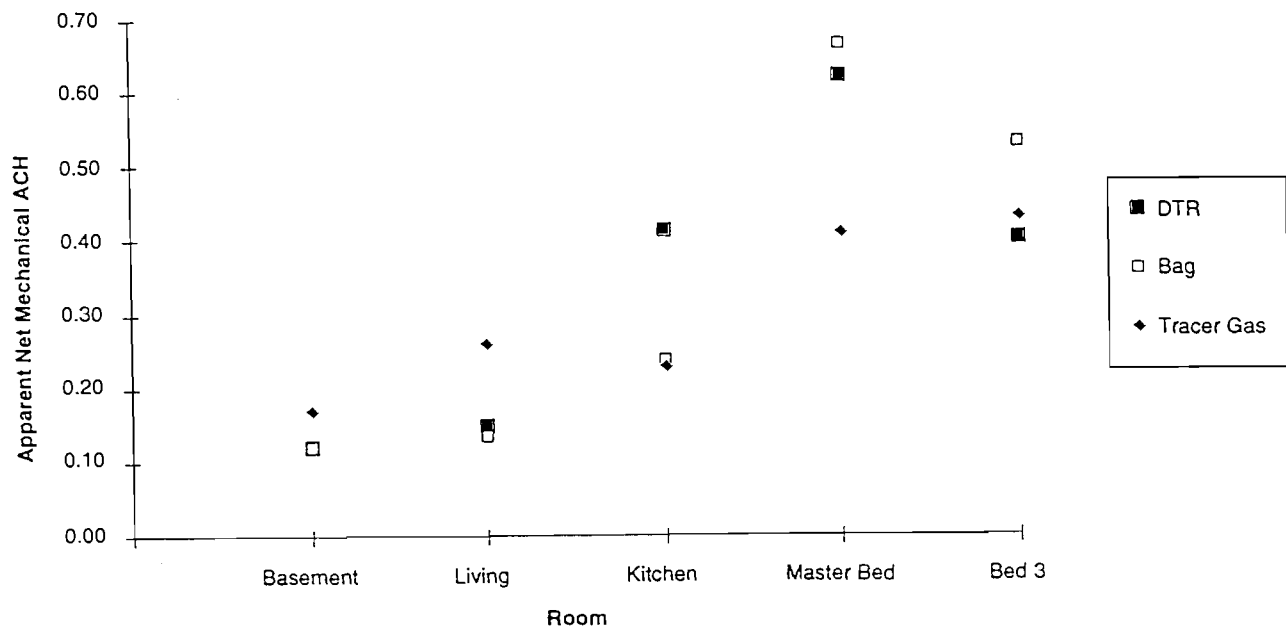
As an example, the following chart shows the results at house CE2-8. It should be noted that the air flows at the furnace supply registers within this house were estimated using two techniques, a bag inflation/deflation method, and the CMHC duct test rig. Both techniques resulted in similar calculated ventilation air proportions to each room.

**Figure 8.9 Comparison of Room Mechanical AC/H Rates at house CE2-8**

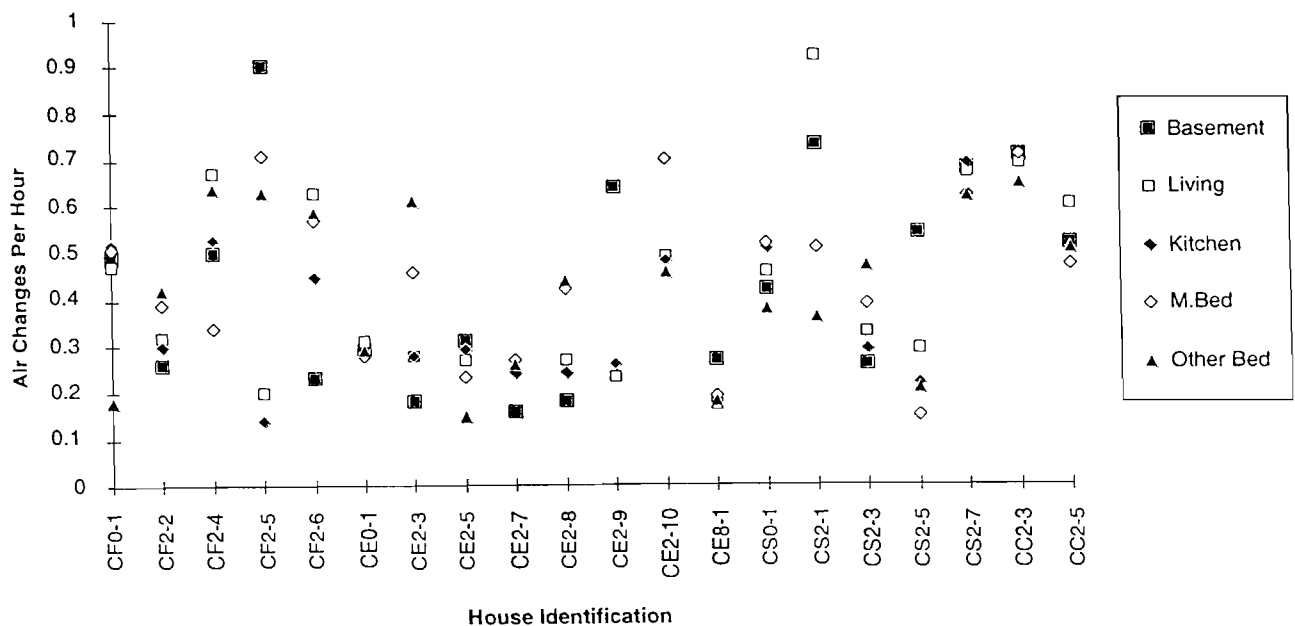
The following graph summarizes the results for five commonly chosen sampling locations within each house.

Figure C.1 Graph of Total Air Change Rates

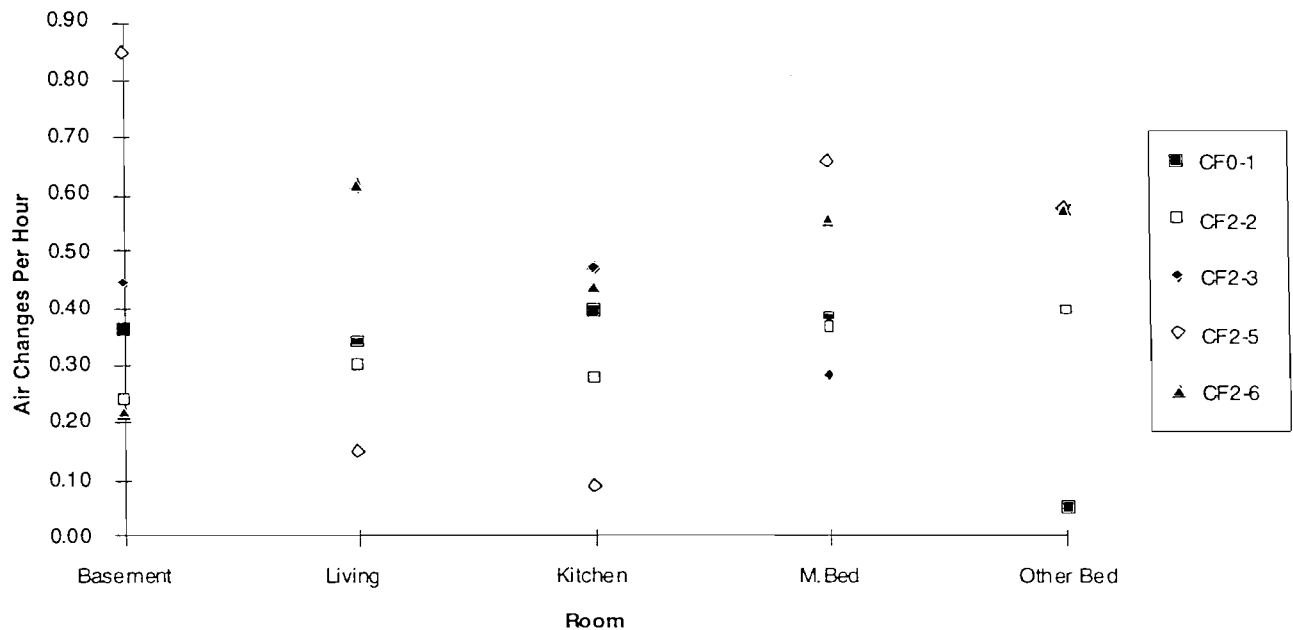
Graphically, the results for all homes with fully ducted systems are as follows:

**Figure C.2 Fully Ducted Systems – Apparent Mechanical AC/H Rates by Room**

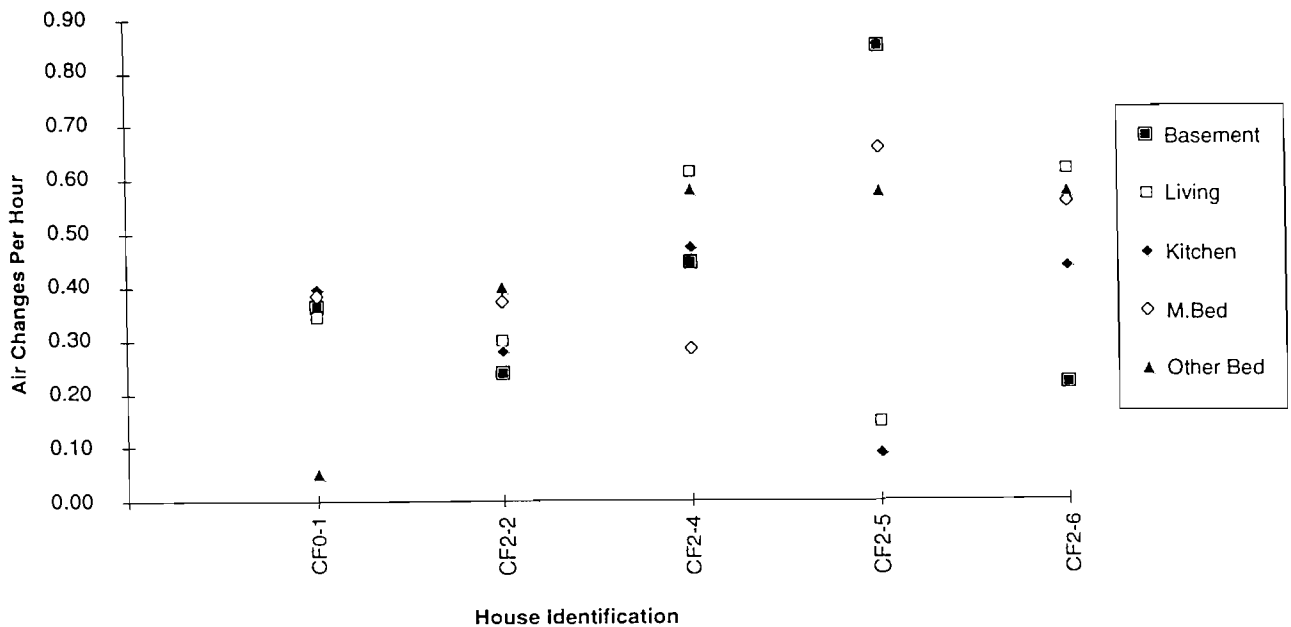
**Figure C.3 Fully Ducted Systems – Apparent Mechanical AC/H Rates by House**

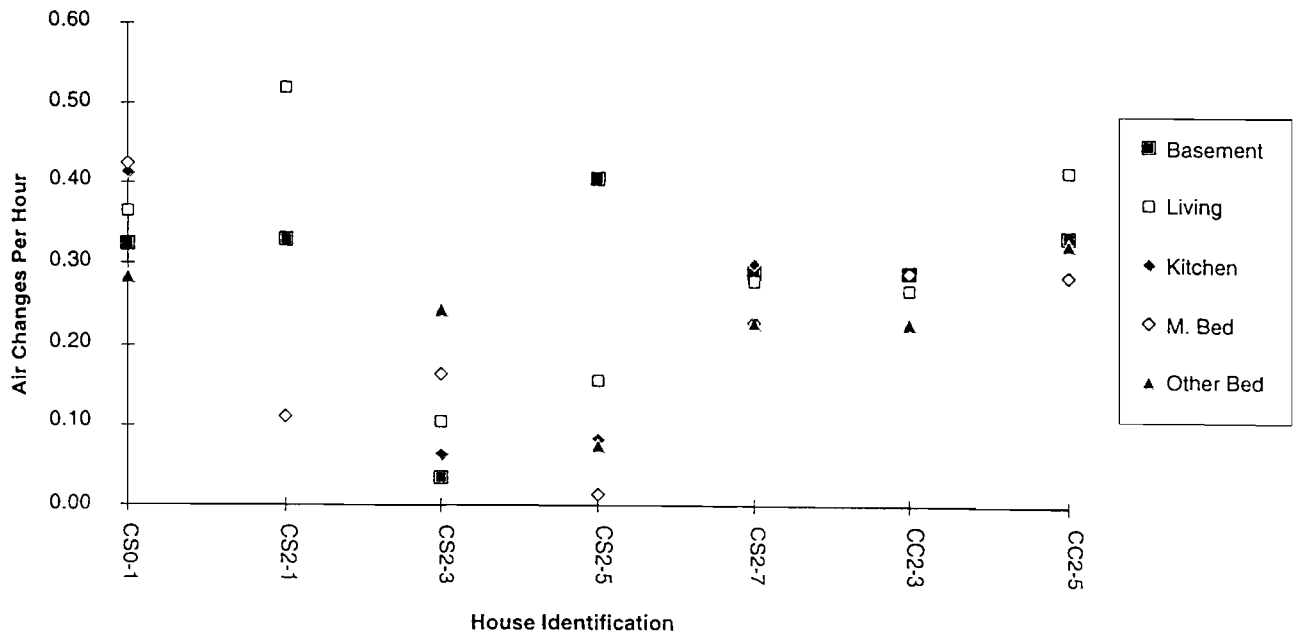
**Figure C.7 Simplified Systems – Mechanical Ventilation Rates by House**
