Aboriginal Affairs and
Northern Development Canada

THE BIG PICTURE

CONTAMINATED SITES IN NUNAVUT

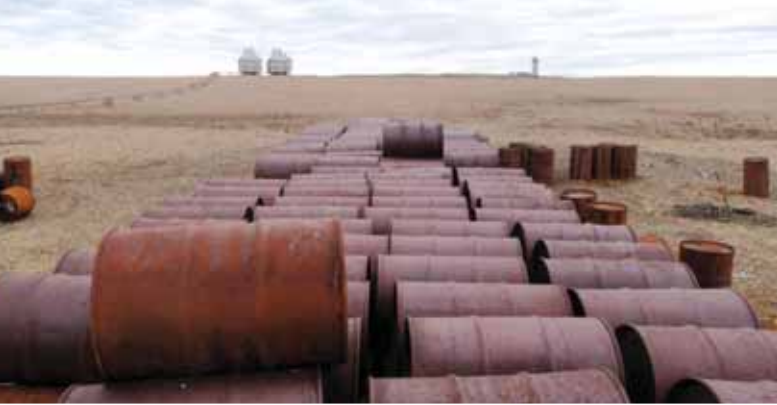
A pile of barrels at the CAM-B (Hat Island) site.

Debris litters the site along with barrels and landfills, which may contain asbestos. Soils are contaminated with PCBs, hydrocarbons, zinc and copper.

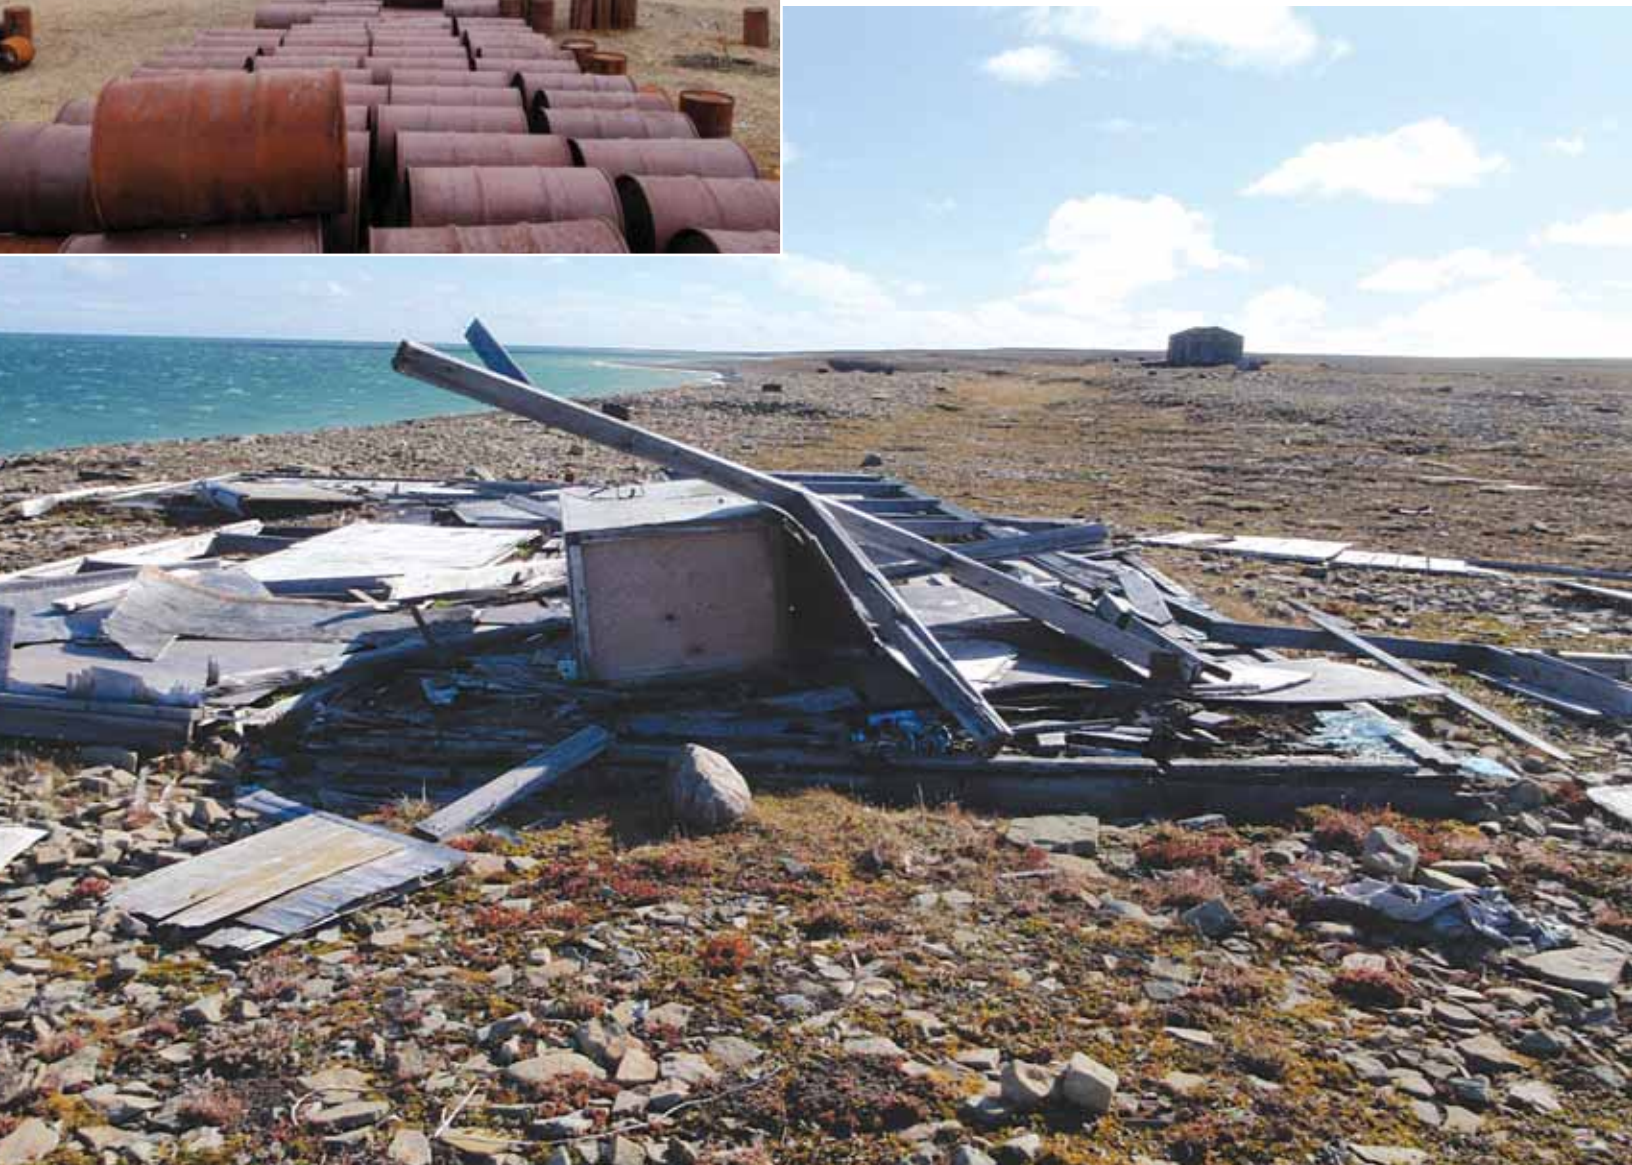
Wooden debris at the CAM-B (Hat Island) site. An abandoned cabin can be seen in the distance.

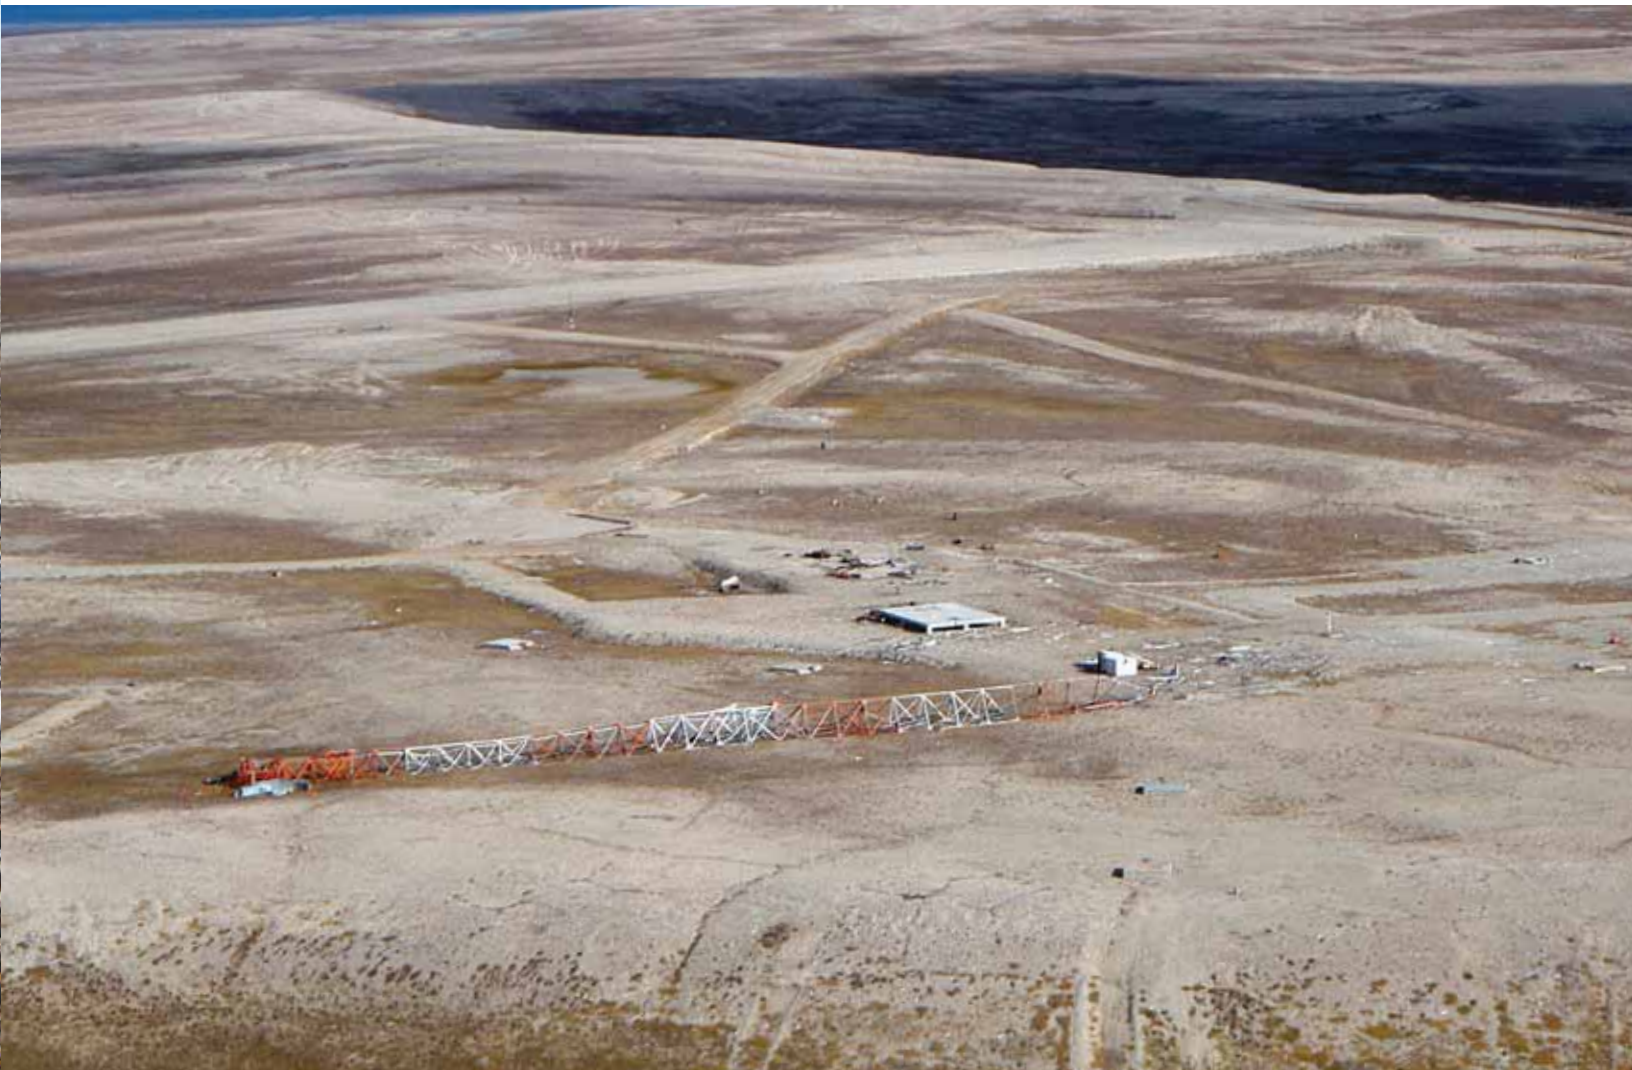
A toppled antennae at the CAM-C (Matheson Point) site.

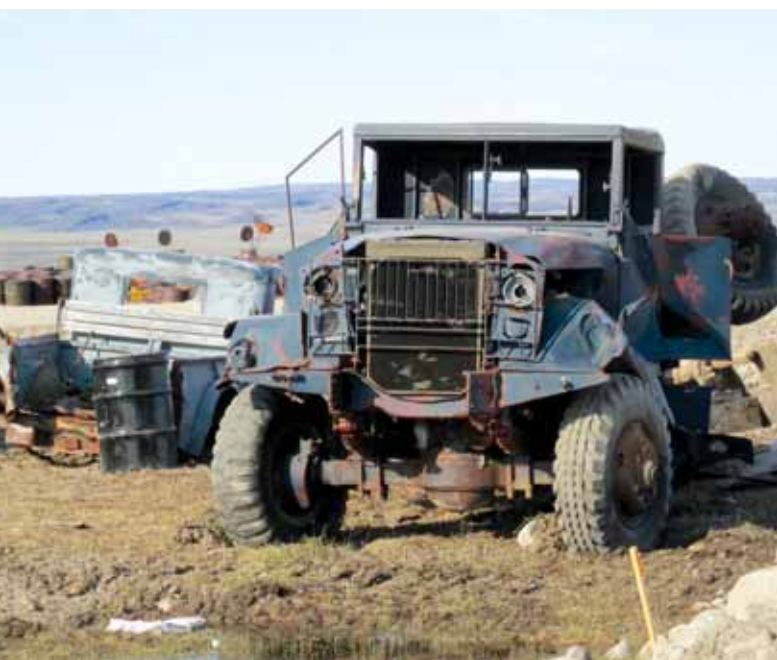
Several collapsed buildings, hazardous and non-hazardous debris (including asbestos and more than 6,000 barrels), and one large dump remained on site after closure. Areas of soil were contaminated with heavy metals, hydrocarbons, and PCBs.

Abandoned vehicles at CAM-D prior to remediation.

Remediation activities on this site were completed in September 2011, and the final demobilization of equipment is expected to be complete by September 2012. Work included:

- Excavation and management of soil containing low-level contamination in an engineered landfill;
- Excavation, packaging and shipping of soil containing high-level contamination to a southern disposal facility;
- Collection and placement of non-hazardous waste in an engineered landfill; and
- Collection, packaging and shipment of hazardous waste to a southern disposal facility.

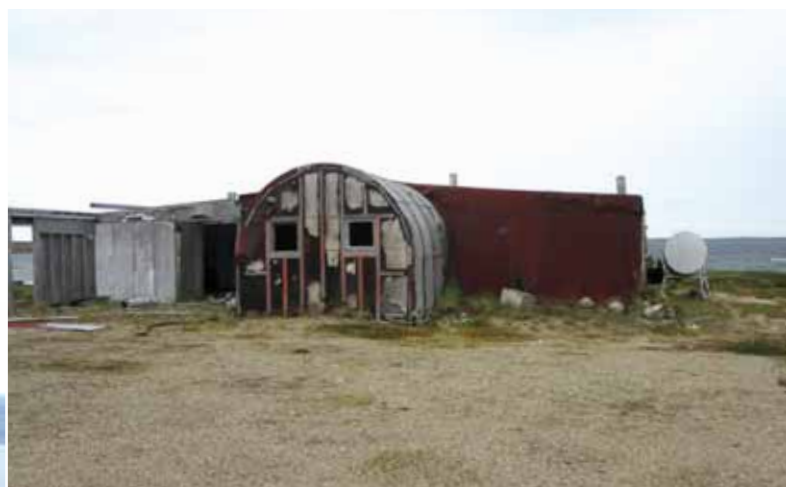
The site currently consists of the remains of five buildings (a hunting cabin, the main building, a generator building and two small radio shacks); two dump areas consisting of extensive metal debris and burn areas; an airstrip; and four fuel caches. There is an estimated 505 cubic metres of metal and hydrocarbon-impacted soil at the site, as well as non-hazardous debris.

One of the buildings left at the site of the former Contwoyto Lake Weather Station.

AANDC will conduct a Phase 3 Environmental Site Assessment in 2012. Based on detailed assessment work, and pending funding, AANDC will begin to develop a strategy to remediate the site.

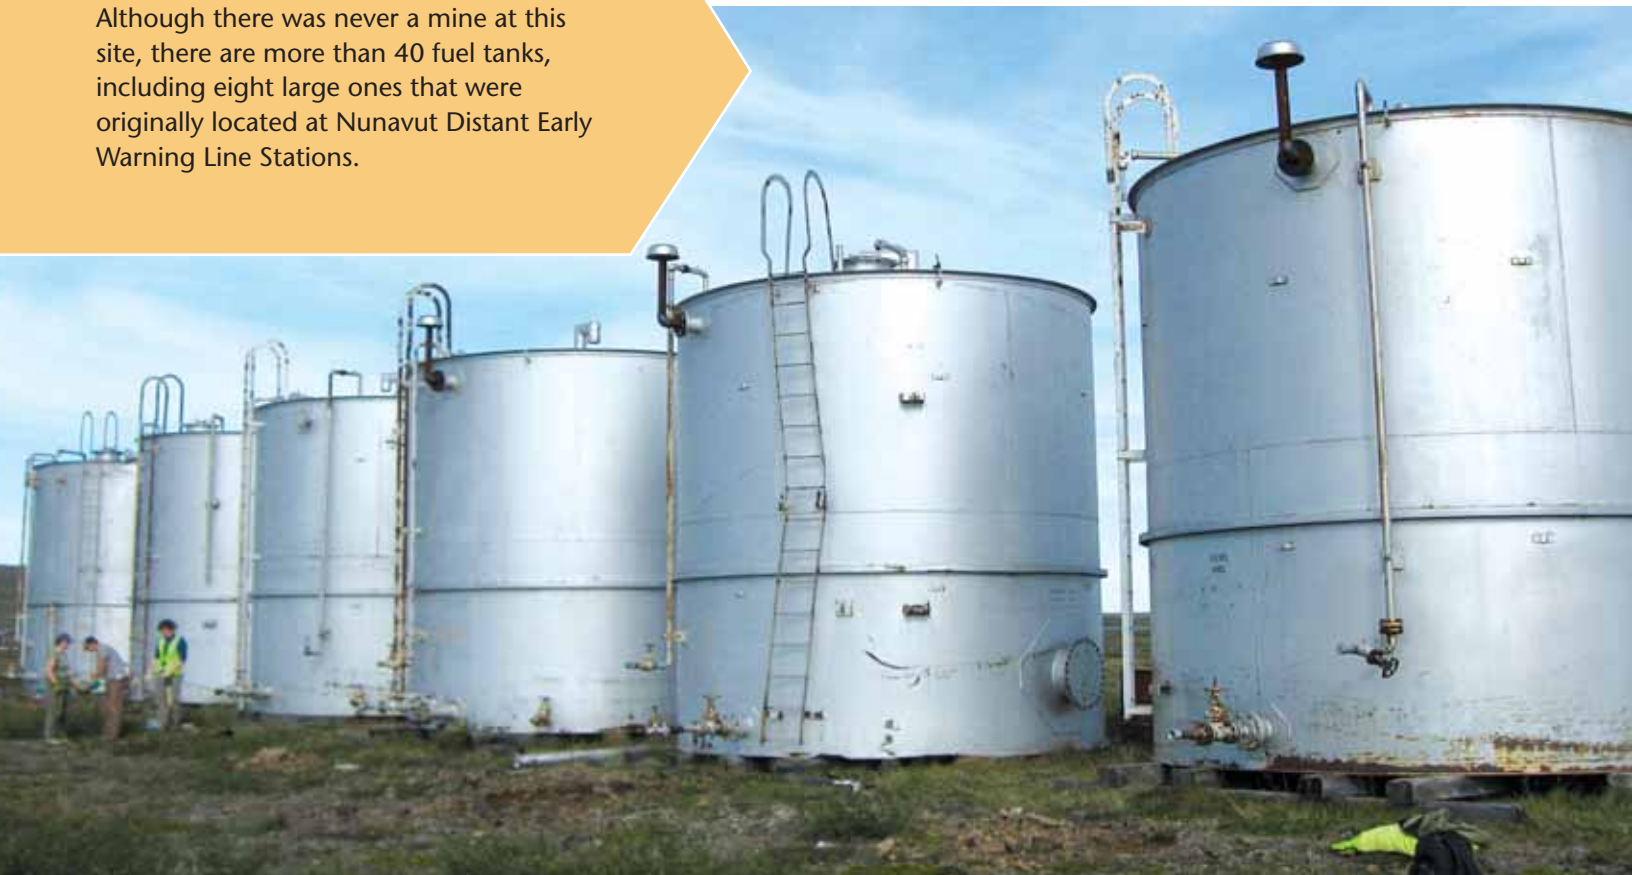
These oil tanks will be removed during the remediation of the Hope Lake area.

AANDC and Public Works and Government Services Canada (PWGSC) will work together to issue a Request for Proposals for the clean-up in 2012. Remediation work is expected to begin in the fall of 2012, and be completed by summer or fall of 2014.

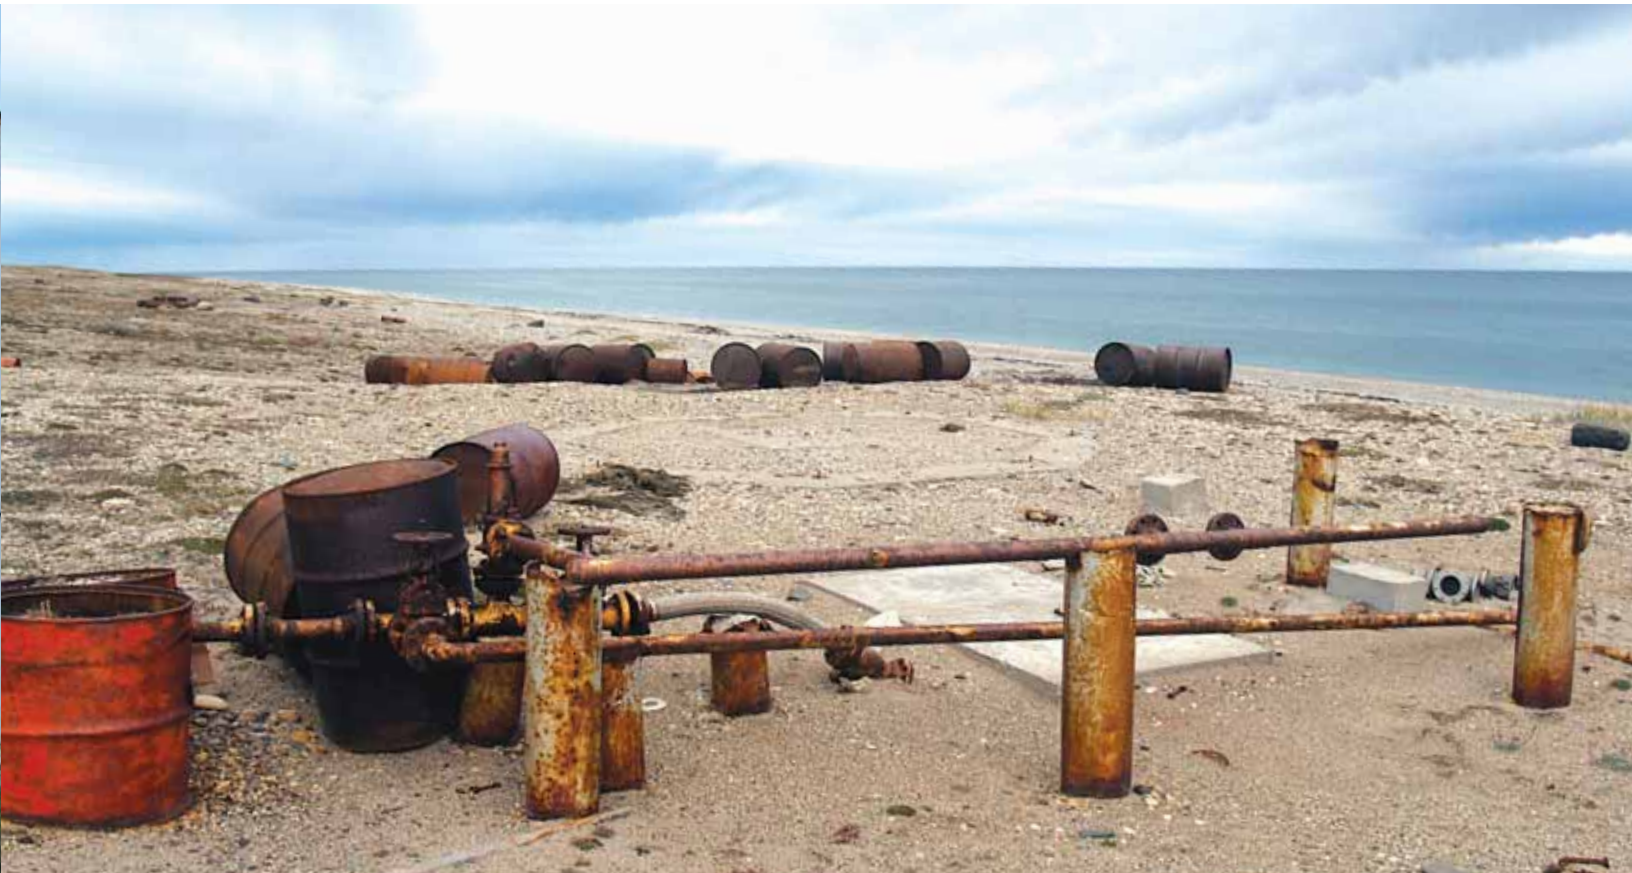
The site included buildings, radar towers, fuel storage facilities, and an airstrip. Several barrel storage areas, dumps, and infrastructure were left at the site. Most structures contained PCB-amended paint. Soil was contaminated by PCBs, and in certain isolated areas, with lead and copper. A number of barrels and a range of hazardous and non-hazardous debris were also abandoned at the site.

Debris, including barrels and metal piping, litter the PIN-B (Clifton Point) site before remediation.

- Packaging and shipment of all PCB-amended paint material to a southern disposal facility;
- Demolition and disposal of all infrastructure in a new on-site non-hazardous landfill;
- Excavation and off-site disposal of more than 350 cubic metres of contaminated soil; and
- Excavation and treatment of more than 10,000 cubic metres of soil contaminated with hydrocarbons.

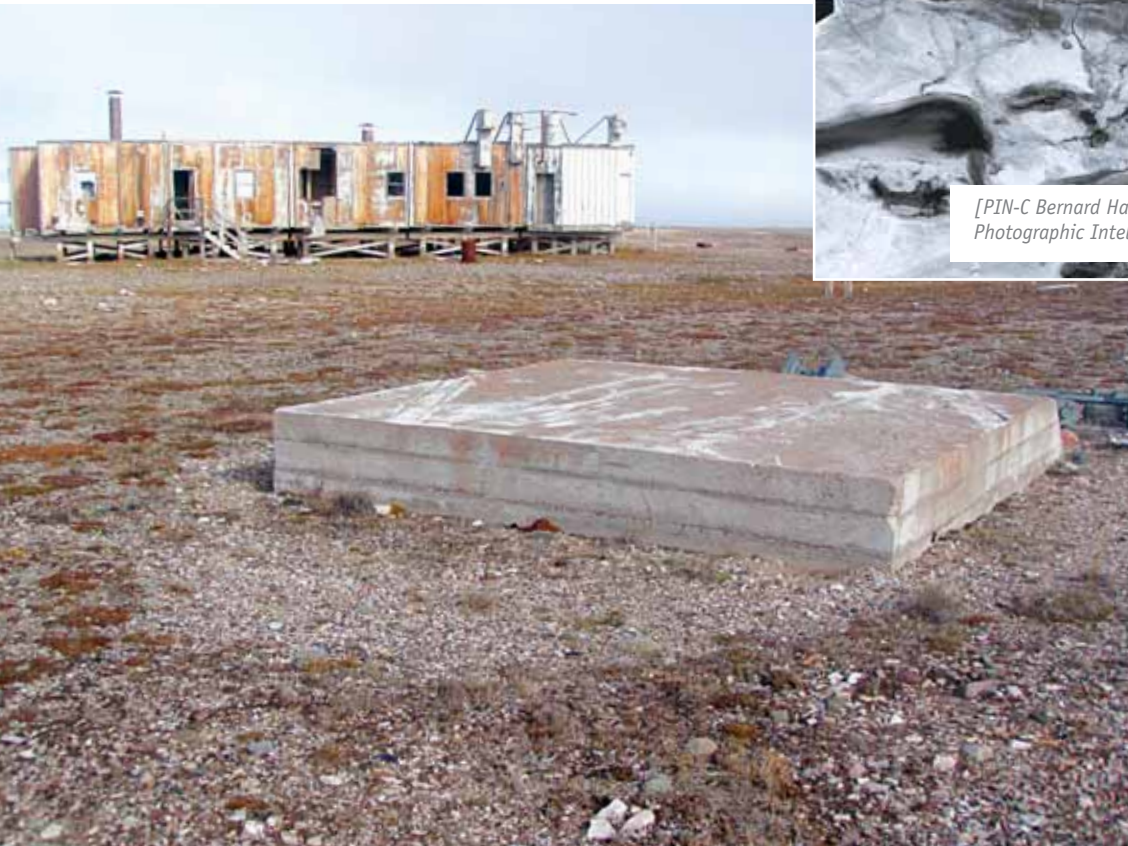
There are soils contaminated with PCBs and copper, and there is some evidence of hydrocarbon contamination. Buildings are unsafe as they have been painted with PCB-amended paints and contain asbestos tiles and insulation. The site also contains debris, including a fallen radar antenna.

Infrastructure remaining on the PIN-C (Bernard Harbour) site includes this old building and building pad.

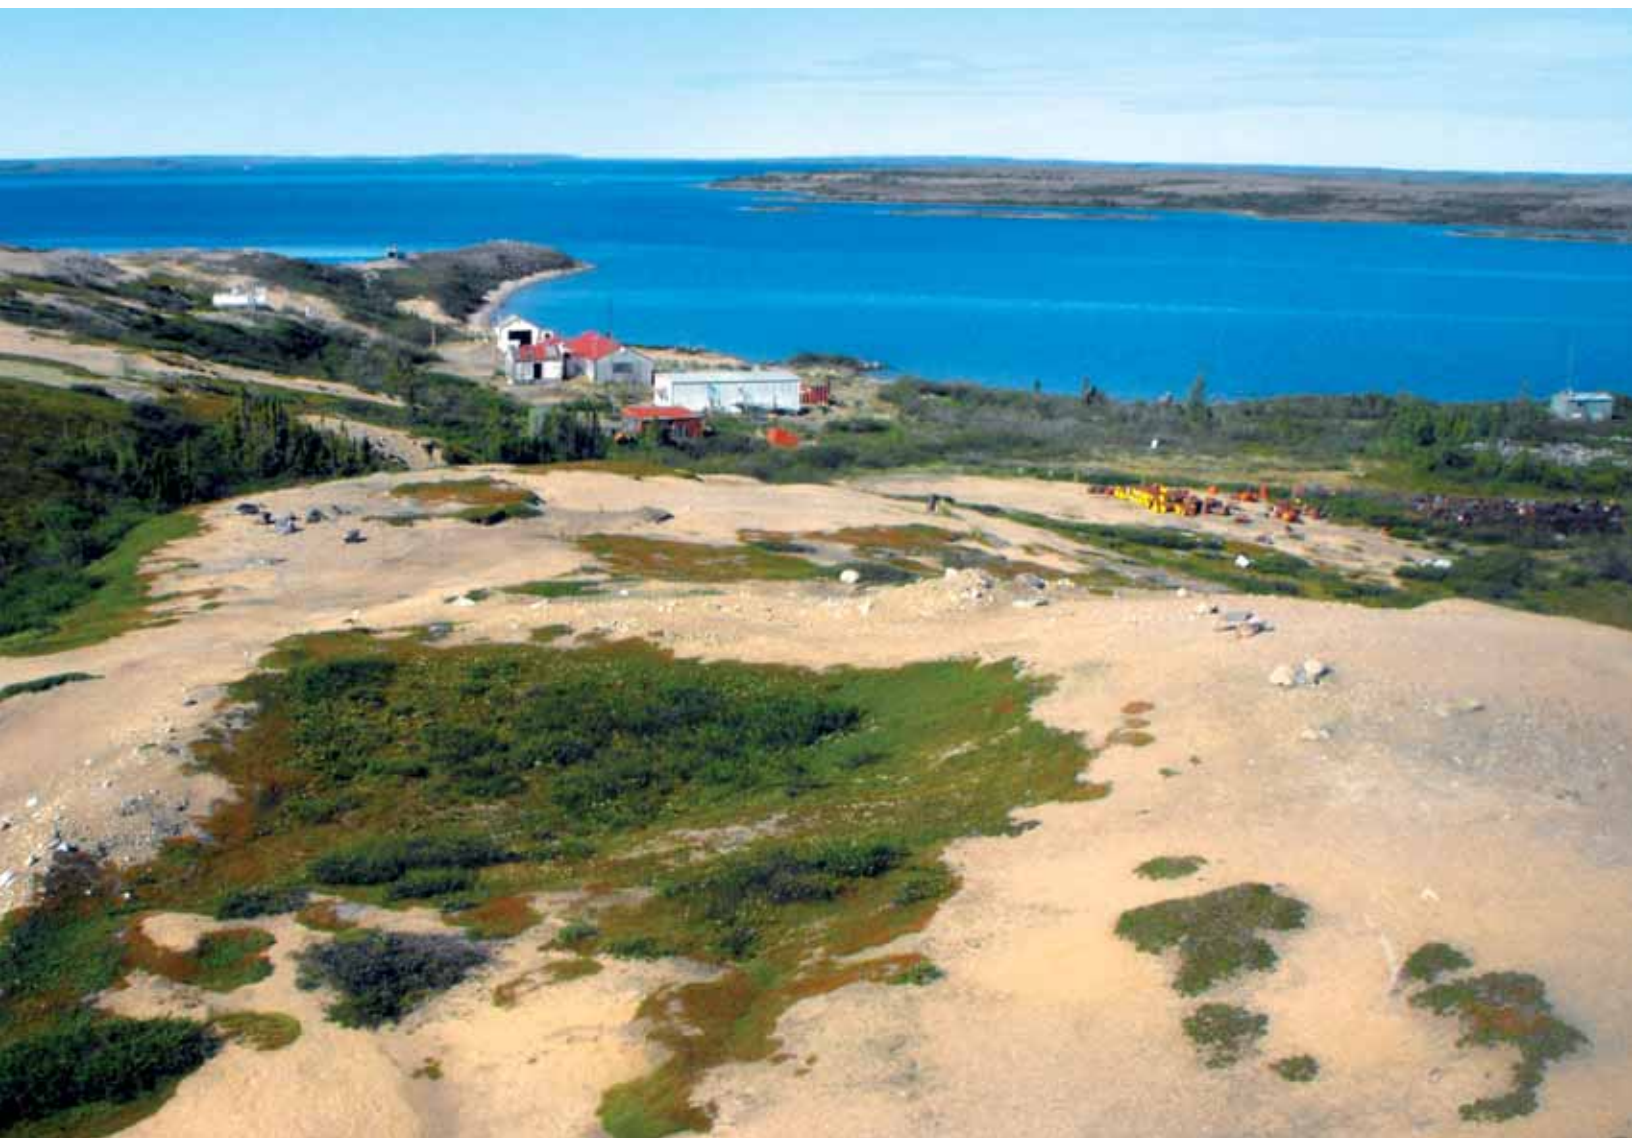
Infrastructure remaining at the Ennadai Lake Weather Station.

AANDC will conduct a detailed Environmental Site Assessment of the site in 2012, pending funding. Based on the detailed assessment work, AANDC will begin to develop a strategy to remediate the site.

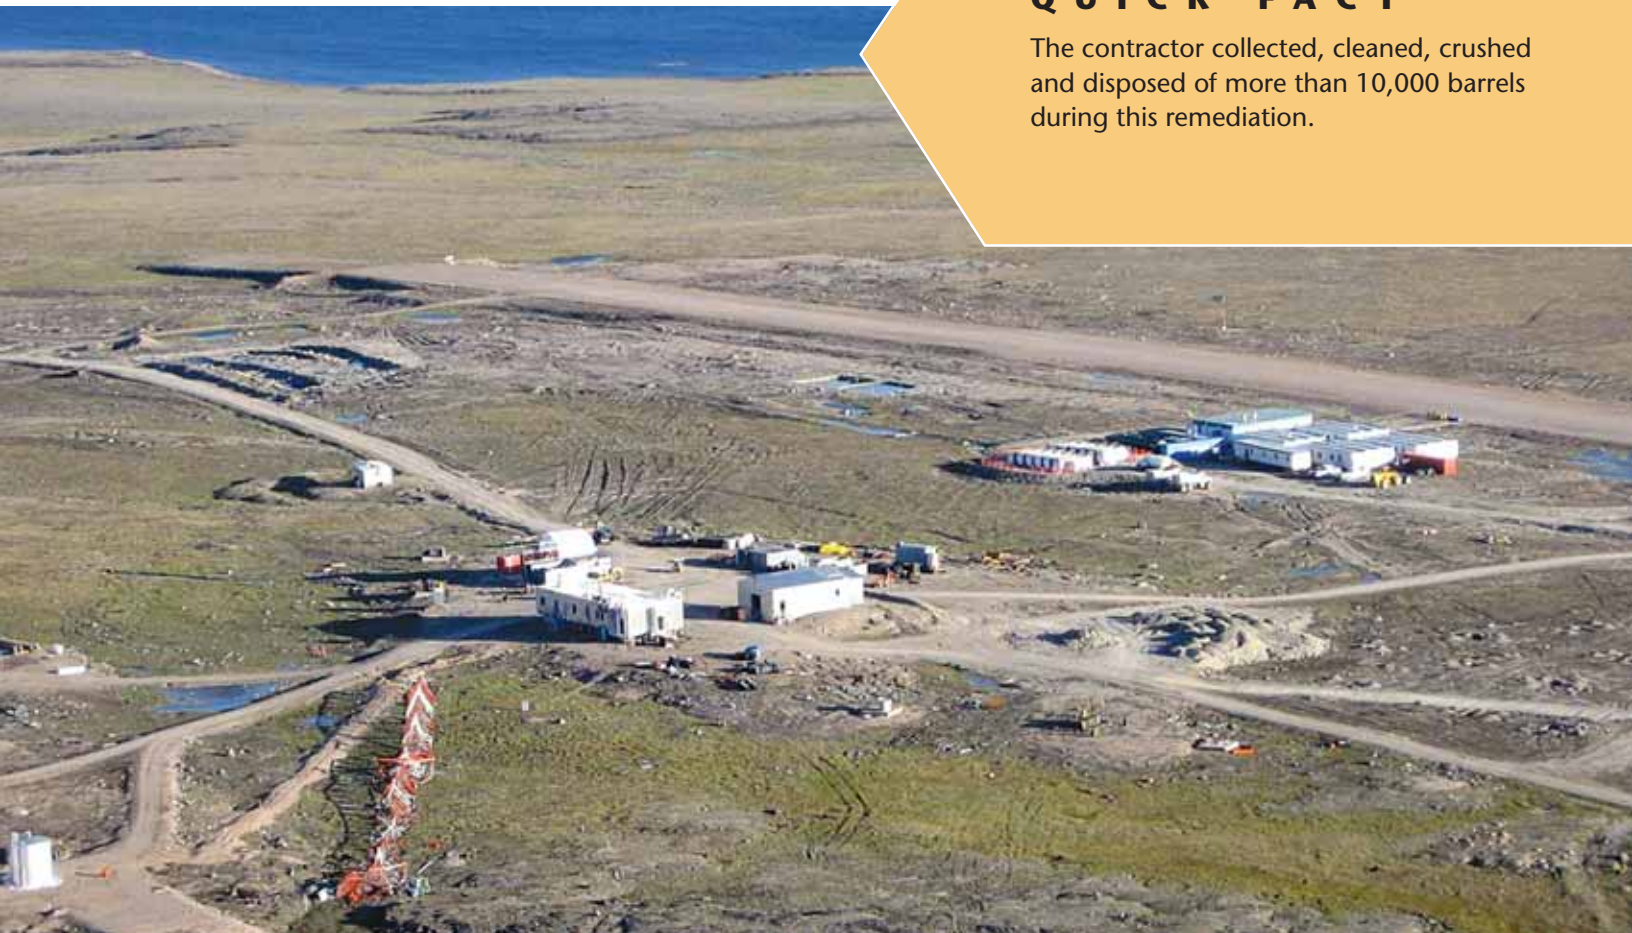
Aerial view of site prior to remediation. These buildings have all been removed.

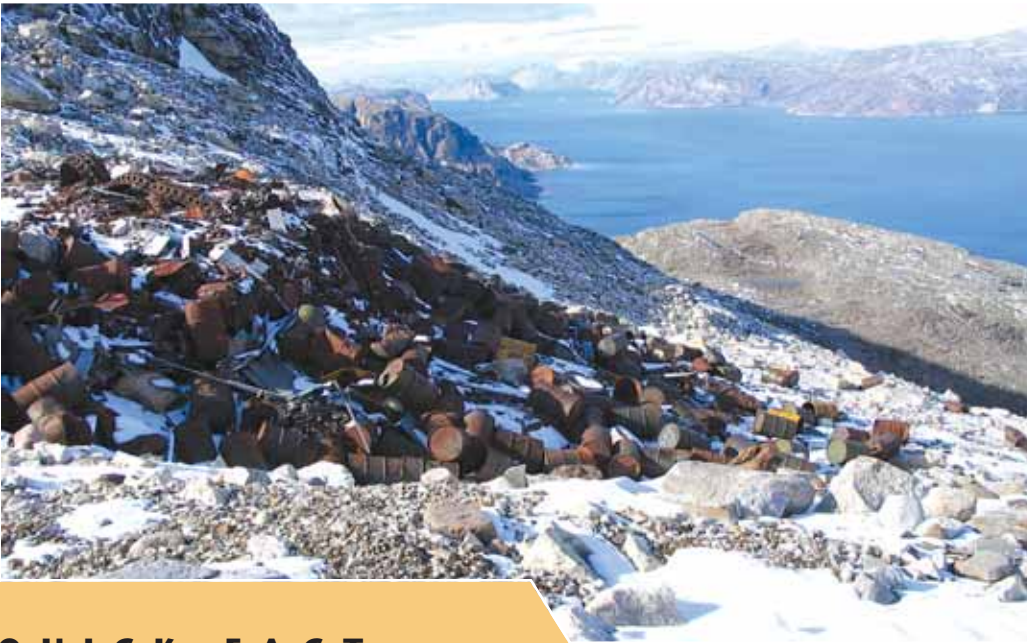
A look at FOX-C before and after remediation.

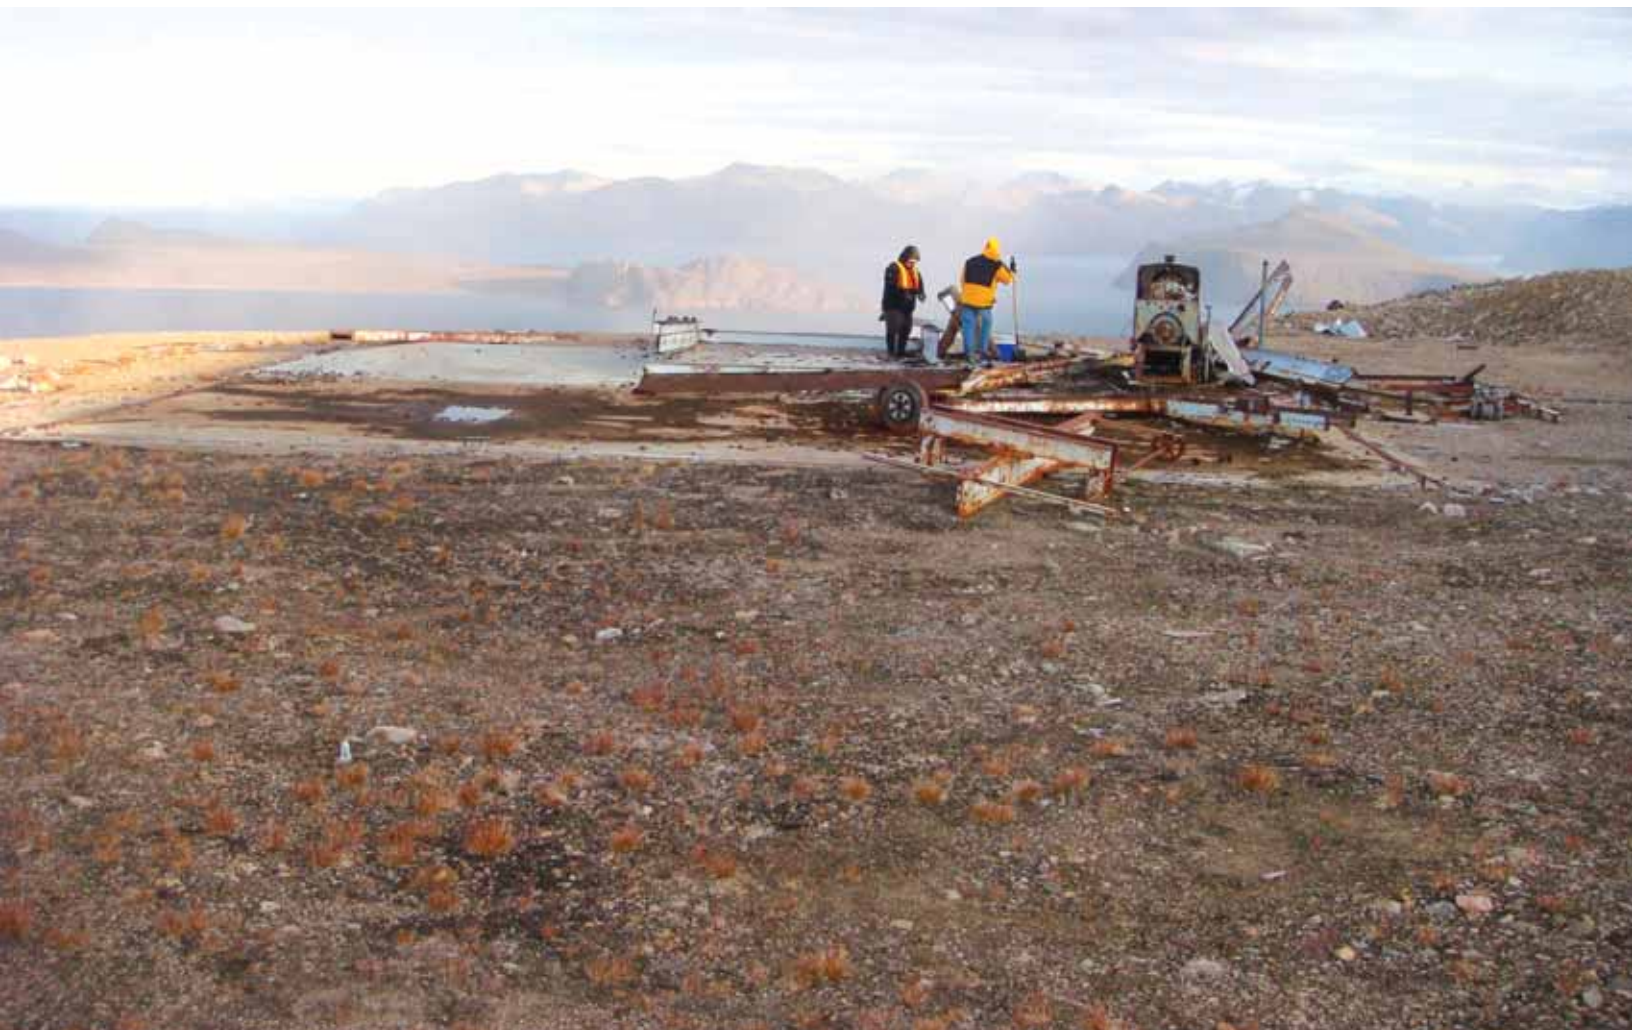
AANDC workers dig a test pit around the site of a former garage to test for petroleum hydrocarbons.

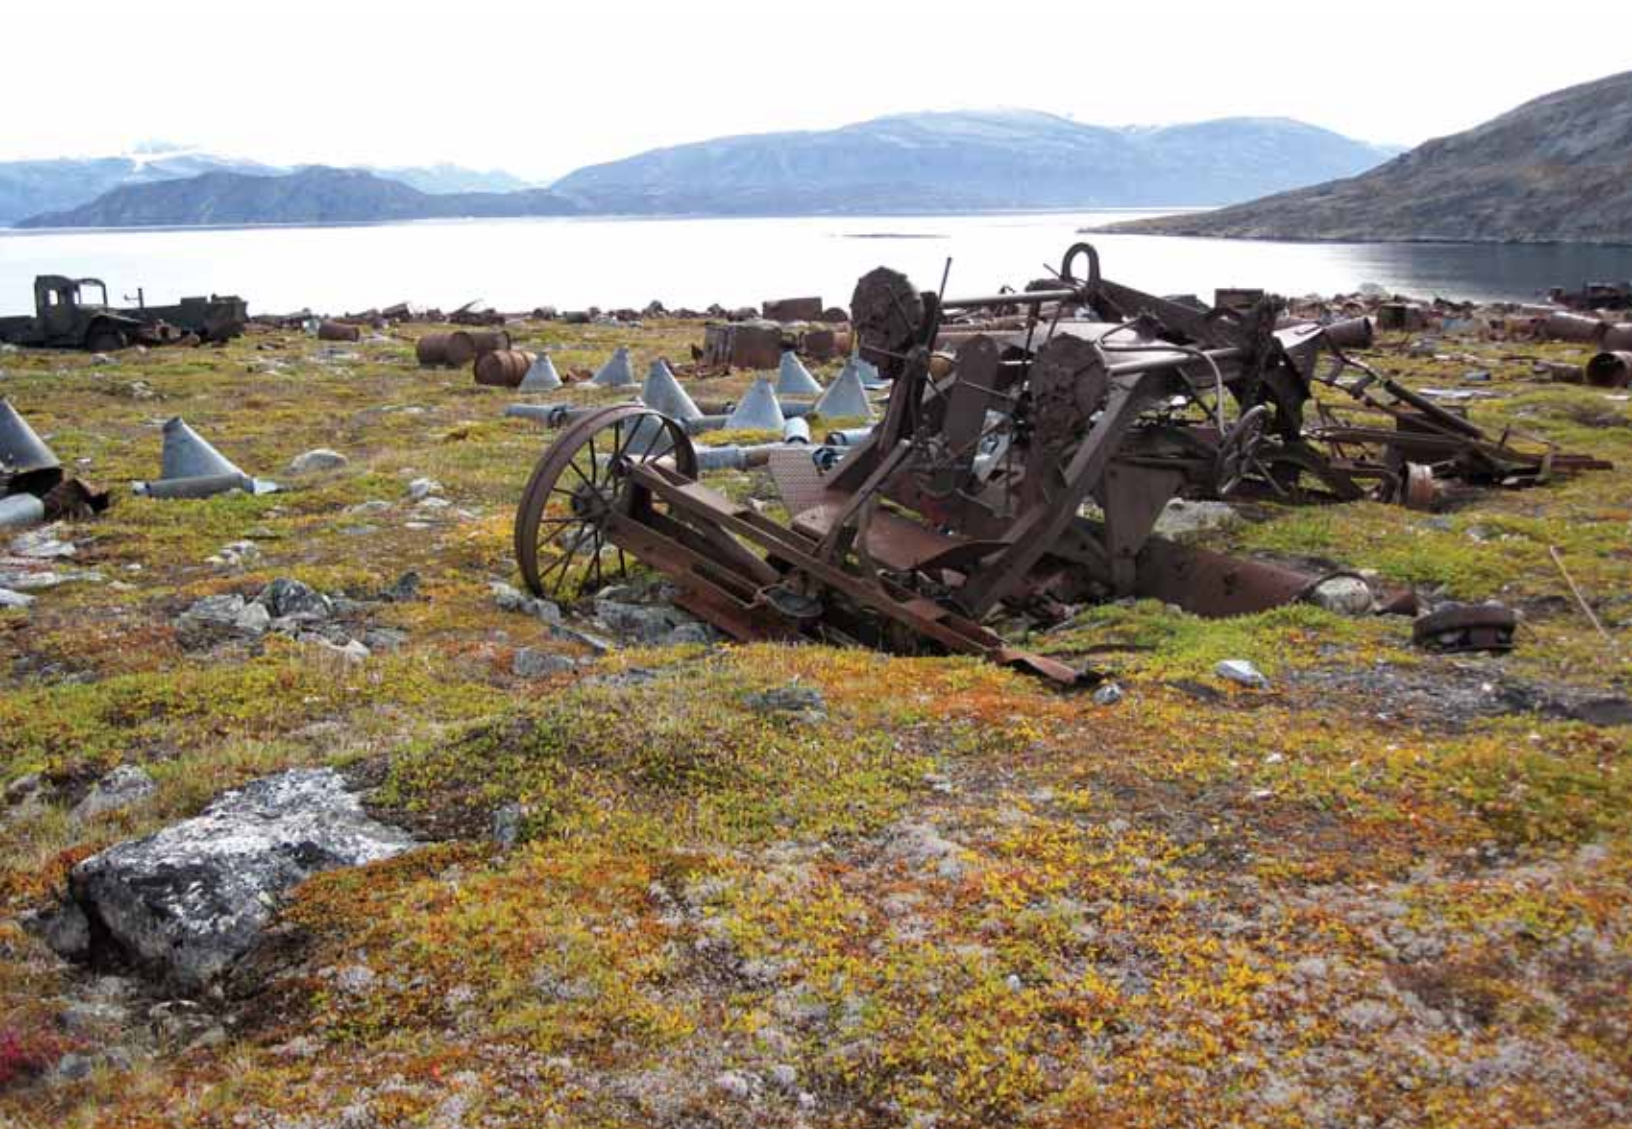
Abandoned vehicles in the Padloping Island vehicle dump.

AANDC and Public Works and Government Services Canada (PWGSC) worked together to issue a Request for Proposal for the clean-up of both Padloping Island and nearby Durban Island. It was awarded in April 2012.

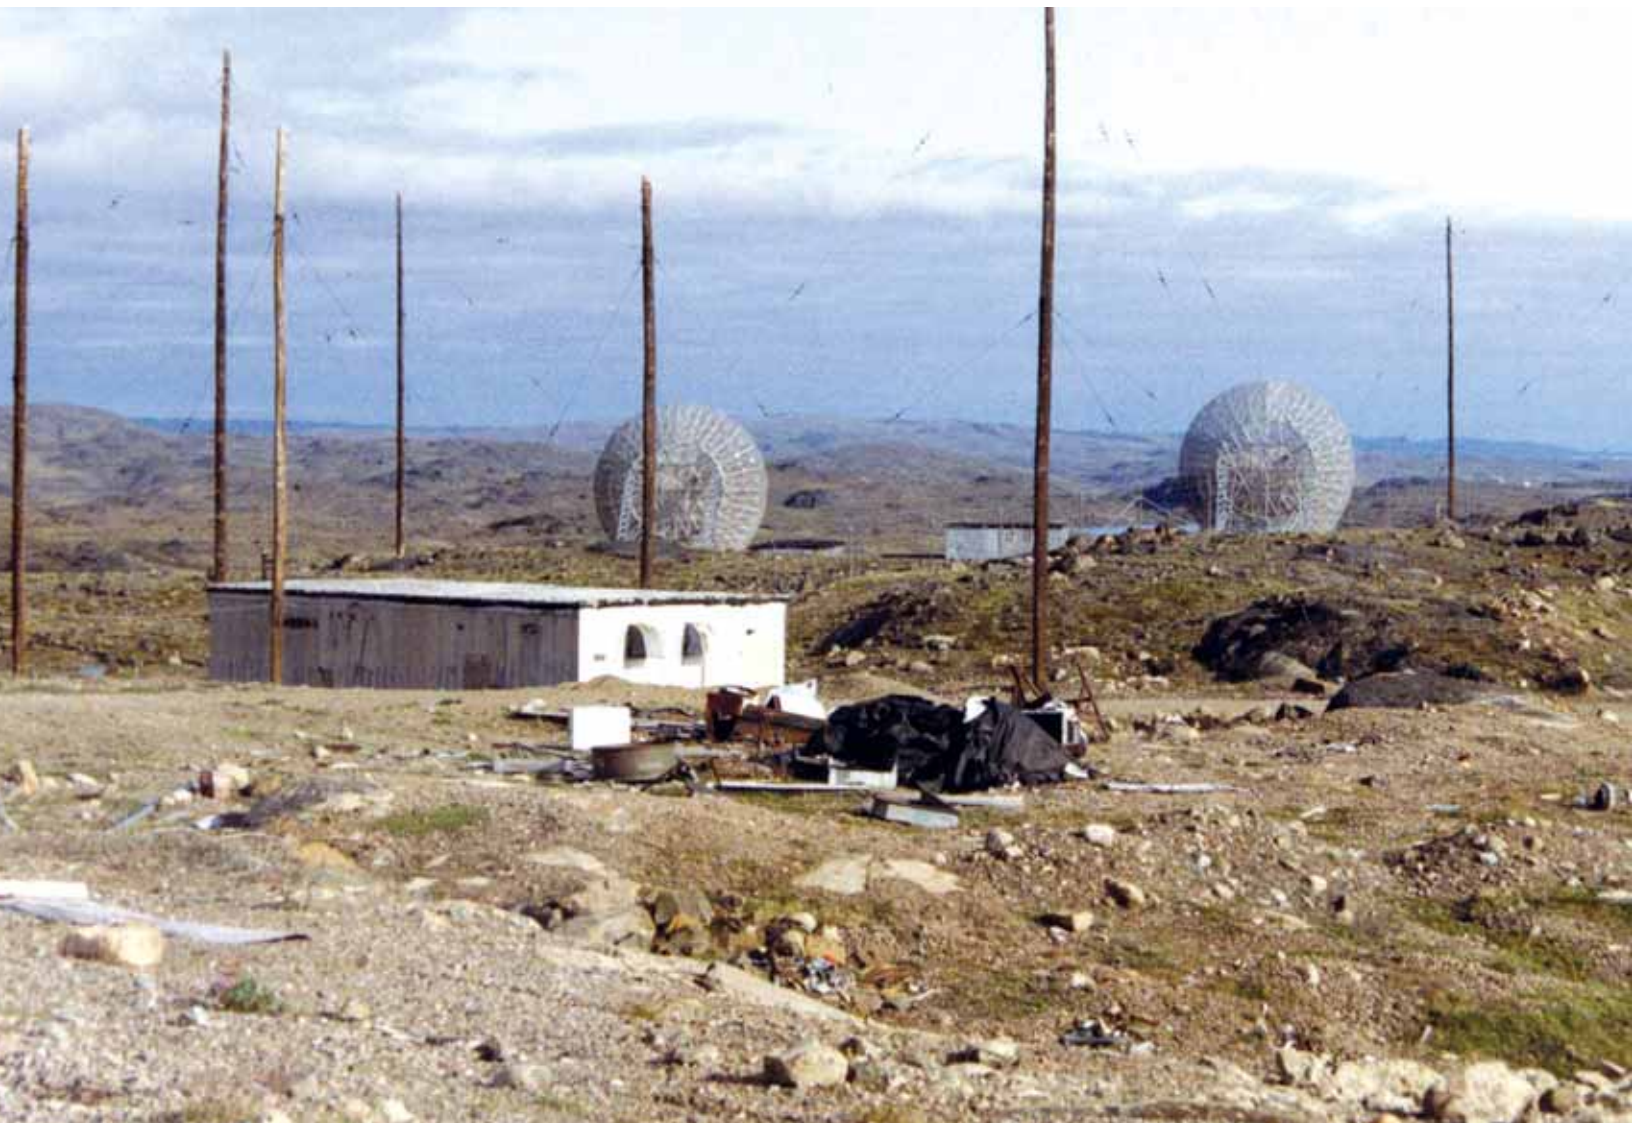
Debris at the Iqaluit Upper Base site prior to remediation.

- Collection of non-hazardous materials and construction of an engineered landfill on-site; and
- Packaging and shipment of hazardous materials to southern disposal facilities.

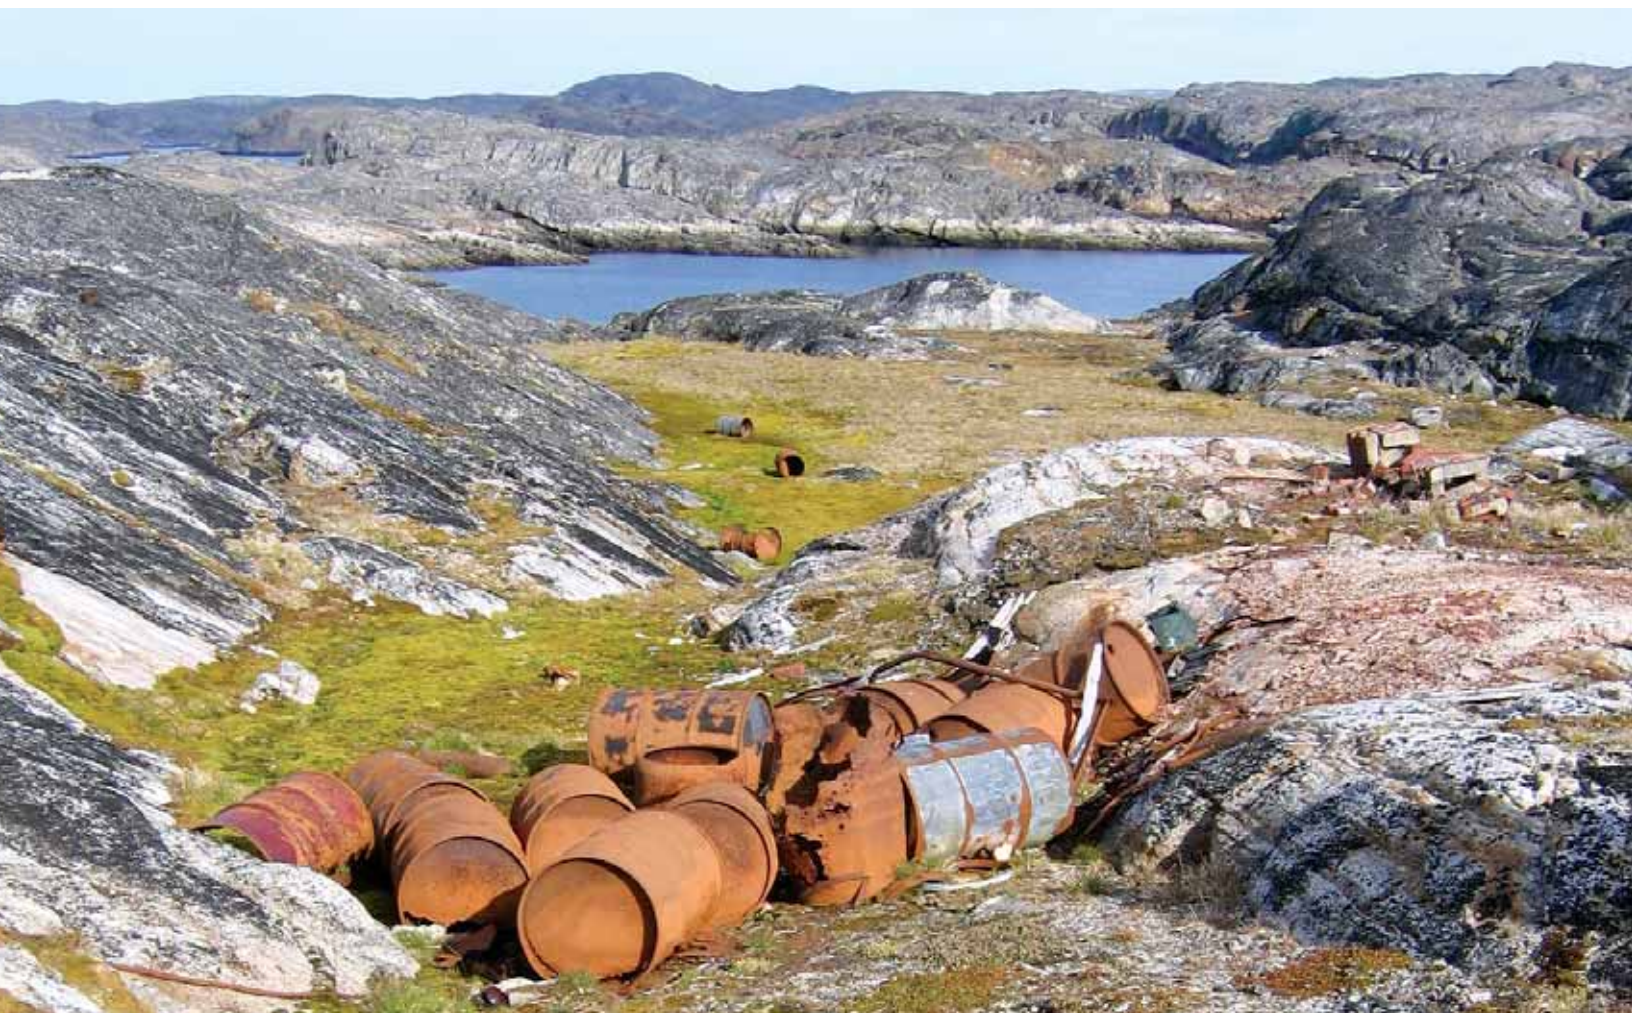
This site consisted of two standing buildings, the remains of three additional buildings, two helipads, and a beacon tower. In addition, hazardous and non-hazardous debris was scattered throughout the site, and areas of soil were contaminated with heavy metals and hydrocarbons.

Debris like these barrels were cleaned up during the remediation of the Radio Island site.
