Feasibility of Deploying a Dual-frequency Identification Sonar (DIDSON) System to Estimate Salmon Spawning Ground Escapement in Major Tributary Systems of the Fraser River, British Columbia

**Canadian Technical Report of
Fisheries and Aquatic Sciences 2592**

J. A. Holmes¹, G. Cronkite¹, and H. J. Enzenhofer²

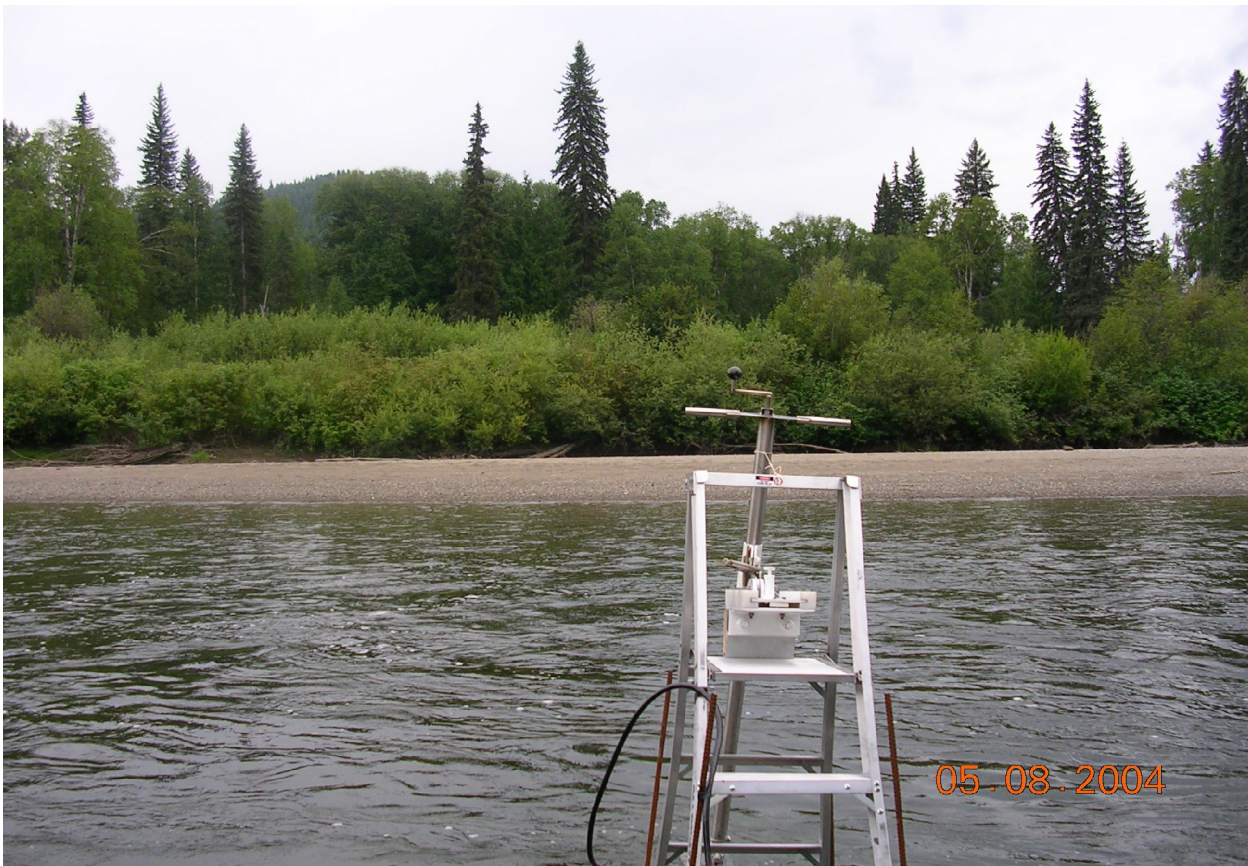
Figure 2. View from the left to right bank at the recommended DIDSON site on the Horsefly River on 05 Aug 2004.

Site: MRP tagging site, about 800 m above river mouth on Quesnel Lake (Fig. 2)

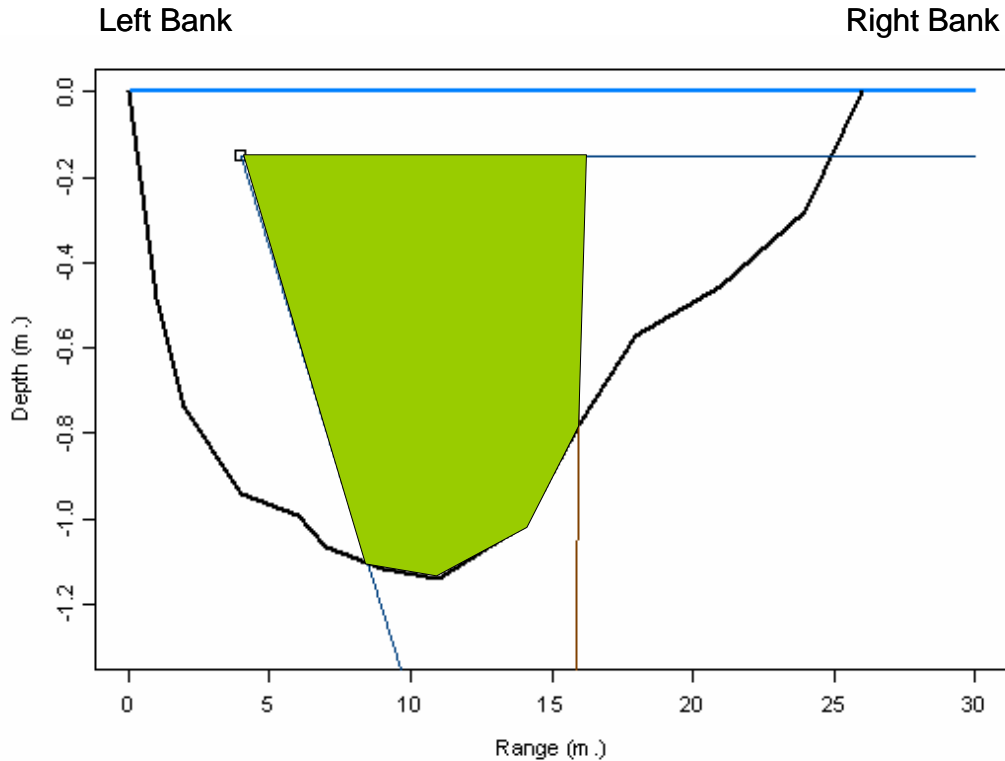
Figure 4. Cross-sectional profile of the Horsefly River showing coverage of the water column by the DIDSON system in high frequency mode, range of 2 to 12 m from the transducer (10 m total) and an aim of -6° relative to the surface (area in green). Note the difference in vertical and horizontal scales.

Cross-section: Exposed gravel bar on the right bank that would be covered at higher flows and 2 m high eroding sill on left bank. Bottom is planar, no visible scalloping or large boulders that could block the acoustic beams (Fig. 4). Channel is skewed towards the left bank (Fig. 4).

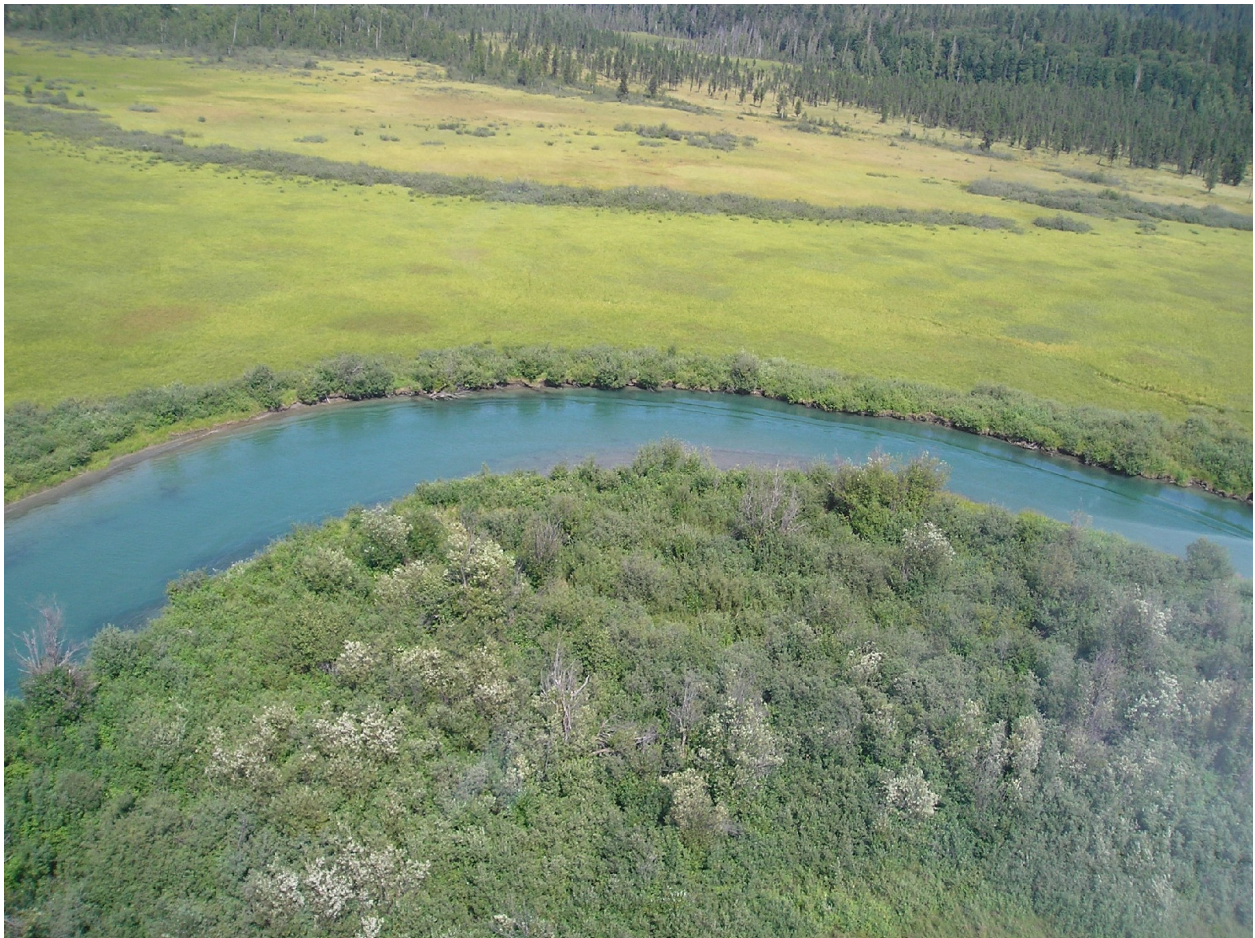
Figure 5. Aerial view of a potential DIDSON deployment site in the lower reaches of the Mitchell River below the mark-recapture program tagging site and known spawning locations. Photo taken 11 Aug 2004.

Site access: All sites are remote and access is via jet boat from the north arm of Quesnel Lake or helicopter (Fig. 5).

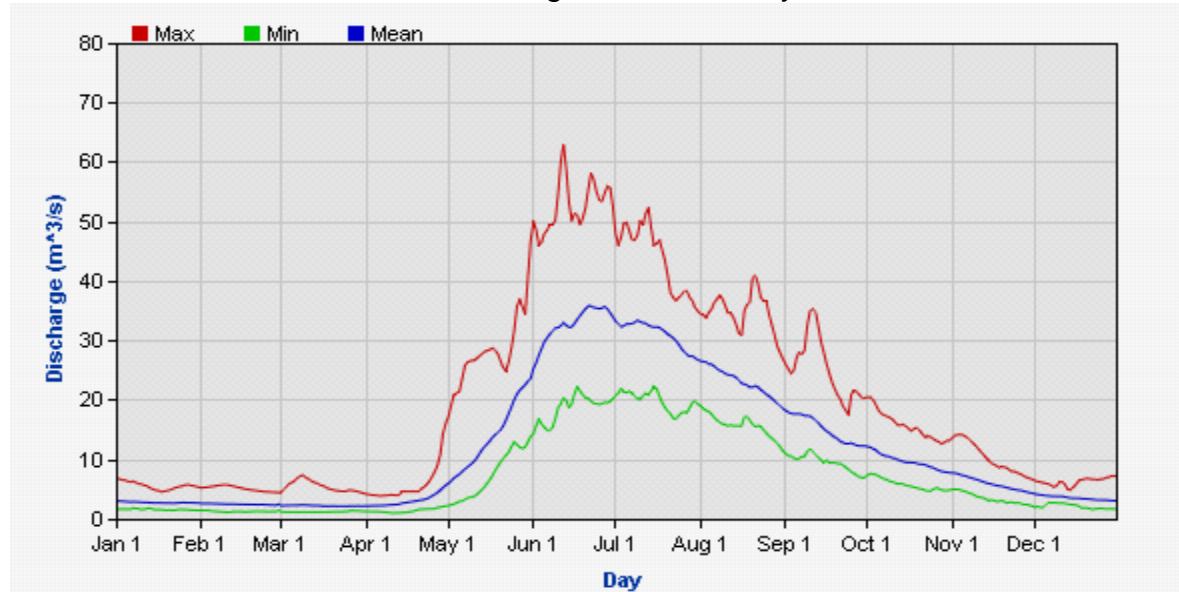
Figure 6. Minimum, maximum and average daily discharge in the Mitchell River at the outlet from Mitchell Lake from 1961 to 1982. Data retrieved from Water Survey of Canada website accessed 07 Mar 2005. URL of this page: http://staflo/index_e.cfm?cname=flow_daily.cfm

Discharge: Environment Canada maintained a gauging station at the outlet of Mitchell Lake (Station 08KH014) from Jan 1961 to Dec 1982. Mean daily discharge during this period ranged between $1.18 \text{ m}^3 \cdot \text{s}^{-1}$ and $63 \text{ m}^3 \cdot \text{s}^{-1}$, with an average of $12.6 \text{ m}^3 \cdot \text{s}^{-1}$ (Fig. 6). Maximum discharge occurs in the June to September period, coincident with the migration of sockeye salmon. Flow variations (Fig. 6) related to precipitation in this hydrograph are dampened by the presence of the lake. Further downstream at potential DIDSON sites below Cameron Creek, discharge variations may be more extreme.

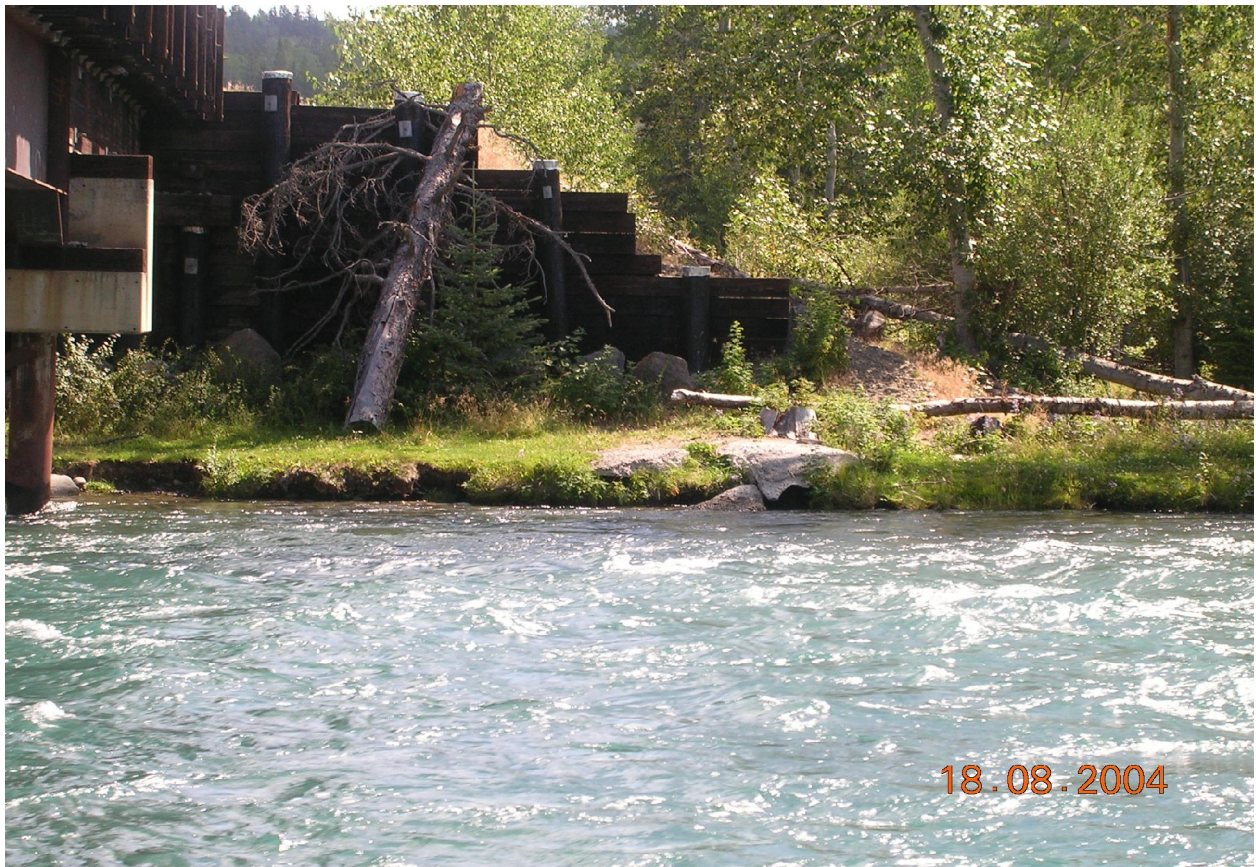
Figure 7. DIDSON test site and recommended deployment site on the right bank of the Chilko River at Henry's Bridge, 18 Aug 2004.

Site: Forest Service road bridge (Henry's Bridge), about 12 river km below Chilko Lake outlet (Fig. 7).

Site: Recommended site for system enumeration of sockeye salmon escapement in the Chilko River. Upstream side of Henry's Bridge (see Fig. 7).

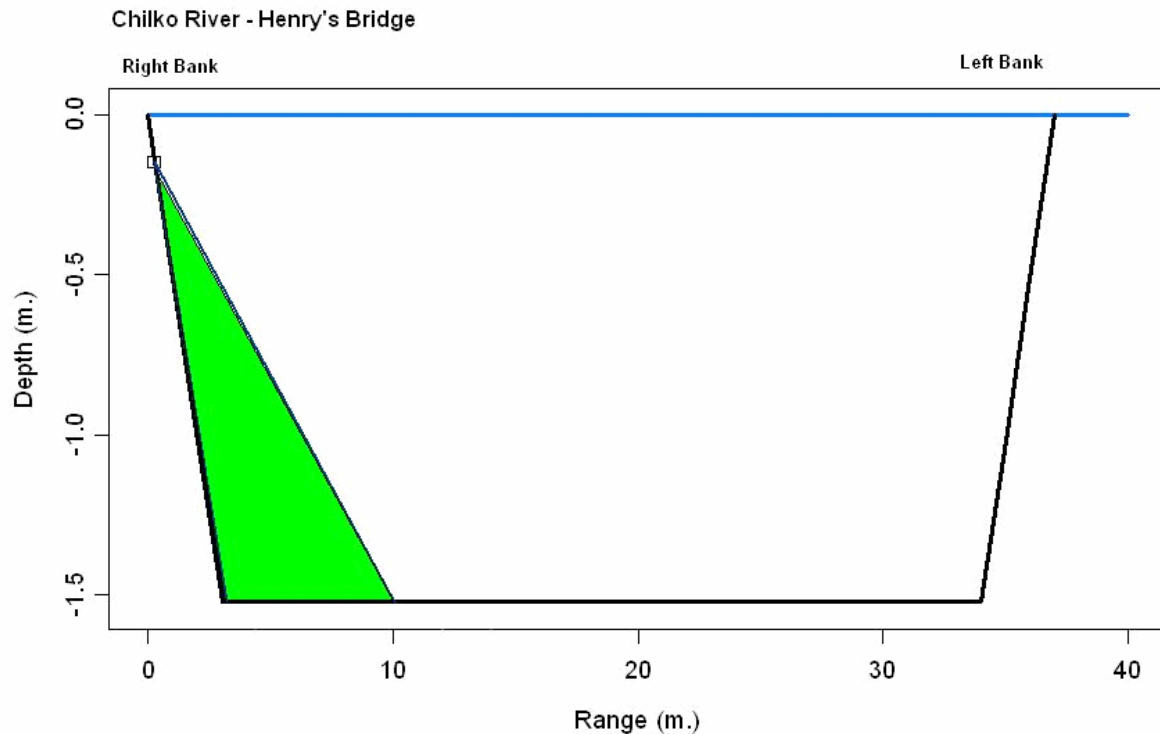
Figure 9. Estimated cross-section profile of the Chilko River at Henry's Bridge, showing DIDSON beam coverage during testing (green area) on the right bank with the high frequency mode, a range of 2-2-12 m from the transducer, and an aim of -16.5° relative to the surface.

Bottom visible: About 2.5 m from transducer.
 Beam coverage: 6% of cross-sectional area.

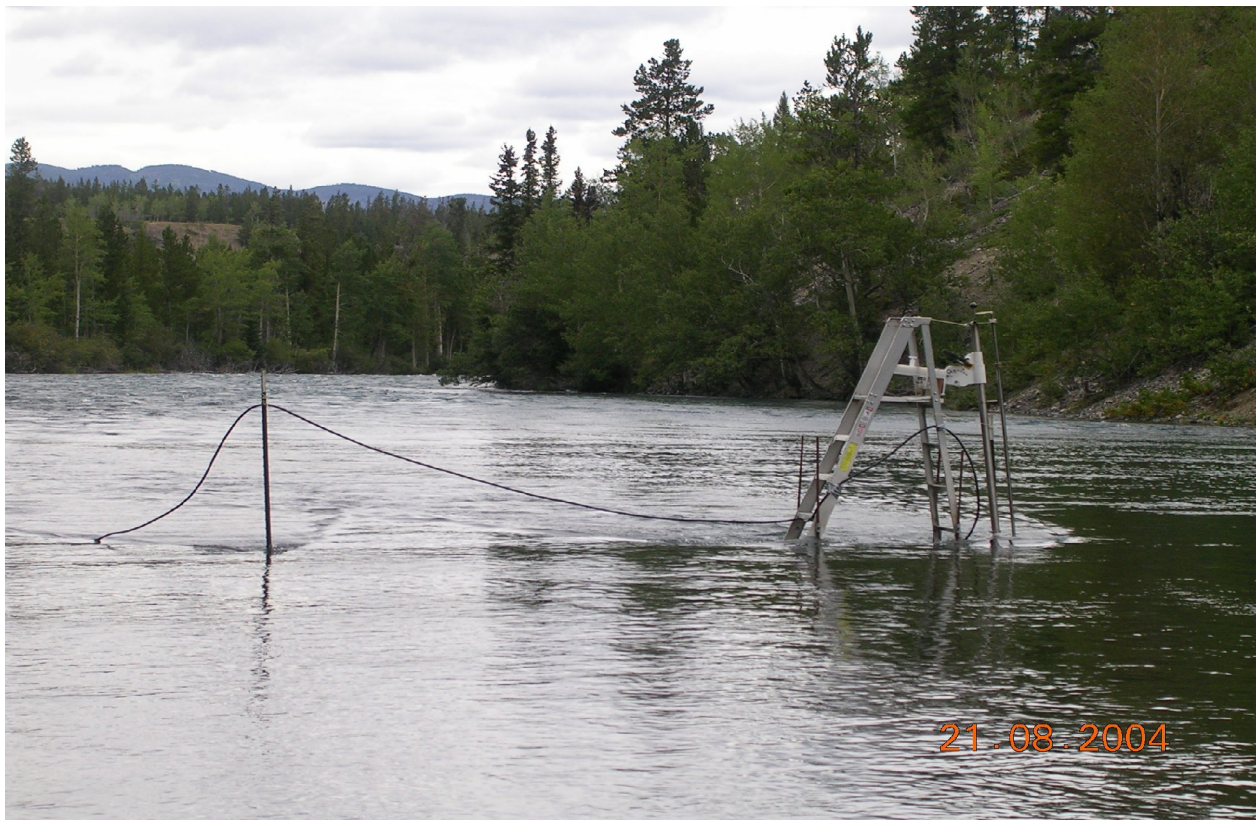
Figure 10. DIDSON test site on the left bank of the Chilko River (looking downstream) above the confluence with Lingfield Creek. Photo taken 21 Aug 2004. Red arrow marks downstream location or right bank at top of riffle below Lingfield Creek mouth where migrating salmon were observed.

Site: MRP tagging site about 100 m above confluence with Lingfield Creek, 8 river km below Chilko Lake (Fig. 10).

The lower right bank site (red arrow in Fig. 10) at which migrating sockeye salmon were observed and recorded may be suitable as an enumeration site. However, this site is at the bottom of a high unstable bank, so access is by boat only and would be dangerous at night because of the high current

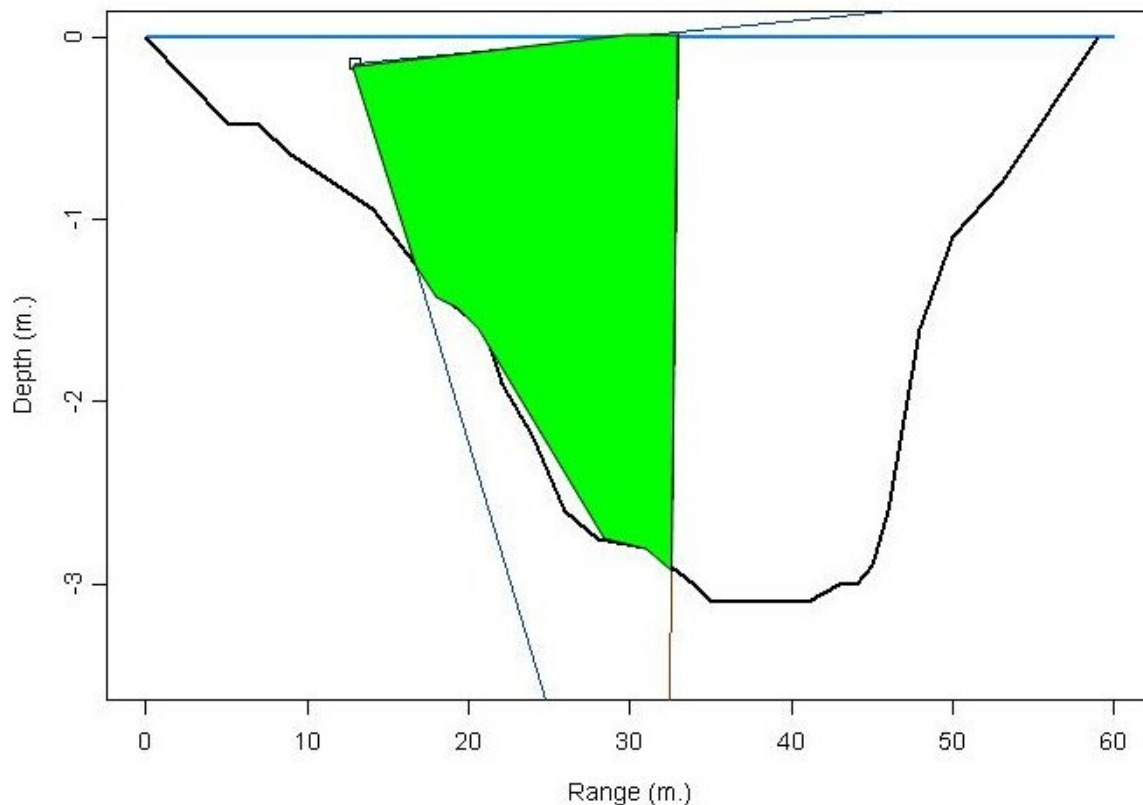
Figure 11. Cross-section profile of the Chilko River at the Lingfield Creek test site showing the area ensonified (in green) during low frequency mode and range set to for 2 to 22 m (20 m total) from the transducer. The transducer is positioned 12 m off the left bank, looking towards the right bank.

Cross-section: Relatively flat and shallow shelves extend approximately 14 m off the left bank and 10 m off the right bank to a deep trench down the middle of the site (Fig. 11).

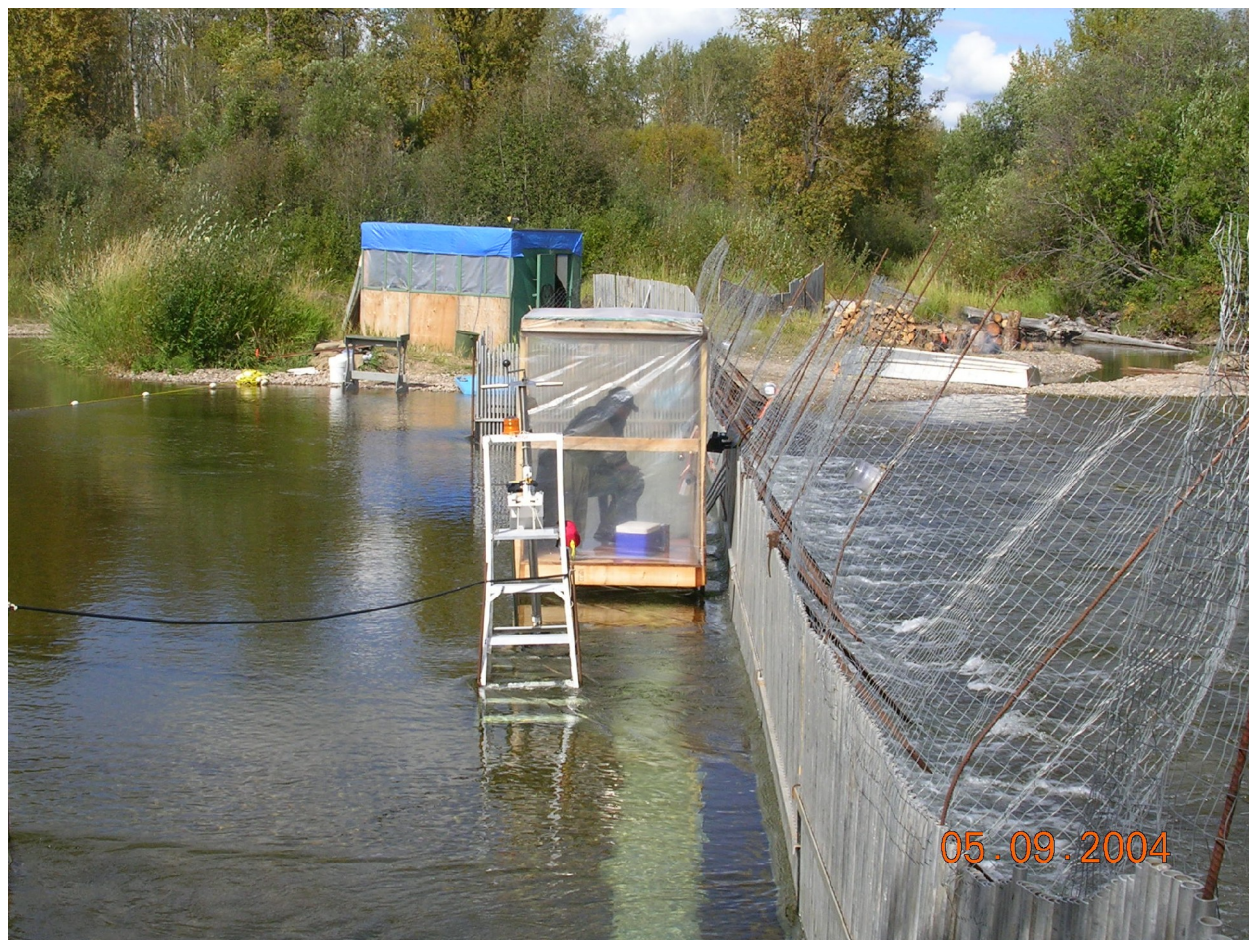
Figure 12. DIDSON equipment configuration used for count comparisons at the Stellako River Fish Enumeration Fence, 01 Sept 2004. The DIDSON equipment is about 5 m off of the right bank. Gate through which fish pass during counting is behind counting shed.

Site: Fish fence, about 250 m upstream of pool near upstream side of fish fence (Fig. 12).

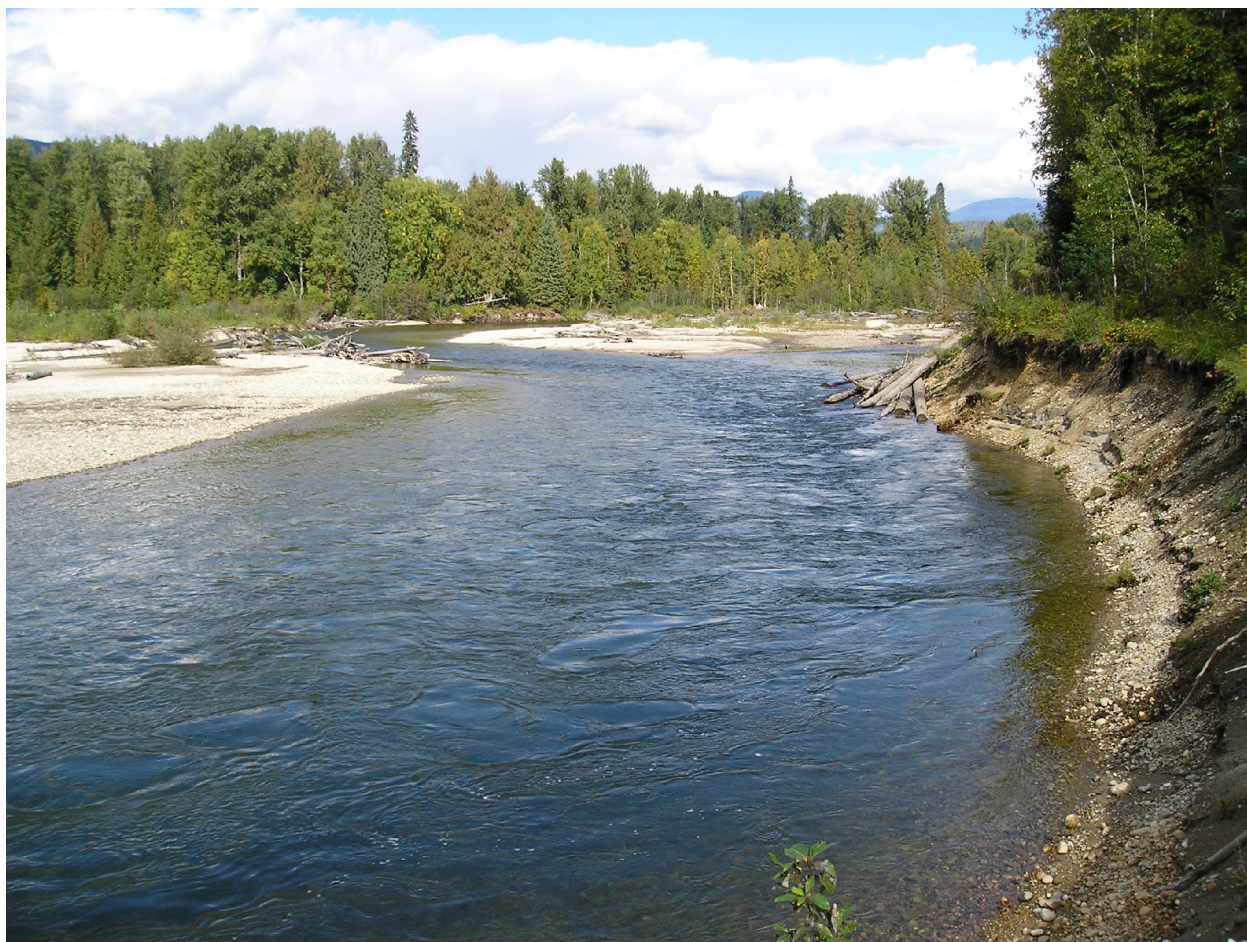
Figure 14. Potential DIDSON deployment site near the mouth of the Seymour River. Photo taken 22 Sept 2004 from the left bank at the end of an airstrip in Silver Beach Provincial Park.

Site: 1 km above the mouth at the end of a light plane airstrip (Fig. 14).

Site: Recommended site is beside an airstrip site about 1 km above the mouth in Silver Beach Provincial Park (Fig. 14). Other sites examined but rejected for DIDSON deployment include Celista Road bridge crossing, (largely white water, with large rock outcrops), the Flying Dutchman's curve (above spawning habitat), and the mouth (slough-like and access is via a walking trail about 1 km long).

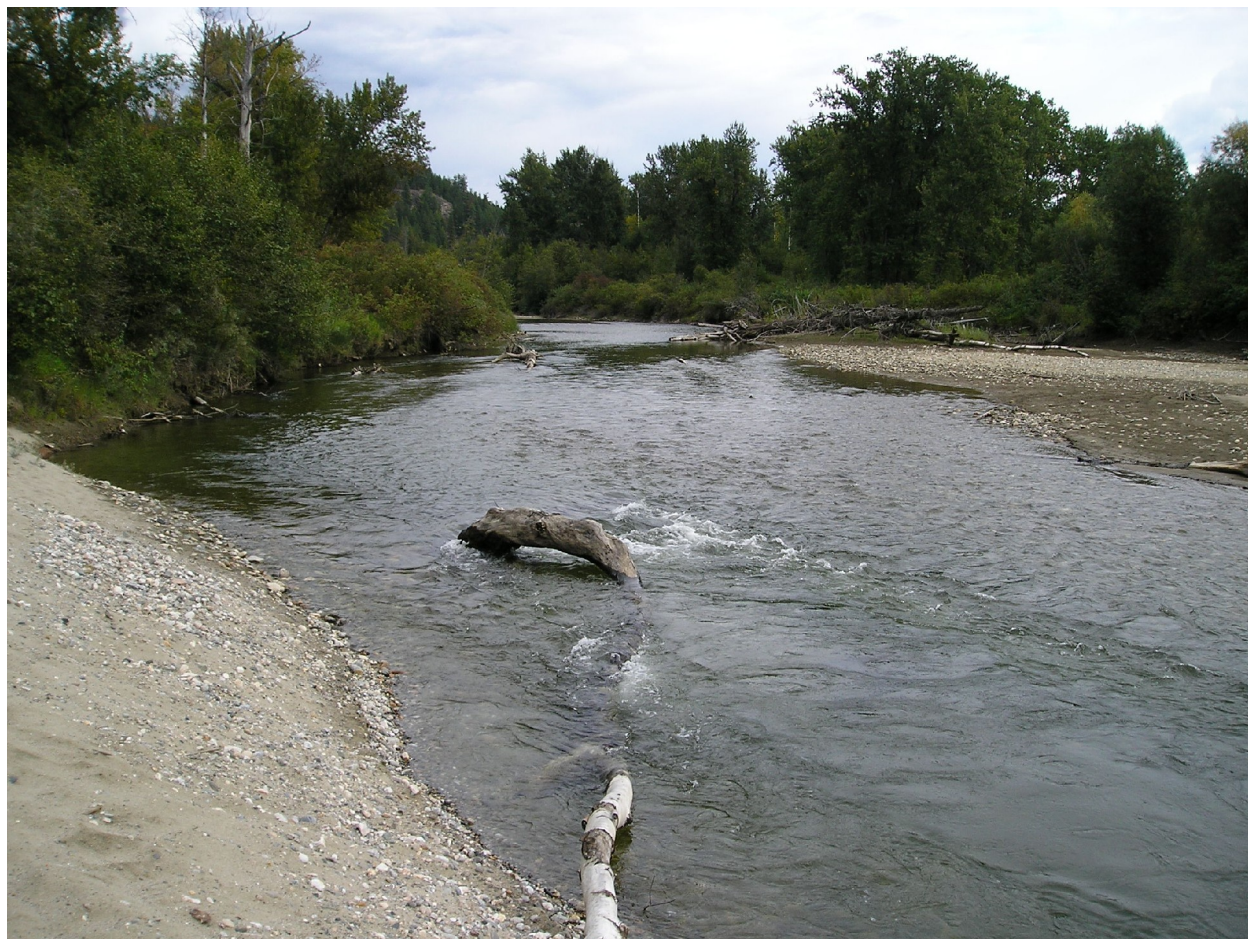
Figure 16. Potential DIDSON deployment site near the mouth of Scotch Creek. Photo taken from the right bank, 22 Sept 2004.

Site: 1 km above mouth, right bank (Fig. 16).

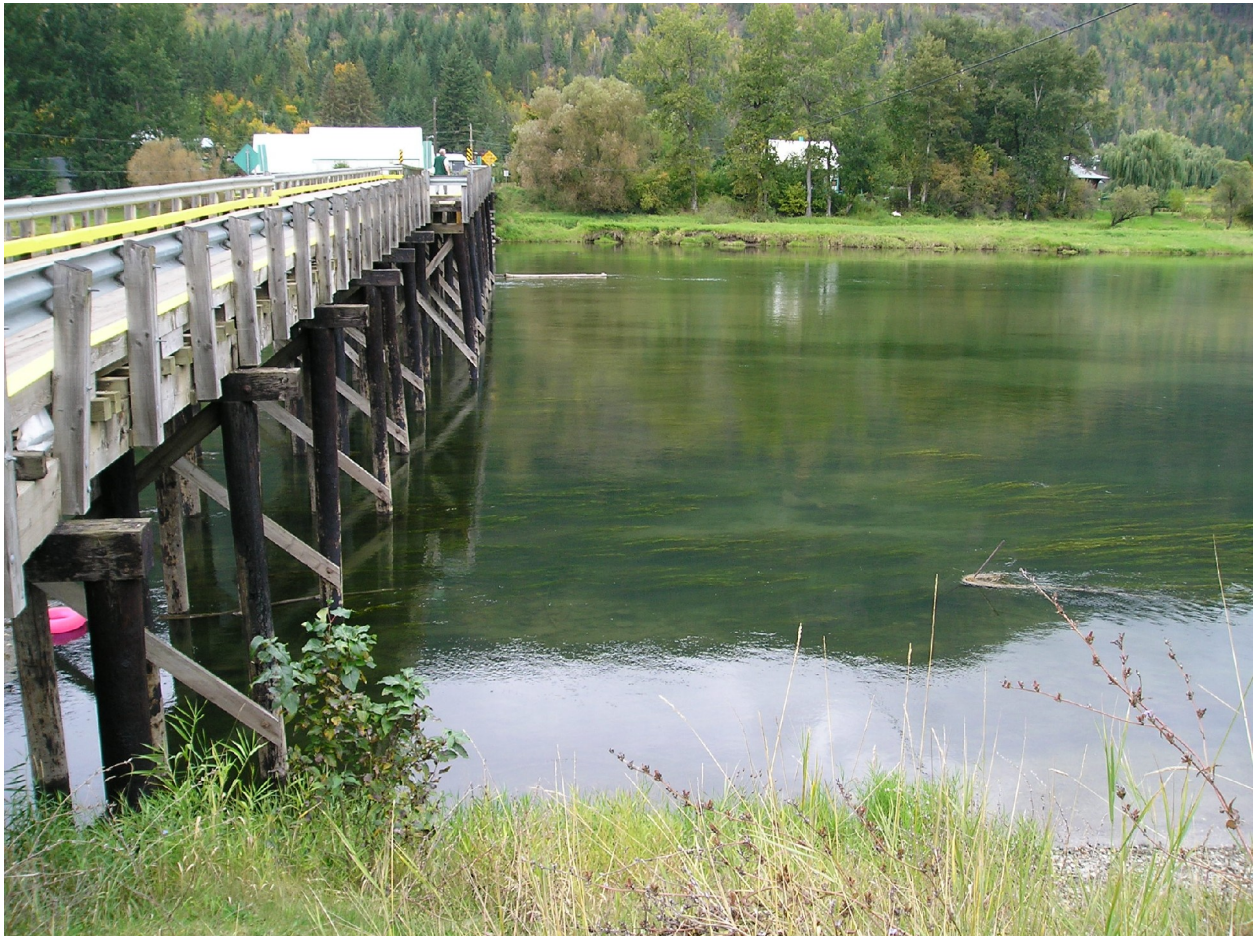
Figure 18. Bridge crossing from Riverside Drive (right bank) over the lower Shuswap River to Mara (left bank). The second of four potential DIDSON sites between Mara Lake and Enderby. Photo taken from right bank on 23 Sept 2004.

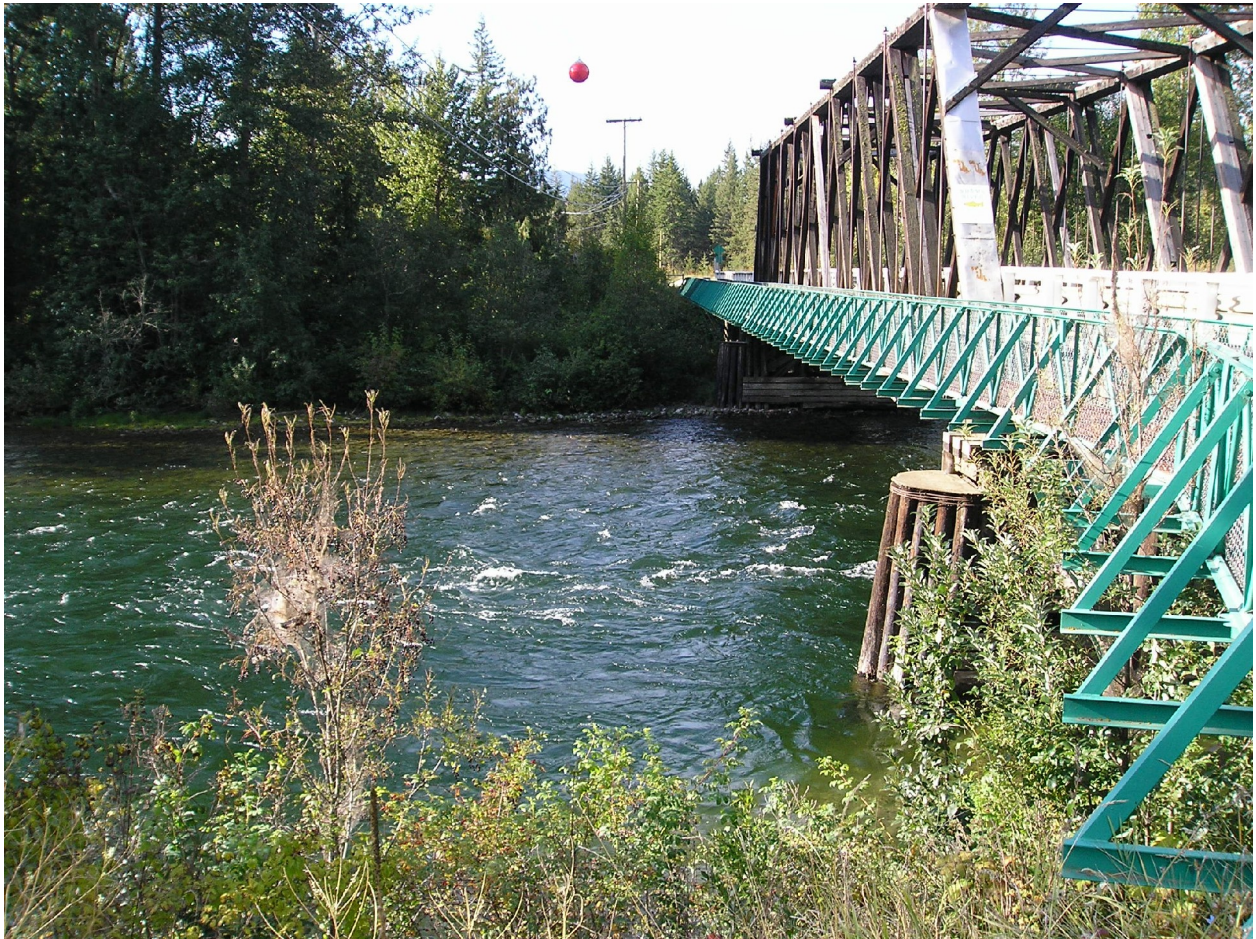
Figure 21. Lower Adams River at the Squilax-Anglemont Road Crossing. Photo taken from the left bank on 22 Sept 2004.

Site: Downstream side and below single lane bridge over the Lower Adams River (Fig. 21).

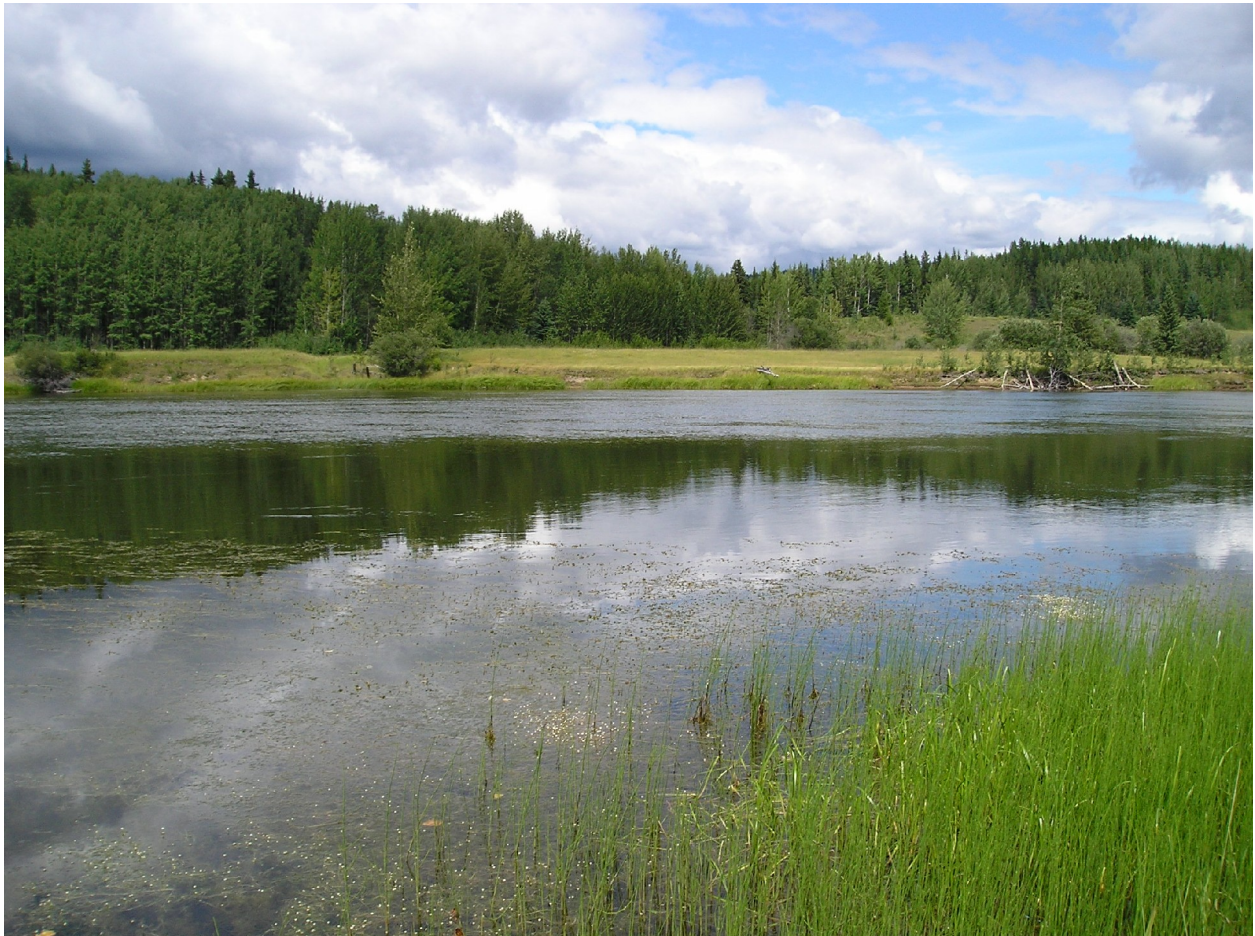
Figure 23. Lower Stuart River at the end of Sturgeon Point Road. Picture taken from the right bank on 21 July 2004.

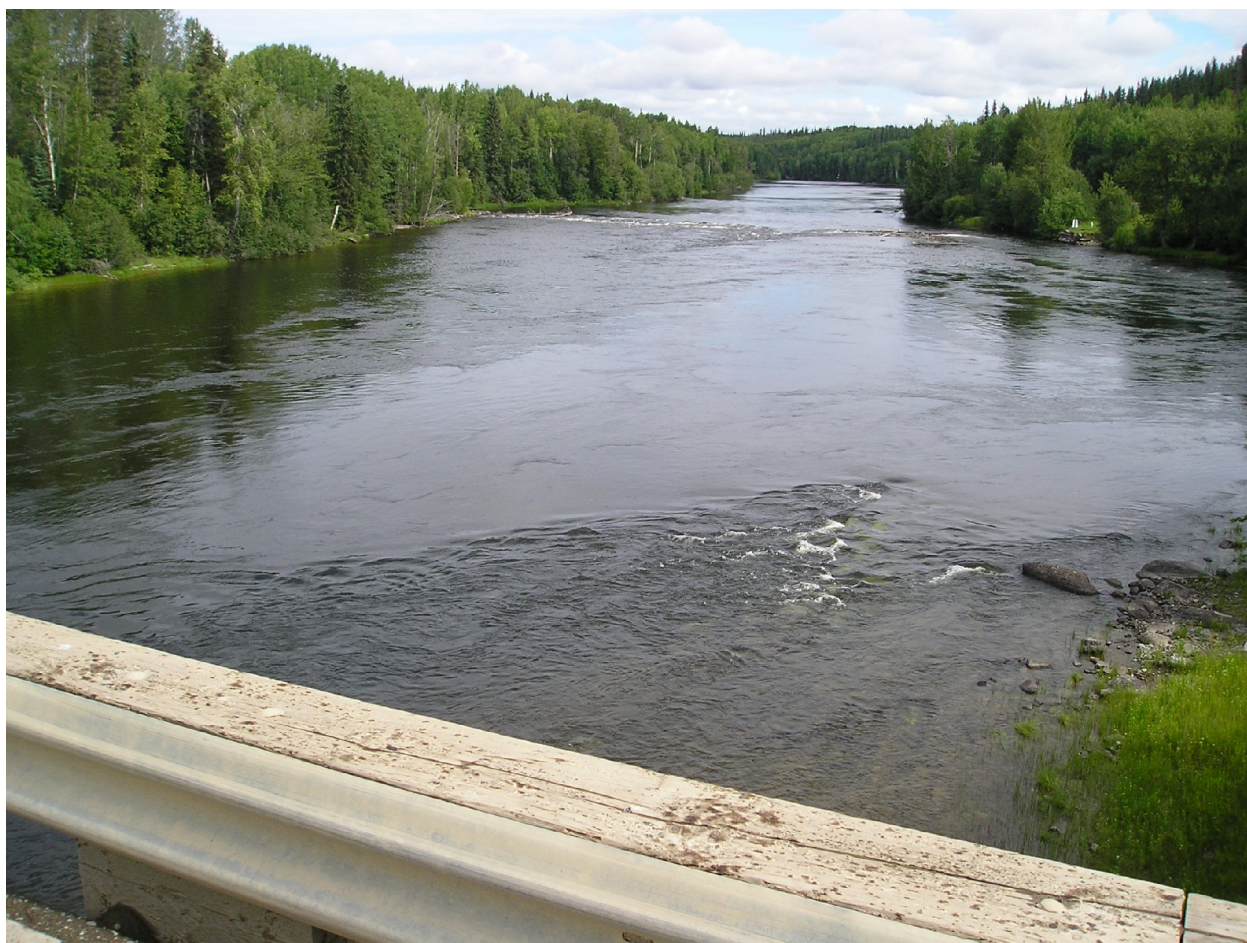
Figure 25. Tachie River on the upstream side of the Tanzuil Road bridge. Picture taken near the left bank on 21 July 2004.
